धातुकर्मीय अन्वेषण रिपोर्ट संख्या : 74/2023

विषय: Metallurgical investigation of Bell Crank Lever

सन्दर्भ: ADE/Wagon's note no- MW/APB/BMB/Escorts , Dated -11/05/2023

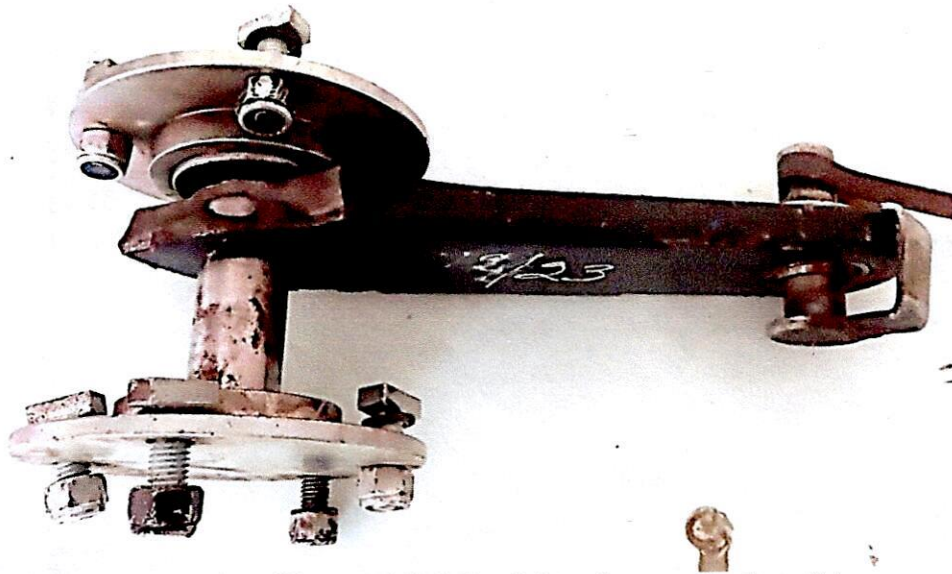
A fractured Bell Crank lever is received for Metallurgical investigation (**fig 1**). Visual examination revealed that bell crank lever had breakage in fatigue manner (**fig. 2&3**). Topography of the fracture face revealed that fracture had initiated from weld and parent metal interface in fatigue manner. Shear lips were also noticed at the initiation point (**fig 3**). Counter fracture face was not received.

Fig.1: Photograph showing of fractured Bell Crank lever in as received condition.

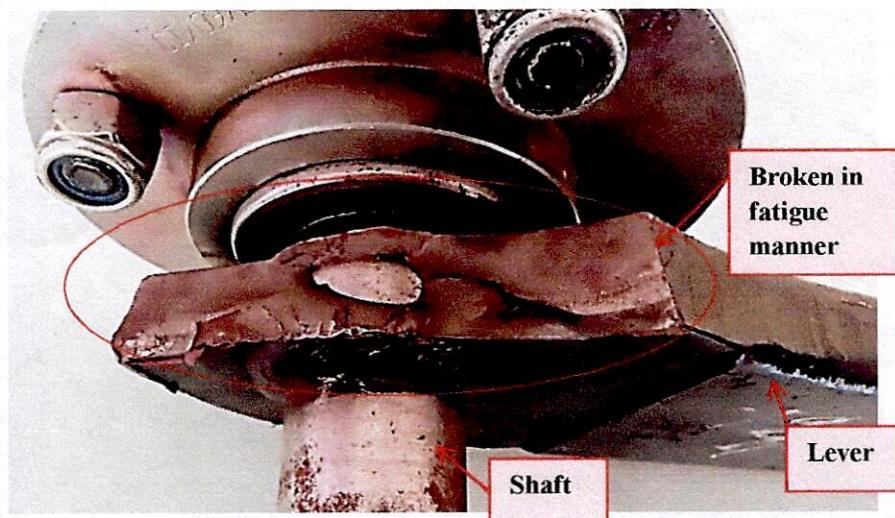
Fig.2: Photograph showing breakage of Bell Crank lever in fatigue manner.

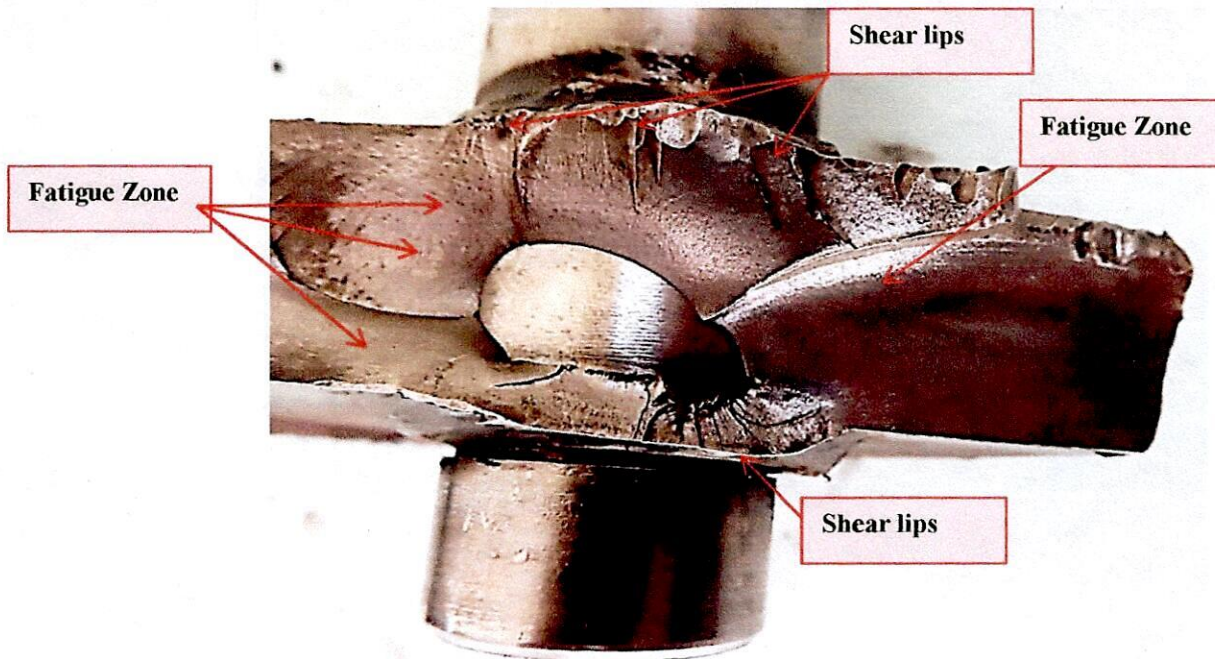
Fig.3: Close view of fig.2 showing fatigue initiation in shear lips forms.

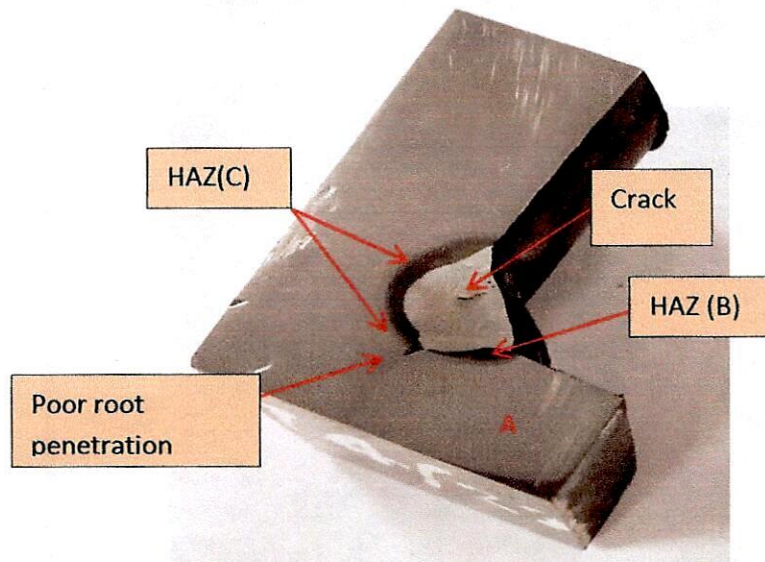
Macro-examination test was conducted at the fracture initiation location. It revealed weld profile & welding defects (fig.4)

Fig.4 Photomacrograph showing welding defects and weld profile at weld Zone.

Macro examination of the fracture location containing (weld portion & parent metals), revealed welding defects such as lack of penetration, crack etc.

Presence of welding defects such as poor root penetration & cracks in weld profile are also observed. Contour of weld profile may be considered satisfactory.

- (i) Welding procedure may be looked into to avoid as such type of failure.
- (ii) Material must ensure as per relevant specification.

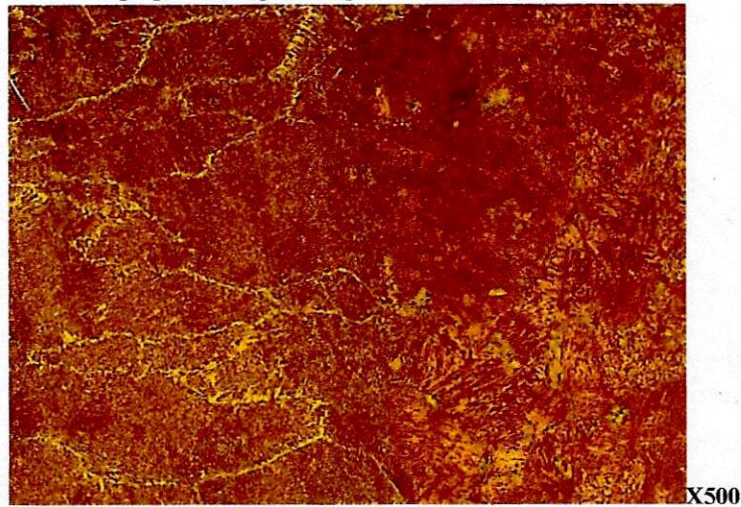
Fig.5 Photomicrograph showing martensite structure at the fatigue initiation zone in HAZ (Location indicated as (B) in fig.4)

It is evident from above tests that metallurgical properties of bell crank lever conform to the relevant specification. Topography of the fracture face revealed that fracture had initiated from weld and parent metal interface ie HAZ. Martensite structure in HAZ indicates that weld and HAZ has undergone fast quenching.

The failure of bell crank lever might be attributable to combined effect of brittleness of weld and presence of needle like martensite structure in HAZ resulted in initiation of fatigue crack leading to the failure of Bell crank lever under cyclic load.

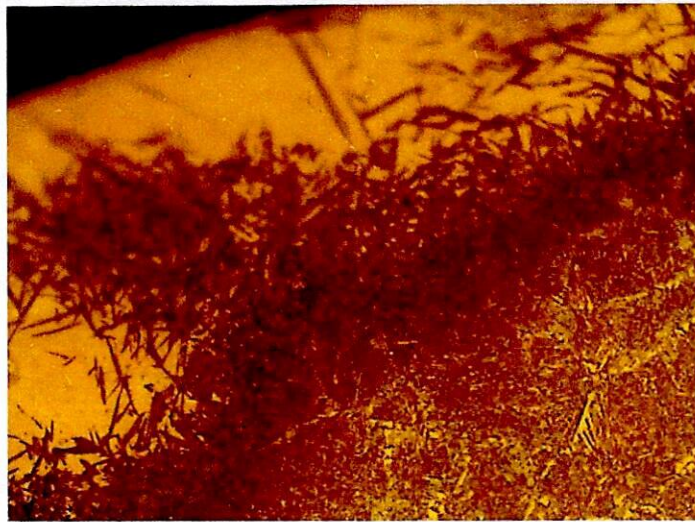
**Fig.6 Photomicrograph showing martensite structure at the fatigue initiation zone in HAZ
(Location indicated as (C) in fig.4)**

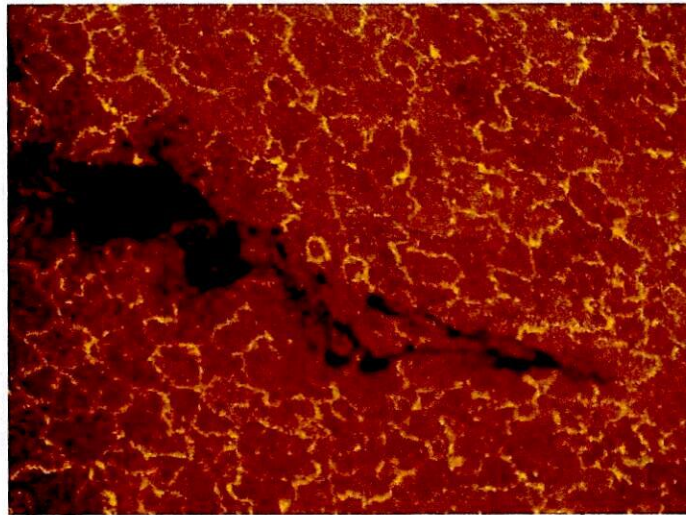
**Fig.7, Photomicrograph showing as cast columnar grains structure along with intergranular crack
in weld portion.**

Microstructure of the bell crank lever revealed directional as rolled ferrite pearlite structure against normalized structure indicative of manufactured from plate instead of forging. Microstructure of weld portion revealed cast columnar grain structure with a micro crack in welded beads. Microstructure at the initiation zone revealed needle like martensite structure prone to crack formation.

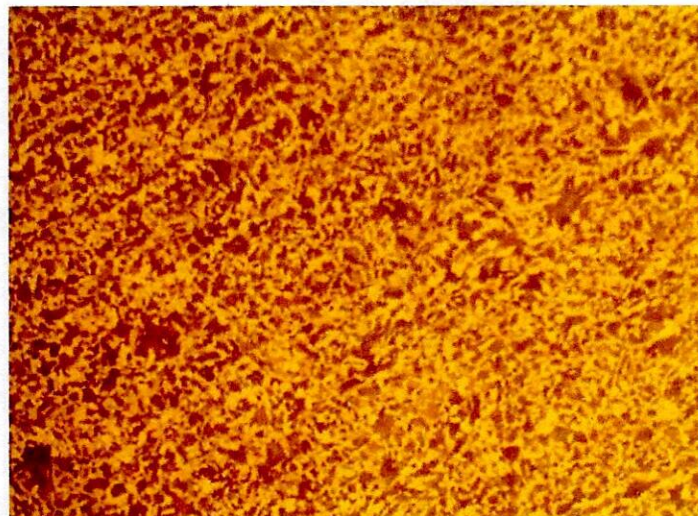
**Fig.8, Photomicrograph showing as rolled ferrite pearlite structure along with directionlity
(Location indicated as (D) in fig.4).**
