No: MC/WA/Failure

Date: 07.08.2023

Sub: Wheel disc crack in LHB coaches.

**CODE OF PROCEDURE FOR ULTRASONIC TESTING OF
LHB WHEEL IN SERVICE**

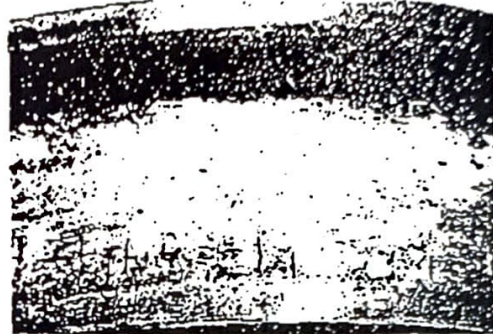
4. Thermal Cracks - Thermal cracks appear on a wheel due to intense heating of the wheel arising out of severe brake binding. Such cracks occur on the tread and generally progress across the tread in a transverse & radial direction. Whenever such a crack becomes visible on the outer face of the rim or a tread crack has reached the outer edge (non-gauge face) of the rim; the wheel should be withdrawn from service. If a crack becomes visible on the outer flange face the wheel should be withdrawn from service.

Wheels involved in severe brake binding should be examined carefully during the maintenance to rule out the possibility of rejectable thermal cracks. Such wheels may be identified by presence of flats (even within acceptable limits) and severe discoloration or blue black heating marks on the tread.

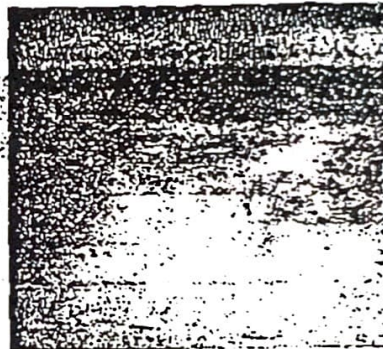
5. Heat checks - Thermal cracks are deeper and need to be distinguished from fine superficial cracks visible on the tread on or adjacent to the braking surface. These are called heat checks, which are usually denser than the thermal cracks. Heat checks are caused on the tread due to heating and cooling cycles undergone by the wheel during normal braking. Such wheels do not need to be withdrawn but should be carefully distinguished from the rejectable thermal cracks.
