## Armature lifting arrangement - LW/PER - August 2018

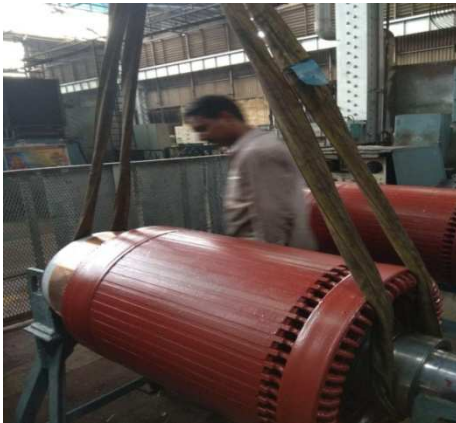
TM Armature was being lifted by using Nylon belt during overhauling. In this case the load of armature was partially transferred from belt to evolutes of coil since it is touching at the edge. This may lead to failure of Armature as well as damage to rope.

Lifting rope touching with  
Armature coil Evolutes

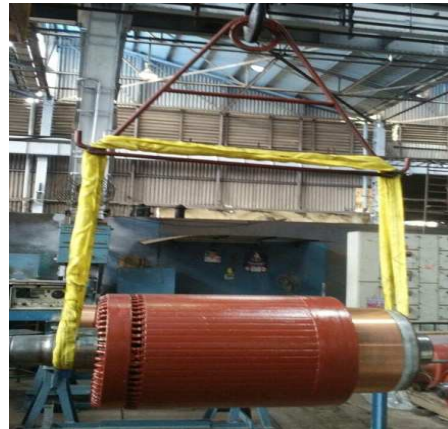
Gap is ensured between lifting rope  
and Armature coil Evolutes

QC team of Traction Motor has fabricated a lifting tackle with spreader as shown in the figure. This arrangement does not allow belt to touch the armature coil evolutes. It will reduce the failure of Armature.
