Decoupling of 101224 NR LWACCW in 02421

03.08.2021

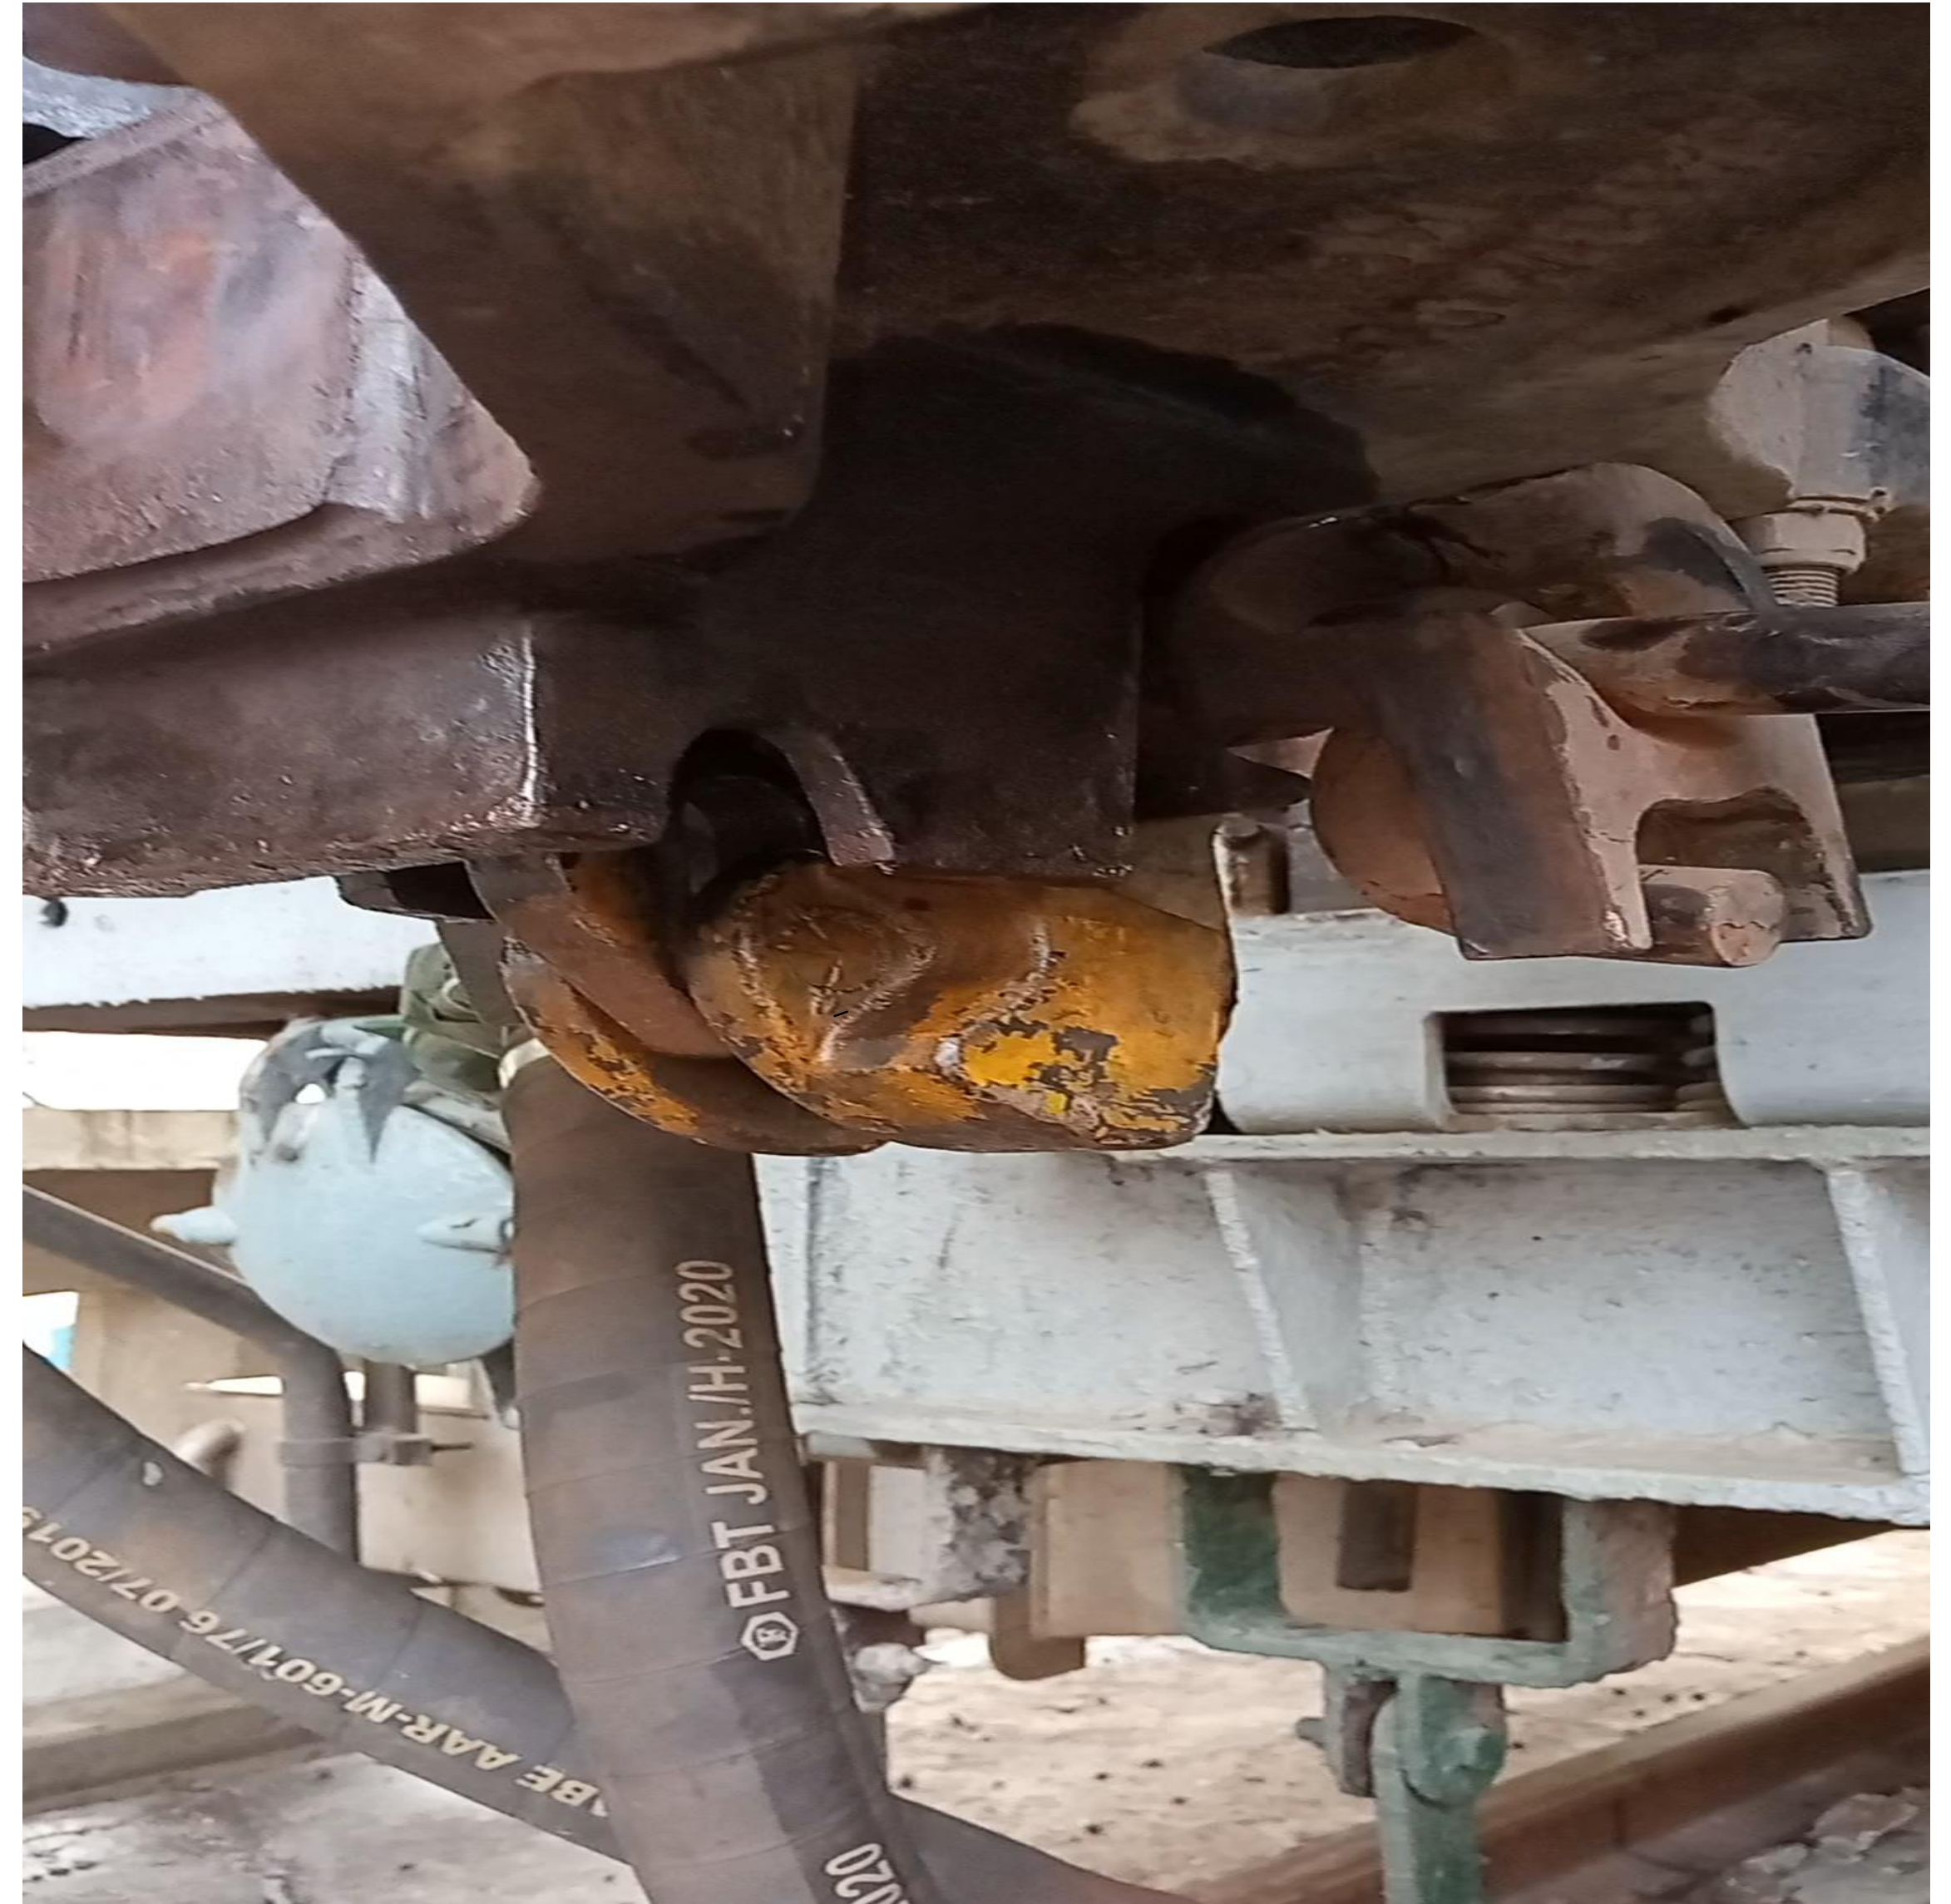
Dellner Coupler

- The manual operating handle is completely locked.
- Now, if the rotary is lifted manually, toggle goes backward, freeing the knuckle lock.
- If the knuckle lock is free, the knuckle can come out due to excessive vibration, resulting in decoupling.

- Installation of lock pin arrangement by M/s Dellner make AAR H type coupler. (Ref: Director/Carriage/RDSO Letter no. MC/BLB/CBC/DELLNER dtd 22.10.2020)
- STR for improved high tensile tight lock CBC. (Ref: RDSO Specification no. RDSO/2011/CG03 (Rev. 3) dtd 30.04.2019)

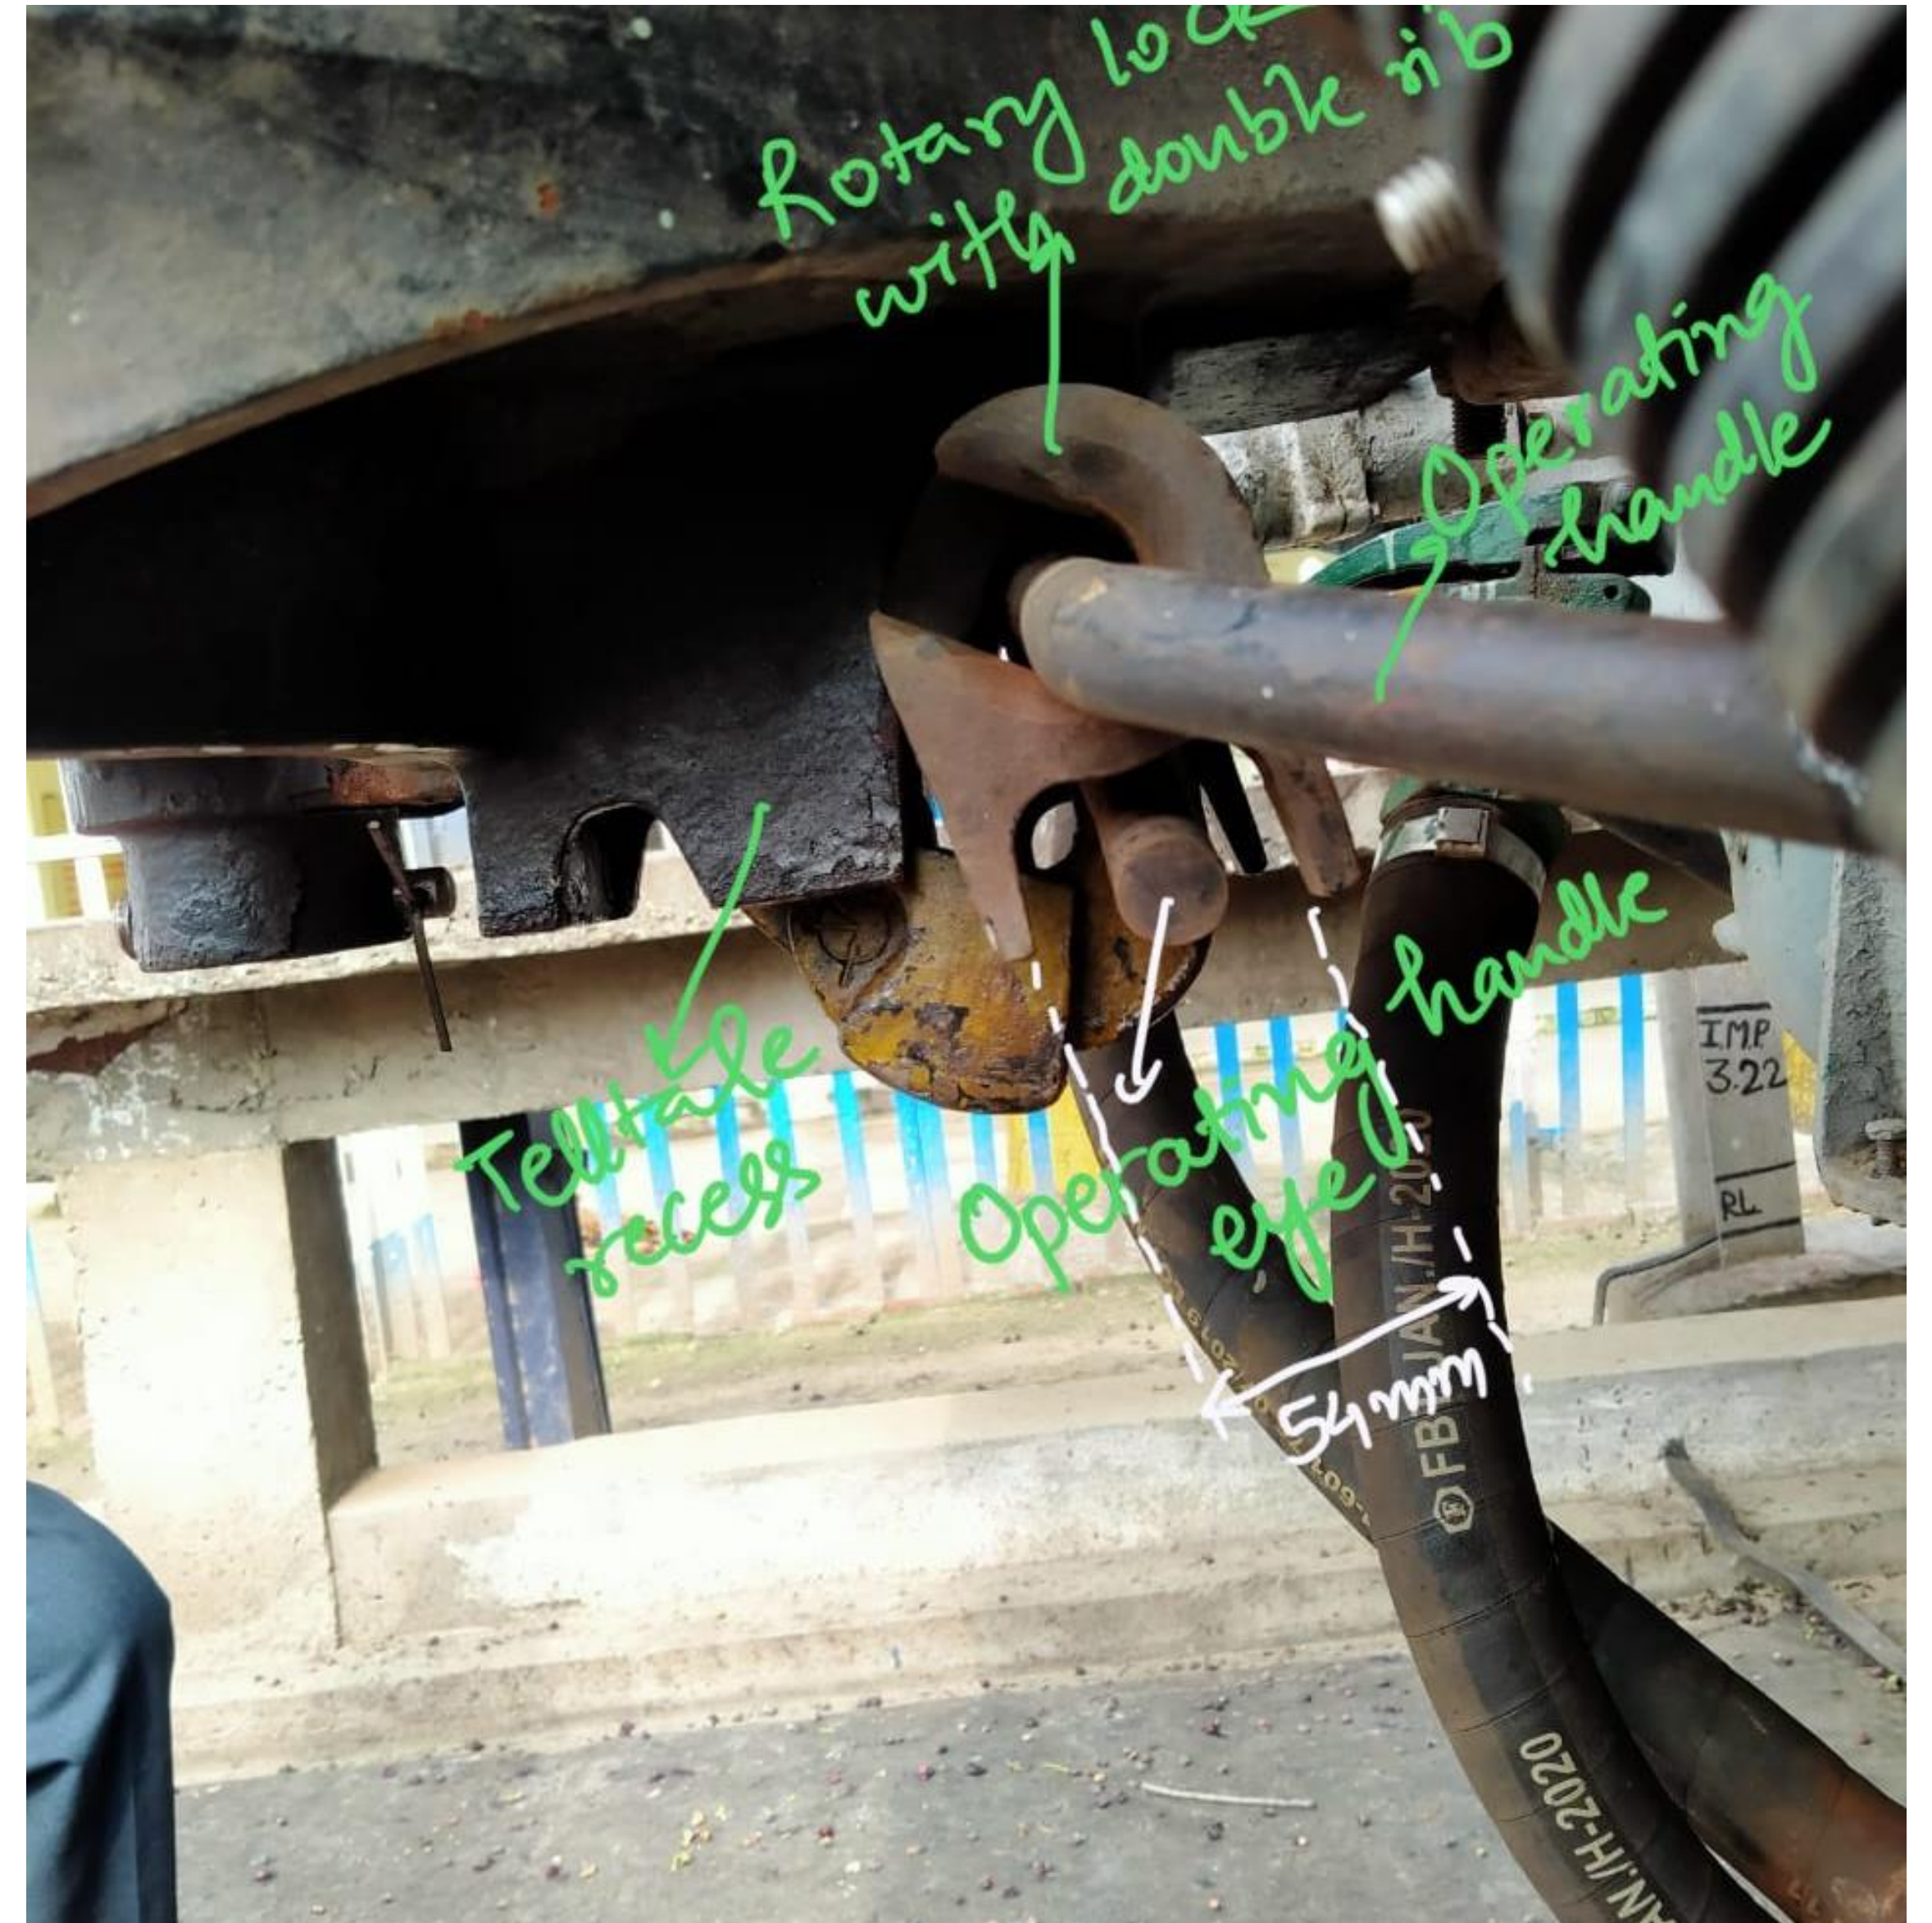
Rotary lock lifter with double rib

- Rib slot distance was measured as 54mm
- The diameter of the operating handle eye was found to be 22mm between the ribs

- All other things were in their limits except the clearance between rotary lock lifter rib and the operating handle eye, which should be between 1/8" and 1/4".
- The oil on the surface of the CBC parts could've assisted the decoupling phenomenon.

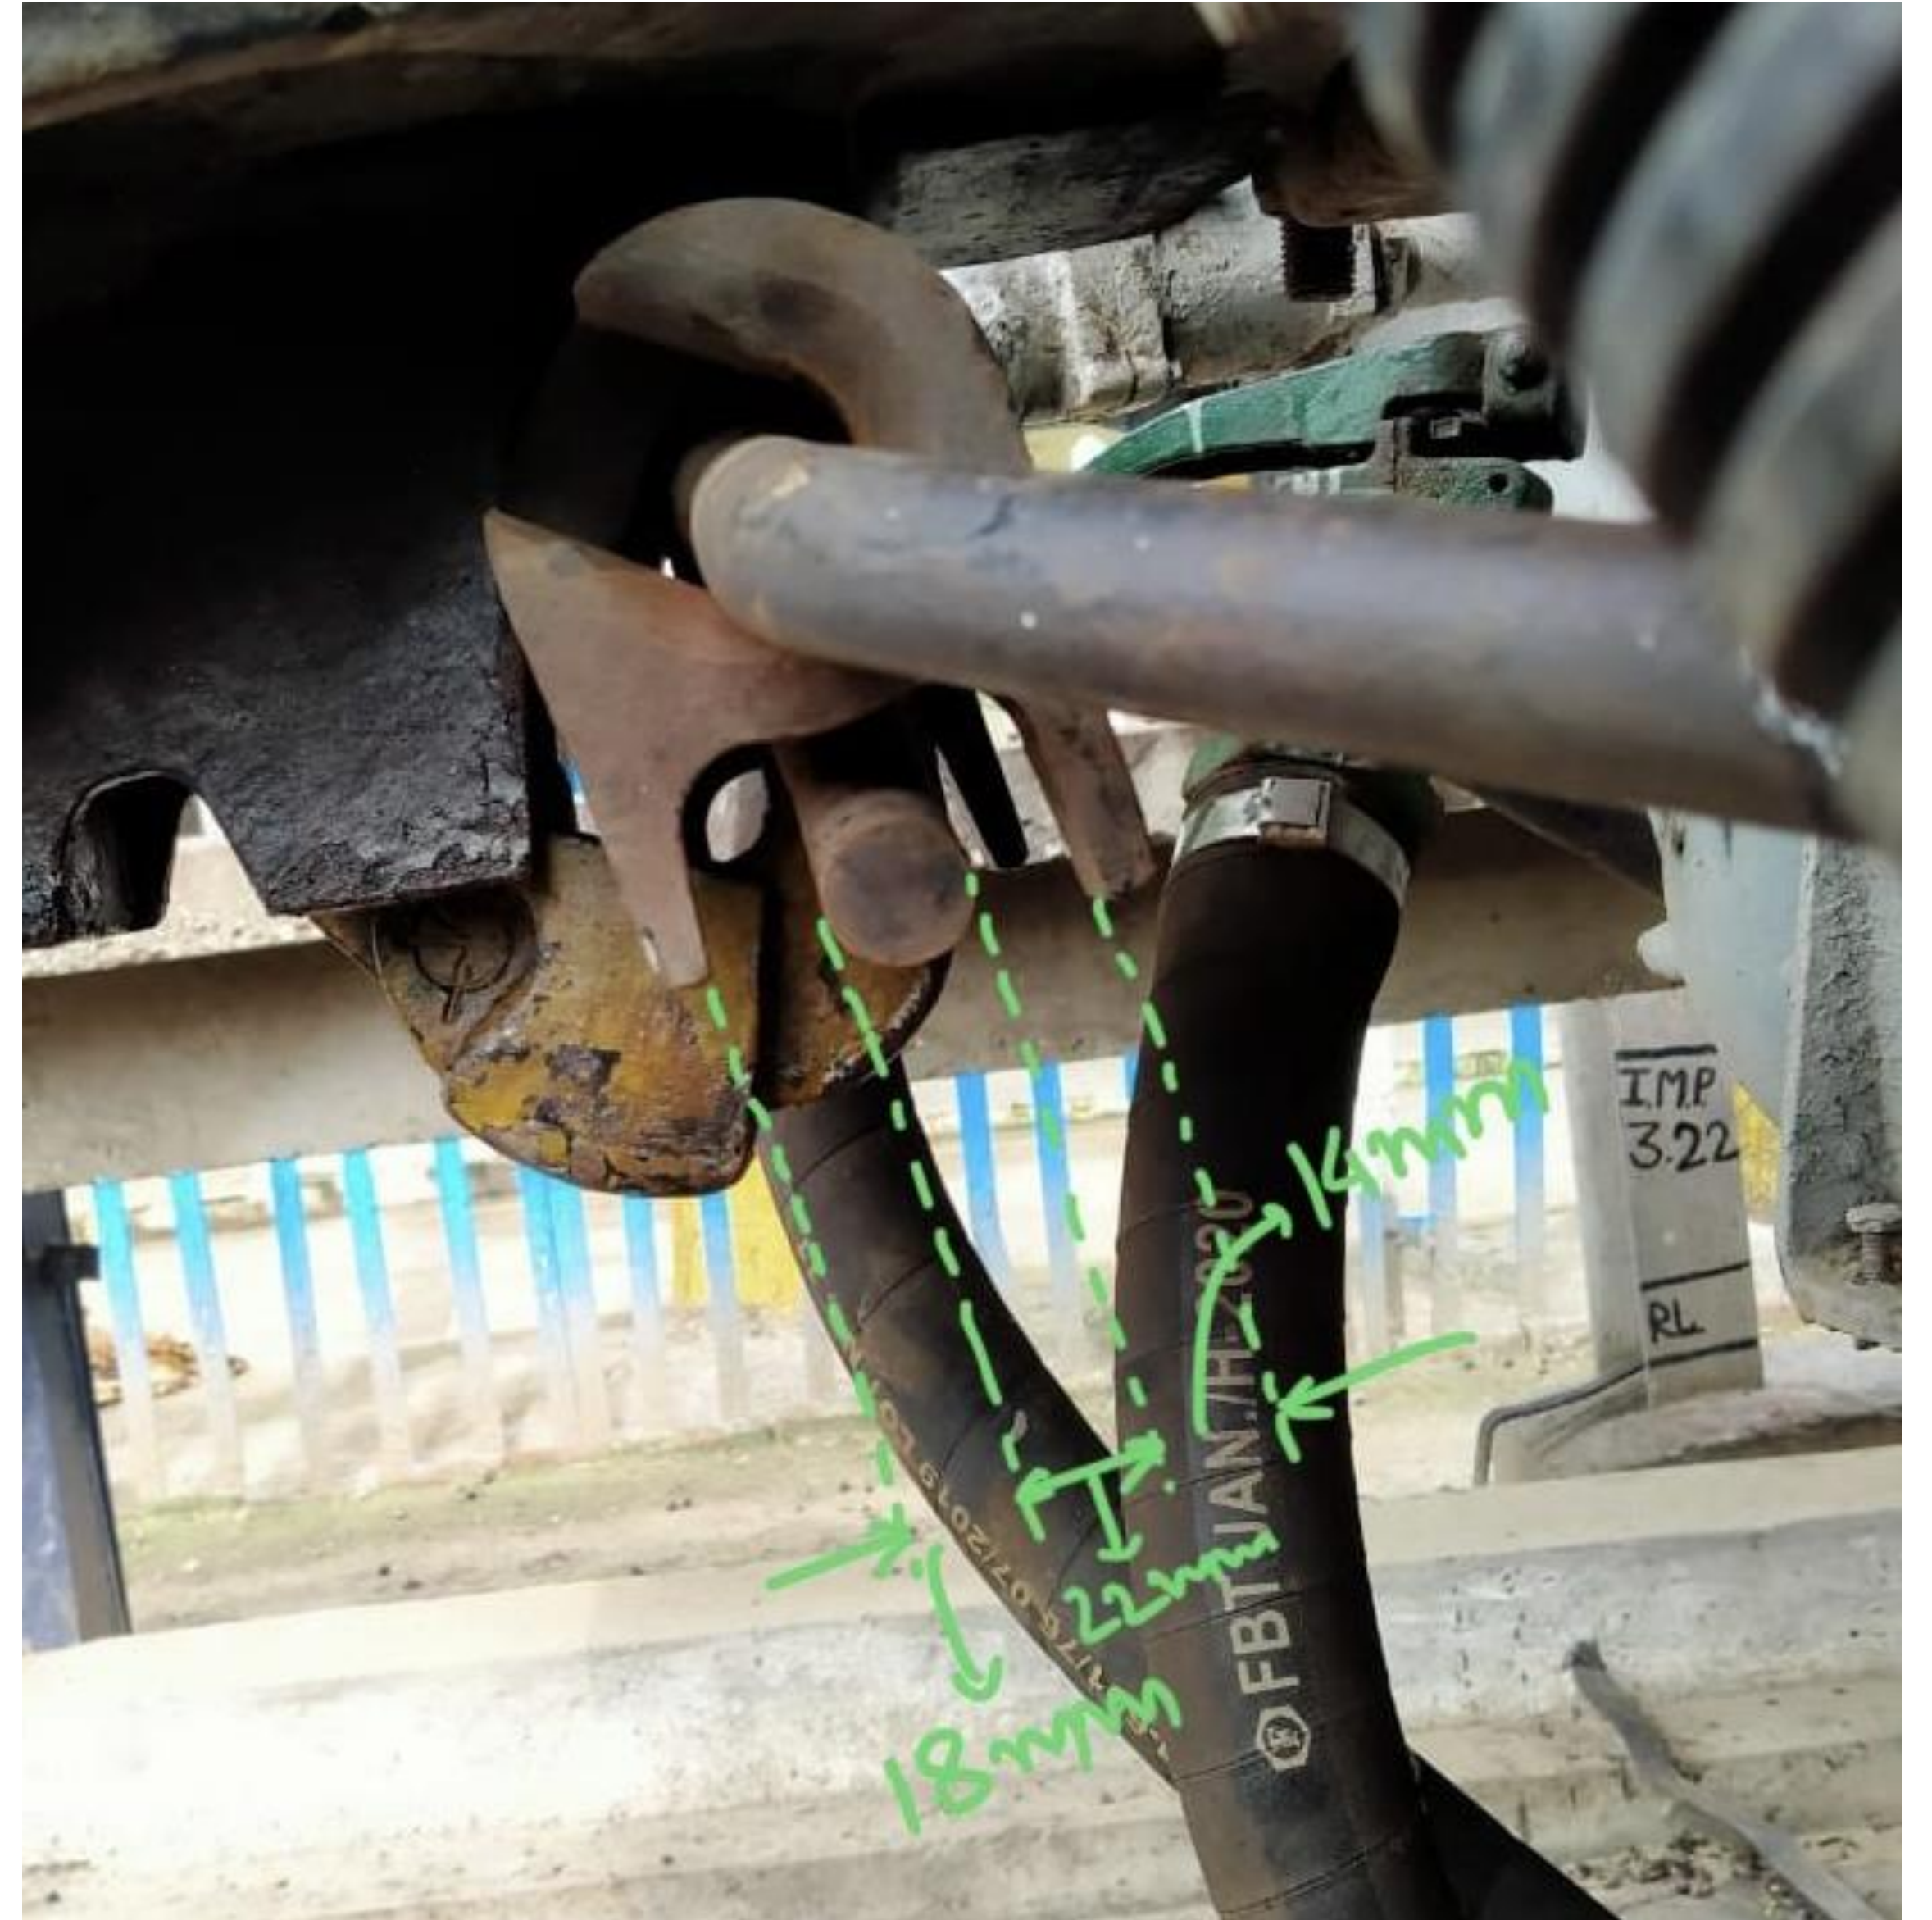
Rotary lock lifter with double rib

- The clearance between the operating handle eye and the rib measured were:
 - 18mm on the front side
 - 14mm on the rear side

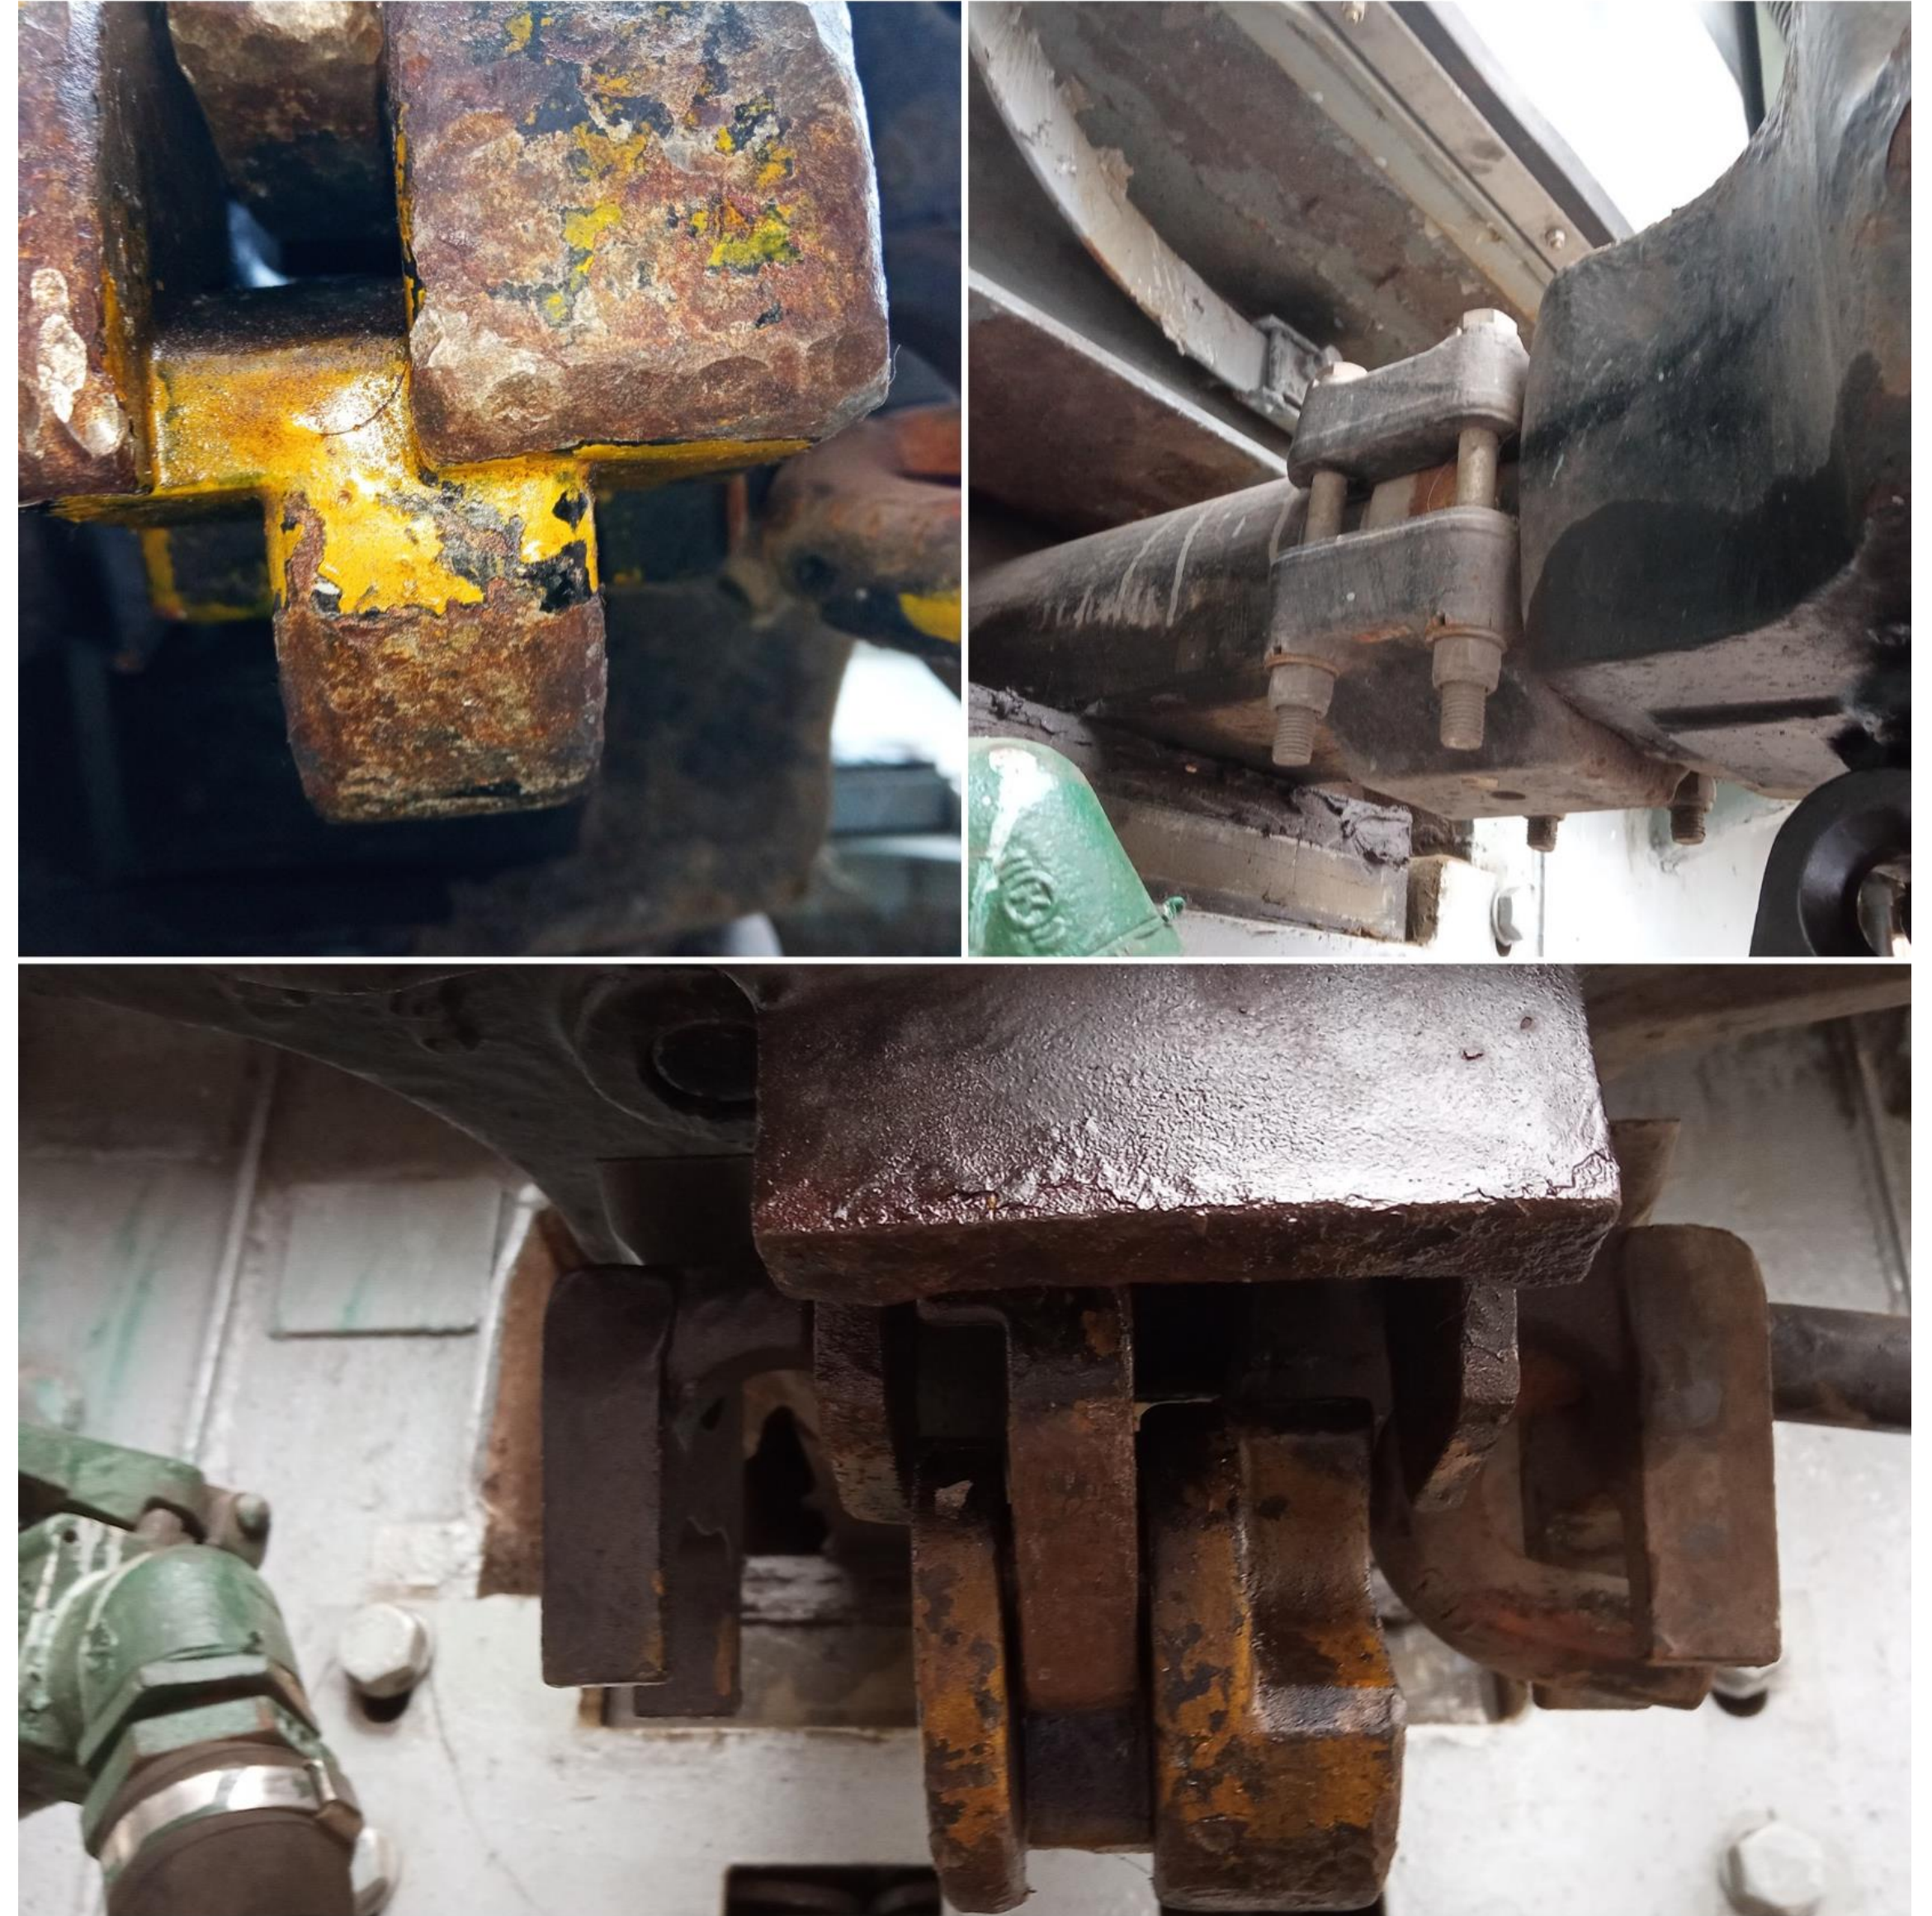
CBC Parts

- CBC parts (knuckle, knuckle lock, lock lifter rotary and toggle) were found in oiled condition.

- According to the firm's statement, the operating eye clearance is not a point of check in the CBC coupling parts.
- Firm's representative stated the cause of decoupling is the oil which was found on the surfaces of CBC parts.

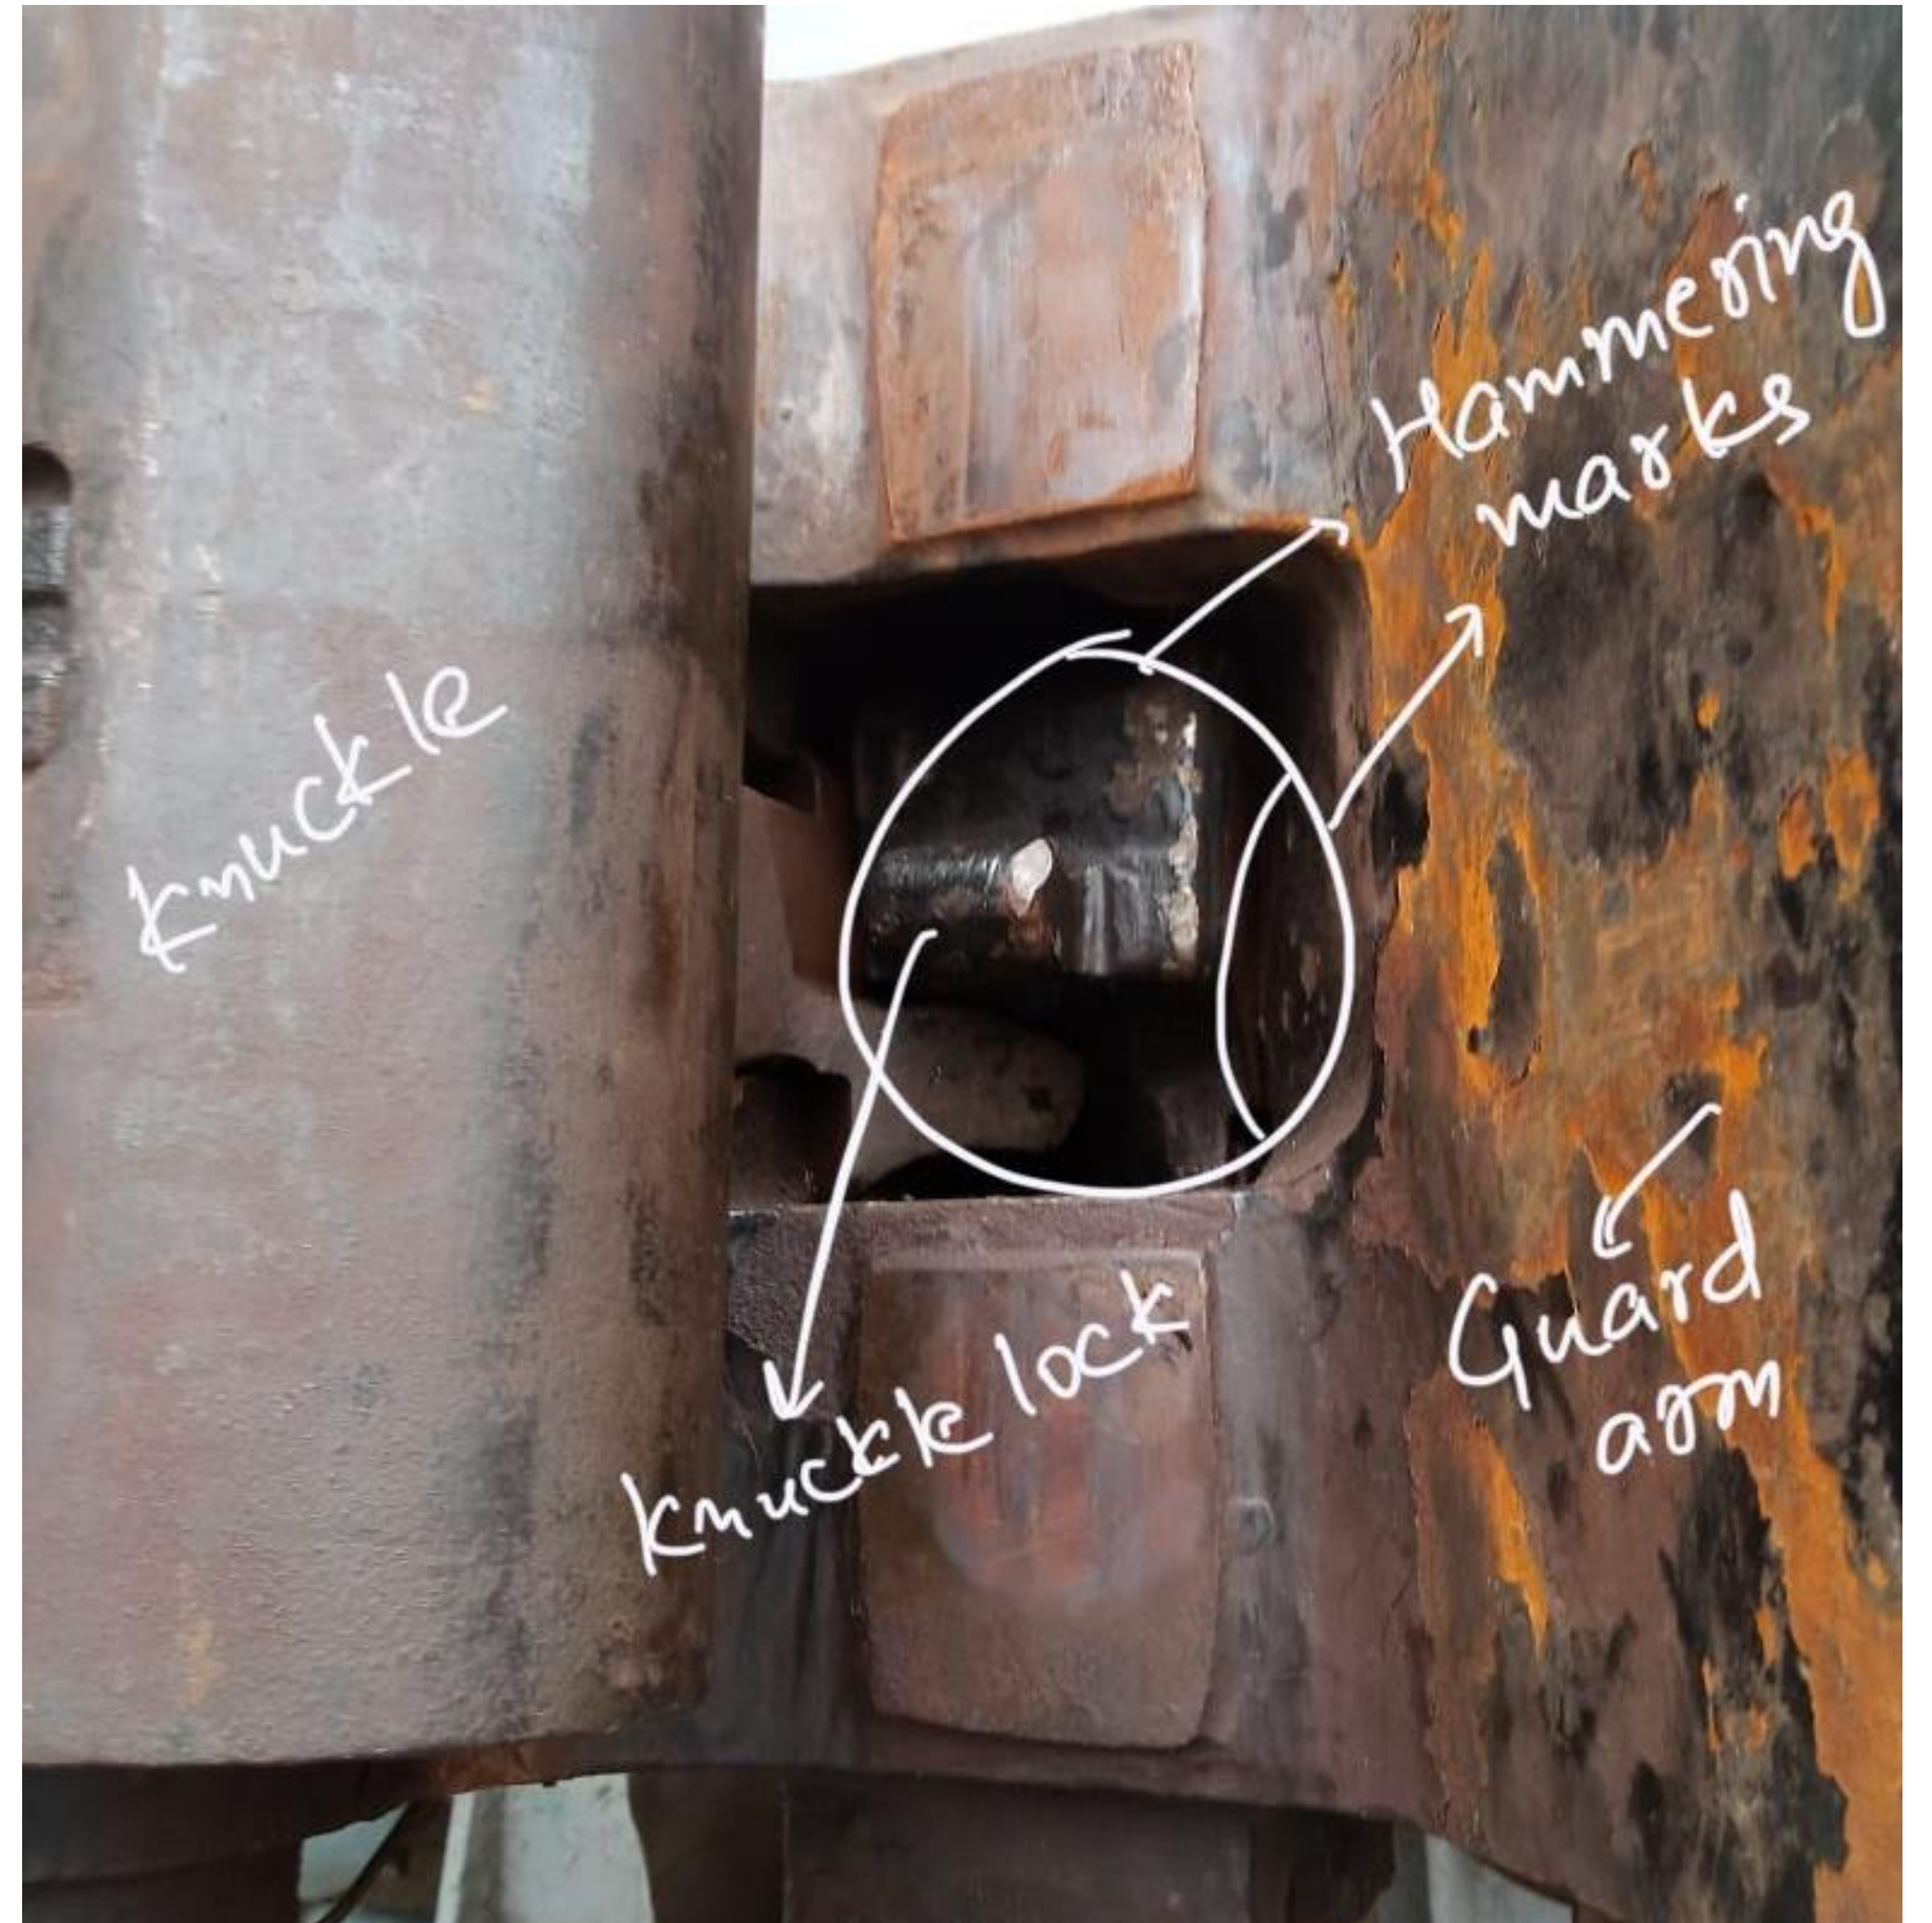
CBC Parts

- There were marks of hammering on the knuckle lock and adjoining parts.
