# HOT AXLE

S.K.SUMAN (CI/C&W)

# FAILURE INVESTIGATION REPORT OF CTRB FAILED ON 02.01.2023 OF DHANBAD DIVISION

# Failure Investigation of Hot Axle CTRB

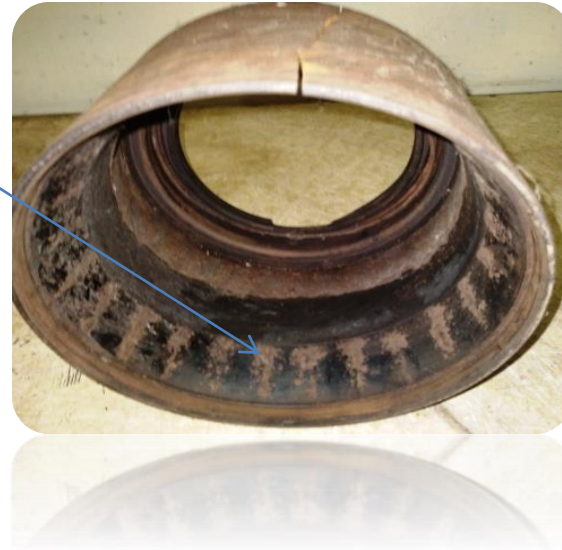
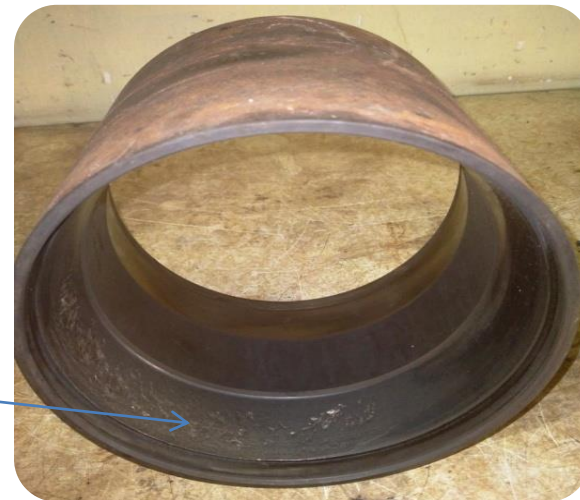
Brinelling Marks

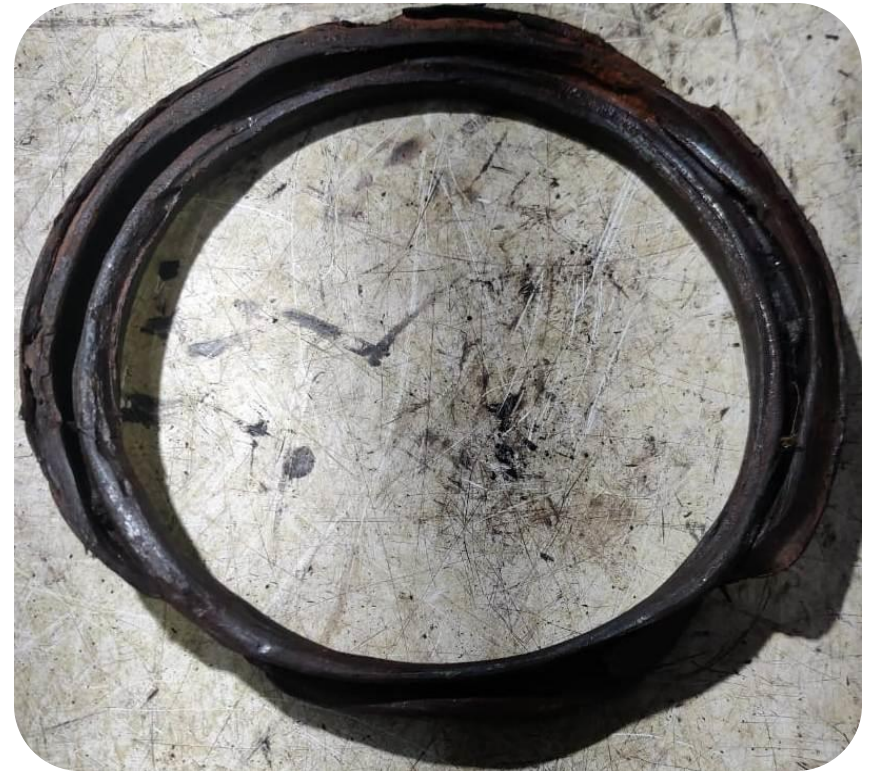
DAMAGE SEAL

- Seal is inspected visually to detect different defects *i.e.*, damage, deformation, rubber seal etc.

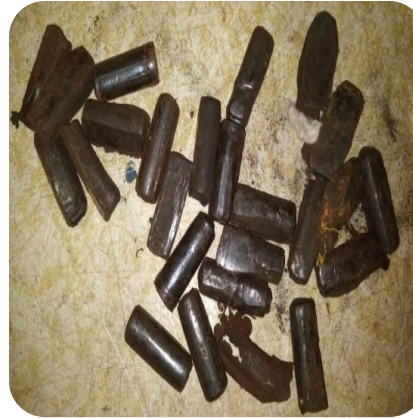
ROLLER (deformed)

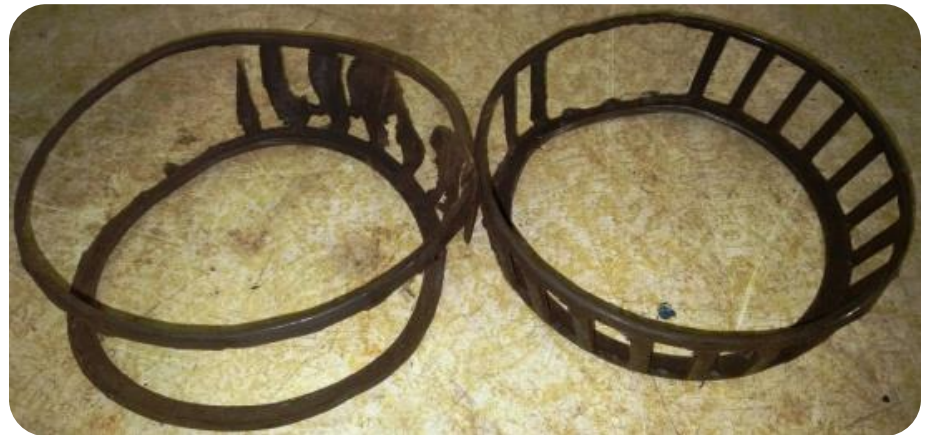
CAGE (BROKEN)

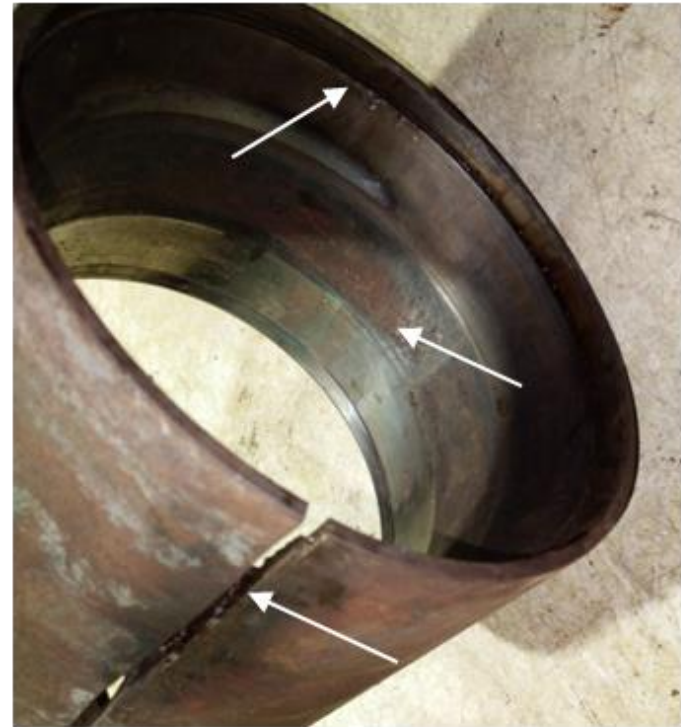
- **Visual-Examination:**
- Longitudinal tearing was observed on the Cup.(Fig. 1)
- Contaminated grease was observed inside the groove of the Cup. (Fig. 1)
- Spalling of metal was observed on the inner surface of the Cup. (Fig. 1)

Fig.1- Showing longitudinal tearing , contaminated grease & spalling of metal on the Cup

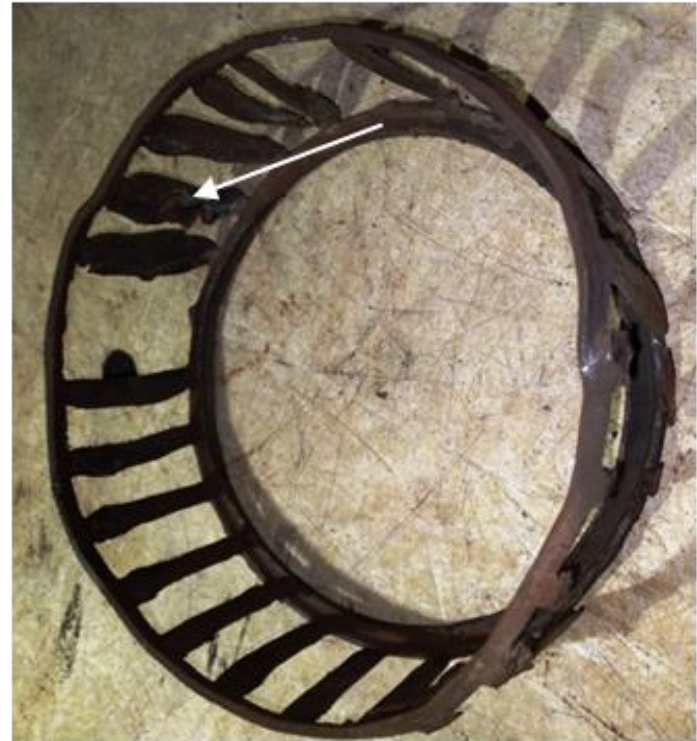
- **Visual-Examination:**
- One of the cages was found damaged and broken. (Fig. 2)
- Rollers of the same cone & cage assembly were found heavily deformed with plastic flow.

Fig.2- Showing broken & damaged cage

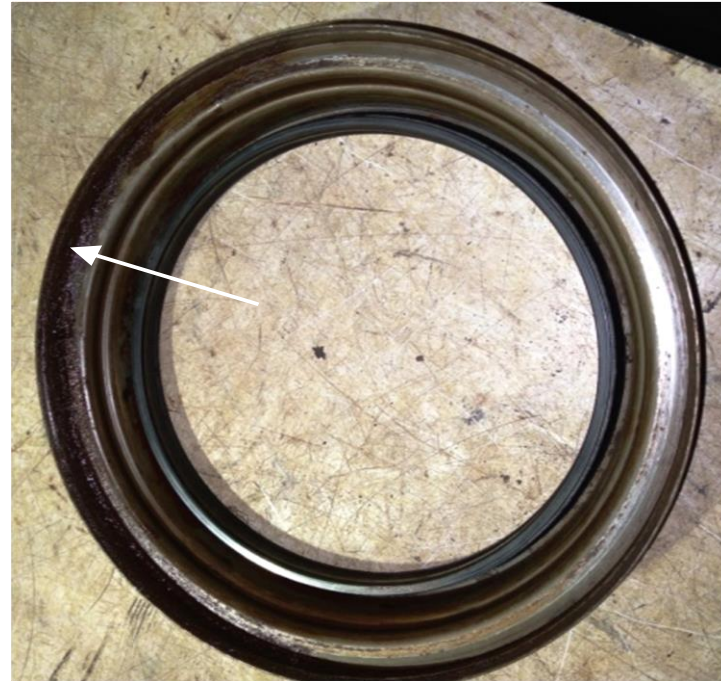
- **Visual-Examination:**
- Contaminated grease was observed on the inner side of the seal. (Fig. 3)
- Heat discoloration mark was observed on the surface of the rollers of the other cone & cage assembly.
- Circumferential wearing & flaking of metal were observed on outer surface as well as inner surface of the cone.
- Other seal, spacer & both seal wearings were not received for investigation

Fig.3- Showing contaminated grease on inner surface of the seal

It was damaged in such a condition that nothing was intact. Therefore, it was not possible to reach in final conclusion. So exact cause can not be ascertained.

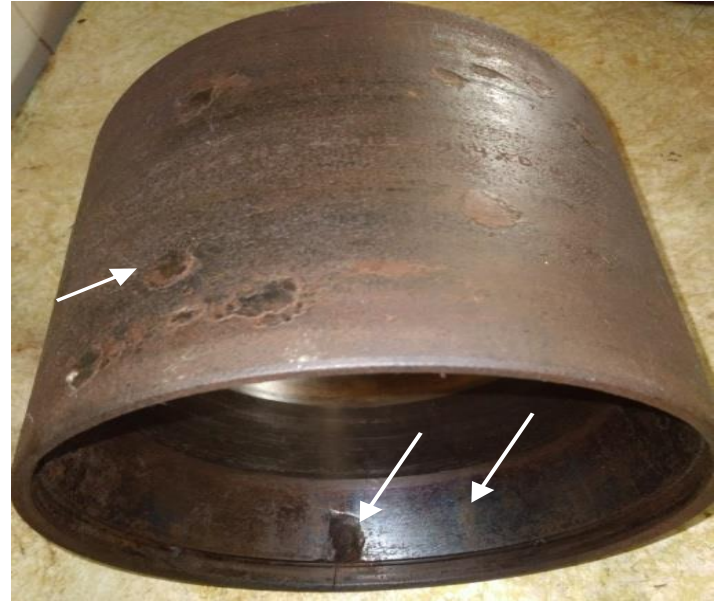
- **Visual-Examination:**
- Pitting marks was observed on outer surface of the cup. (Fig. 1)
- Spalling of metal, heat discoloration & brinelling marks were observed on the inner surface of the cup. (Fig. 1)
- A crack was observed at the edge of the cup.

Fig.1- Showing pitting marks on outer surface and spalling, heat discoloration & brinelling mark on inner surface of the cup.

The failure of CTRB is due to overloading and contamination of grease during service.

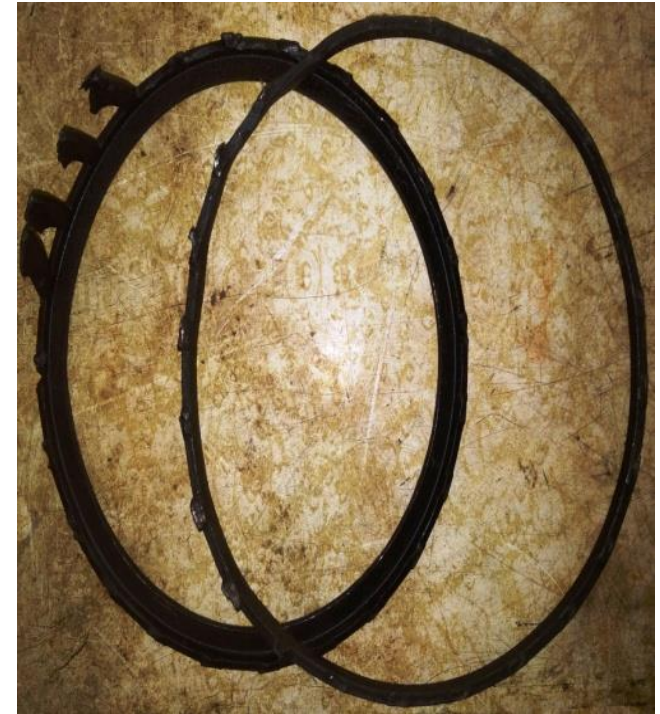
- **Visual-Examination:**
- Circumferential wearing & scoring were observed on outer surface of one of the cone.
- One of the cages was found broken & damaged. (Fig. 2)

Fig.2- Showing broken & damaged cage.

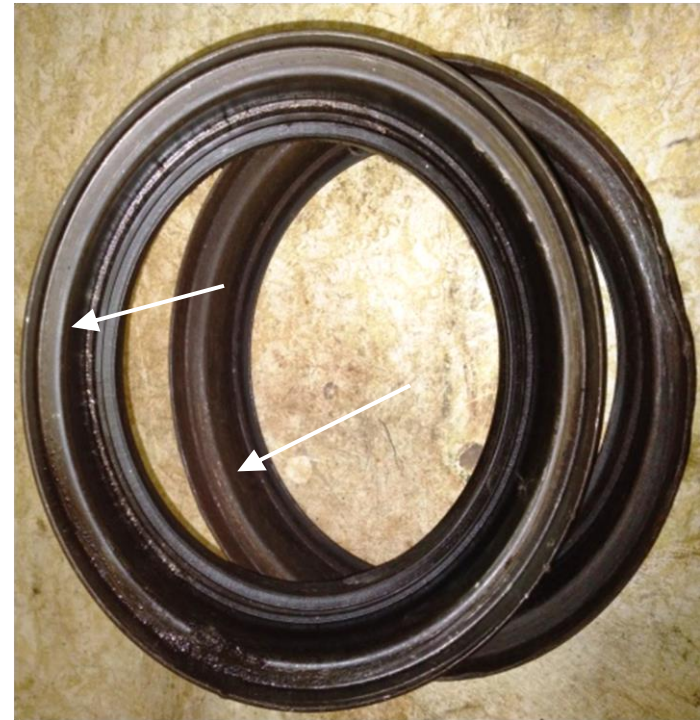
- **Visual-Examination:**
- One of the seal was found without rubber & damaged at the edge. (Fig. 3)
- Contaminated grease was observed in the grooves of the other seal. (Fig. 3)
- Heat discoloration mark was observed on the inner surface of one of the seal wear ring and on the rollers of the other cone & cage assembly

Fig.3- Showing one seal with rubber & contaminated grease and other seal without rubber.

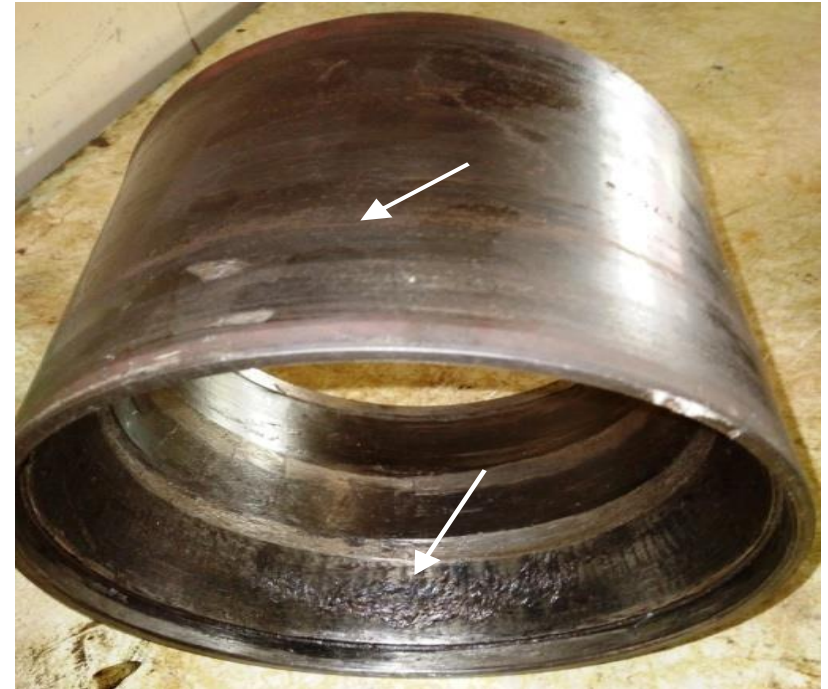
- **Visual-Examination:**
- Most of the vital components of CTRB were not received for failure investigation.
- Scoring & flaking of metal were observed on outer surface of the cup. (Fig. 1)
- Wearing, Spalling, flaking & flow of metal were observed on the inner surface of the cup. (Fig. 1)
- Bulging was observed at the edges of the cup.

Fig.1- Showing scoring on outer surface and spalling & flaking on inner surface of the cup.

The failure of CTRB may be occurred due to overloading during service.

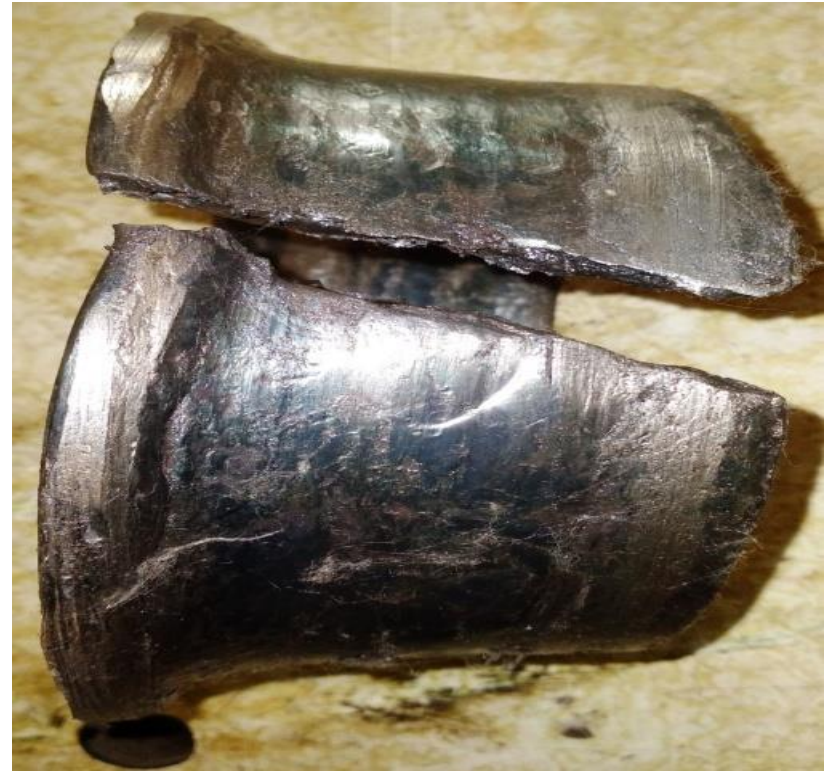
- **Visual-Examination:**
- One of the received cones was found broken & heavily damaged i.e. bulging, plastic flow, wearing & flaking etc. (Fig. 2)

Fig.2- Showing one of the broken & heavily damaged cone.

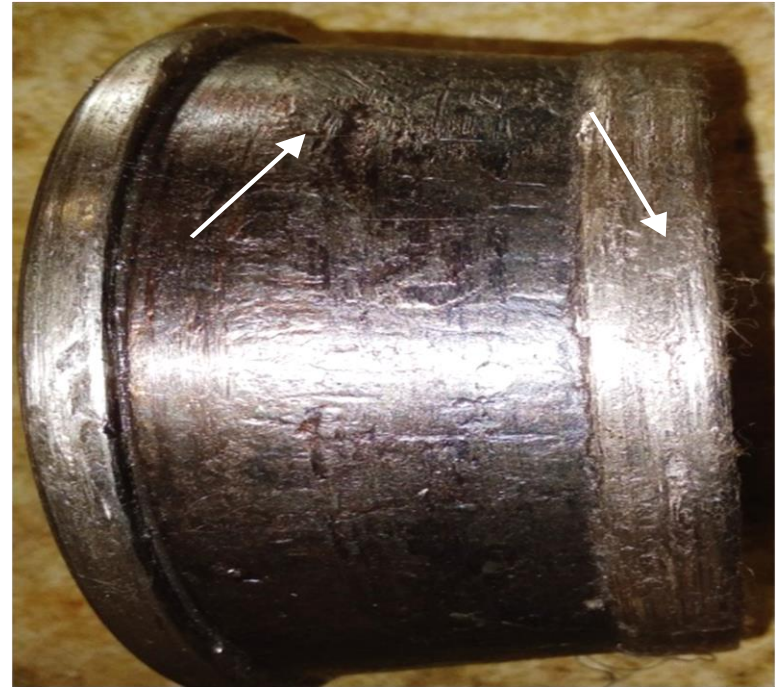
- **Visual-Examination:**
- Plastic flow of metal, wearing & flaking of metal were observed on outer surface of the other received cone (Fig. 3)

Fig.3- Showing plastic flow, wearing & flaking on outer surface of other cone.

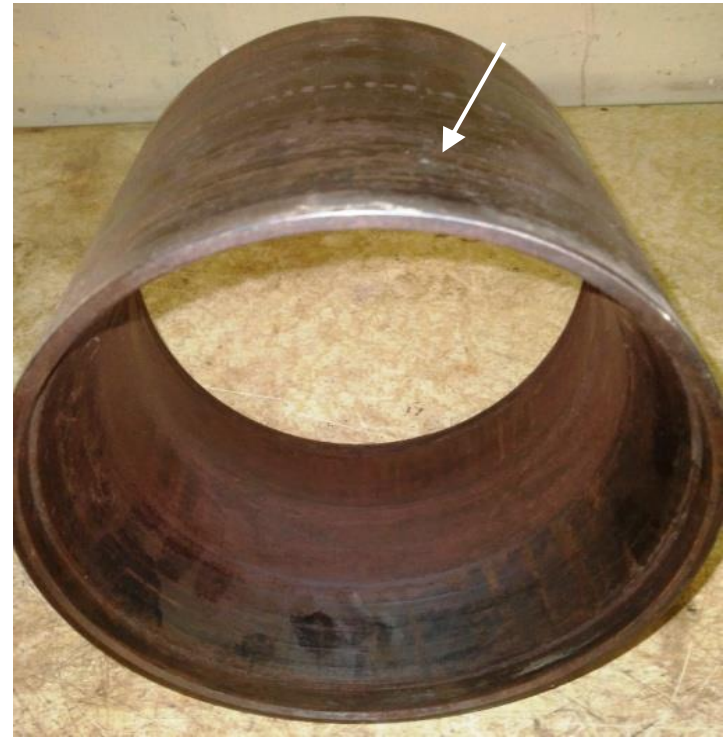
- **Visual-Examination:**
- Scoring mark was observed on outer surface of the cup. (Fig. 1)
- Contaminated grease was observed inside the grooves of inner surface of the cup.
- Heat discoloration was observed on inner surface of the cone.

Fig.1- Showing scoring mark on outer surface of the cup.

The failure of CTRB is due to overloading and contamination of grease during service.

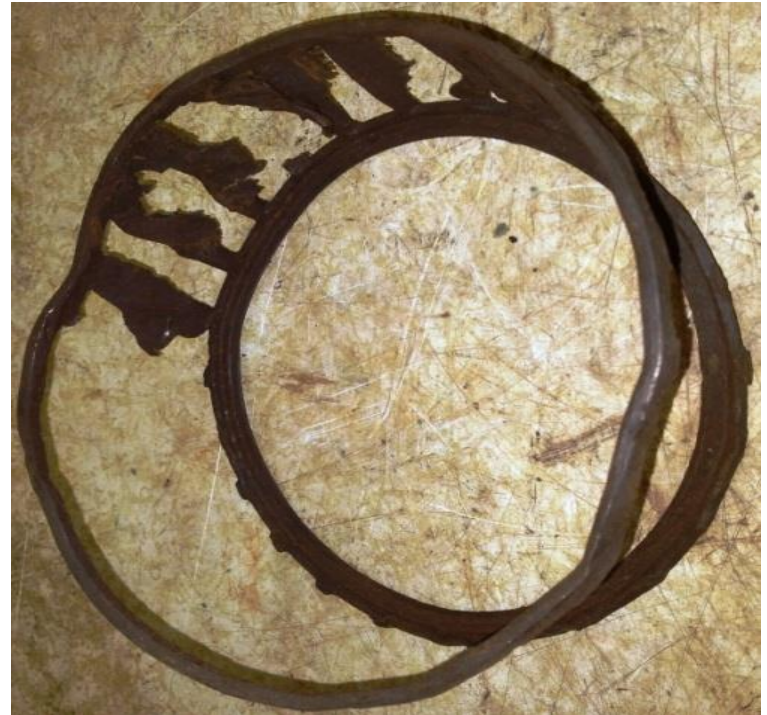
- **Visual-Examination:**
- One of the cages was found broken, deformed & damaged. (Fig. 2)
- Other cone & cage assembly was found broken, deformed & damaged.

Fig.2- Showing broken, deformed & damaged cage.

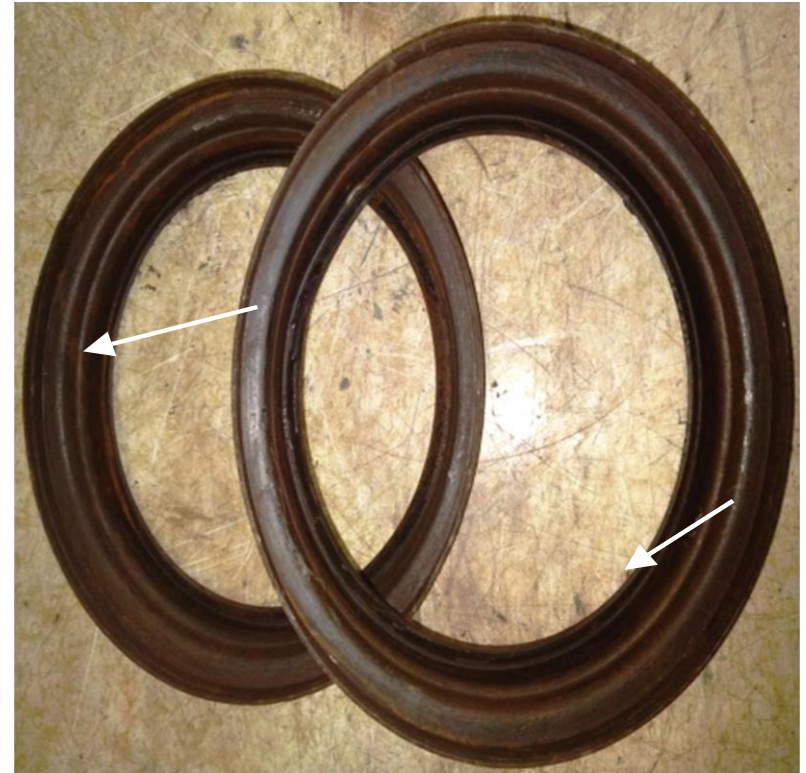
- **Visual-Examination:**
- Both of the seals were found without rubber. (Fig. 3)
- Plastic flow of metal & deformation were observed in most of the received rollers.

Fig.3-Showing both seals without rubber.

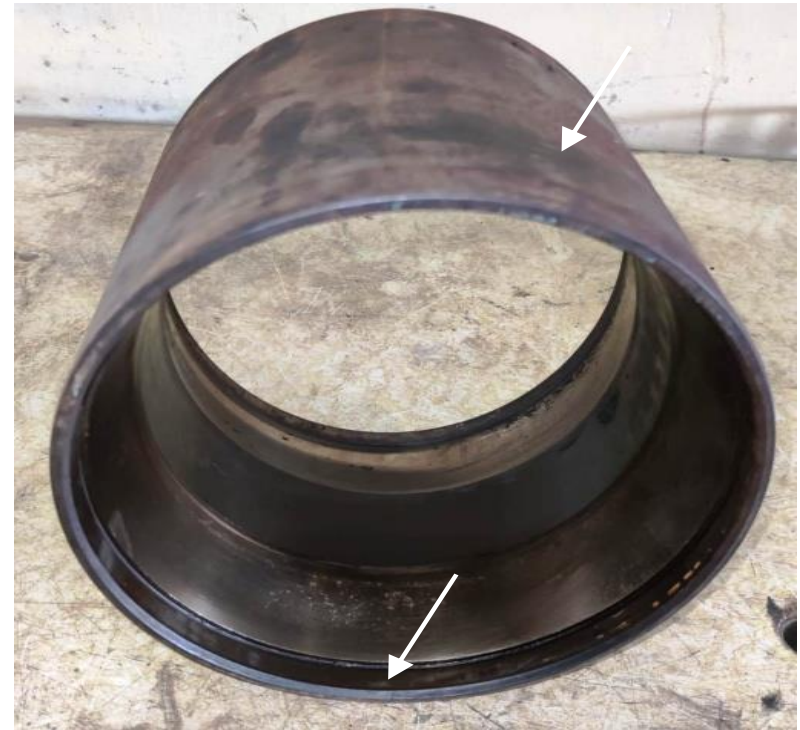
- **Visual-Examination.**
- CTRB was received in oxy-cut condition.
- One of cage and seal was stuck inside the cup during oxy cut.
- Circumferential scoring marks were observed on outer surface of the cup. (Fig. 1)
- Contaminated grease was found inside the groove of the seal stuck with the cup as well as inside the groove of the cup. (Fig. 1)
- Heat discoloration marks were observed on the inner surface of the cup.

Fig.1- Showing circumferential scoring marks on outer surface of the cup and contaminated grease inside the groove.

The failure of CTRB is due to overloading and contamination of grease during service.

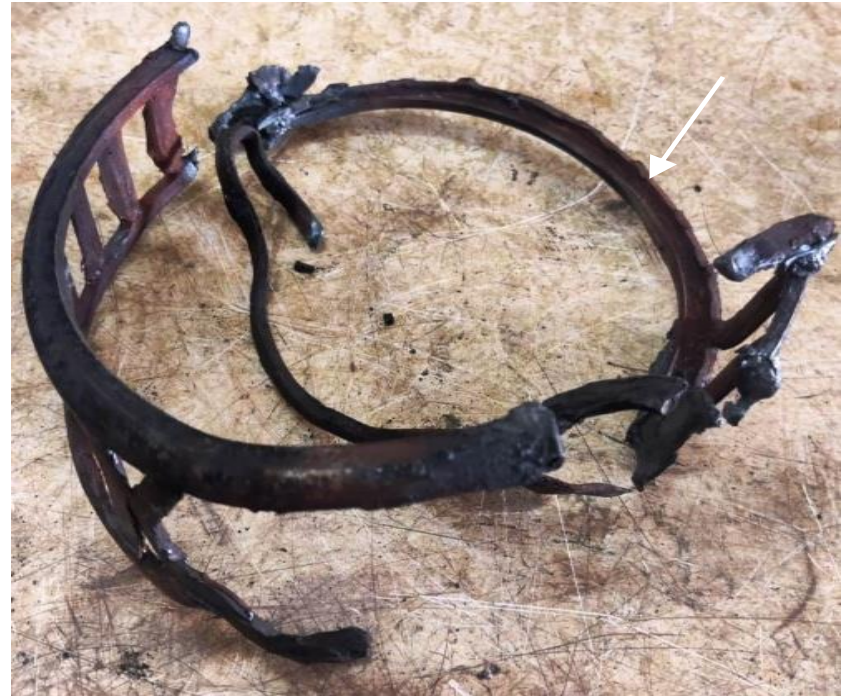
- **Visual-Examination:**
- One of the cage was found broken, damaged & deformed. (Fig. 2)

Fig.2- Showing broken ,  
damaged & deformed cage

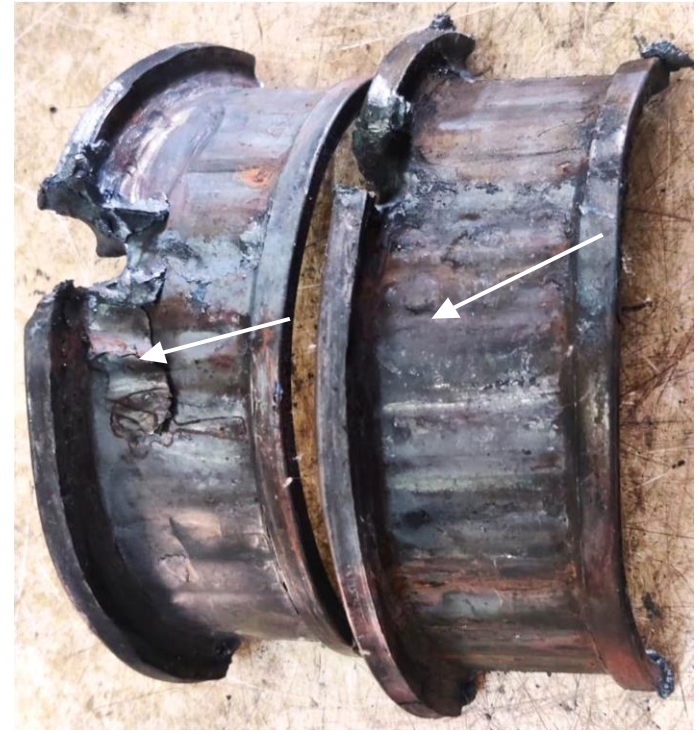
- **Visual-Examination:**
- Deep brinelling marks with plastic flow of metal were observed on outer surface of one of the cone and heat discoloration mark was observed on the inner surface of the other cone. (Fig. 3)
- Rollers and one of the seal was not received for failure investigation.

Fig.3- Showing deep brinelling marks with plastic flow of metal on outer surface of one of the cone.

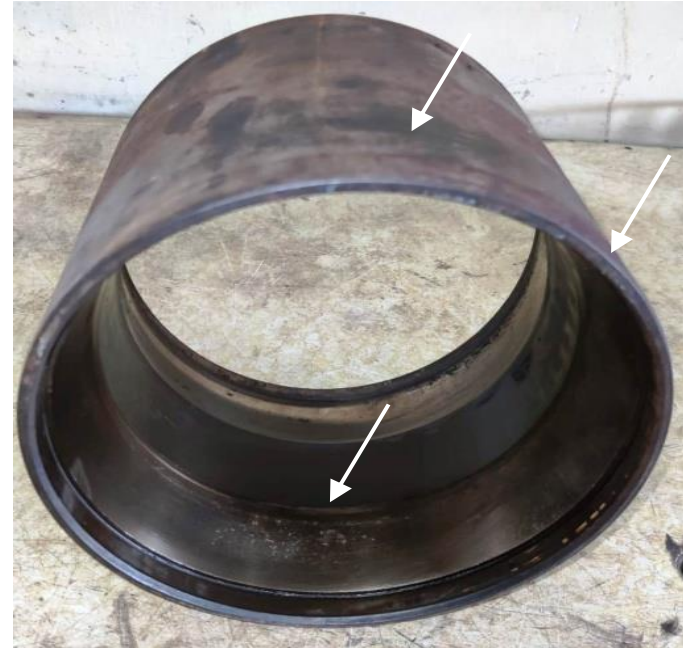
- **Visual-Examination:**
- Circumferential scoring and pitting marks were observed on the outer surface of the cup. (Fig. 1)
- Spalling of metal and contaminated grease inside the groove was observed on the inner surface of the cup. (Fig. 1)
- Bulging was observed at the edge of the cup. (Fig. 1)
- A groove formation was observed on the inner surface of one of the seal and contaminated grease was observed inside the groove of both the seal.

Fig.1- Showing Circumferential scoring on outer surface of cup. Spalling of metal and contaminated grease inside the groove on the inner surface of the cup and bulging at the edge of the cup.

- The failure of CTRB is due to overloading and contamination of grease during service.

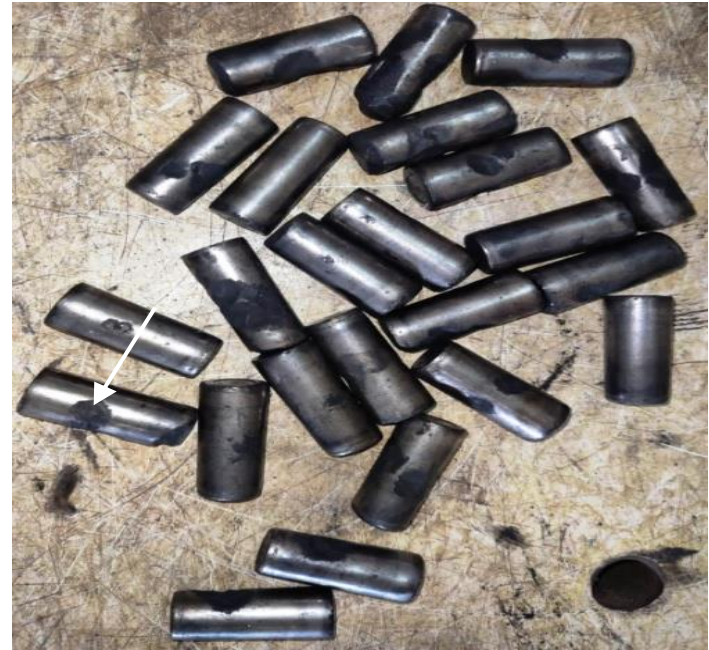
- **Visual-Examination:**
- Flaking of metals and pits were observed on almost all the rollers of one of the cone and cage assembly. (Fig. 2)
- Contaminated grease was observed in between one of the cage and cup assembly.

Fig.2- Showing flaking of metals and pits on almost all the rollers of one of the cone and cage assembly.

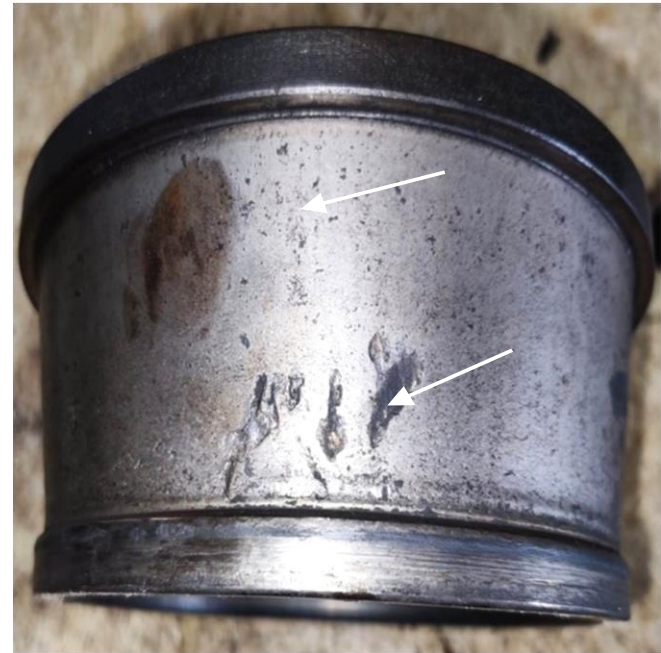
- **Visual-Examination:**
- Pitting & flaking of metals were observed on outer surface of the cone. (Fig. 3)
- Contaminated grease was observed inside groove of one of the cage.

Fig.3- Showing pitting & flaking of metals on outer surface of the cone.

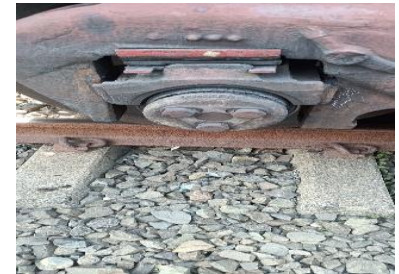
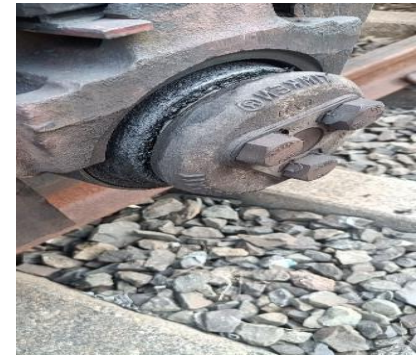
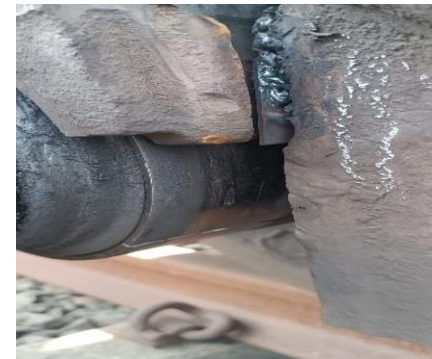
Note: 1. Crown sheet heavily worn out.  
 2. Colour matching of adapter was done. Only 30 % matching was achieved which is less than RDSO mandated minimum 80 %. The insufficient contact area of the defective adapter caused impact loading on the CTRB, causing cup breakage.

As per adapter investigation report. 1. Crown Sheet Heavily worn out  
 2. Colour matching of adapter was done. Only 30% matching was achieved, which is less than RDSO mandated minimum 80%.  
 Insufficient contact area of the defective adapter caused impact loading on the CTRB, causing Cup breakage (crack).

\*CTRb failed due to adapter failure.[insufficient contact area of the defective adapter caused impact loading on the

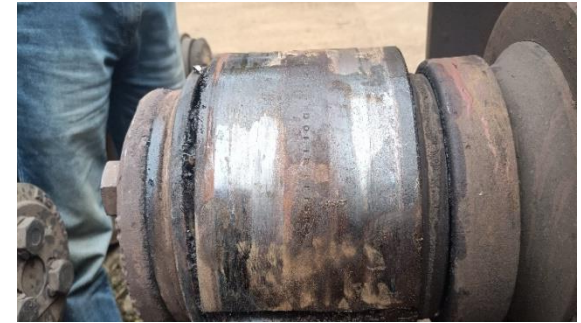
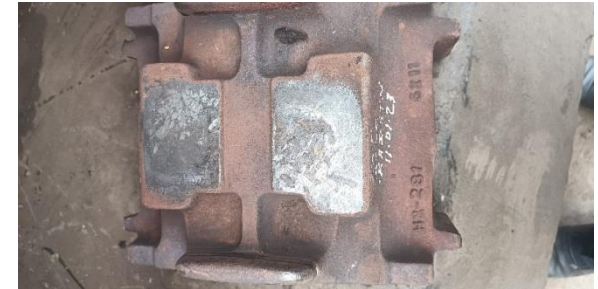
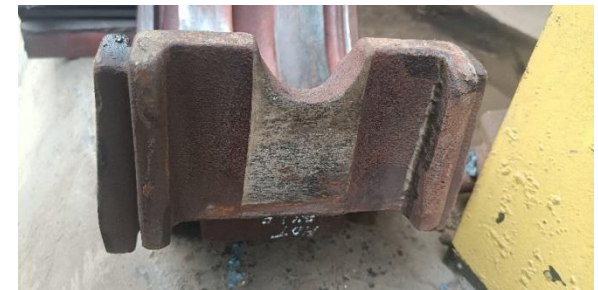
Sr.No	Attribute	Reading as per G- 81 manual (in mm)	Measured value (in mm)
1	Side measurements	181-175 (Narrow Jaw Adapters) 268 – 262 (Wide Jaw Adapters)	<u>267</u>
2	Side lug	97-103 (Narrow Jaw Adapters) 130 – 136 (Wide Jaw Adapters)	<u>130</u>
3	Crown lug	155.5-163.5 (Narrow Jaw Adapters) 156 – 164 (Wide Jaw Adapters)	<u>156</u>
4	Shoulder groove	Maximum 0.7 mm groove is allowed	<u>No groove found</u>
5	Machined relief	Minimum 0.8 mm machined relief should be there.	<u>OK</u>
→ 6	Bore radius	110.50 <sup>+0.015</sup> <sub>-0.112</sub>	<u>110.30</u>
7	Adapter bore seat to crown seat	26.2-22.7 (Narrow Jaw Adapters) 48.5 – 45 (Wide Jaw Adapters)	<u>48.5</u>
General Remark		<u>Adapter bore radius is less than specified limit in S.N. 06.</u>	
Conclusion		<u>Adapter is condemned.</u>
