FAILURE ANALYSIS-II

Case study of different failures

M.Chandra
Lect./EM

AN EXAMPLE OF THE INVESTIGATION REPORT

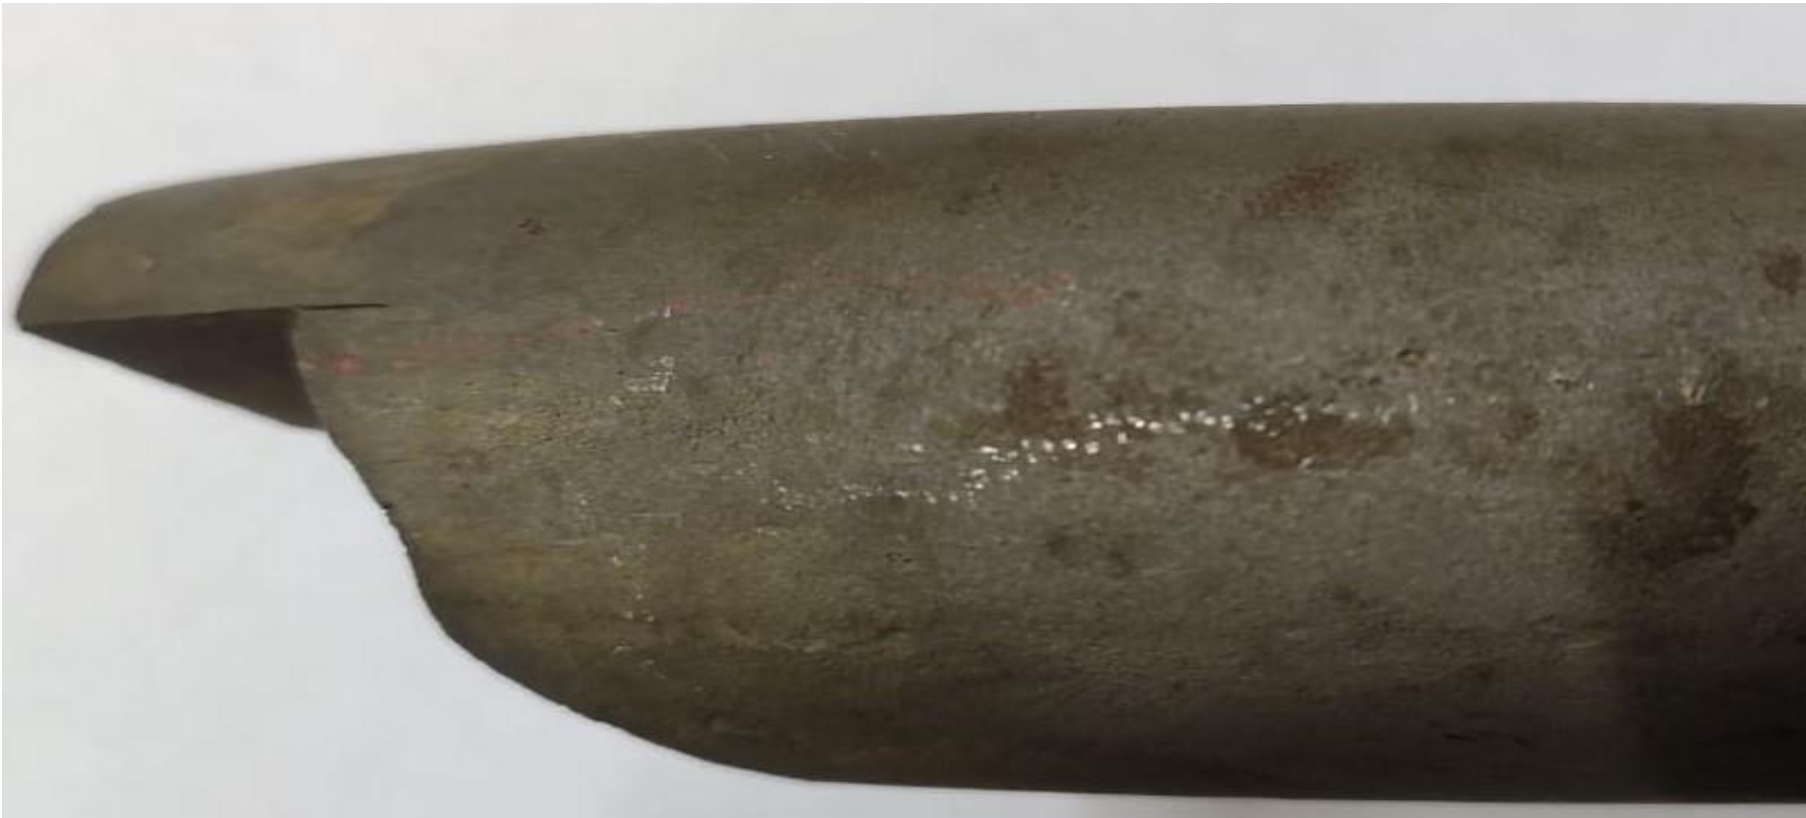
Seam contributing to failure

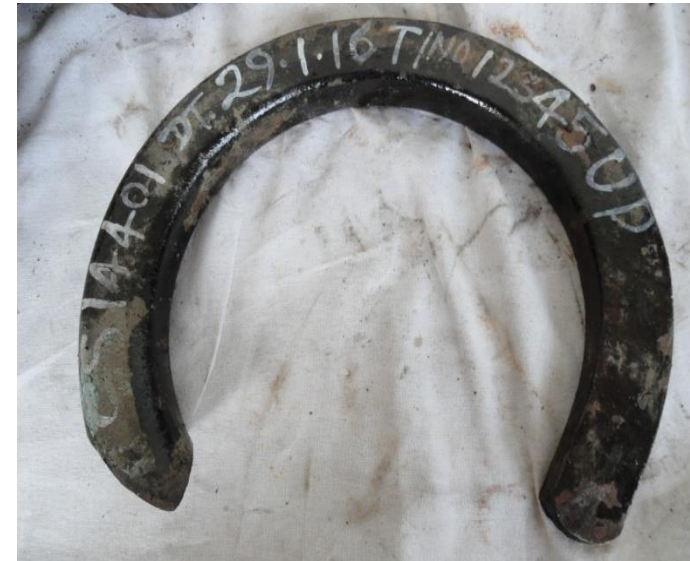
▶ Fig.1:- Broken Helical spring

▶ 2.1. Location Fracture: - Fracture took place at first turn from bottom end.

▶ 2.2. Nature of Fracture: - Fracture was transverse, progressive in nature & inclined at an angle of 45°

from the Longitudinal axis of the spring wire indicating torsional fracture.
Fatigue covered approx 5% of the cross sectional area

(i) Corrosion pits were present at /near the fracture. It acted as point of Stress Concentration & nucleus of fatigue.

Proper care should be taken to avoid formation of stress raisers i.e. corrosion pits on Spring surfaces.

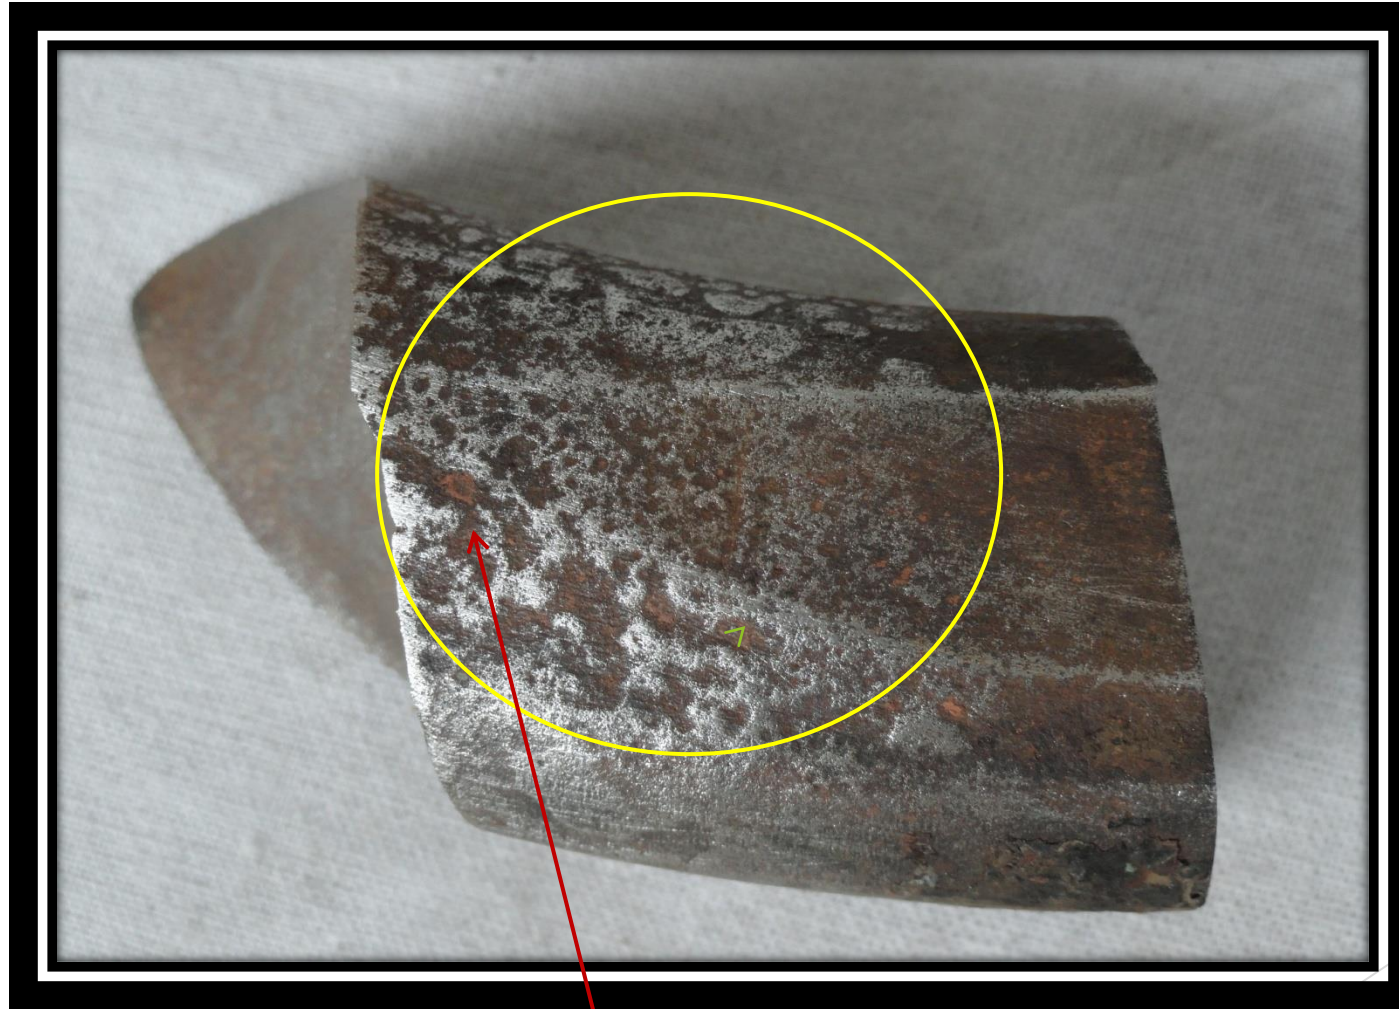
Areas showing deep corrosion pits

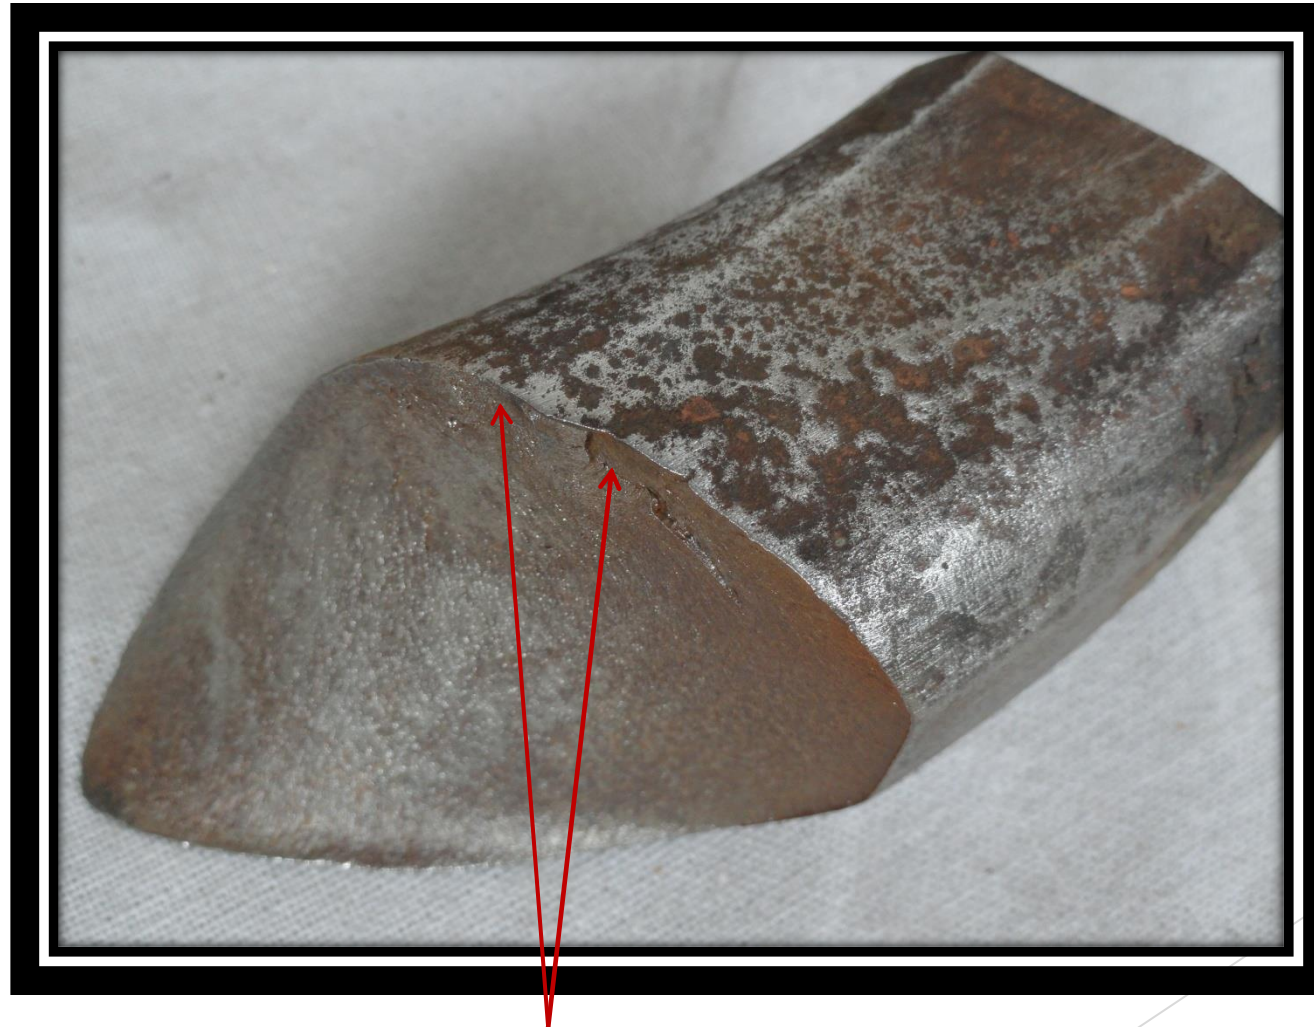
Arrows indicate the corrosion pits as points of stress concentration and nuclei of fatigue causing failure

Corrosion pits at/near the fracture provided location of stress concentration and made the material notch sensitive.

This led to nuclei of fatigue and subsequent failure of the material during service.

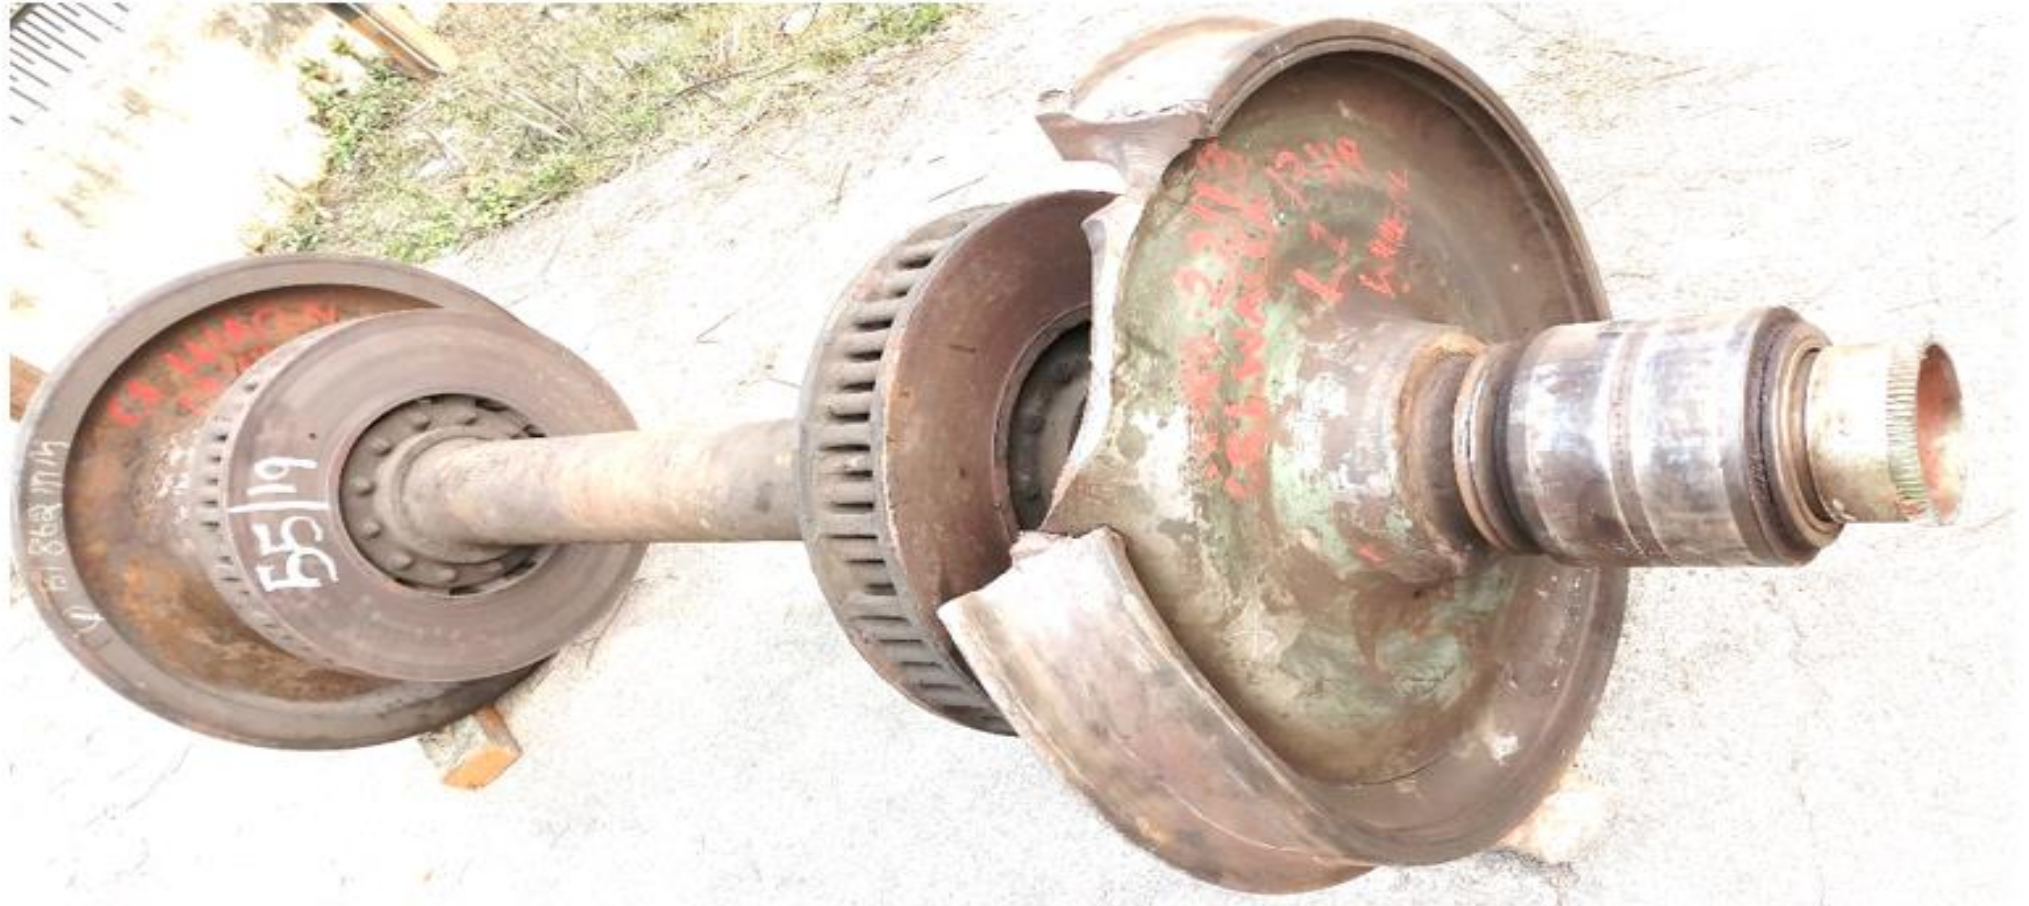
Fig.1: Photograph showing fractured wheel set in as received condition.

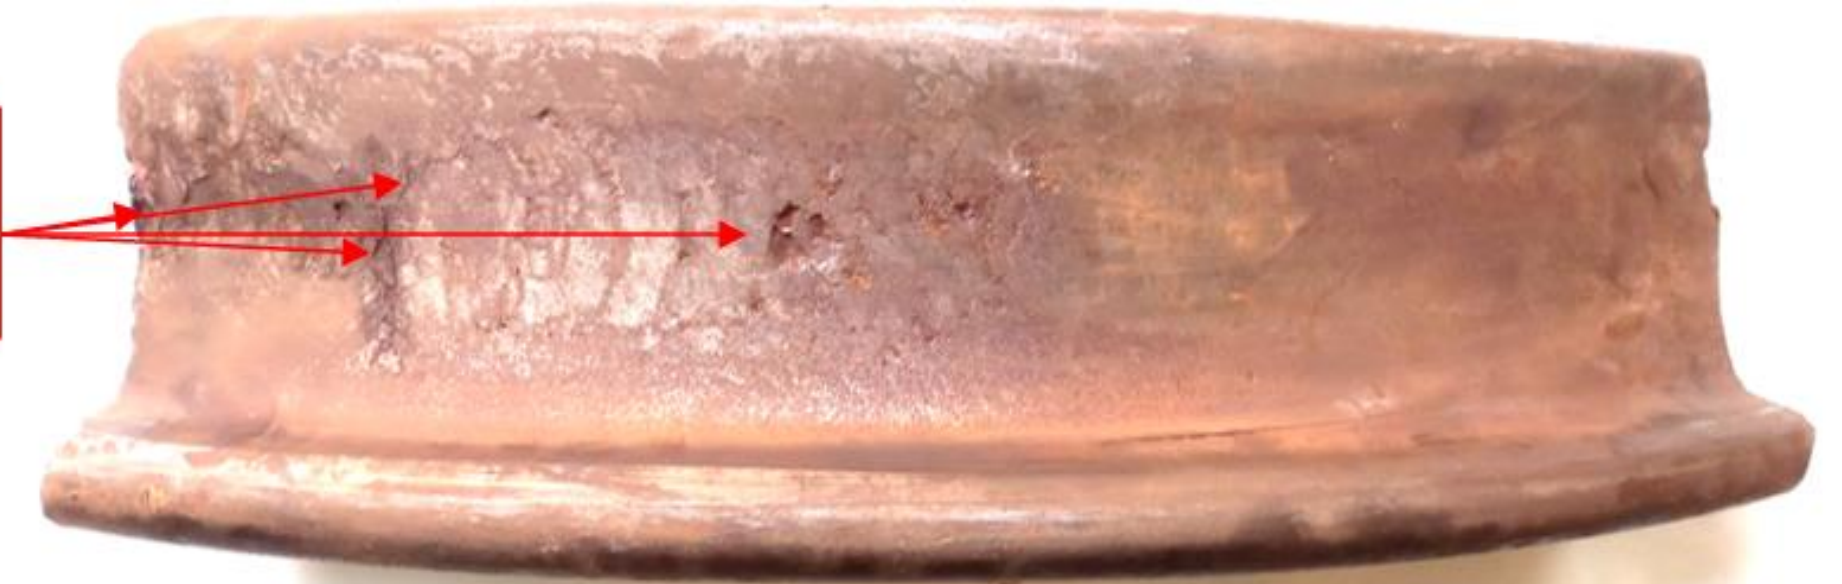
Shelling marks,
Pits,
Thermal cracks

Fig.2: Photograph showing fractured part of wheel in as received condition having shelling marks, pits and thermal cracks on tread surface.

- ▶ It is evident from above that metallurgical properties of failed wheel are satisfactory. Cyclic impact/hammering effect during service due to combined effect of shelling and flat wheel on the tread area above the crack have led to extra stresses in the web. Furthermore, due to wear of rim of about 28.50 mm, the modulus of compressive stresses decreases which is induced by rim quenching at the time of wheel manufacturing. Stresses, owing to cyclic impact, had concentrated on minimum thickness of the web portion and as a result, a crack had initiated in the web portion and further propagated during service, leading to failure of wheel.

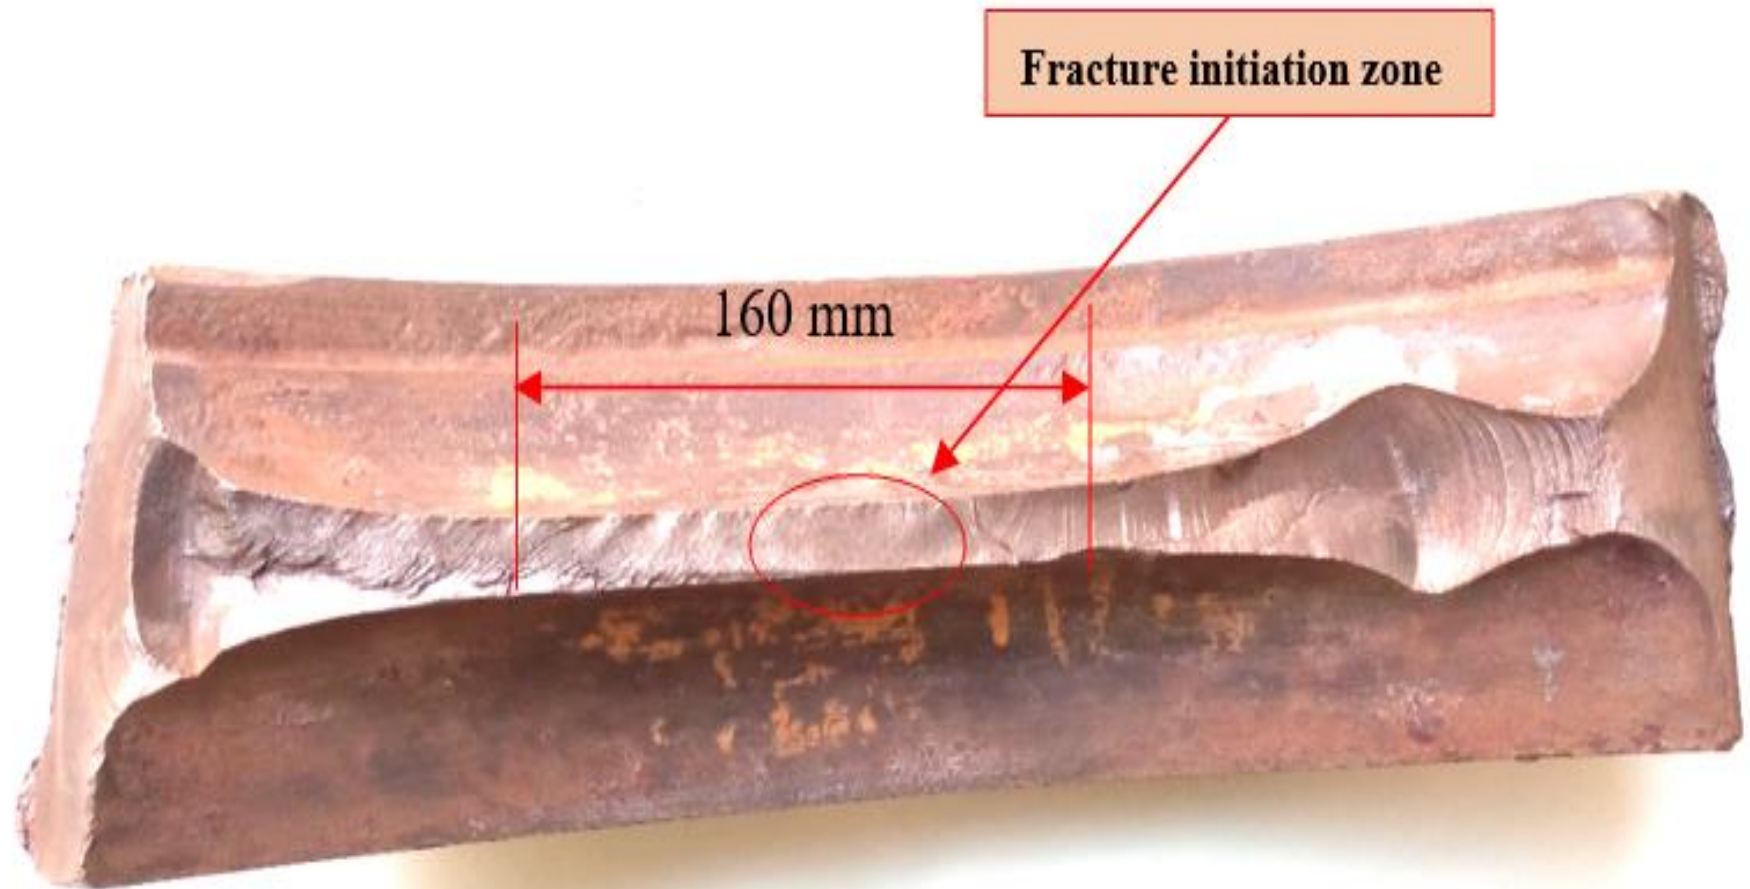
Fig.3: Photograph showing fracture face of the wheel piece.

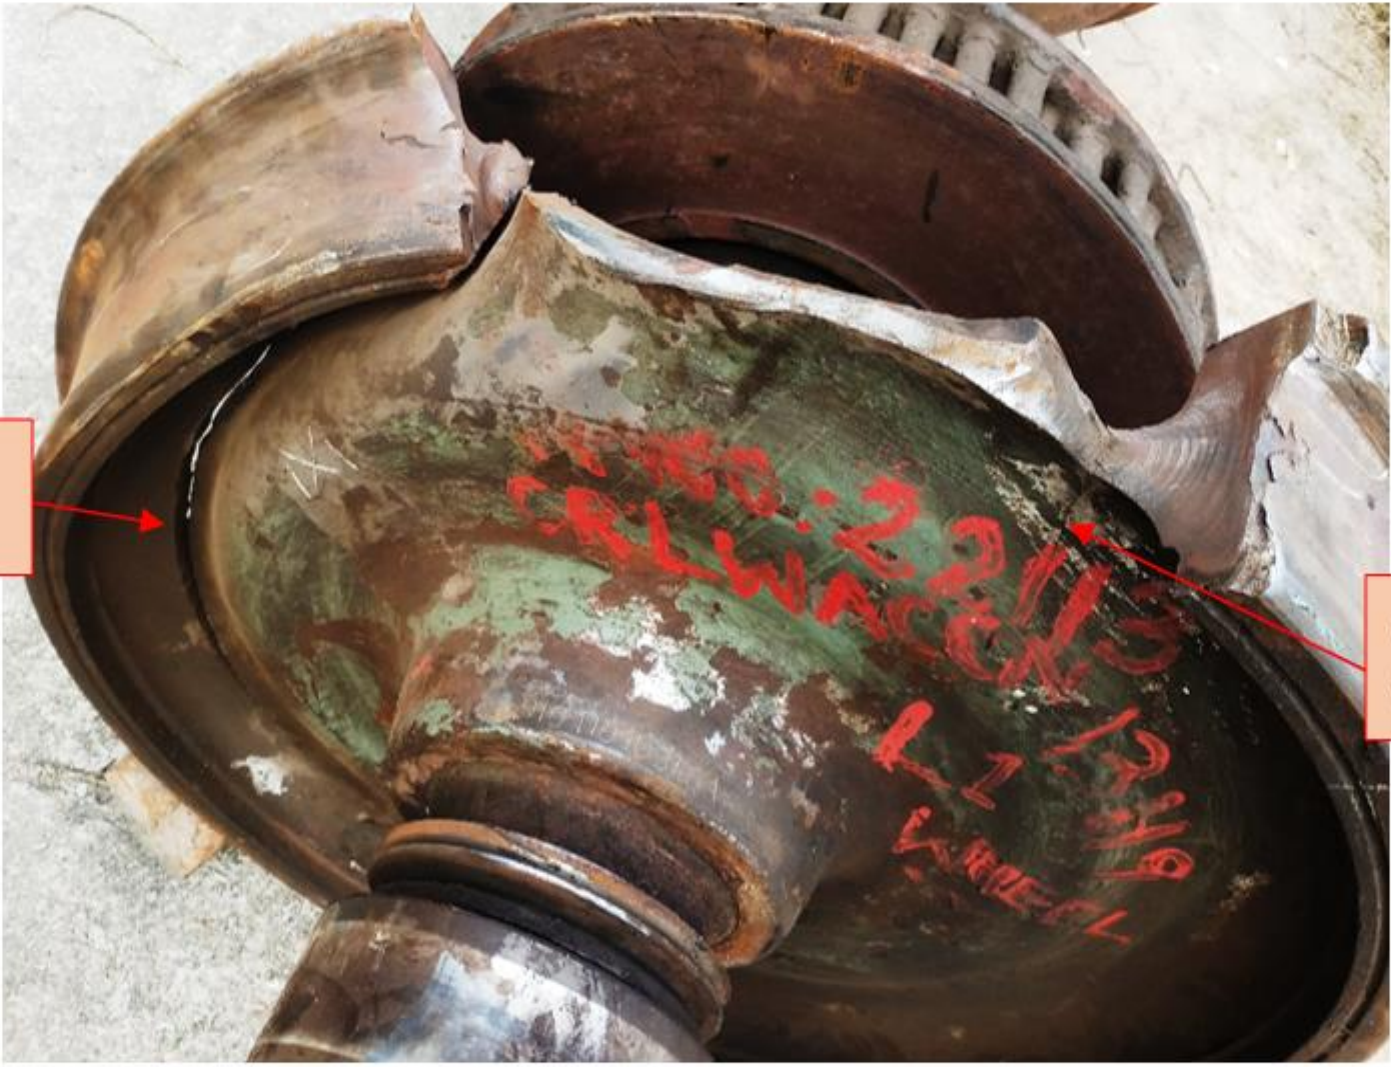
Crack length
about 80 mm

Fig.4: Photograph showing two numbers of crack in fractured wheel set.

- ▶ During magnetic particle testing, it was observed that the crack has extended approx. 10 mm one side and 15 mm other side apart from visual cracks.

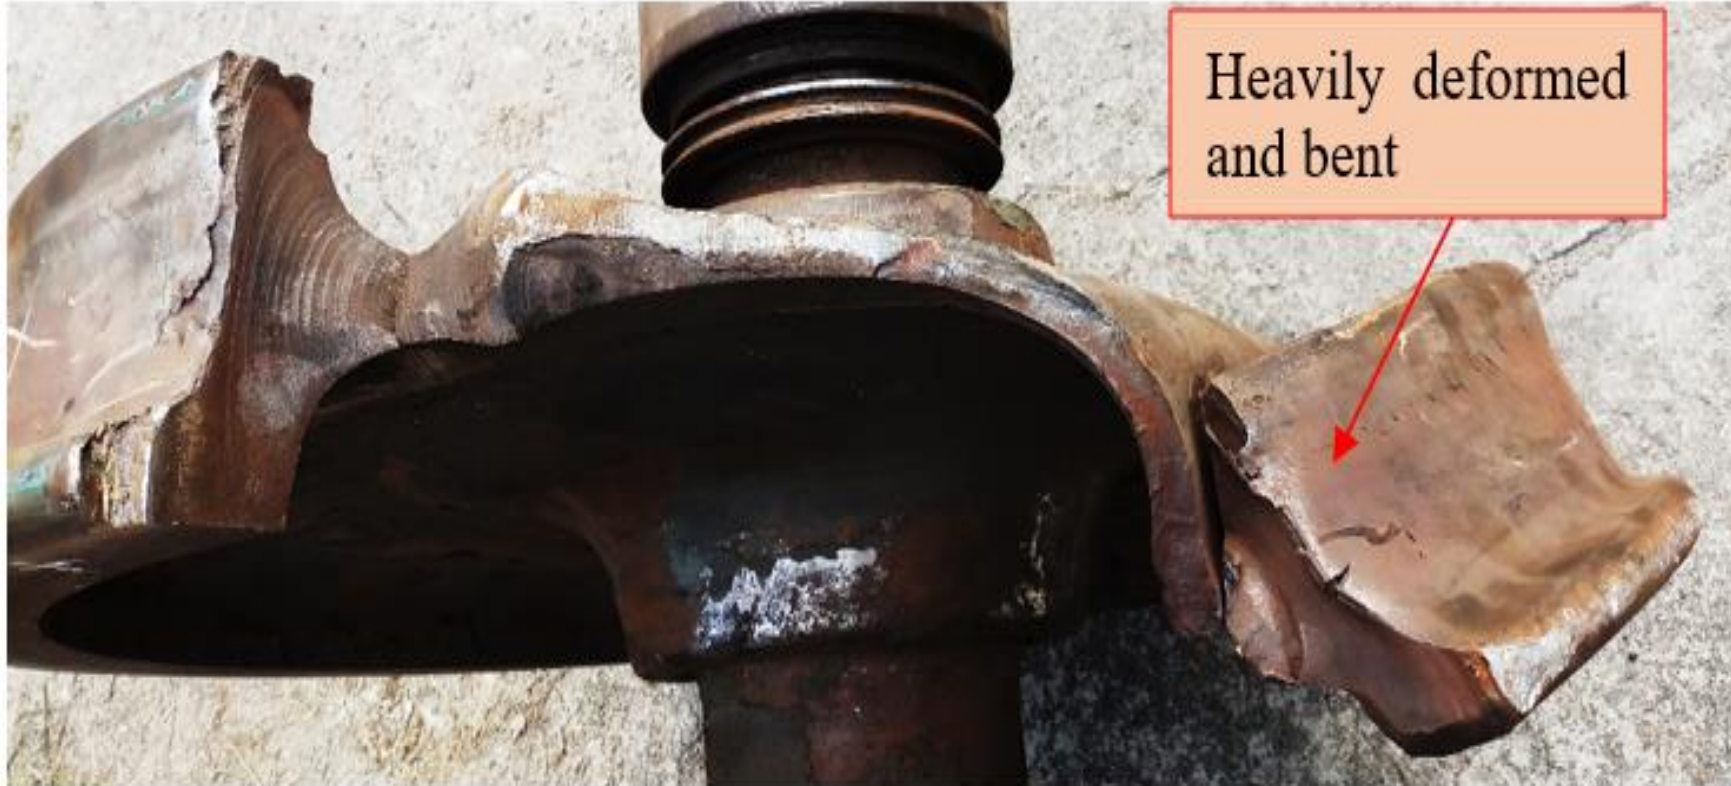
Fig.5: Photograph showing fracture face of the wheel set.

- ▶ Metallurgical properties of the wheel are considered satisfactory. Failure of wheel is attributable to cyclic impact/hammering effect during service due to combined effect of shelling and flat wheel on the tread area above the crack. Stresses due to cyclic impact had concentrated on minimum thickness of the web portion and as a result, a crack had initiated in the web portion and further propagated in fatigue manner during service.

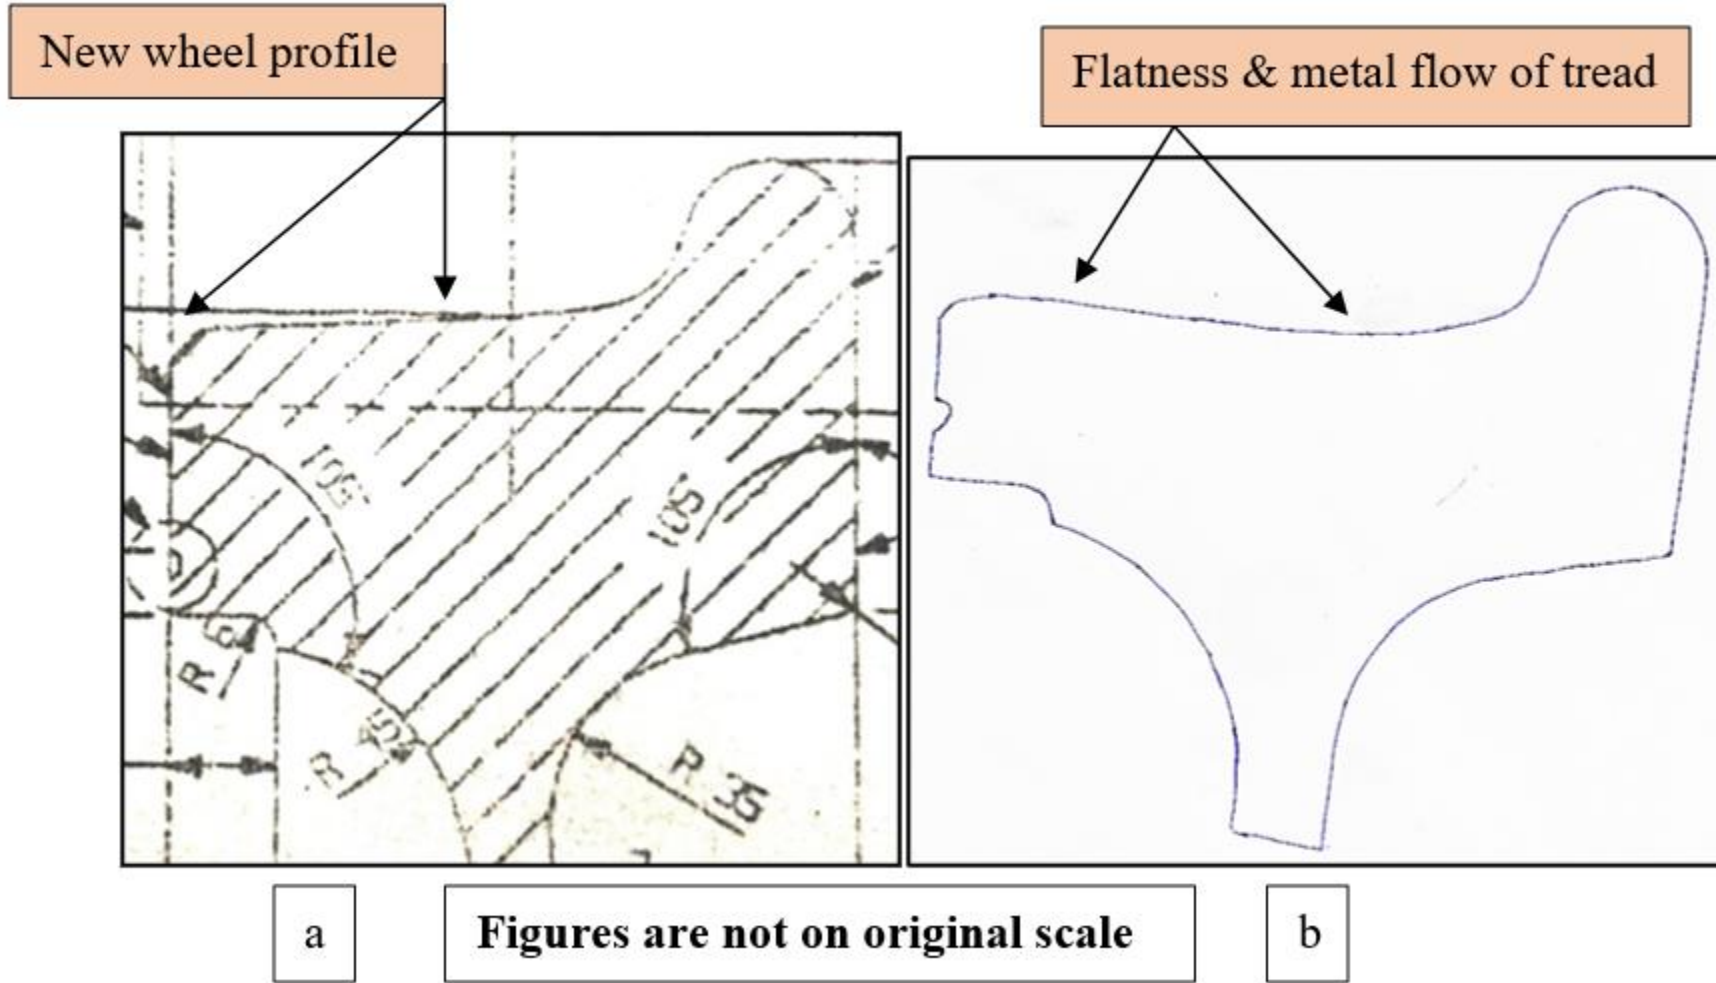
Wheel rim thickness was found about 30.50mm against 59mm in new wheel which indicates that wheel has wear out about 28.50 mm in service/turning. Metal flow and flatness was also observed at tread surface on broken piece.

Fig.6: Photograph showing (a) Profile of new wheel. (b) Profile of worn out wheel

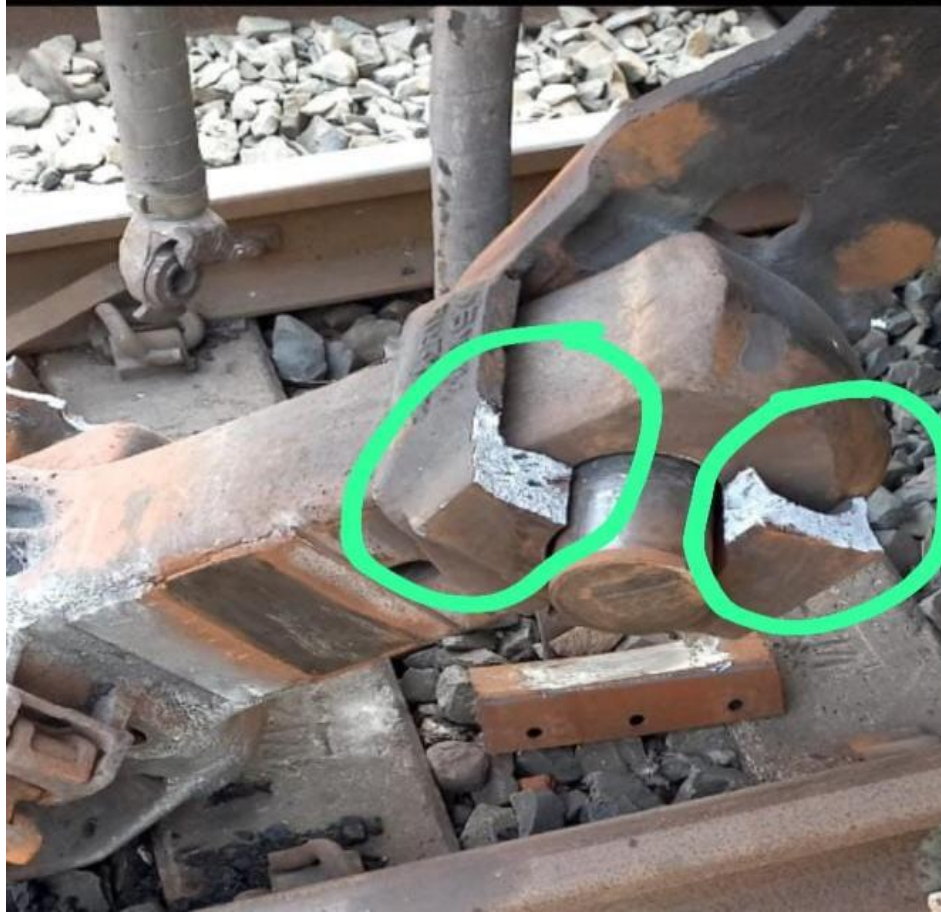
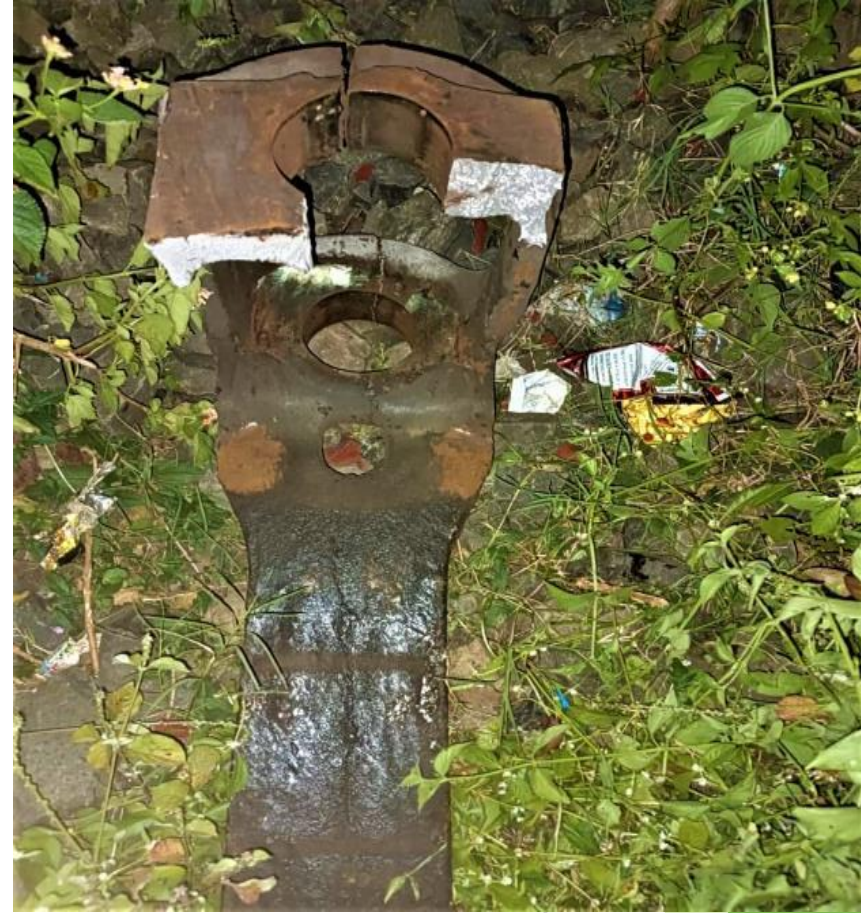
Broken CBC Yoke

(III) Visual Examination:- Visual examination revealed breakage of CBC yoke and striker casting. One side strap of yoke broken near yoke pin-hole area. Fractured face shows bright crystalline appearance throughout the surface. Deep crack also observed on opposite side near yoke pin hole. Fractured face of striker casting also found bright crystalline in appearance. Particulars of the manufacturer are visible. Counter part of broken CBC yoke is not received.[Ref fig.a,b &c]

(X) Probable cause of failure:-The failure of CBC assembly is attributable to breakage of CBC yoke . Metallurgical properties of yoke like heat treatment, microstructure and hardness are not satisfactory as per specification which adversely affected mechanical properties strength and toughness. Higher side carbon content is also contributory factor inducing brittleness. Breakage of striker casting is consequential damage under service stresses.

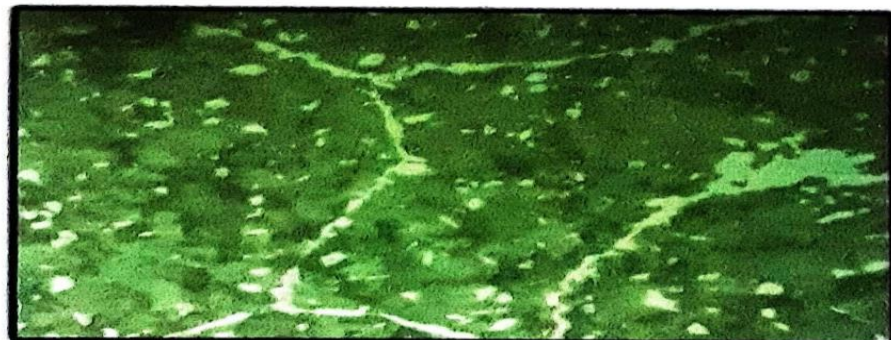
fig(d)

(VIII) Micro Examination(Yoke):- Matrix revealed coarse grains of ferrite-pearlite instead of uniform distribution of tempered martensite. (fig-d&e)

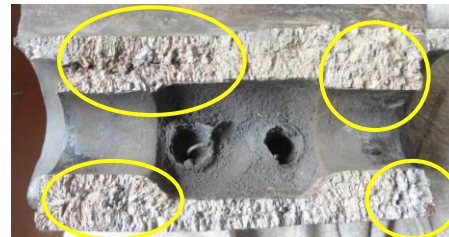
Location of Fracture:- Fracture took place at approx. 200 mm. from the tail end.

Nature of Fracture:- Fracture was transverse and coarse crystalline in nature.

Other Observations:- Casting defects like shrinkage cavities, & porosities observed throughout the fracture face.

Fig.2:-Fracture Face of broken knuckle showing presence of shrinkage cavities, porosities.

- (ii) Hardness value of the material is within specified limits.
- (iii) Casting defects like shrinkage cavities & porosities were present throughout the fracture face. This reduced the effective cross-section & in turns the load bearing capacity of the

material and acted as stress concentrator and ultimately caused the failure of the material during service.

7.**Conclusion:** - Failure is attributed to major casting defects like shrinkage cavities, porosities .

8.**Remedial Measures:** - Appropriate steps like proper pouring temperature, adequate gating and risering of the mould during casting should be ensured to avoid formation of casting defects like shrinkage , porosities, etc. during manufacturing level..

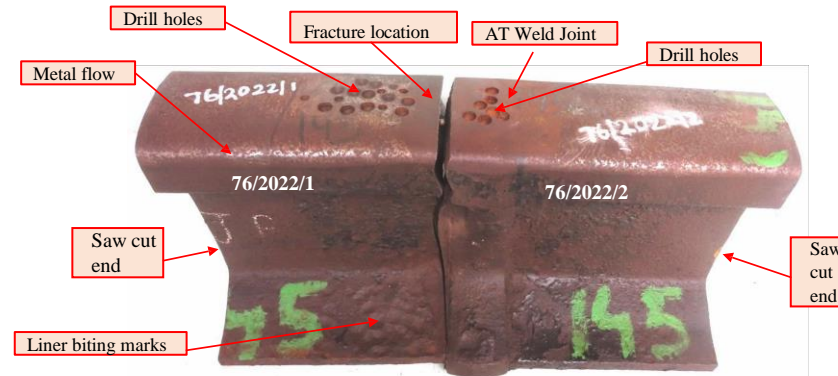
AT welded rail pieces (counter to each other) were received for metallurgical investigation (**fig.-1**). One end of both pieces was fracture face and other end of both the pieces was saw cut. Topography of fracture revealed that the fracture had taken place transverse direction, towards HAZ - AT weld region in fast progressive fatigue manner (**figs.- 3 & 5**). Weld protruded fins were noticed at bottom of AT weld, this fin might be acted as stress raiser for fatigue initiation and dimension of fatigue zone is about 34 mm/ 12 mm on major/semi minor axis. The rest of the fracture faces were crystalline in nature (**figs.- 2, 4 & 6**). Metal flow was noticed on the gauge face side of rail table (**fig.-1**). Drill holes were also noticed on the rail table (**fig.-1**).

Fig.1 Photograph showing broken pieces of AT welded rail in as received condition from gauge side.

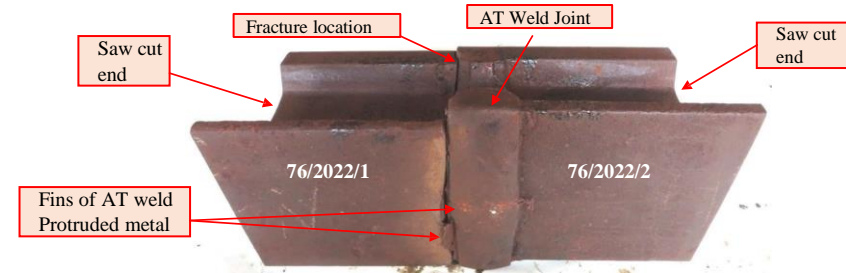
Fig.2: AT weld protruded fin at bottom of AT welded rail.

It is evident from above that the metallurgy of rail conforms to the relevant specification and AT weld does not conform to the relevant specification in terms of chemical composition i.e. high Si% - 0.67% against specified 0.50% max. (If single shot crucible was used, specified Si% is 1.20% max., chemical composition conformed to the relevant specification), low Mo% - 0.07 against specified 0.10-0.25% and low V% - < 0.0005% against specified 0.1 – 0.15%, low hardness of AT weld & high hardness of HAZ. Microstructure of weld zone revealed cast columnar grains of pearlite in broken matrix of ferrite, microstructure of heat affected zone revealed fine pearlite with specks of ferrite at places & microstructure of parent rail revealed pearlite structure with specks of ferrite at places. The AT Weld had broken transversally from HAZ - AT weld region in fast progressive fatigue manner, weld protruded fins were noticed at bottom of AT weld, this fin might be acted as stress raiser for fatigue initiation.

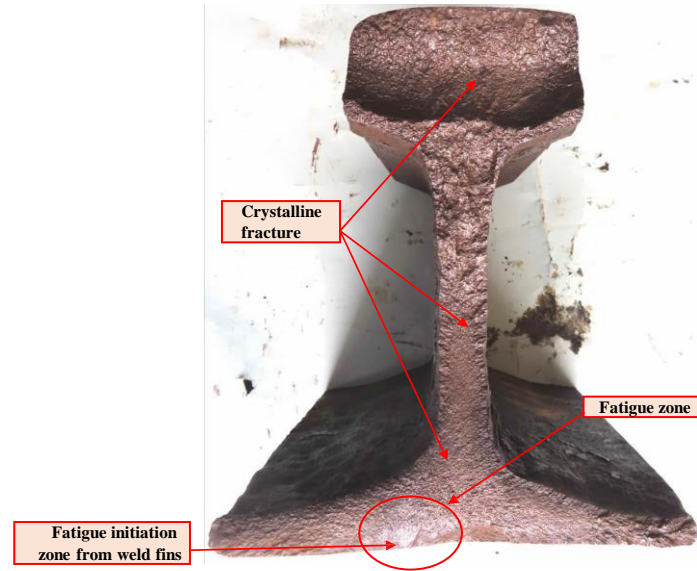
Fig.3: Fracture initiation of fatigue zone and crystalline fracture face of sample no 76/2022/1.

The sample contains two fractured pieces of AT welded Rail, which are counter of each others. The fractured rail weld pieces have been examined visually fatigue defect of size 34 mm X 12 mm is observed at rail bottom at one side of flange. This defect is not covered in normal rail testing using Ultrasonic Testing equipment (SRT/DRT) as per Manual for Ultrasonic Testing of rails & welds, Revised 2012.

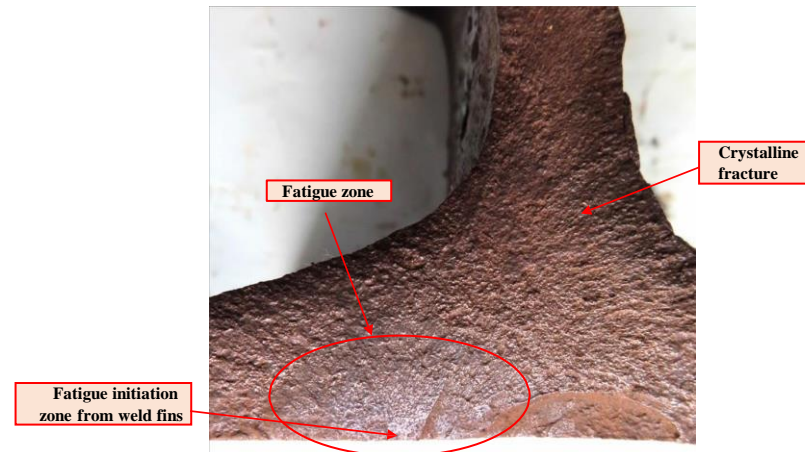
Fig.4: Close view of fracture initiation of fatigue zone and crystalline fracture face of sample no 76/2022/1.

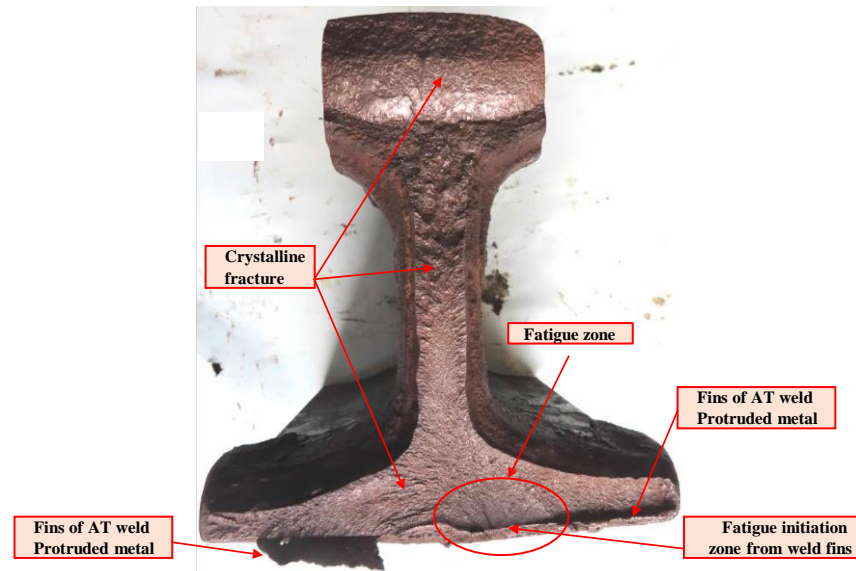
Fig.5: Fracture initiation of fatigue zone and crystalline fracture face of sample no 76/2022/2.

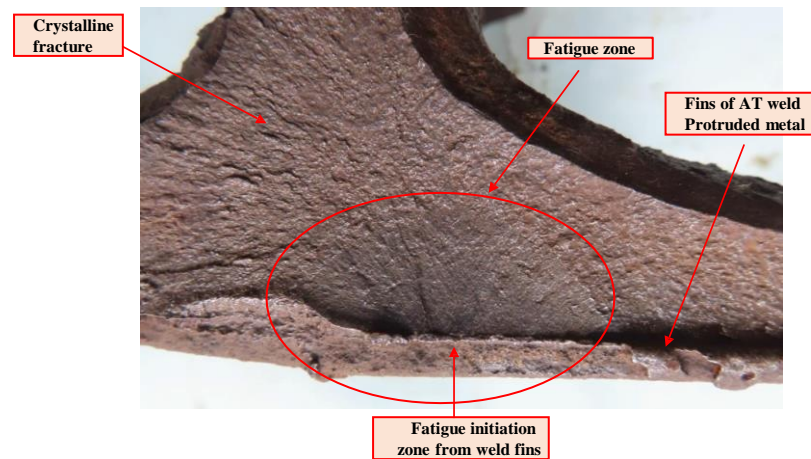
Fig.6: Close view of fracture initiation of fatigue zone and crystalline fracture face of sample no 76/2022/2.

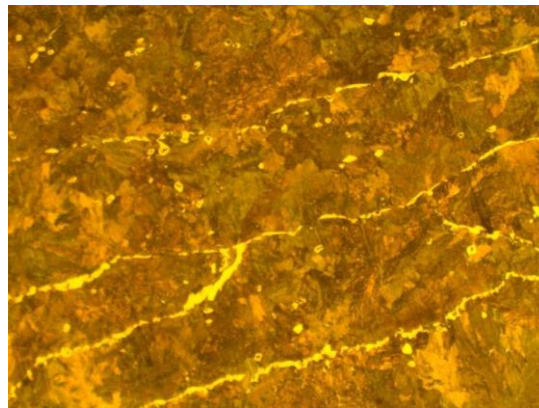
| Sample no. | Location | Observations |
|---|---|--|
| 76/2022 | Weld | Revealed cast columnar grains of pearlite in broken matrix of ferrite (fig. 10). |

Fig.10: Photomicrograph revealed cast columnar grains of pearlite in broken matrix of ferrite in weld portion.

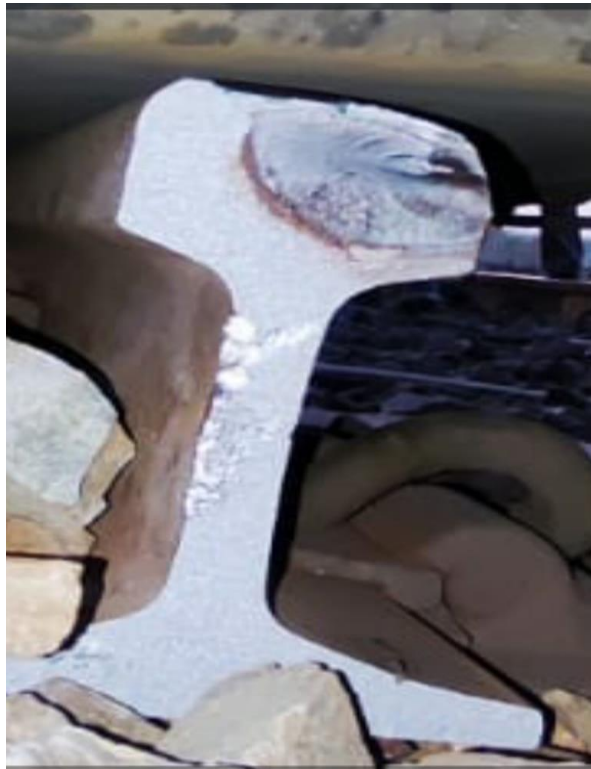
Rail Failure

Transverse Fissure/Hydrogen embrittlement

- Resembles a kidney in shape in the rail head.
- Mainly hydrogen accumulation causes this defect.
- Originates from nucleus/crystalline centre located inside rail.
- Subsurface defect formed around 10-20 mm below rail head surface.
- Propagates outward at right angle to the length of rail.
- Smooth, bright/dark round/oval surface.
- Growth is slow until it reaches up to 25%, then rapid.
- Defect may be introduced during manufacturing of rail or when poor welding is done in rails.
- Can be detected by 70° transducer during UST of rail.
