Vande Bharat Express

Issues
Encountered
During Train
Operation &
Maintenance

Failures of Primary Helical Coil Springs

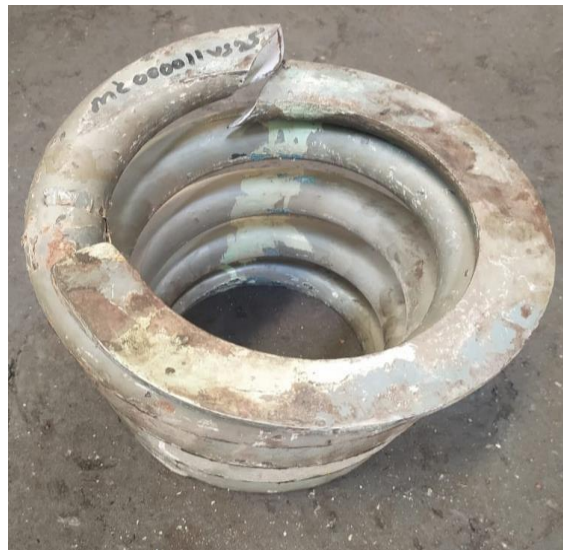
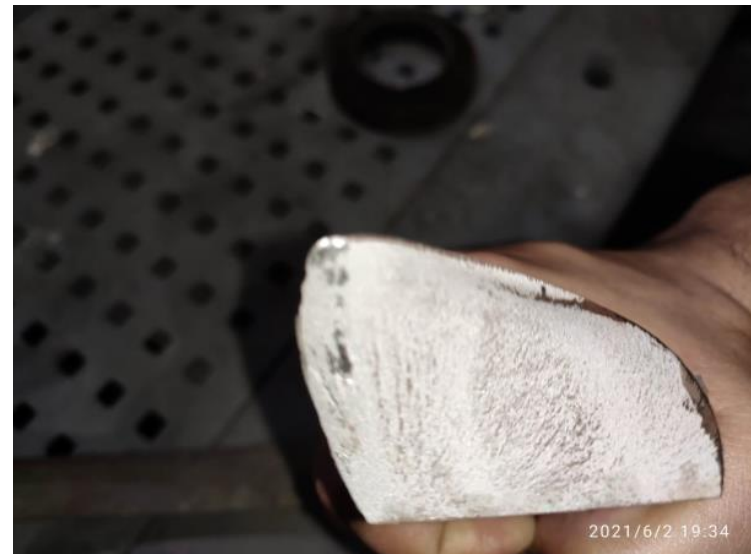
- Main reason of service disruption
- 10 cases so far
- Failure started after train services were restored post Covid lockdown
 - Improper heat treatment
 - Notch formation due to stamping marks
- During SS-1 done by Rolling Stock Workshop, CB springs having slightest doubt were changed
- Failures stopped after SS - 1

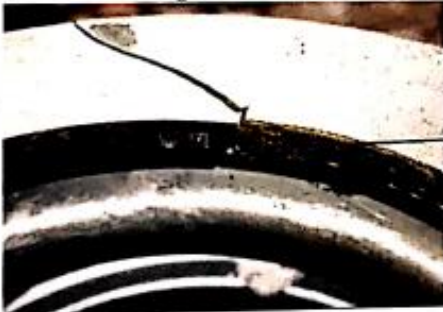
Sample ID	Visual Examination	Dia. Of the spring
S/469/21	<p>Primary Inner Spring had broken from the last coil at the distance about 200mm from the tip into two pieces. The entire fractured surface was having crystalline appearance in nature indicating sudden breakage. Notch formation was noticed near the fractured surface due to deep stamping marks on the both side of the flat portion of the spring (As shown in fig 1 & 2). No other defect was viewed at the fractured surface.</p> <p>Fig.1</p>

- Firms must be advised to carried out proper heat treatment to obtain suitable micro structure as stipulated in relevant specification.
- Stamping of number should be punched properly in accordance with the spec. as to avoid notch formation at the surface of the spring.
- Any type of dent/tool/pits mark appears on the surface of springs at the time of fitment, the springs must be discarded from the service.

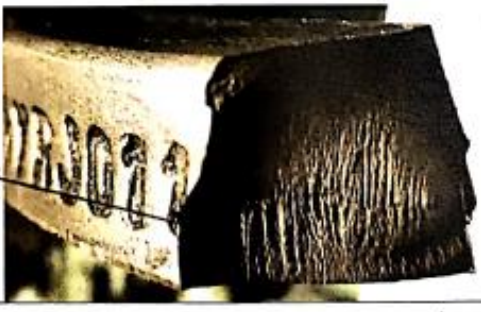
<p>DEEP STAMPING MARKS</p>	28 mm

<p>Streak of martensite</p> <p>Partial tempered martensite</p>	<p>Failure took place chiefly due to the improper heat treatment i.e. tempering of the spring, resulting in retain of martensite against fine tempered martensite structure. Improper chemistry and notch formation due to deep stamping of number were also a contributory factor for the same.</p>

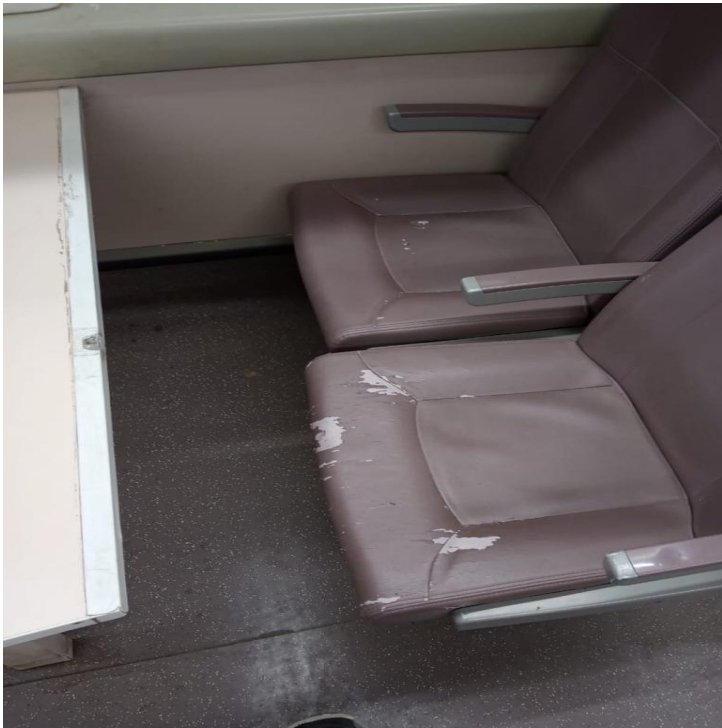
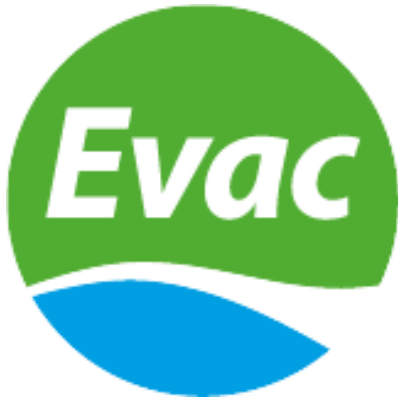
Poor Quality Seats

- Seat covers in about 7 coaches (438 seats) sourced from M/s Airflow peeled off giving shabby look.
- Warranty claim raised
- After a lot of correspondence, firm has finally replaced the defective seat covers

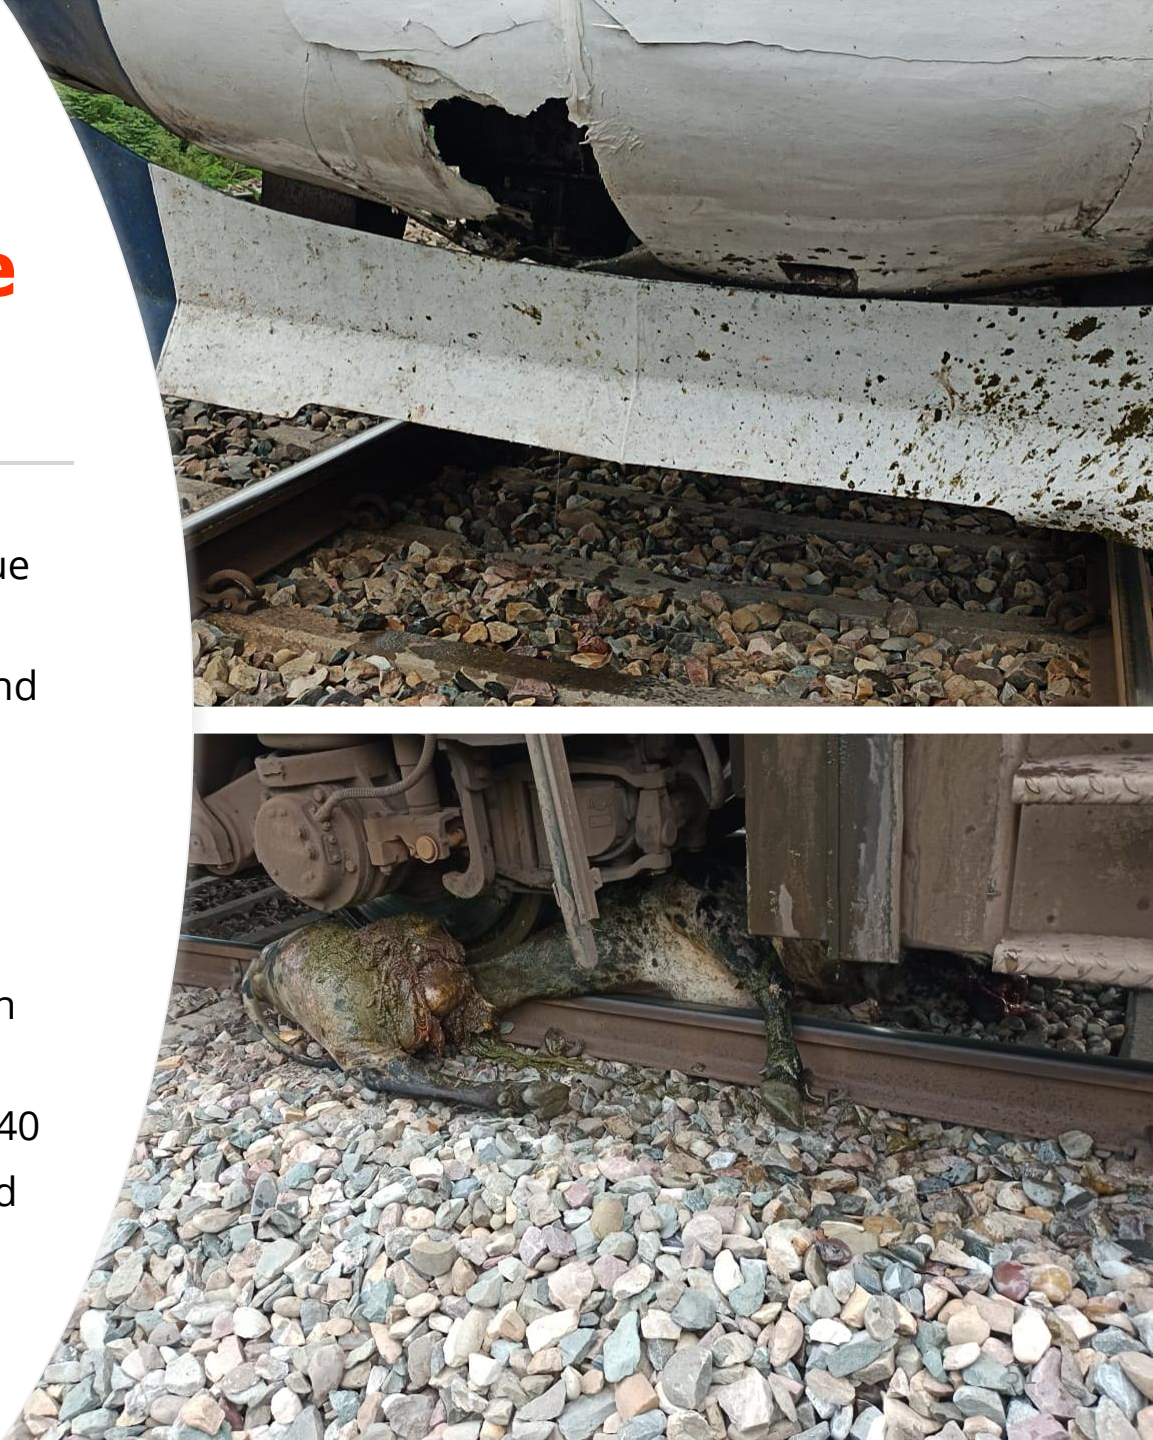
Nose Cone Profile Cover

- Frequent breakage of nose cone due to CRO.
- Nose cone not designed to withstand impact from CRO.
- Gives shabby look when damaged.
- Repair not successful.
- One set costs Rs. 3.16 lakhs.
- Numbers replaced so far – 22 worth Rs. 70 lakhs
- No. of times Nose Cone repaired – 40
- Design of nose cone to be improved by ICF based on Indian conditions

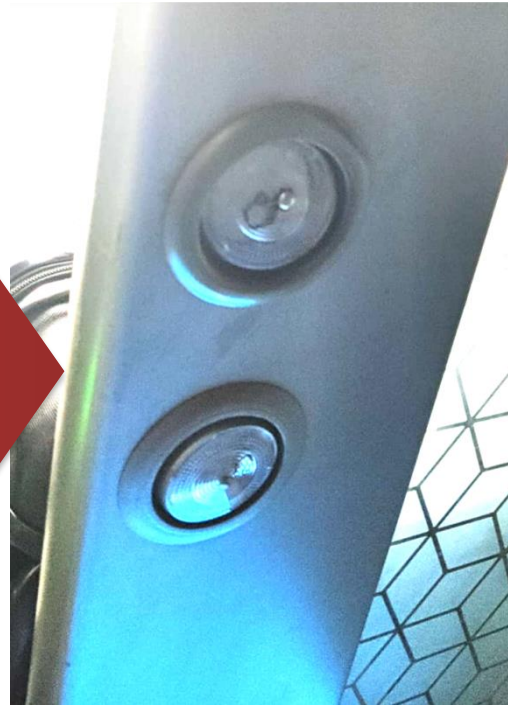
Reading lights poorly designed, with frequent breakage of holders and lights getting defective.

Warranty Claims -485 nos

Design needs to be changed to Shatabdi type of reading lights

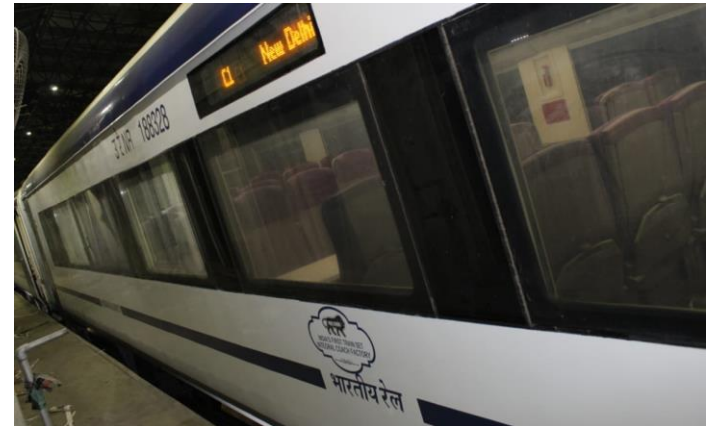
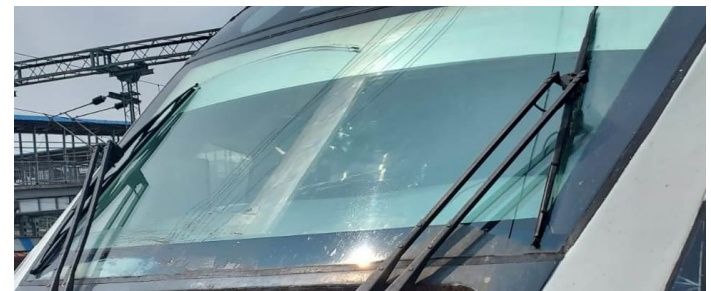
Window Glass Replacement

- 1 Procedure for fixing of glass needs rethinking.
2. Present design is too much time consuming. Same for front lookout glass.
3. Curing time of sealant is quite high

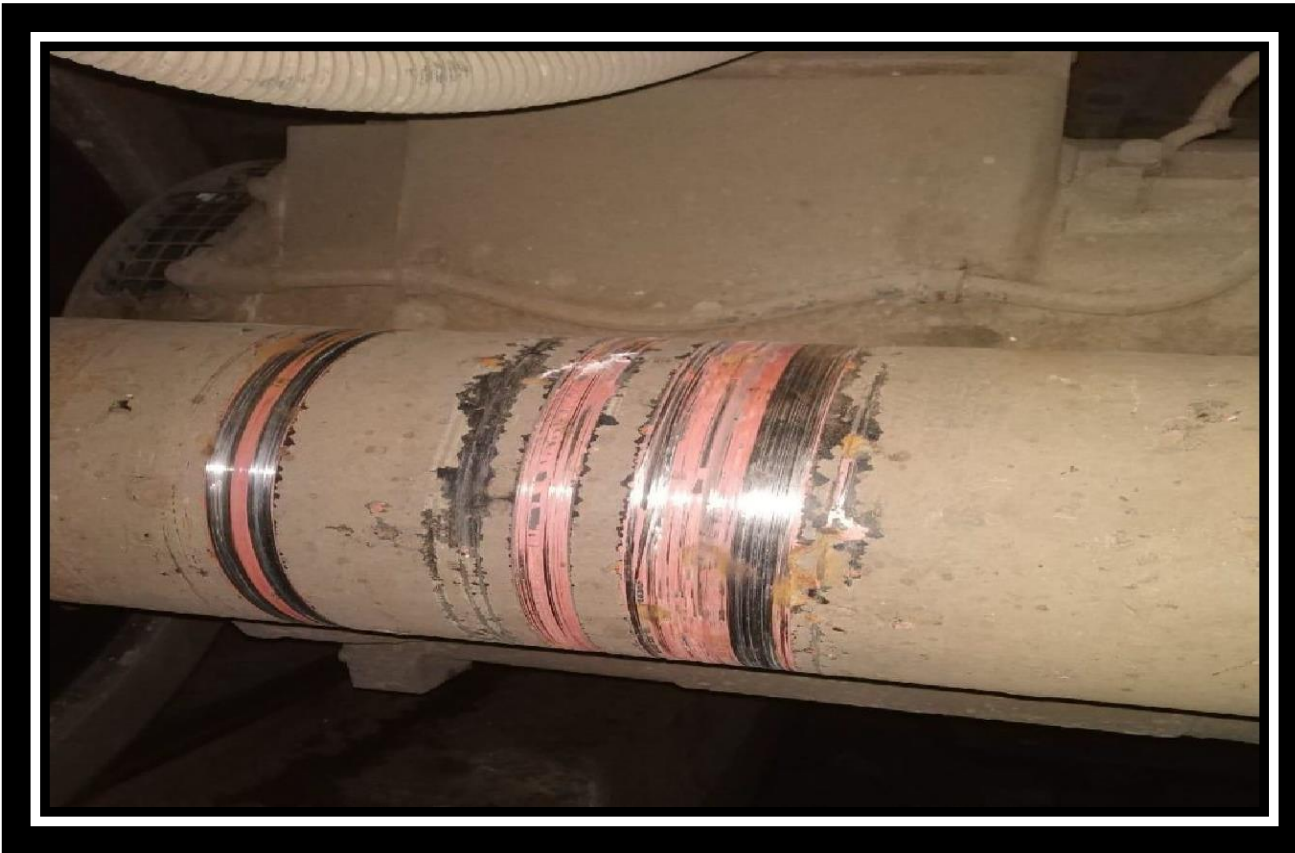
Ballast gets stuck between Axle and TM
and may damage Axle

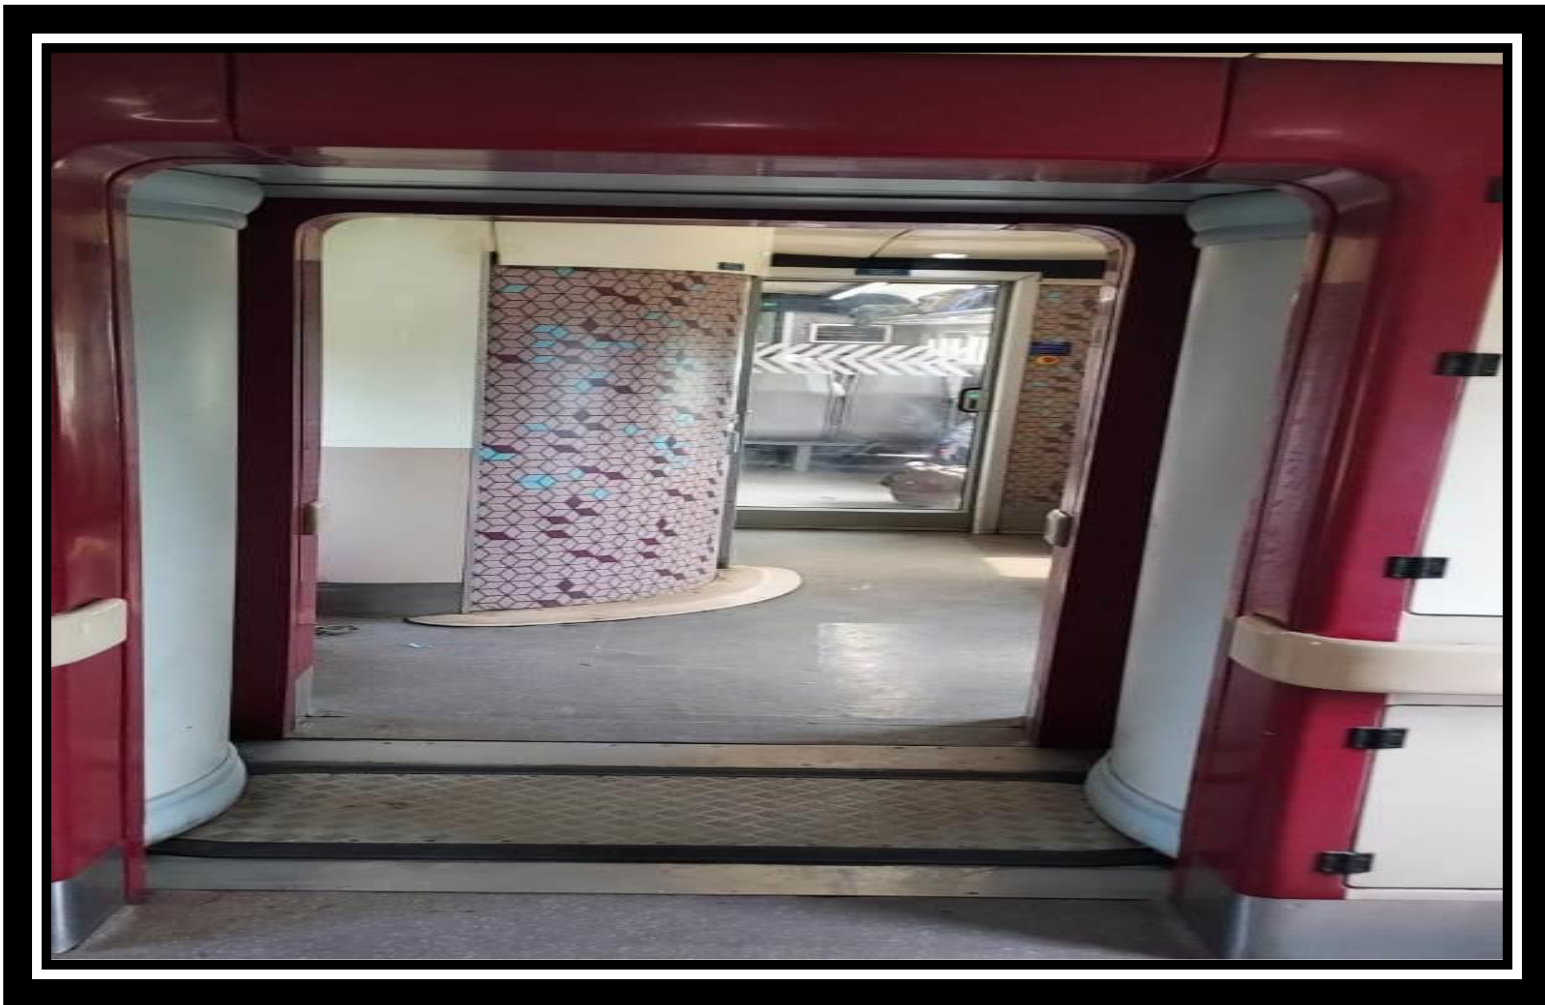
Gangway Design needs to be revisited. Coach attachment and detachment takes too much time in present design

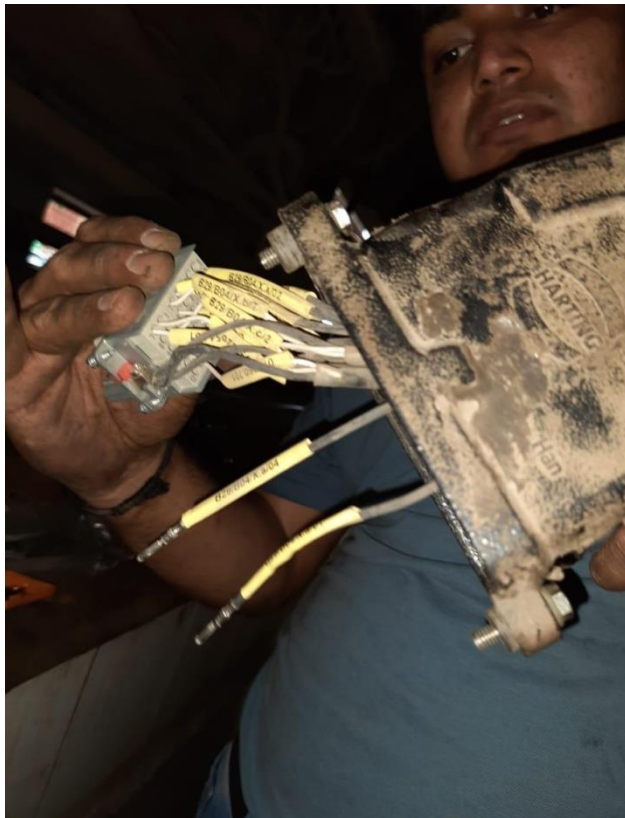
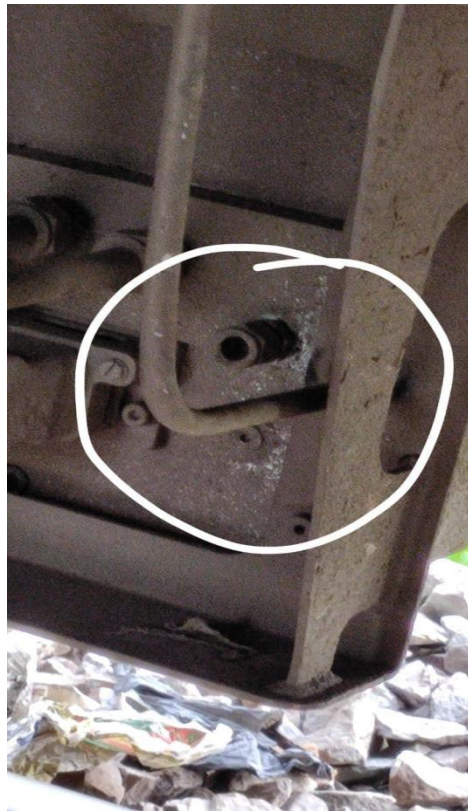
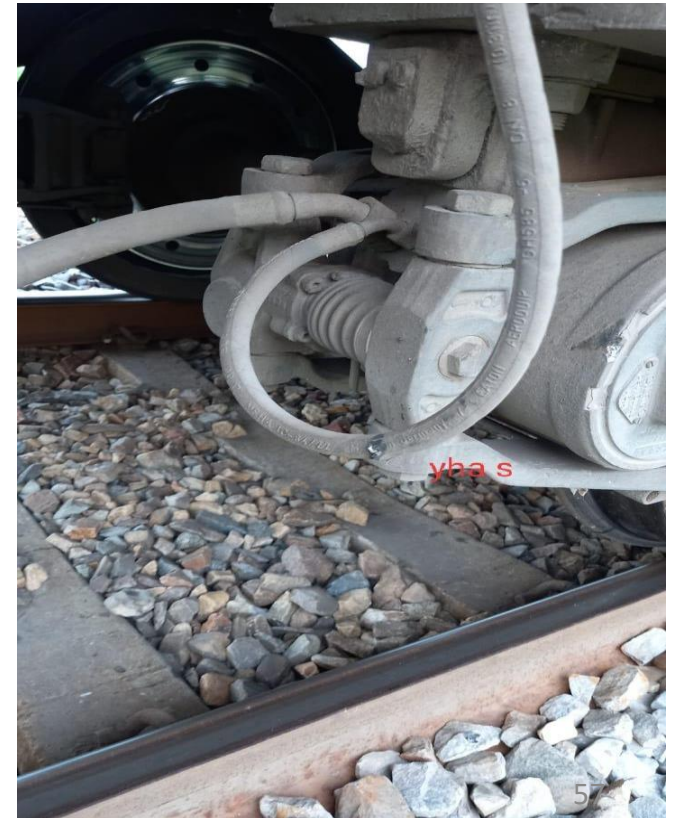
Better protection needed for all under slung equipment against CROs & Ballast Hitting

- Case of ballast hitting on 16.07.2021
- C3 - Emergency brake signal wire pin connection worked out
- C12 - MR steel pipe worked out from its seat
- C10 - Coach parking brake flexible pipe punctured
