Wheel shelling

(mechanism, cause and preventive measures)

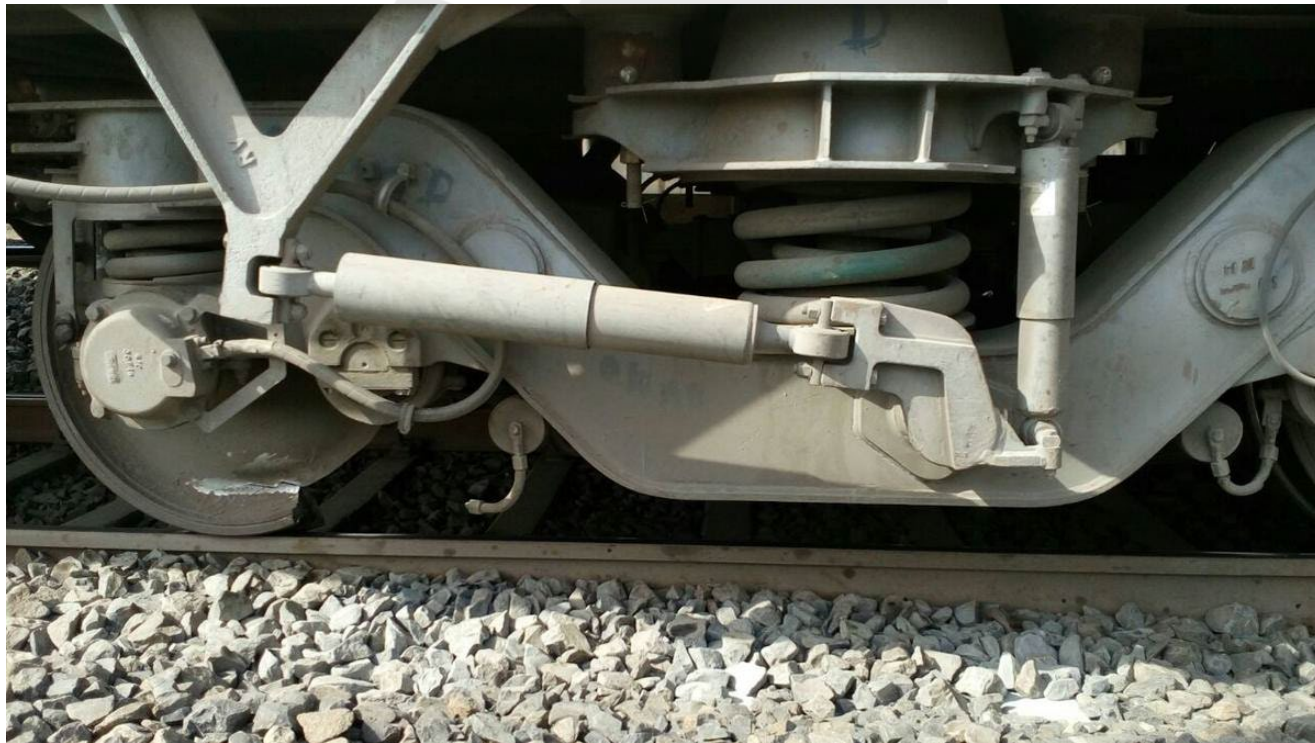
22533/Gorakhpur - Yesvantpur SF Express

- Preexisting cracks in the area of a slide can grow from shallow and harmless cracks into cracks of greater significance due to high thermal and transformation stresses
- This propagation may lead to long fracture on the wheel disk

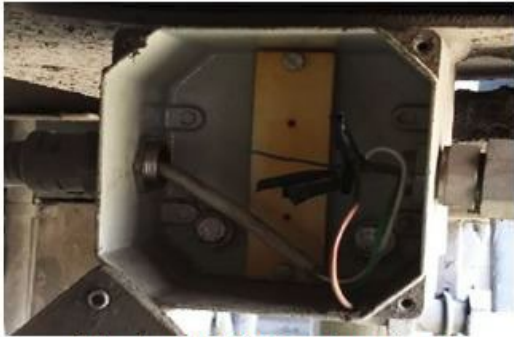
Missing WAGO Terminal

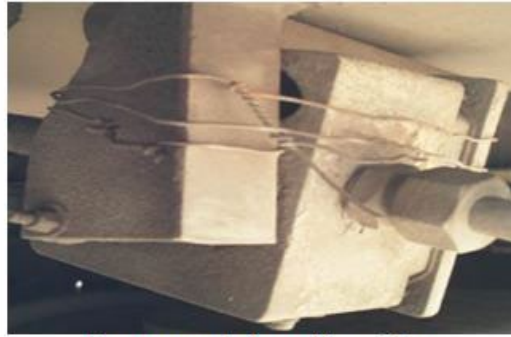
Damaged Junction Box

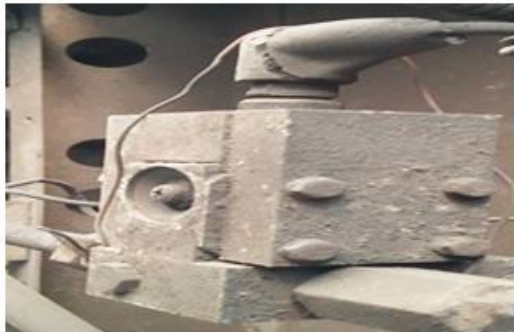
Damaged Connector

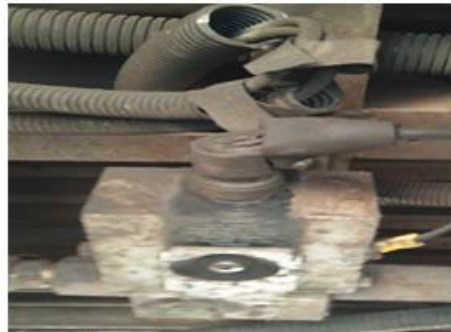
Damaged Connector

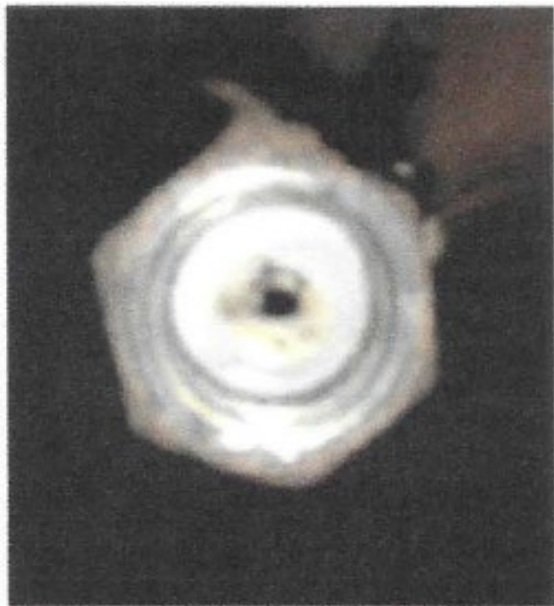
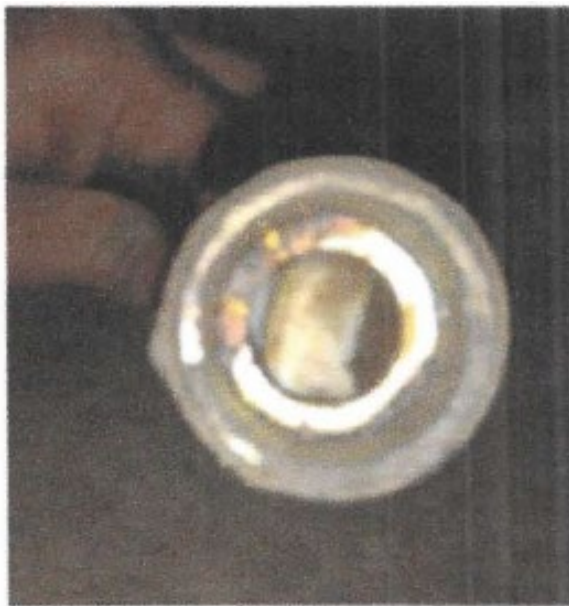
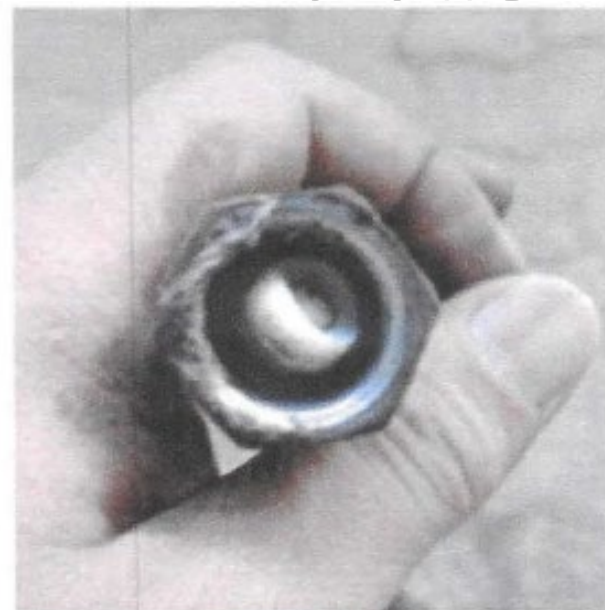
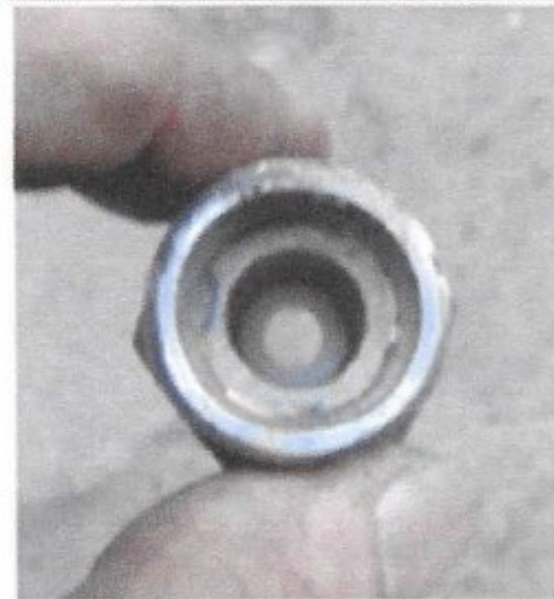
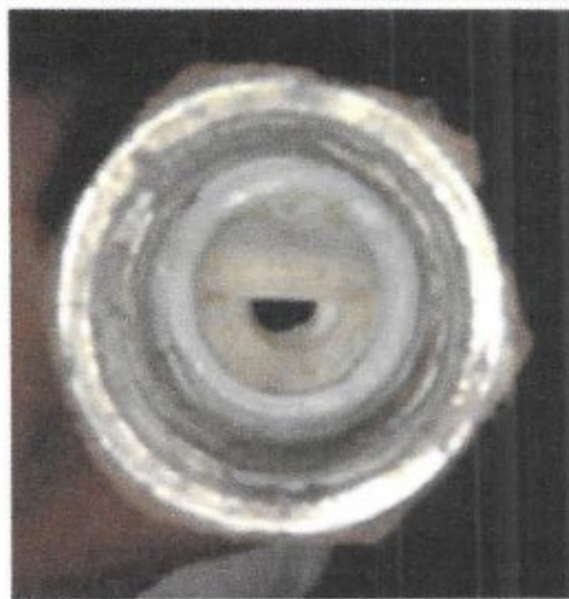
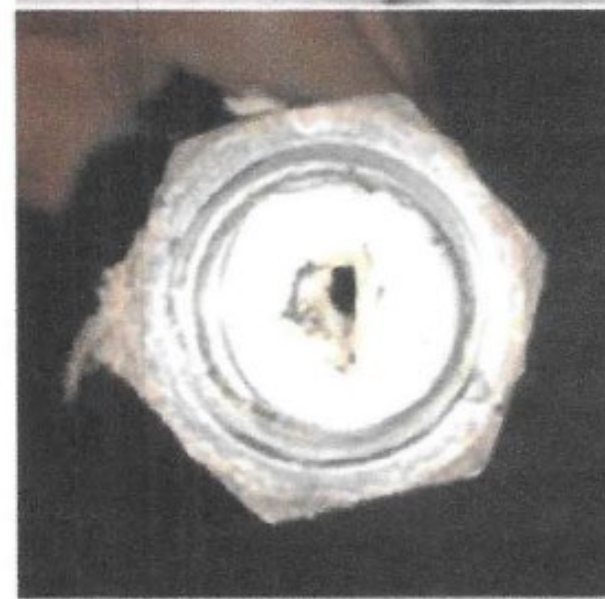
Obstructions in the BC hoses

Restricted airflow due to end fittings

- No.MC/LHB/Brake, dated: 08.03.2019
- No.MC/LHB/Brake, dated: 12.04.2019
- BC line fittings to be standardized (found 8mm, 9mm, 12mm instead of 18mm OD/15mm ID – specified in Alstom manual)
- Bite joints – excess in number – w.r.t. manual
- Washers used in flexible hoses gets shrunk & perished – only Nylon-66 washers to be used

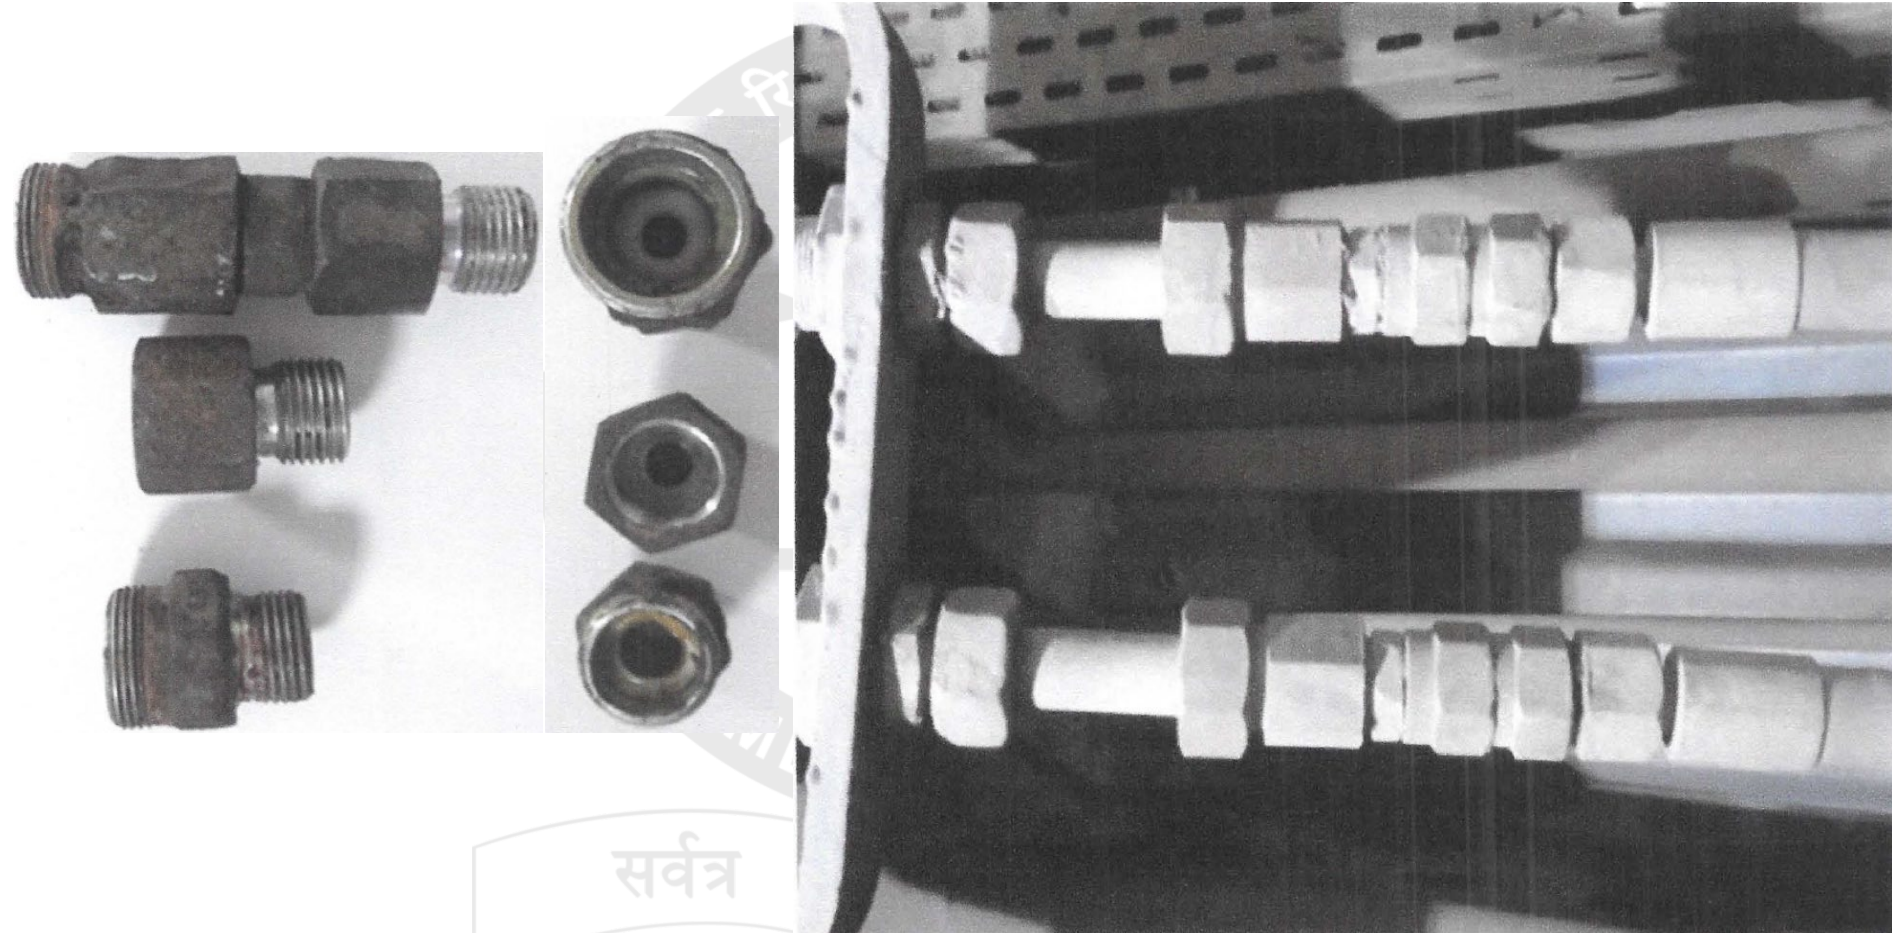
Excessive end fittings

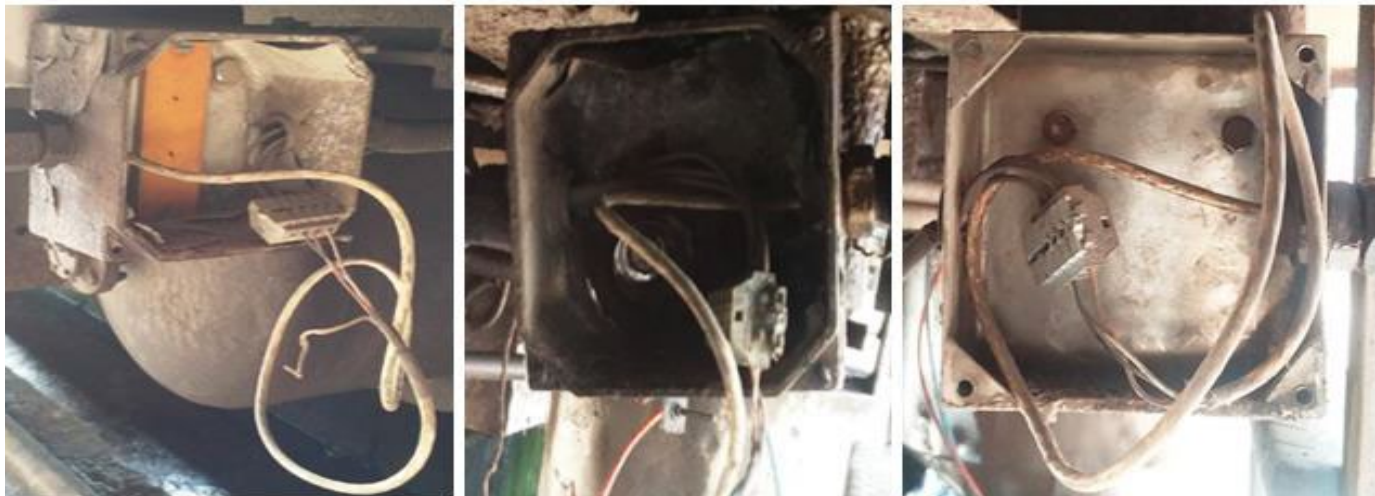
Damaged Speed Sensor Junction Box

- MC/LHB/Brake, dated: 27.09.2019
- One time drive to ensure vibration resistant electrically secured connection in WSP wiring
- SSE/JE made responsible to ensure that fault counter readings for WSP should not repeat
- Proper trouble-shooting of recorded faults – repair to loose/damaged electrical connections
