MEDHA TBU- BT2 8555 CA TBU MAINTENANCE PLAN

TRAIN-18 44TS

Project: Medha Train 18
Product: BT2-8555 CA

MAINTENANCE PLAN OF TBU

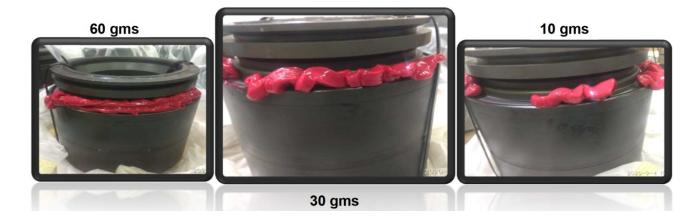
If the oozed out grease does not settle & the quantity of the grease observed is more than 30gms, then the bearing should be removed from service & sent for refurbishment. The grease seal should be examined in detail to identify any mechanical damage. The visualization of grease quantity on the bearing is as show below.

This slight oozing of the grease is acceptable. The grease thus visible should not be cleaned away as the grease forms an additional barrier to prevent further oozing. If the other operating parameters like temperature is normal, then the bearing should be allowed to continue in service.

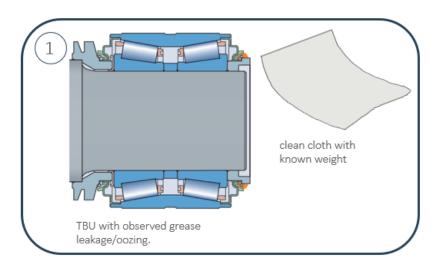
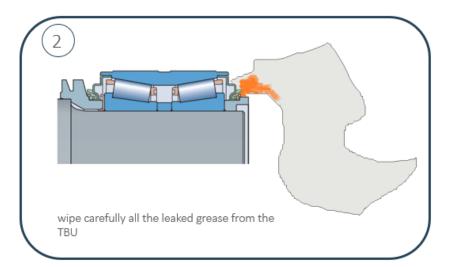
The weight of the grease leaked out can be determined using the below steps.

Weigh the cloth with the grease wiped off, subtract the cloth weight and compare the result with a reference value of 30 g.

Be aware that this is a tentative method, because the result is affected by how well you manage to wipe the grease from TBU. But also by how much dirt gets attached to that cloth.
