Failure analysis of Spring and components of Under frame in Rolling stock

Pankaj Kumar/Professor (Admin) /Jamalpur

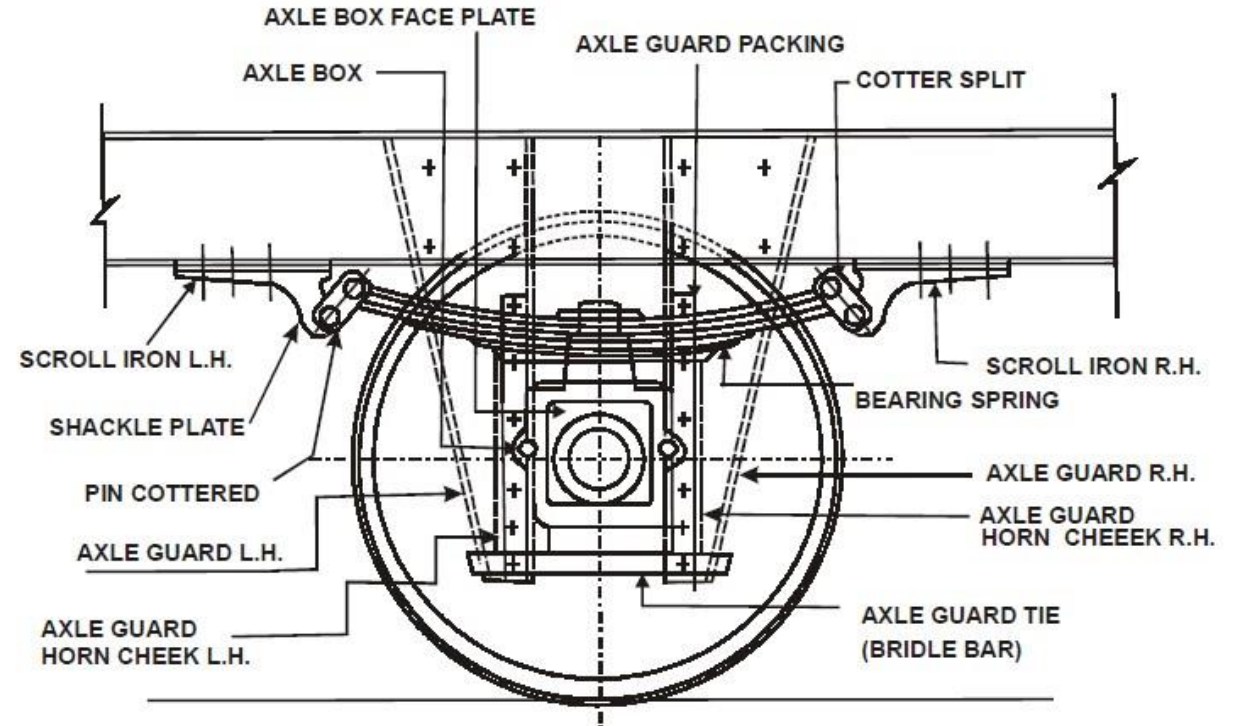
Leaf Spring in Brake van

Steel leaf spring /Laminated in Four Wheeler Suspension

- ❑ In four wheeler wagons the load is transmitted in the conventional arrangement via the sole bar, scroll iron, shackles or shackle plates to the springs and axle box, axle box key plates and bearing journal.
- ❑ Brake van (four wheeler)

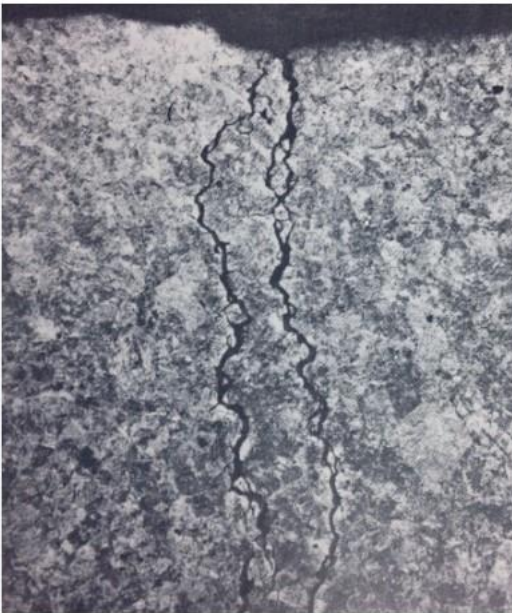
Quenching crack

- Accidental injury to plate: Sharp dents or notches caused during manufacture or in service act as stress raisers and reduce the life of spring.
 - Quenching cracks:-These are usually caused by (a) inadvertent use of **wrong grade of steel** for a given heat treatment procedure, (b) too **drastic** a quenching medium, (c) high **hardening temperature**, (d) insufficient **soaking period**, (e) surface defects such as seams laps, cluster of non-metallic inclusions occurring at or near the surface, (f) **sharp grooves** or dents on surface. In service, they act as stress raisers resulting in premature failure.

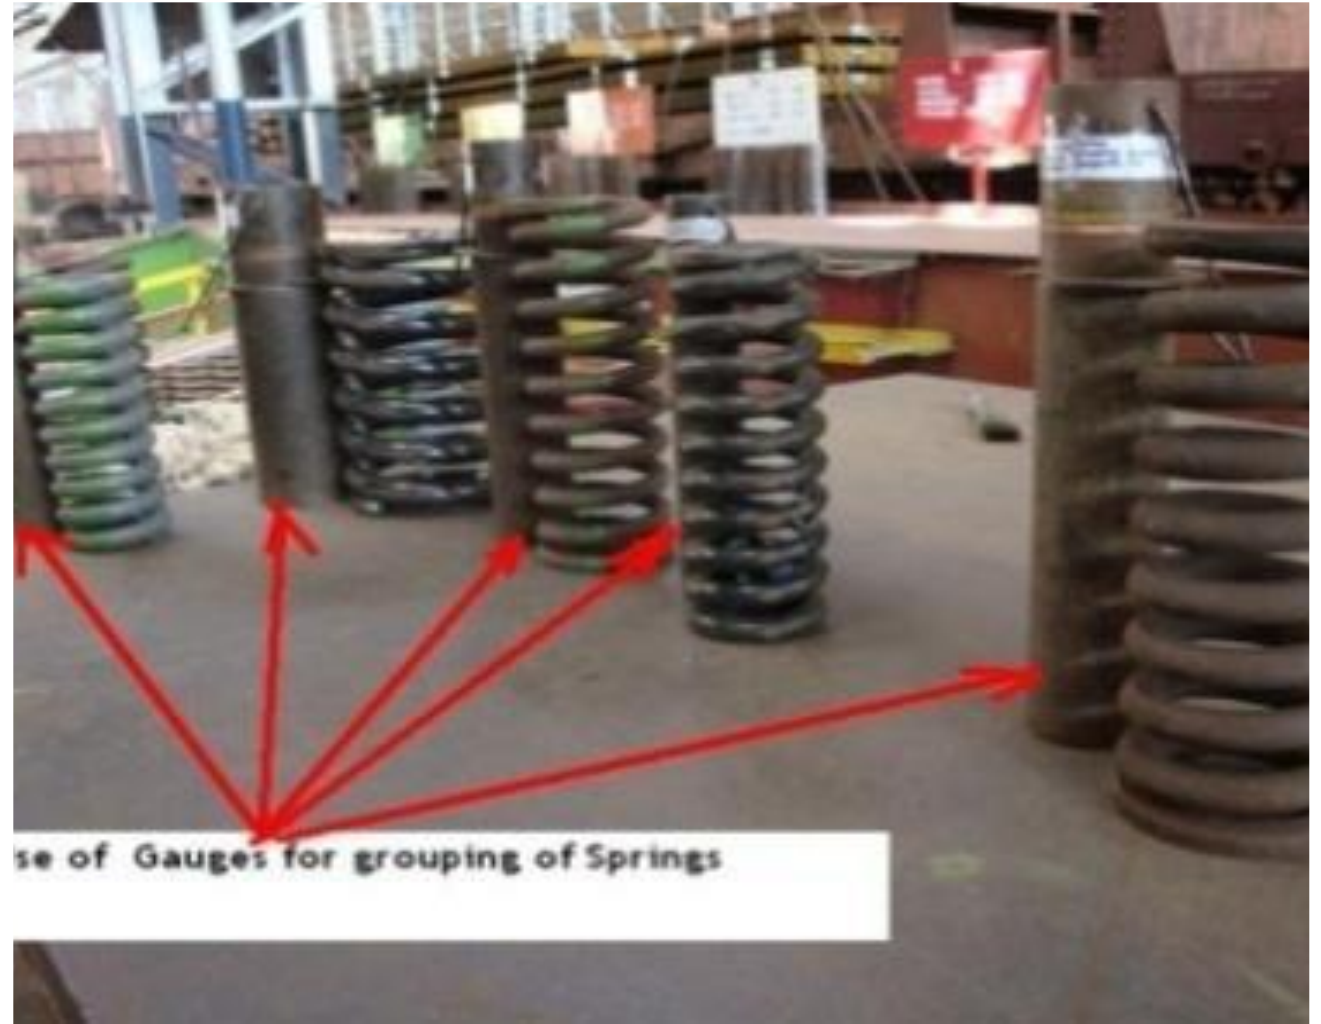
Coil Spring (wagon)

The spring shall be manufactured as per the schedule of Technical Requirement for hot coiled helical springs WD-01-HLS-94 (Rev. I May, 95 with latest amendment) by the spring manufacturers approved by RDSO.

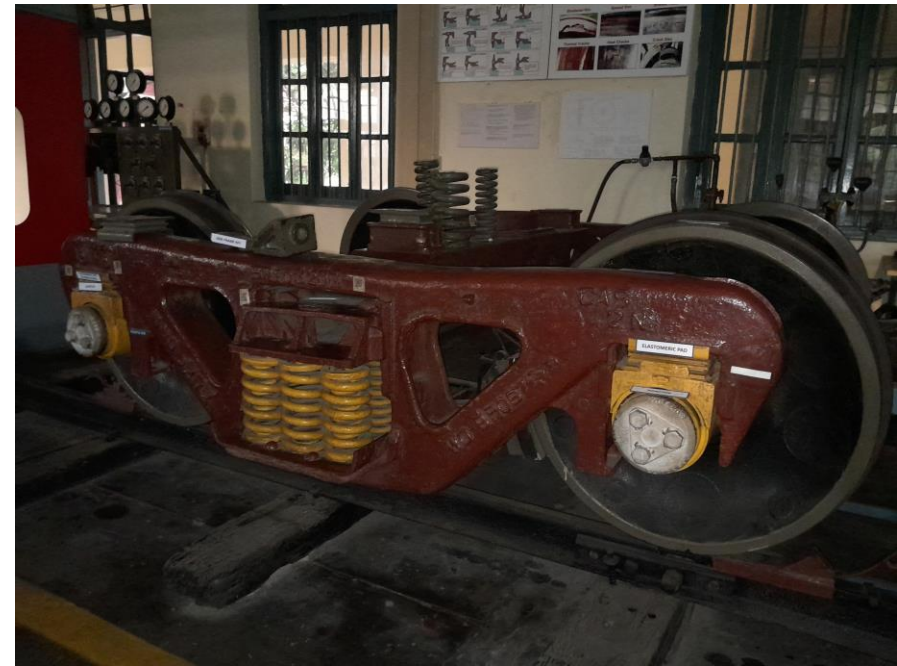
Coil Springs in CASNUB bogie (maintenance practice)

- It is recommended that the springs should be so grouped that the free height variation in the group is not more than 3 mm.
- Mixing of new and old springs should be avoided.
- Coloured band should be provided for easy identification of group height as indicated in the table.

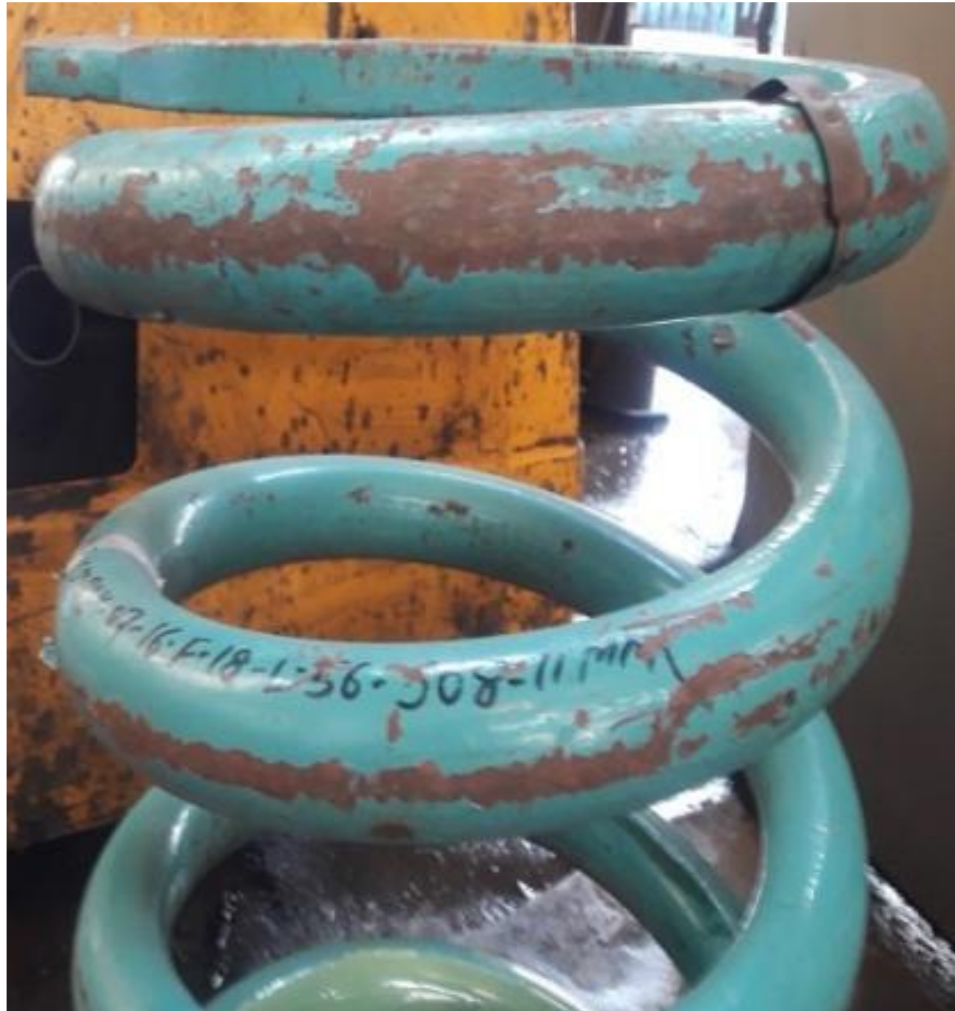
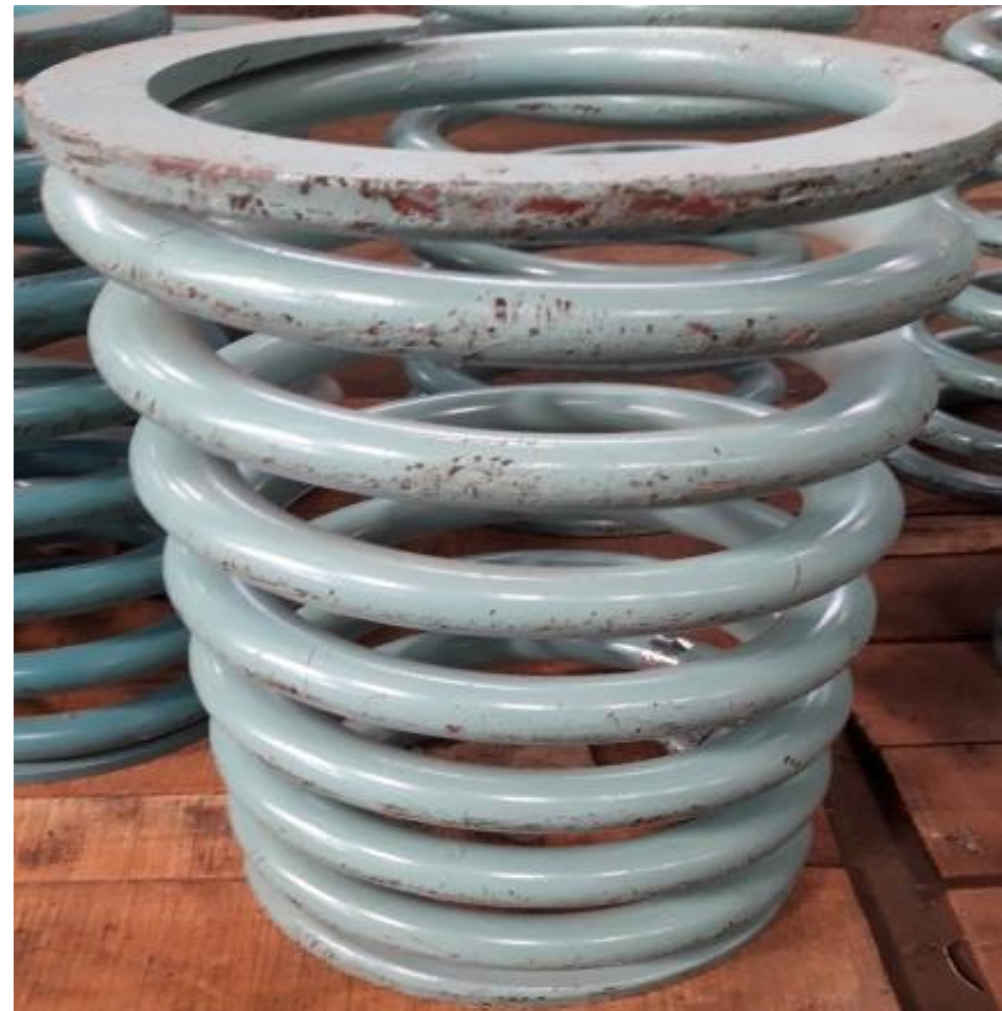
Rolling marks on spring

5.	<p>Storage, Handling and Mounting of Springs:</p> <p>a) Spring should be stored in unpacked and unwrapped condition in a dry covered place.</p> <p>b) Springs should not be rolled on the floor for movement from one place to other.</p> <p>c) Forks, crane hooks etc. should be provided with soft material cover like rubber cover etc. to avoid damage during handling</p>	<p>a) Most of the springs were observed with paint damage. Springs were rolled on the floor for movement from one place to another. (Fig.5, 6 & 7).</p> <p>b) Spring transport trolley was not provided with soft material like rubber cover etc. Crane hooks were also not provided with soft material cover. (Fig.8, 9 & 10).</p>

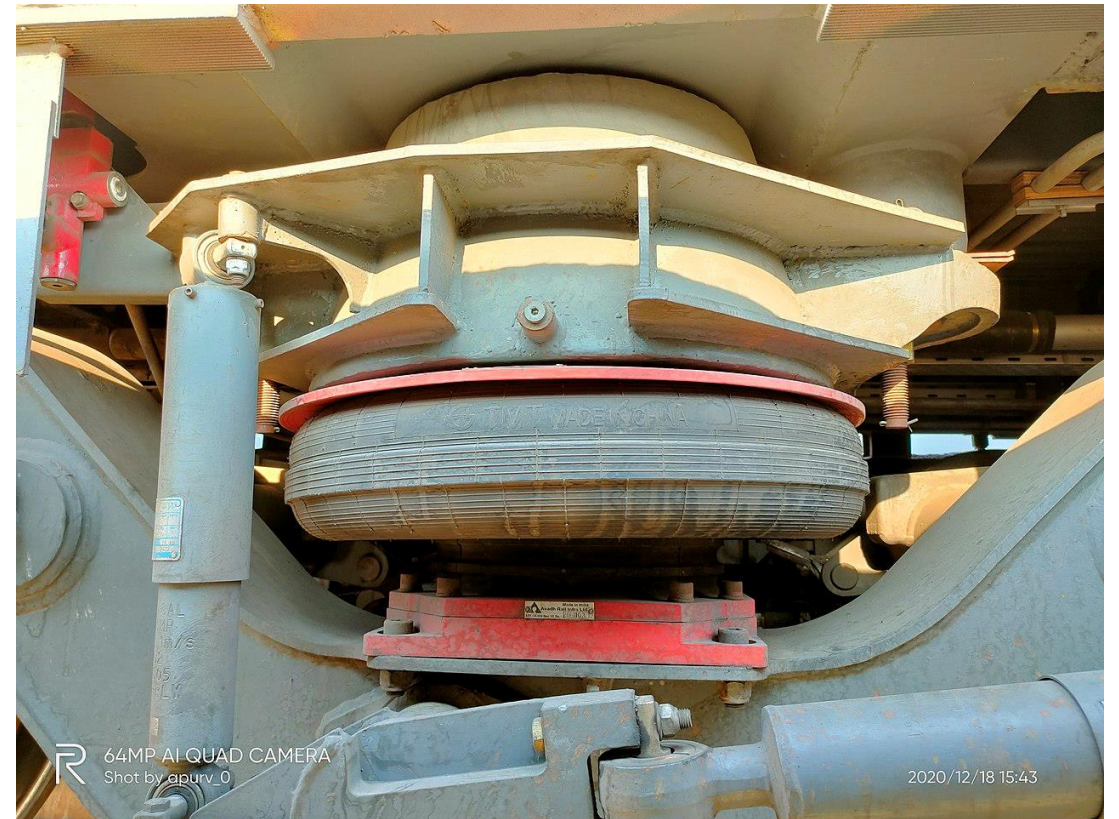
Air spring – cleaning of air spring

- Rubber products can be cleaned with soap and warm water. The cleaned articles should be dried at room temperature. After a fairly long period of storage (6 to 8 months) the product can be cleaned with a **1.5% sodium bicarbonate solution**. Remaining traces of the cleaning fluid should be rinsed off with water.
- Solvents such as trichlorethylene, carbon tetrachloride as well as hydrocarbons must not be used for cleaning purposes.
- Moreover, sharp- **edged objects, wire brushes, emery paper, etc should not be used**. Rubber metal bondings are to be clean using a glycerine-sprit mixture (1:10).

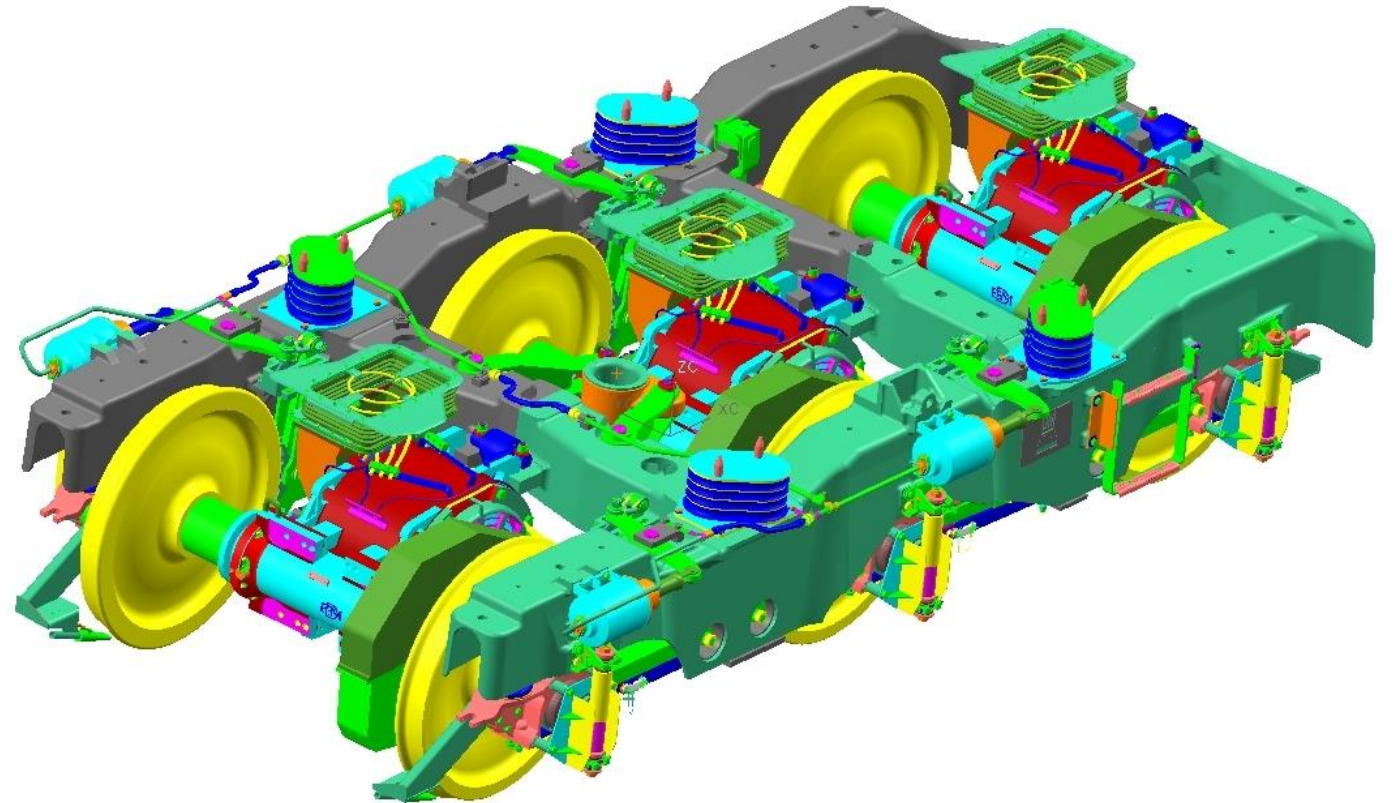
Failures analysis HTSC Bogie of HHP loco

- Axle Lock
- Break binding
- Gearcase leakages
- Hand break not working

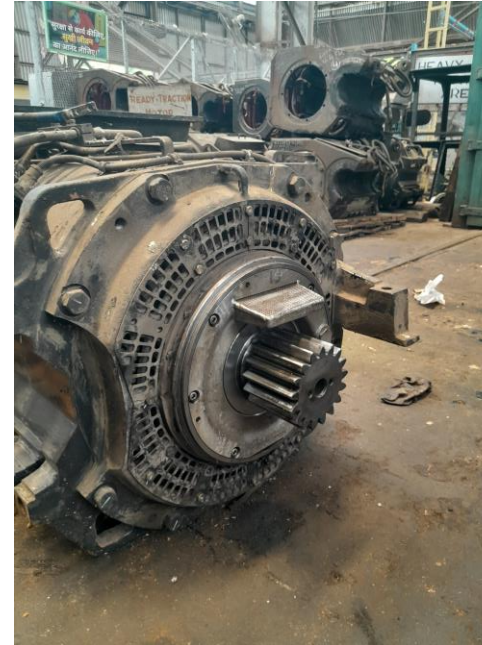
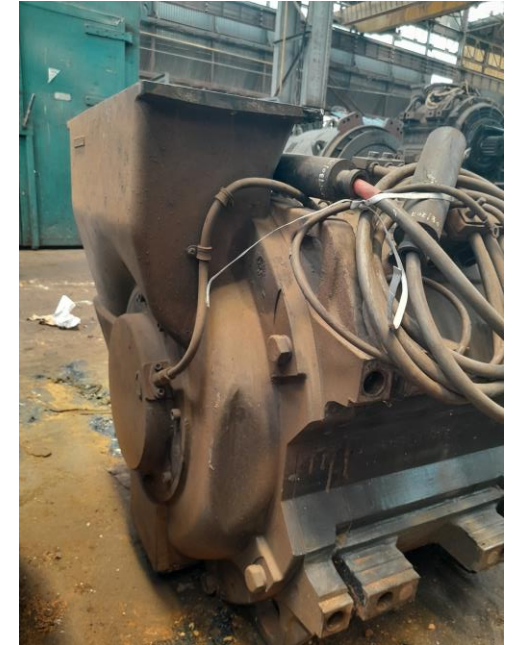
Causes of Axle Lock

- Traction motor bearing seize (Free end bearing is grease lubricated)
- Traction motor Pinion teeth broken
- Bull gear teeth broken
- Gearcase oil leakage (in resultant rear end bearing may seize in lack of lubrication)

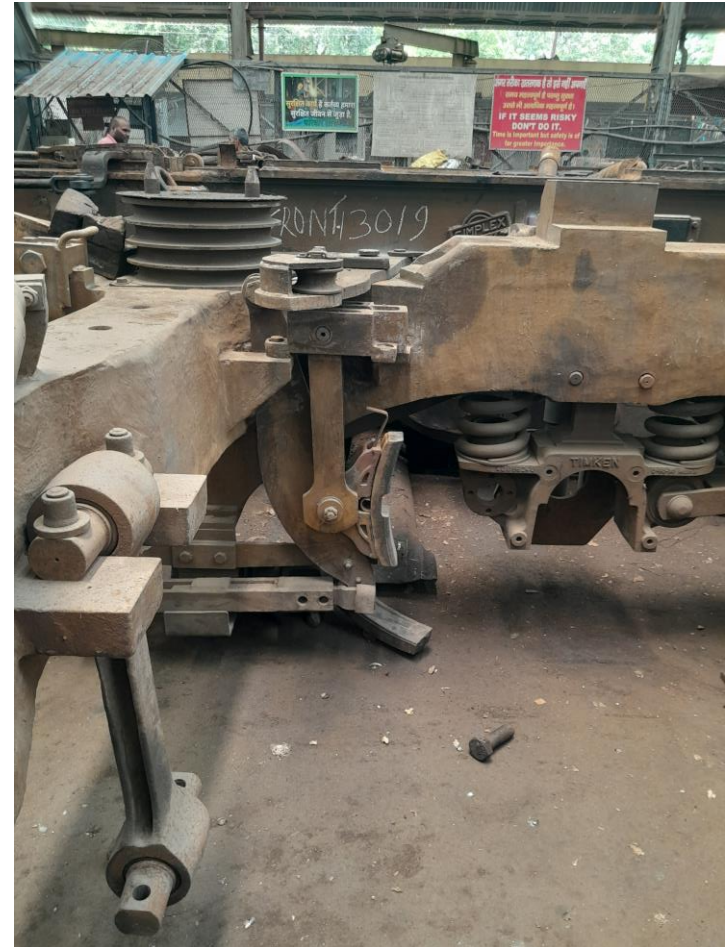
Causes of Axle lock

- CTRB lubrication lack/ Hot box
- MSU tube roller bearing seize
(usually greasing is to be done after 6 months as precaution)

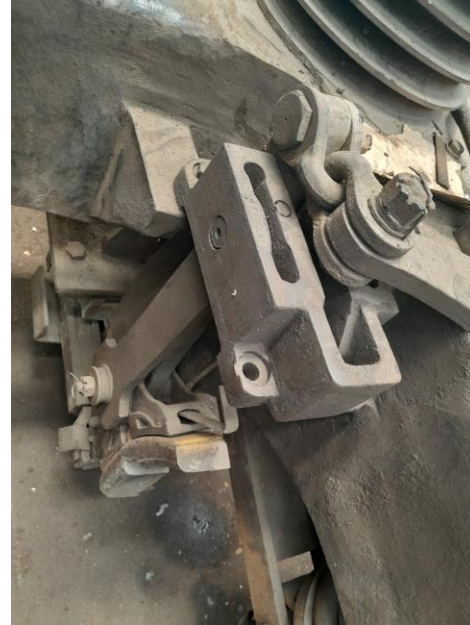
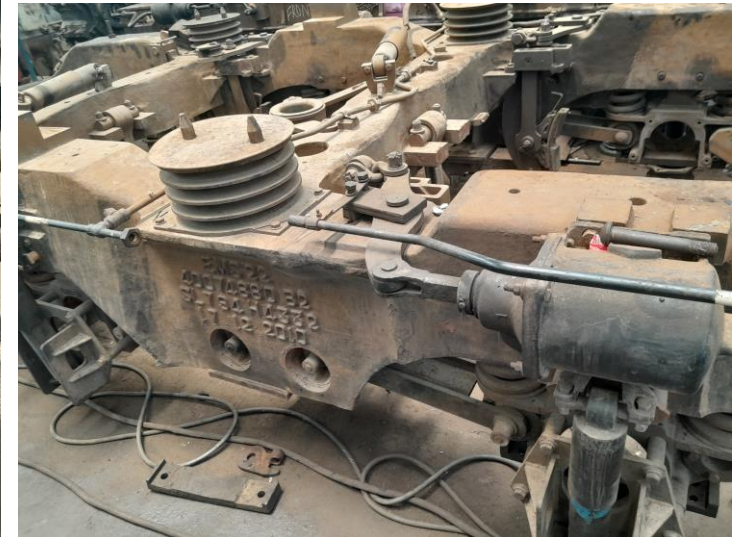
Causes of Break binding

- Hanger struck (sometime Bush piece is fallen in passage and stop the movement of hanger)
- Air pressure not released (C2 relay valve malfunctioning)

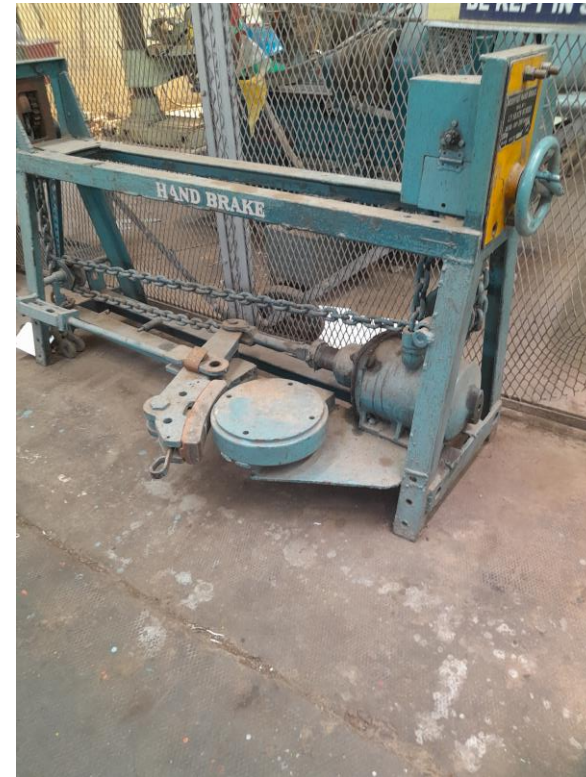
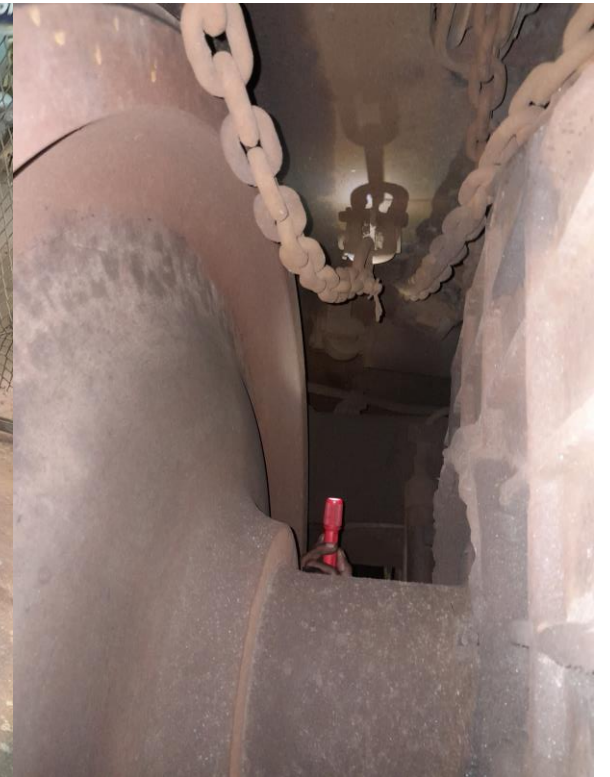
Causes of Break binding-----

- Hand break not released.
(in HTSC bogie hand break is provided on Right side of loco at wheel axle No- 4 & 5)
 - * Chain lock/ fastened at end may be broken.

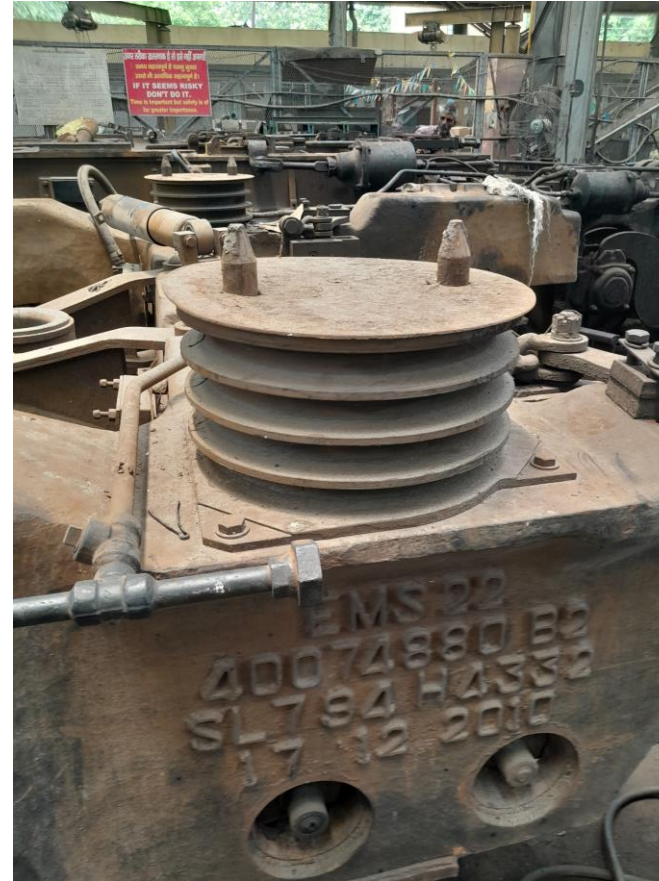
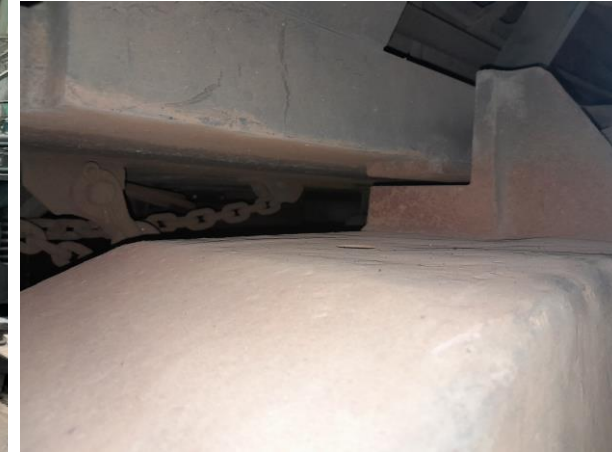
Causes of derailment

- Less vertical clearance
(major reason of less vertical clearance is worn out of Rubber spring or side bearer (secondary suspension)
Minimum it should not be less than 3 mm.
- Each Bogie consists of 4 Rubber spring /Secondary suspension(also called as side bearer) and each carry 12.5% loco load.

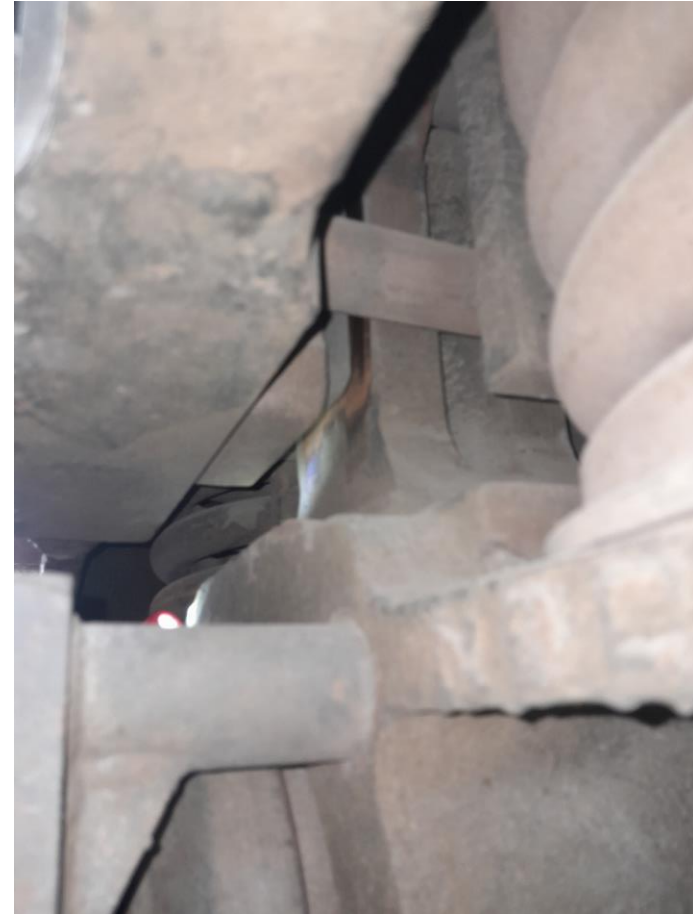
Causes of derailment.....

- Excessive Lateral clearance

(In new condition of WDG4 loco, the maximum total lateral clearance at middle axle should be 0.74 inch or 18.8 mm)
