DEVELOPMENT OF C&W DEPOT INFRASTRUCTURE

LESS DETACHMENT SMART YARD

INTEGRATED COACHING MAINTENANCE CONCEPT

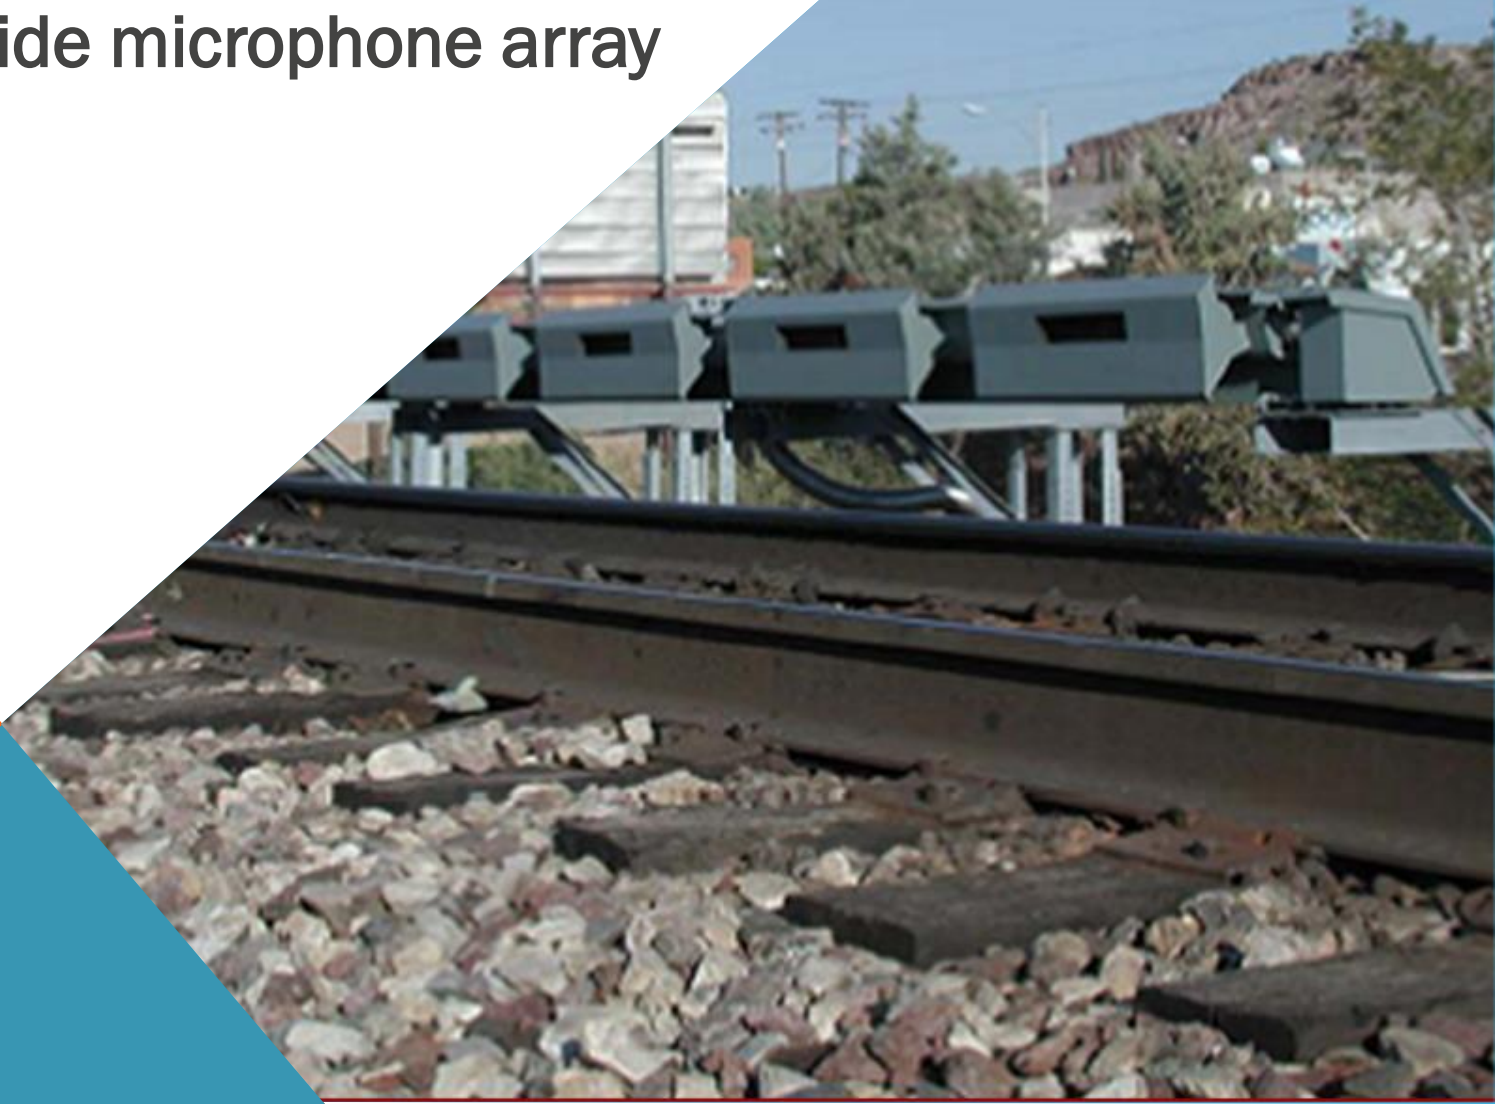
ACOUSTIC BEARING MONITORING SYSTEM

Trackside microphone array

Acoustic Bearing Monitoring System

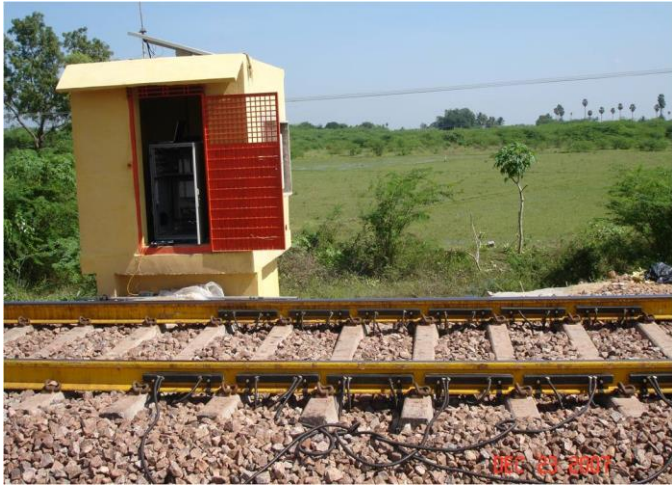
WHEEL IMPACT LOAD DETECTOR

AT ARRAKONAM

Wheel Impact Load Detector

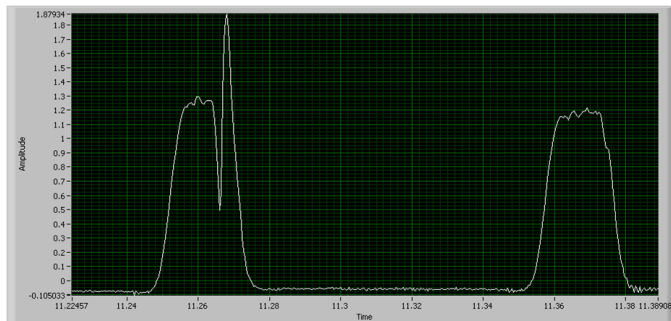
WHEEL IMPACT LOAD DETECTOR

WILD SIGNAL FROM TRACK

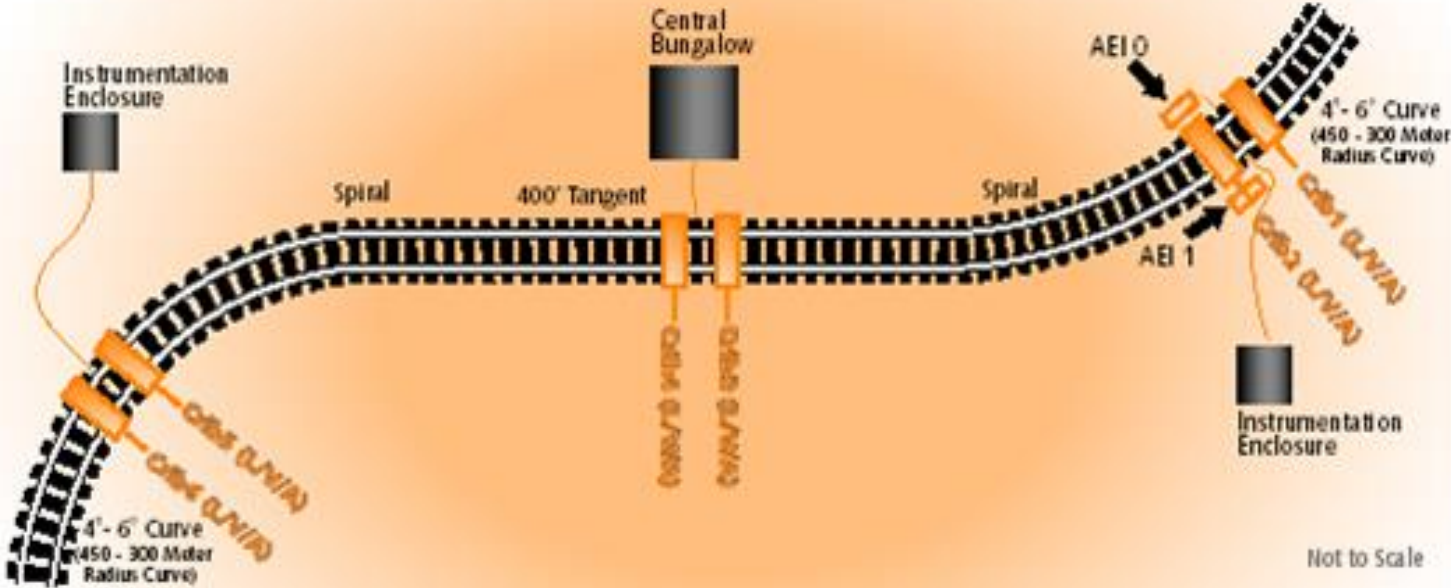
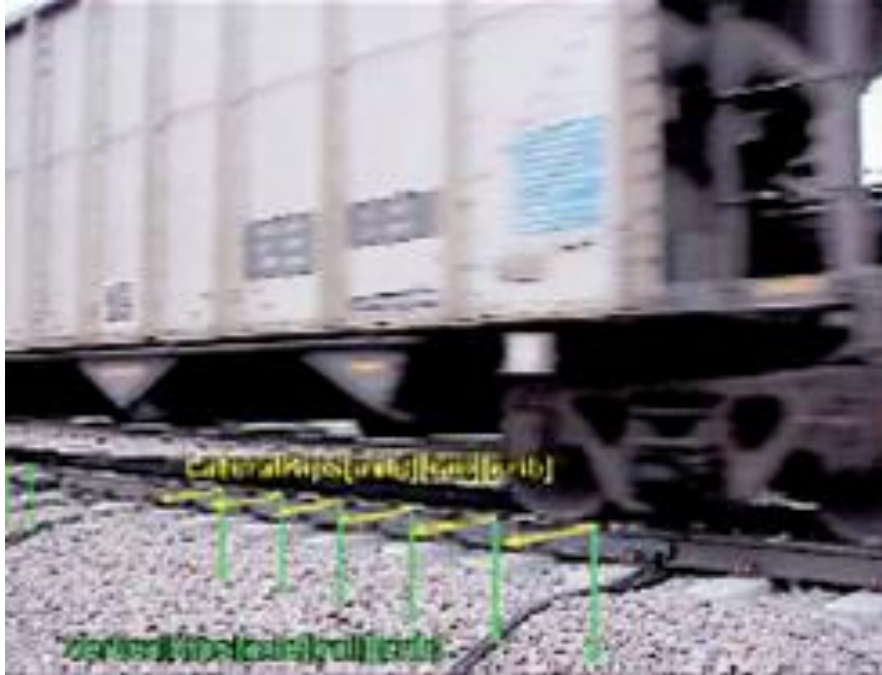
TROLLEY PERFORMANCE DETECTOR

- Angle of Attack (axle)
- Lateral Wheel Load
- Vertical wheel load
- L/V (lateral/ vertical) ratio
- Automatic Equipment Identification

Trolley Performance Detector

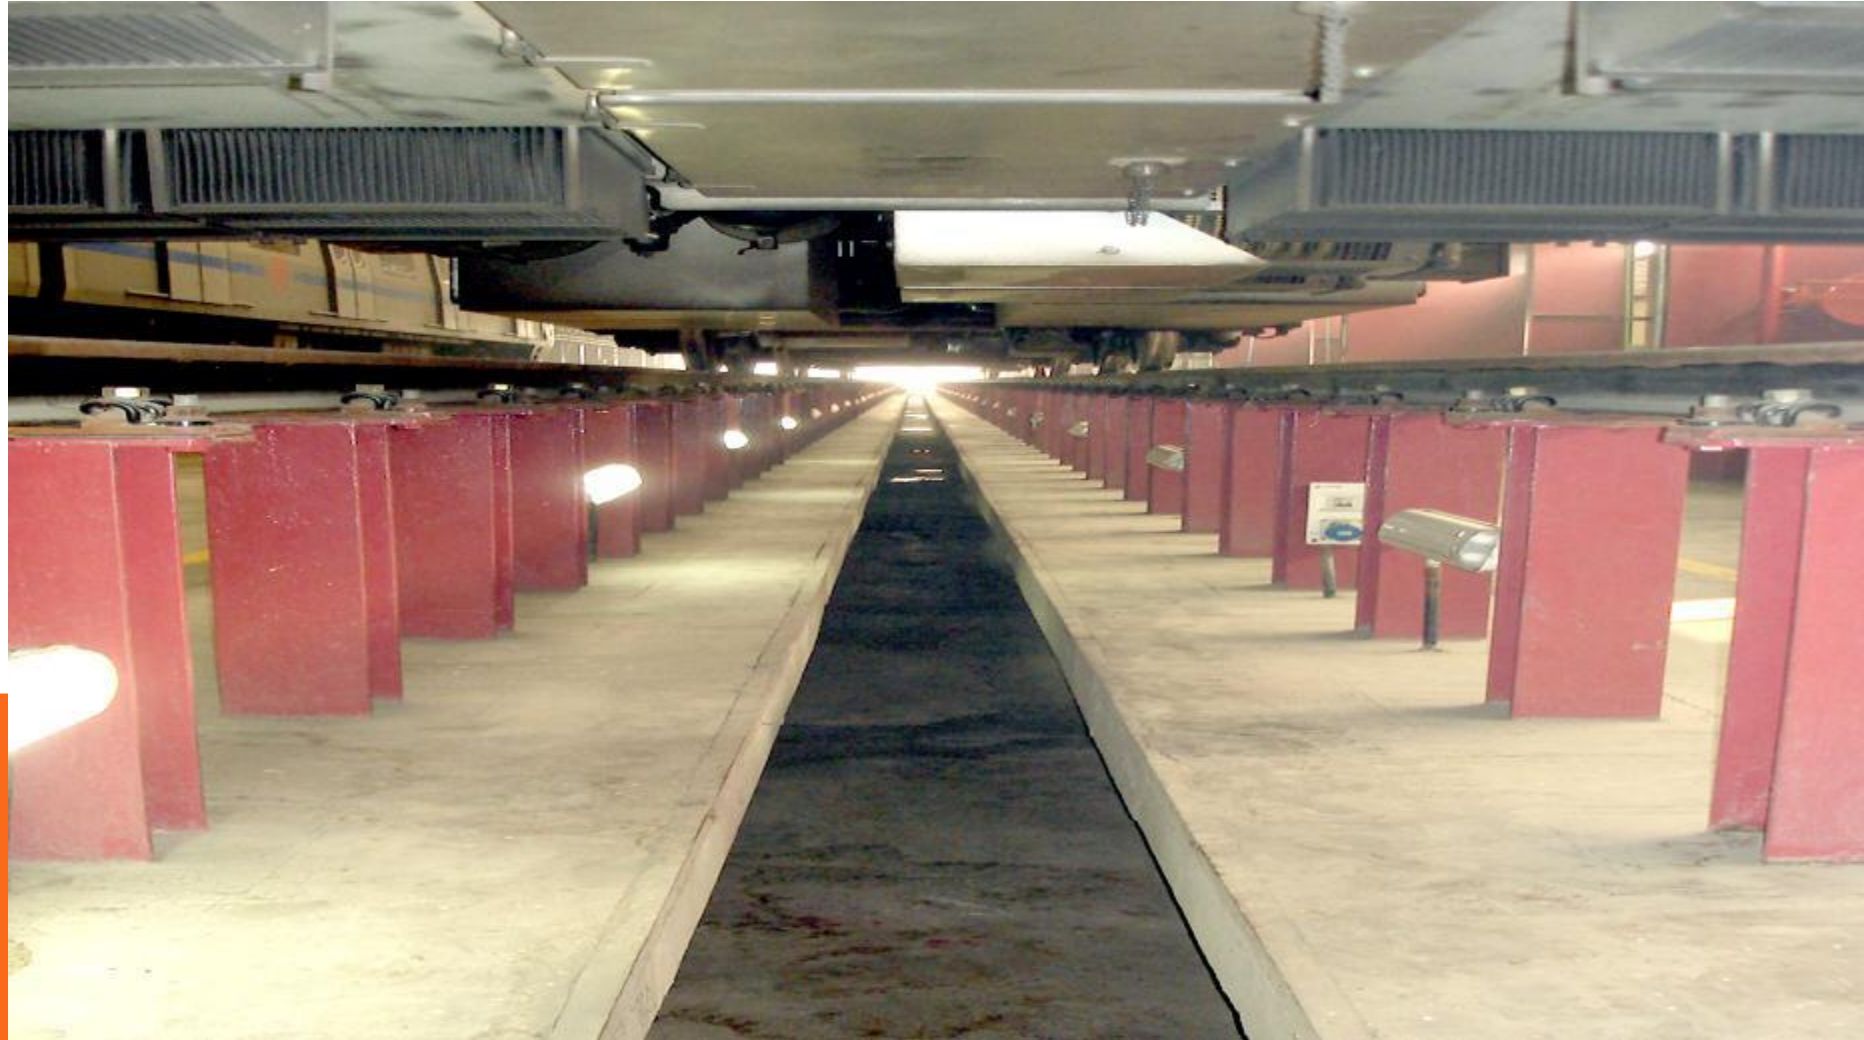
DMRC Coach on Pillar Design Pitline

Easy to Construct – On Steel Pillar

Economical and Expeditious Completion

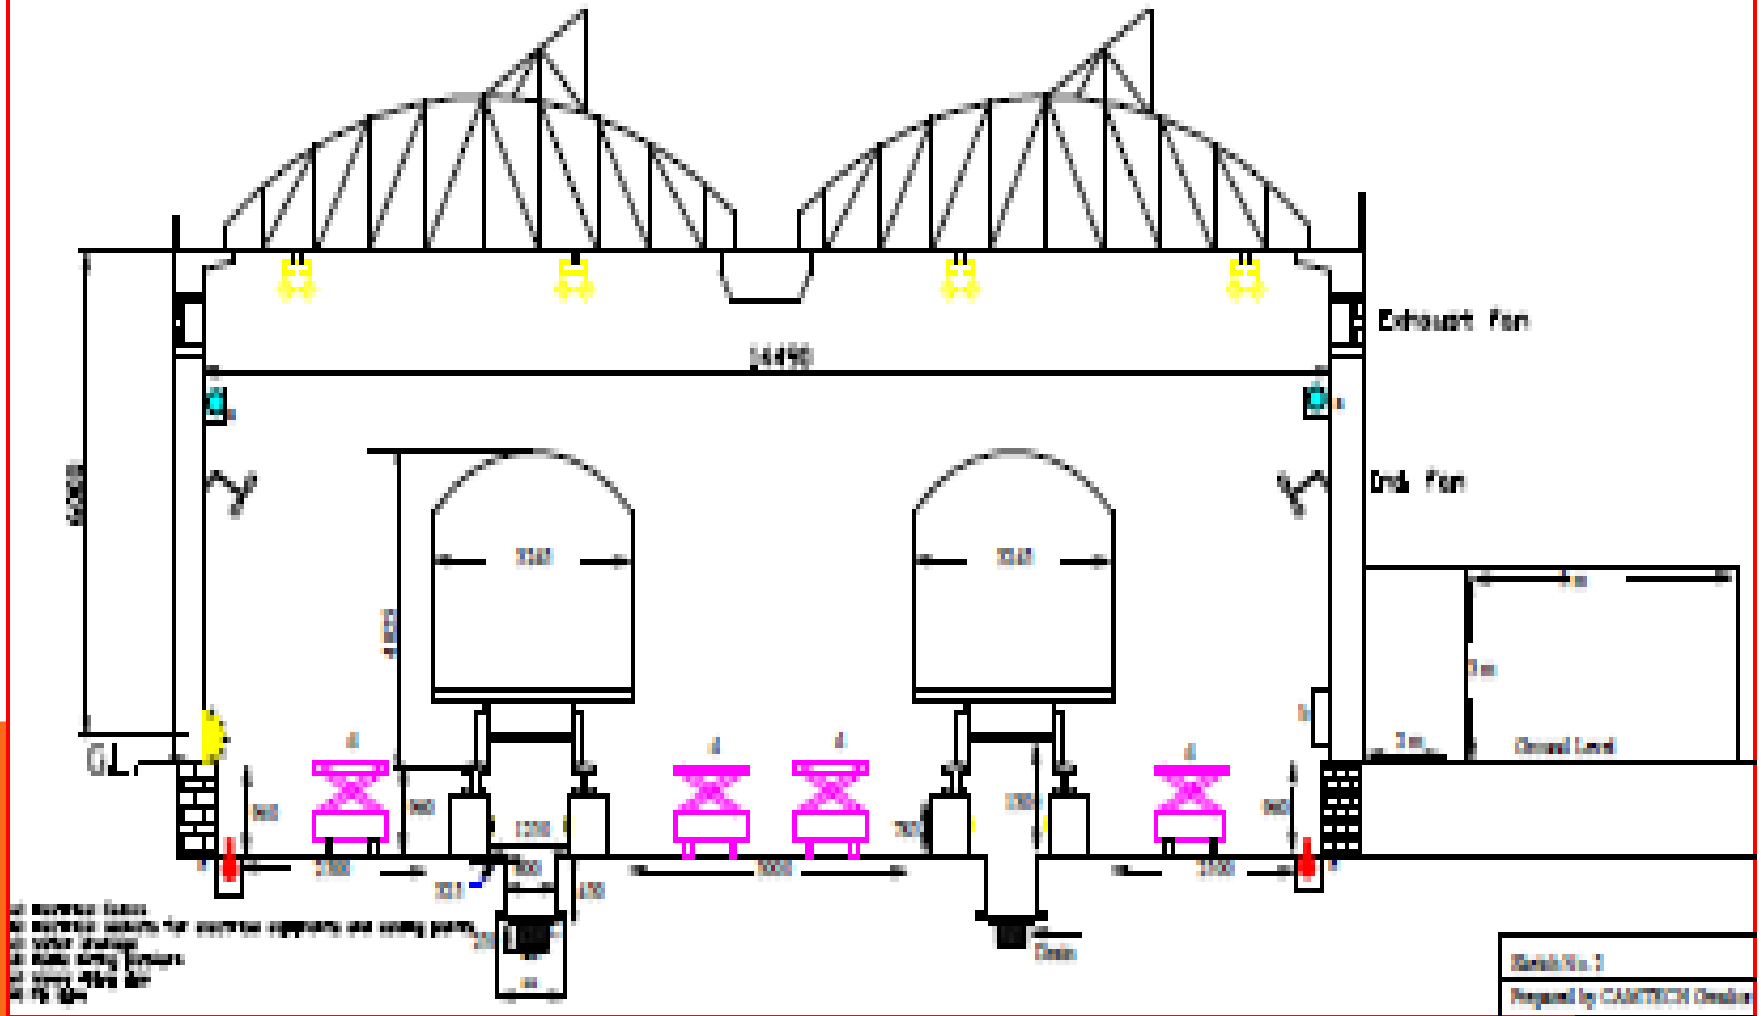
PIT LINE WITHOUT CAT-WALK

Pitline without catwalk with Twin Depth Pit

Oneside or No Catwalk

Twin depth Pit

Size 600mm X 450mm inside pit

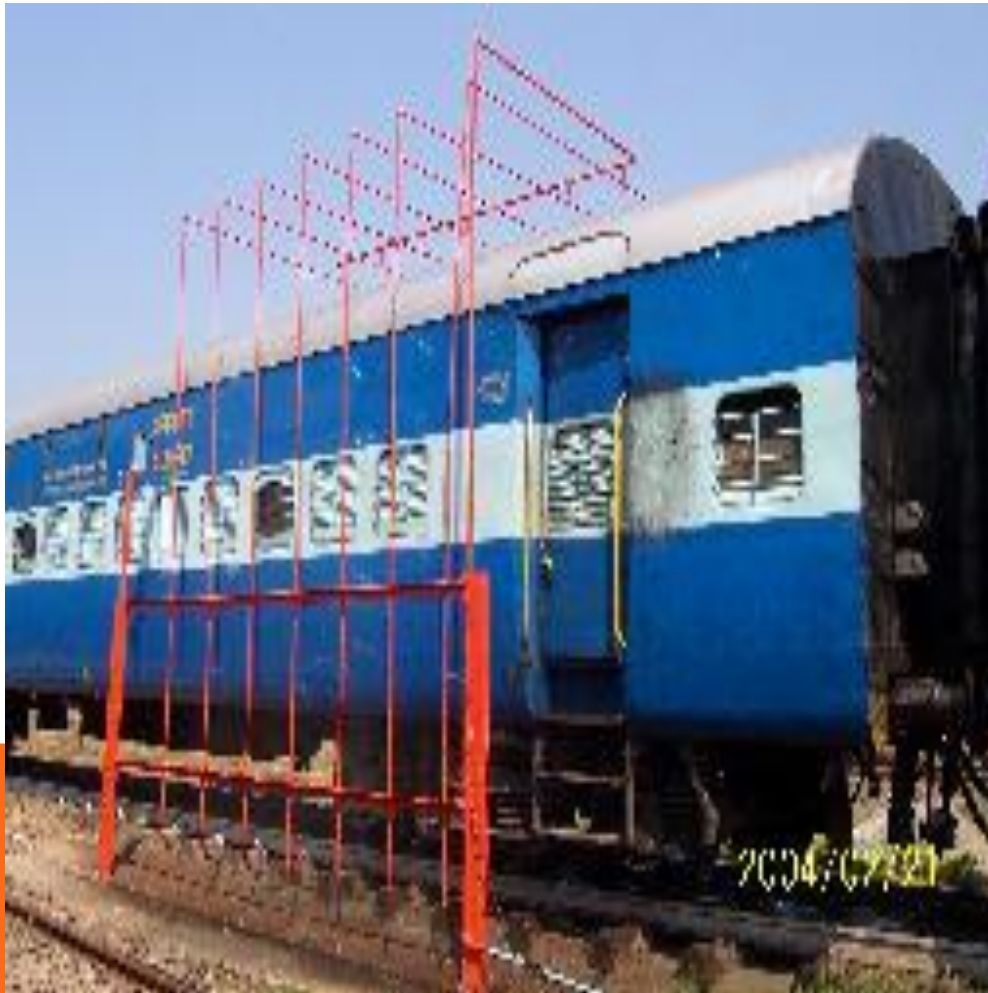
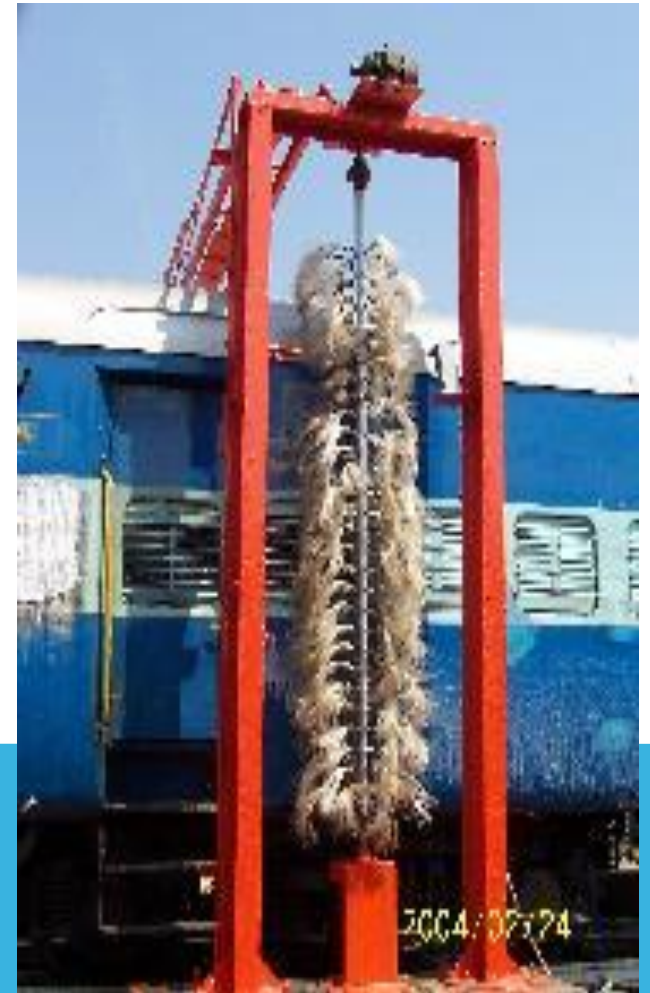
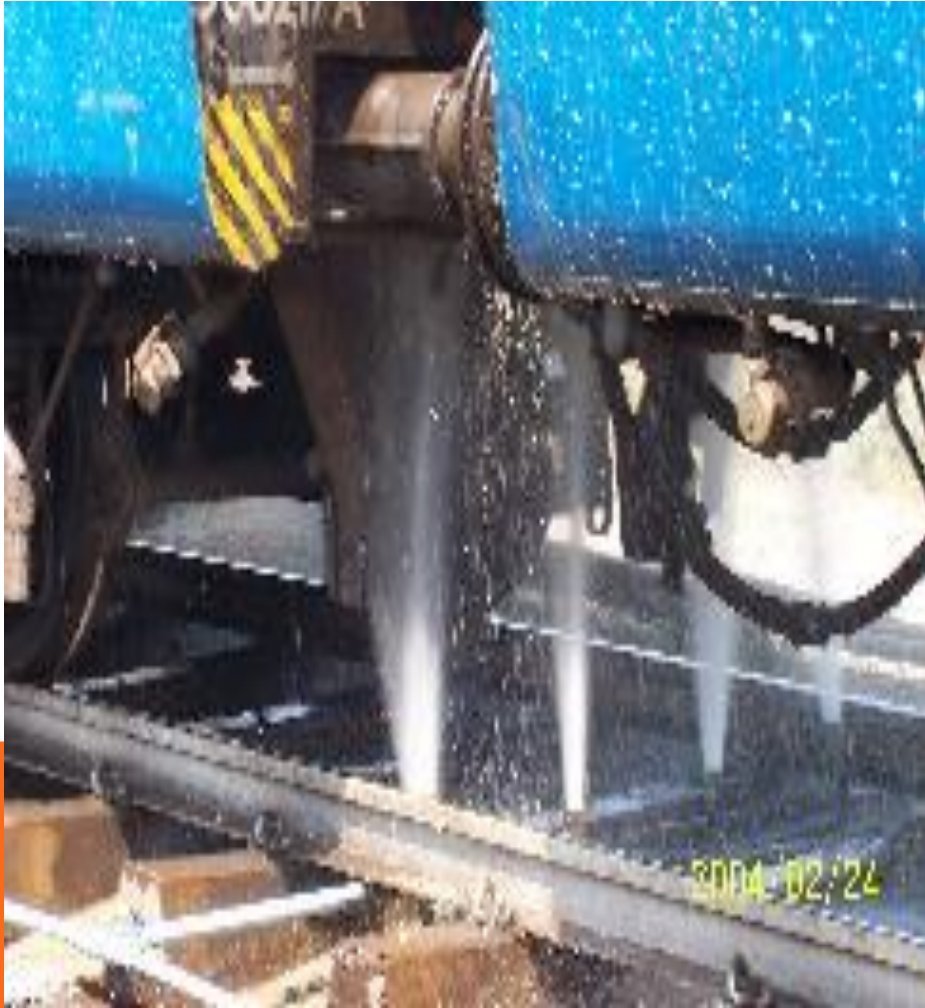
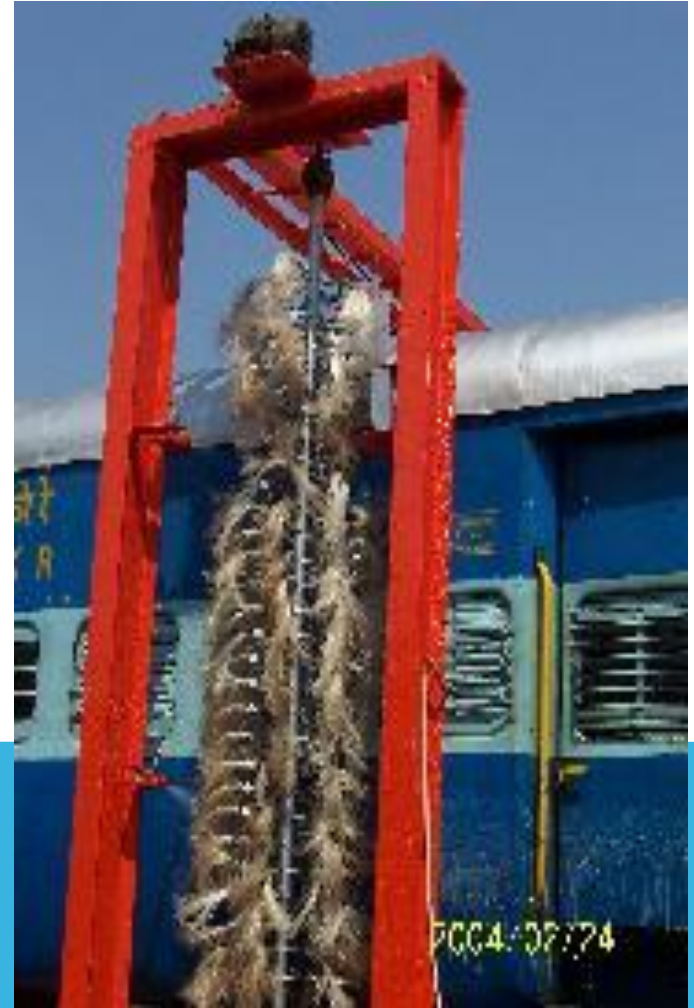
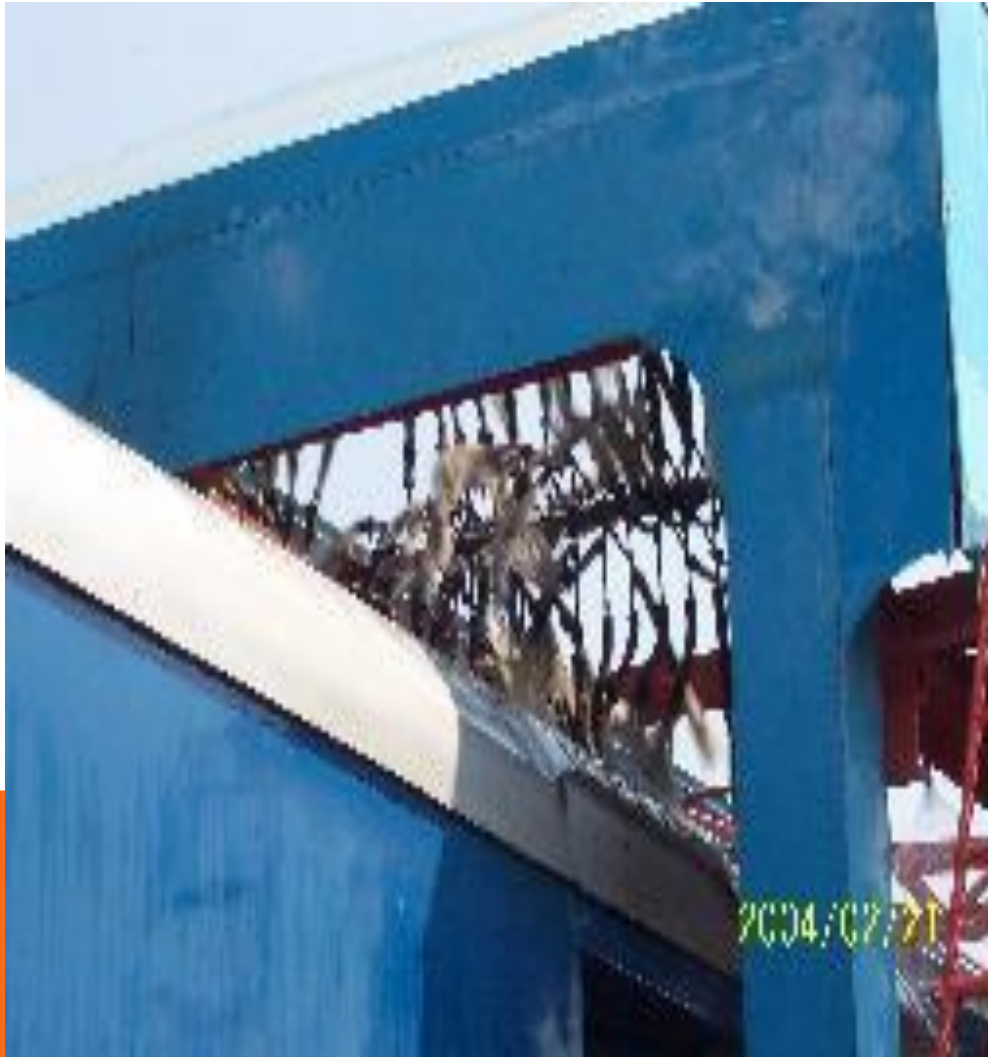
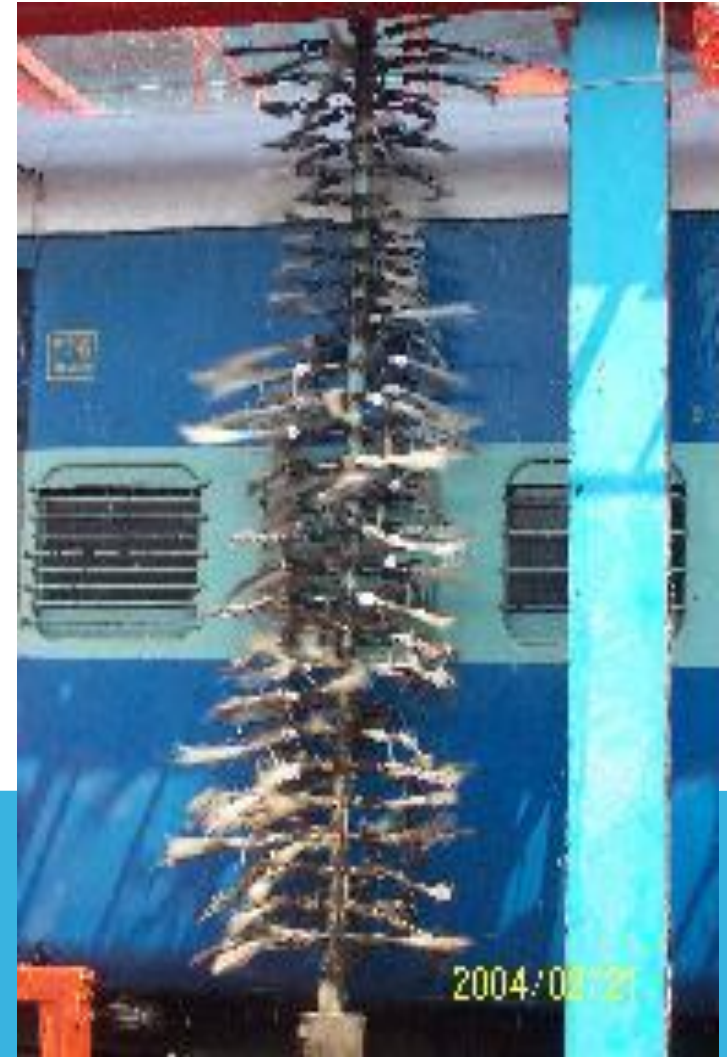
AUTOMATIC COACH WASHING PLANT

Outside Body Cleaning

In moving condition

Reduce the Coach washing time

Reduction in Water Spillage

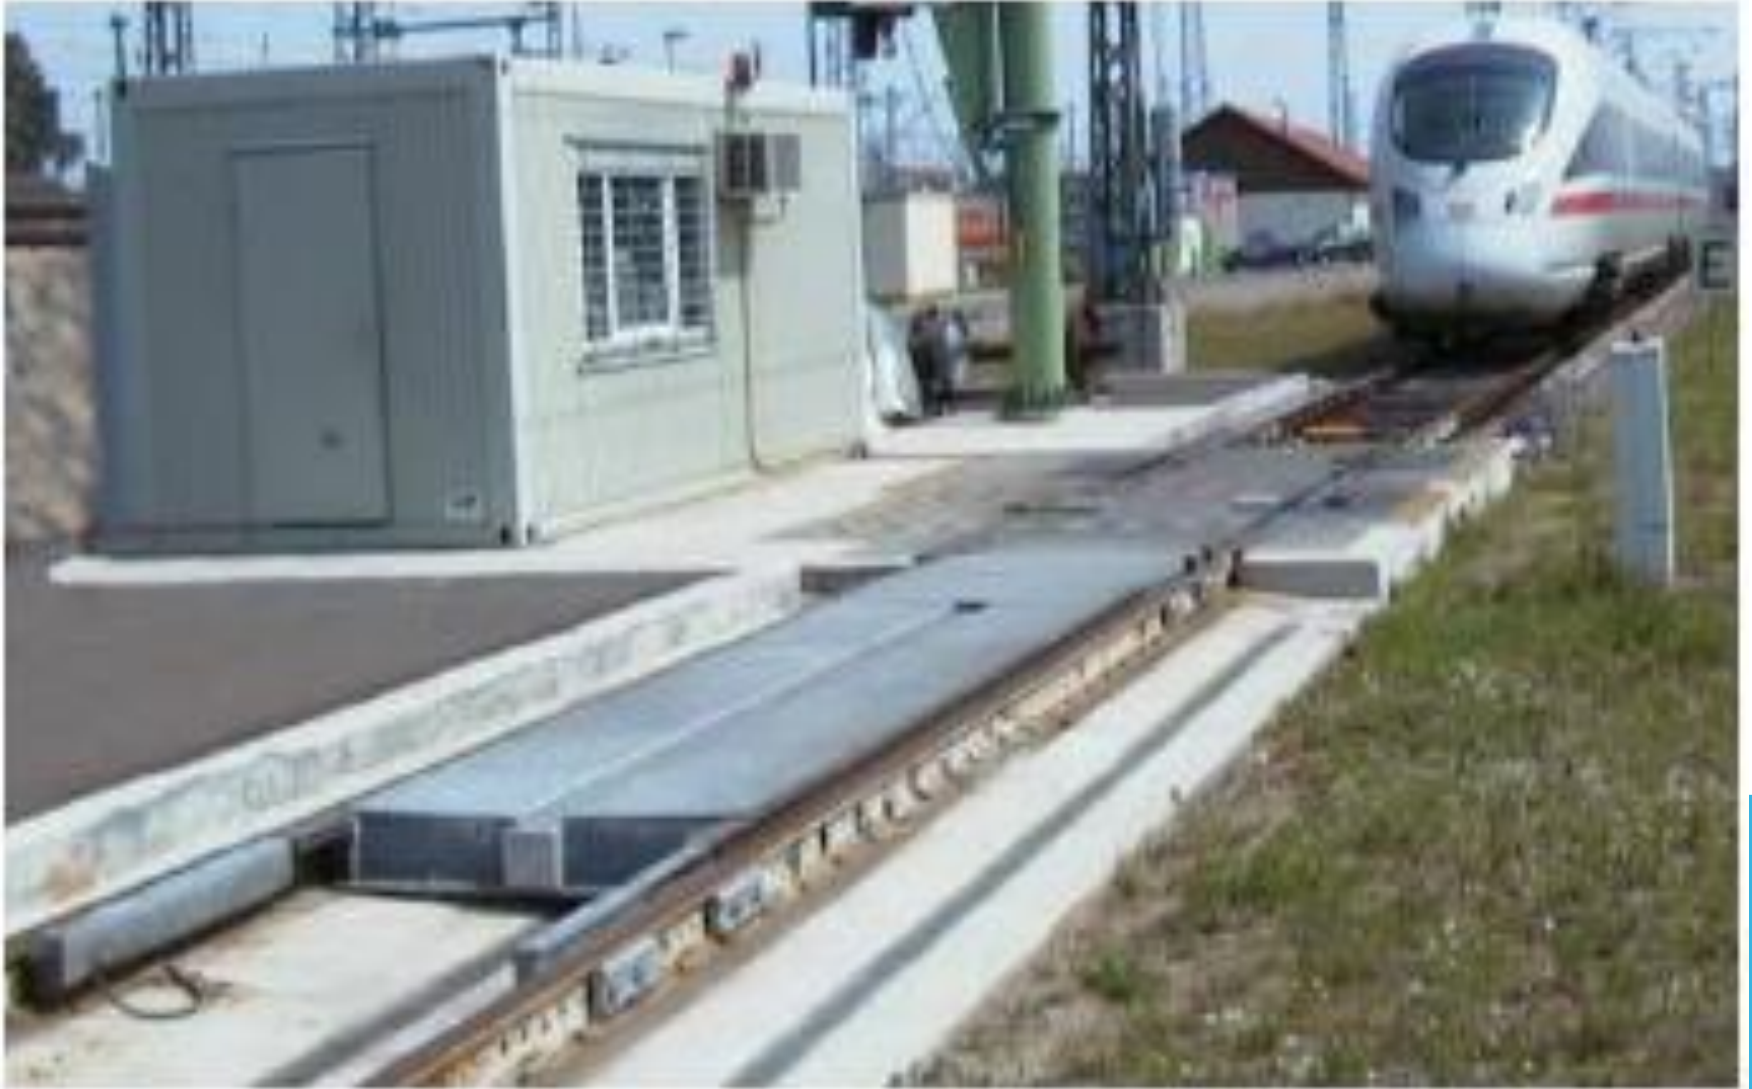
Automatic Wheel Diagnostic System

On line monitoring of wheel profile

On line Crack detection

On line detection of Flat Place

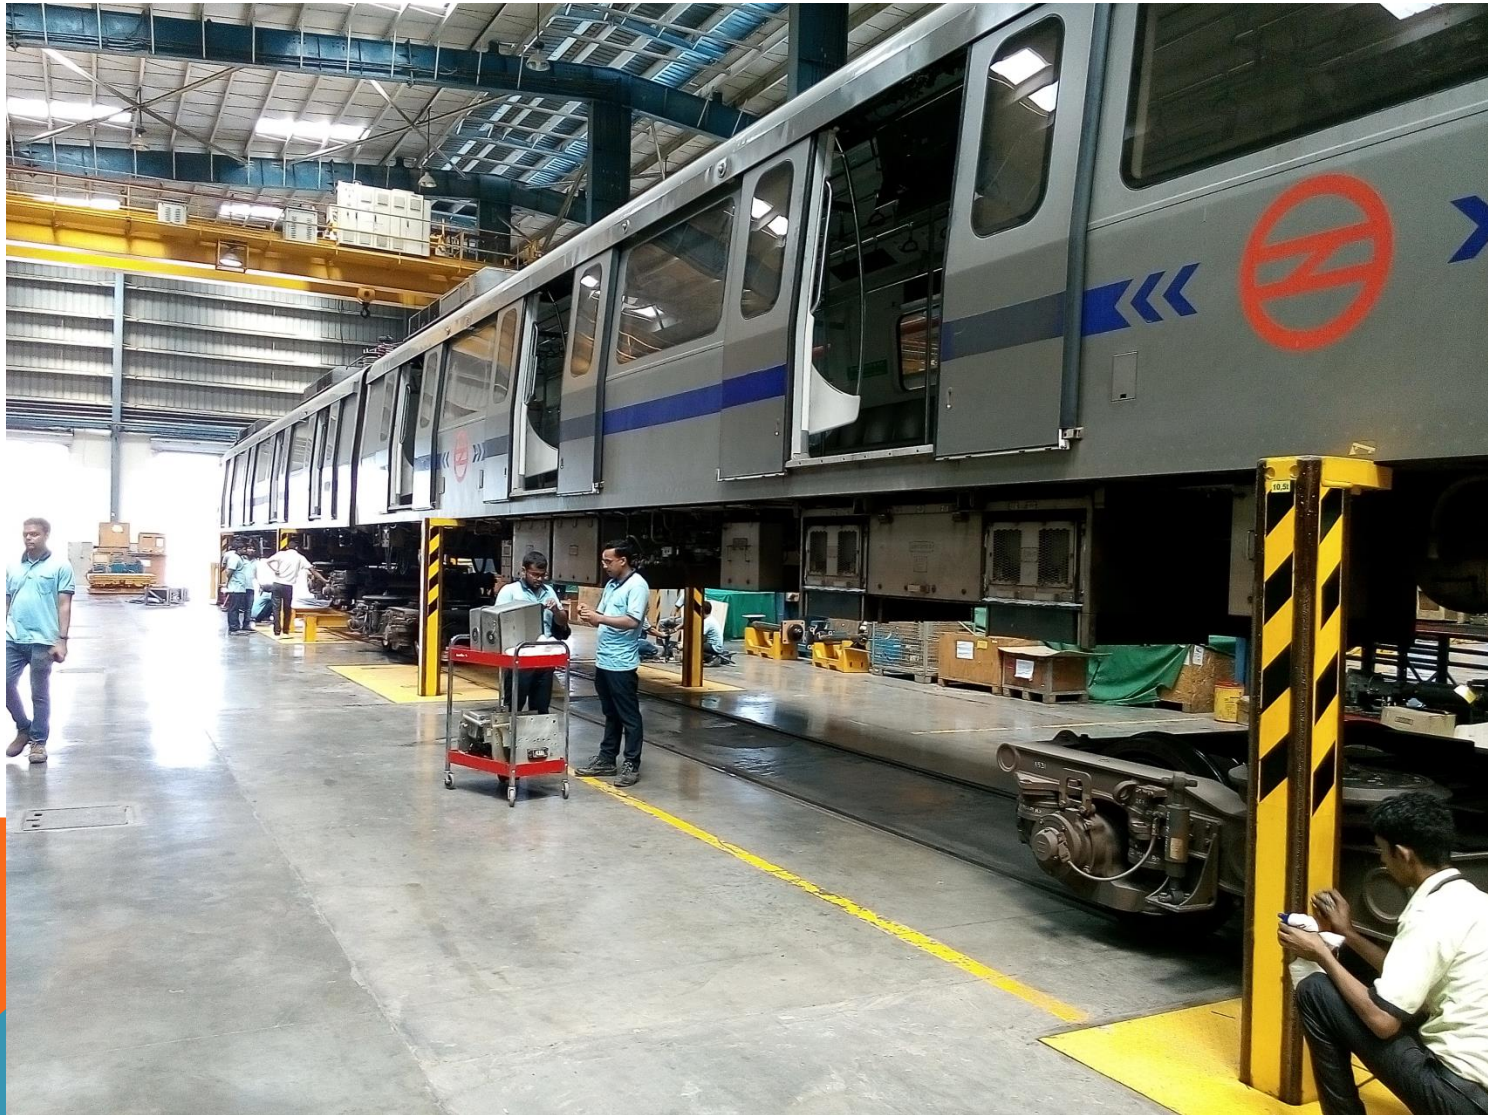
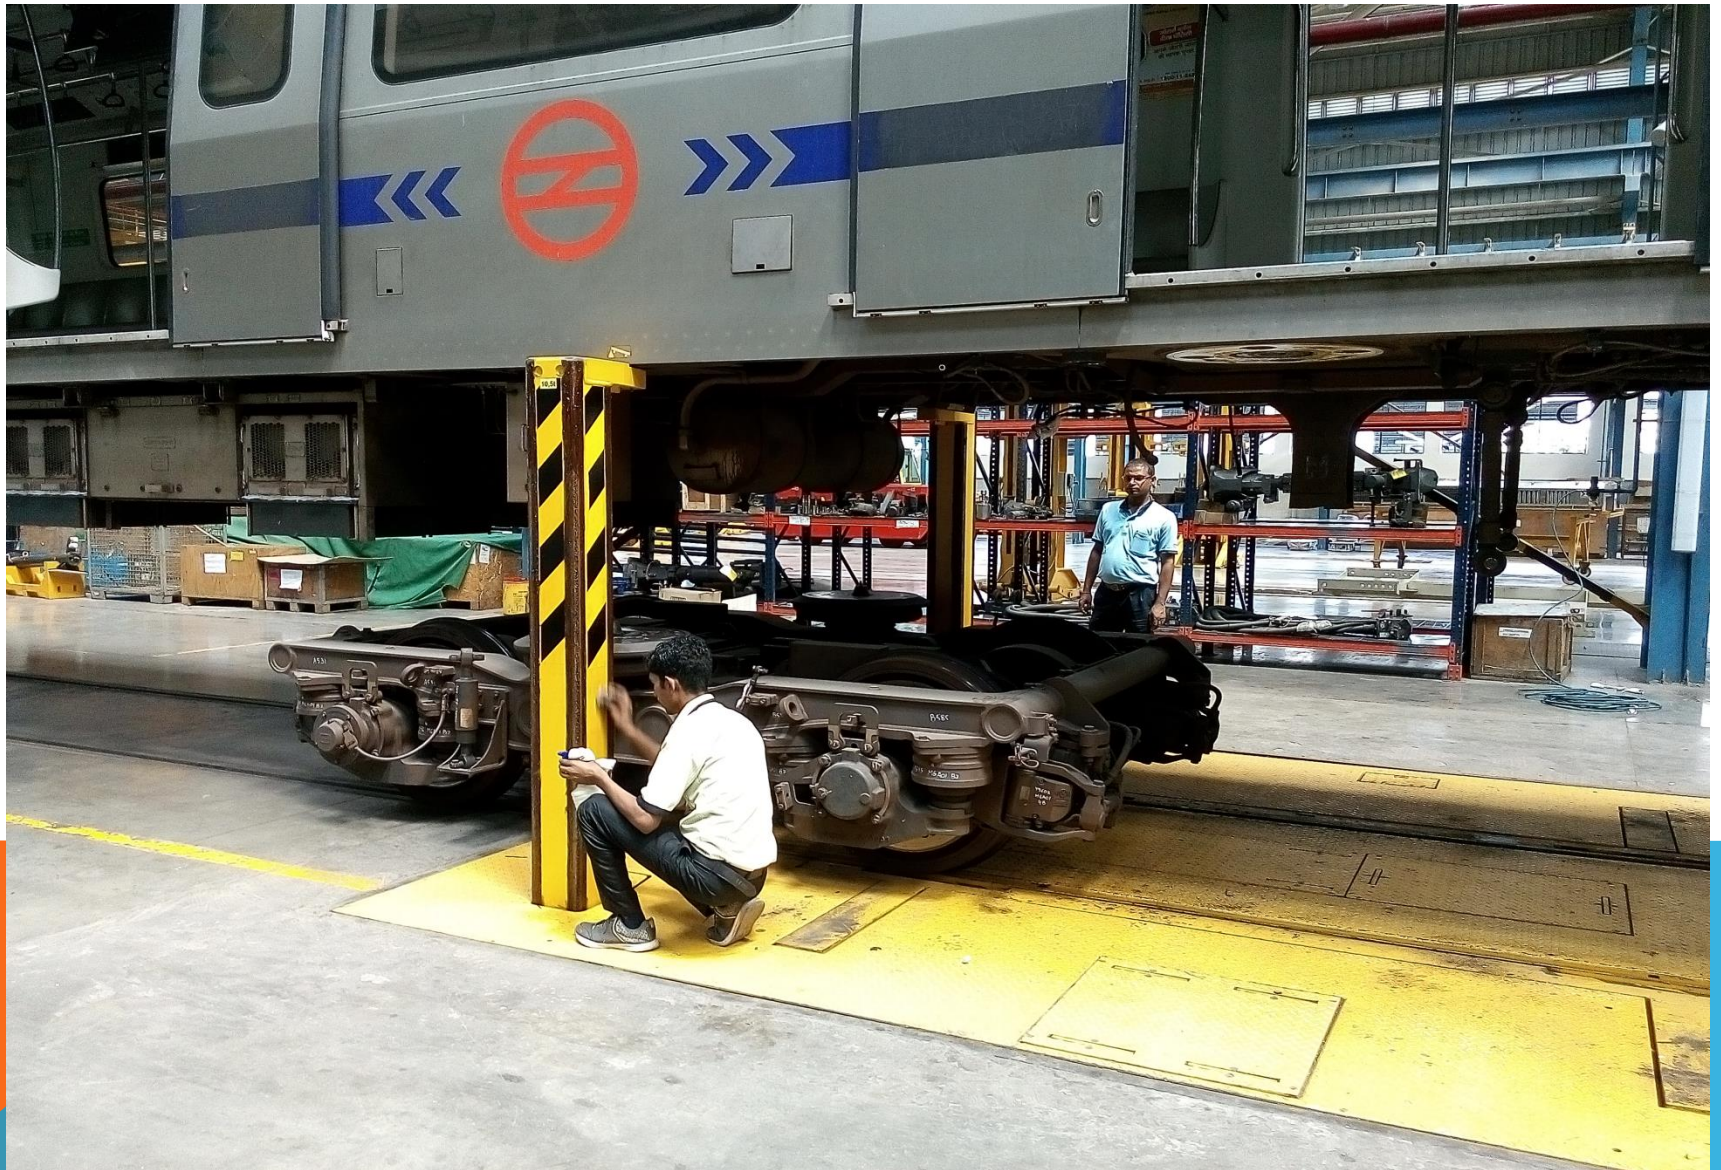
UNDERFLOOR LIFTING PLANT

In Lieu of Synchronized Lifting Jacks

For Lifting of Whole Train Set

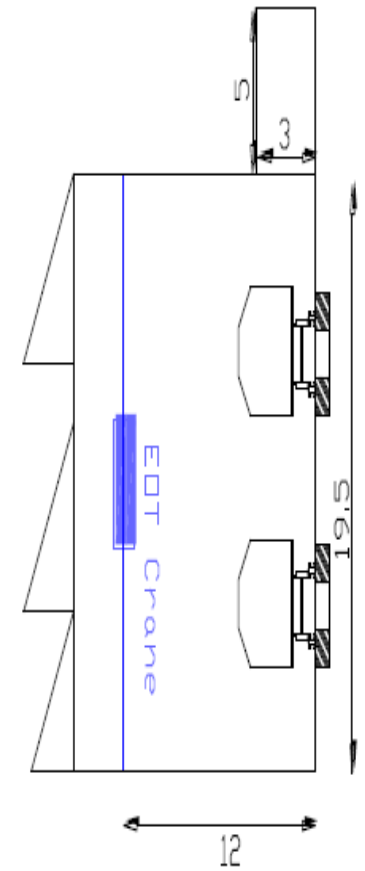
Layout of Integrated Coaching Complex

End View

Maintenance Sickline

Sequence of Operation - Coaching Depot
