CAUSE OF Wheel Shelling (LHB coaches) By R. Kushwaha MSTC/GKP

Wheel Shelling

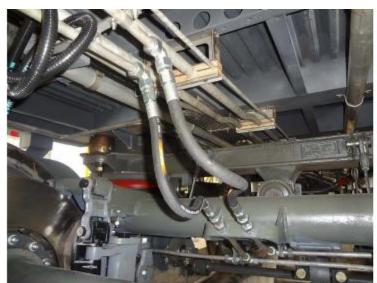
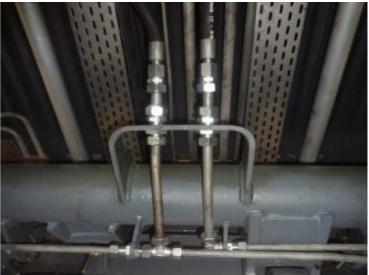
Existing piping arrangement

S.No.	Observations	Causes	Photographs
i.	Less inner diameter	Insufficient air flow passage	
îi.	Washers	The Nylon/Teflon washers provided inside the hose gets perished/shrink due to over tightening or during in service of the coach, which results in blockage of the air passage and thus to inoperativeness of brake cylinders.	
iii.	More nos. of pipe joints/fittings	Restriction in air flow & more chances of occurring leakages.

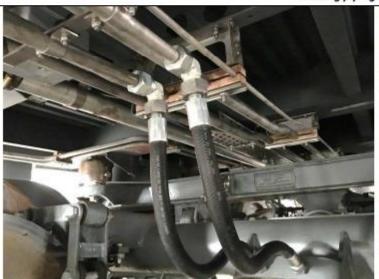
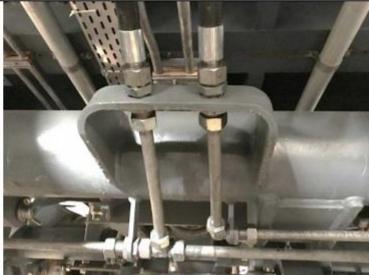
Modified piping arrangement with reduced joints and modified hose

Bigger Inner diameter: Sufficient air flow passage -The diameter of hose was increased from 9mm to 12mm.

No washers: Avoids blocking of air passage and increase smooth operation of brakes- The new hose eliminates the use of washers and have ferrule arrangement at both ends.

Less pipe joints/fittings: Avoids air flow restriction & leakages- By the use of upgraded hose associated joints/fittings for air connections were reduced from 9 to 6nos.

Increase in hose length: Avoids stretching & rupture- The length of upgraded hose was increased from 600 to 650mm, as in original Alstom design and also to avoid stretching & rupture of the hose.

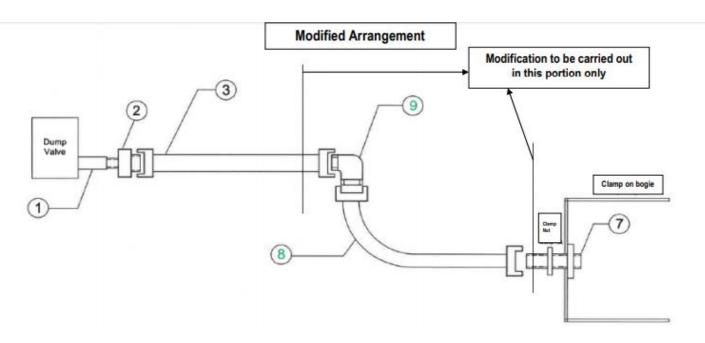
Note: Items at S.No.4, 5 & 6 (in Red) to be deleted and at S.No.8 & 9 (in Green) to be added.
