# FIBA

# Features & Function

# SCHEMATIC DIAGRAM OF FIBA

(as per RDSO specification RDSO/2015/CG-05 Rev. nil)

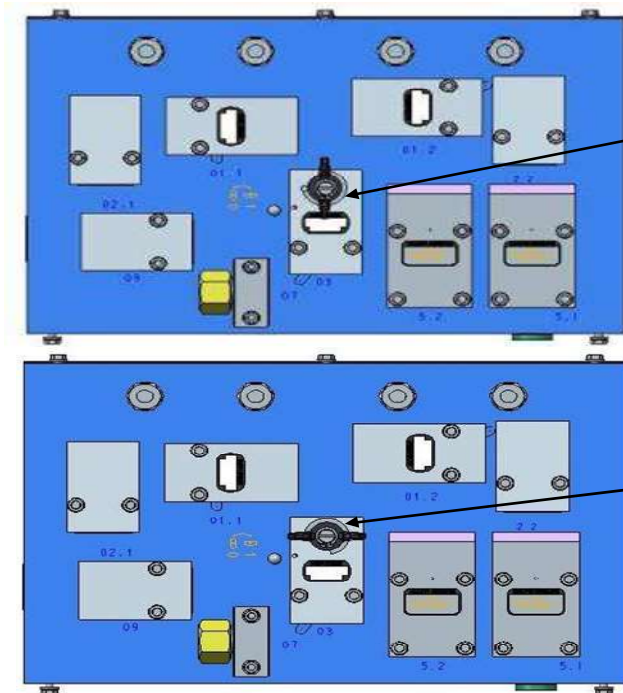
## **Position of Reset / Isolating cock**

ON position of Isolating cock/Reset

ON position of Isolating  
cock/Reset cock

OFF position of Isolating  
cock/Reset cock

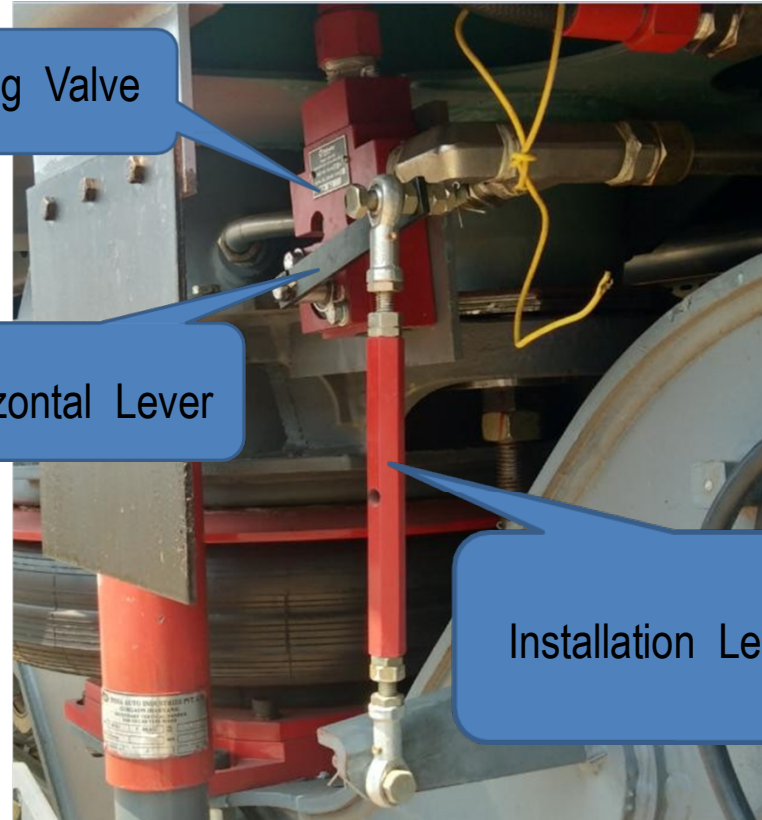
## Failure Due to Installation lever

Leveling valve allows air to or exhausts air from Air bellows to maintain uniform level

Levelling Valve

Horizontal Lever

Installation Lever

- ❖ If installation lever breaks during venting mode all air exhausts from air spring and in that case FIBA Operates. After operation of FIBA Procedure of resetting to be followed .
