Air Suspension in FIAT Bogie

LHB Coach with Air Suspension

Failure on account of FIBA Device and Associated Components till Sep.-2022

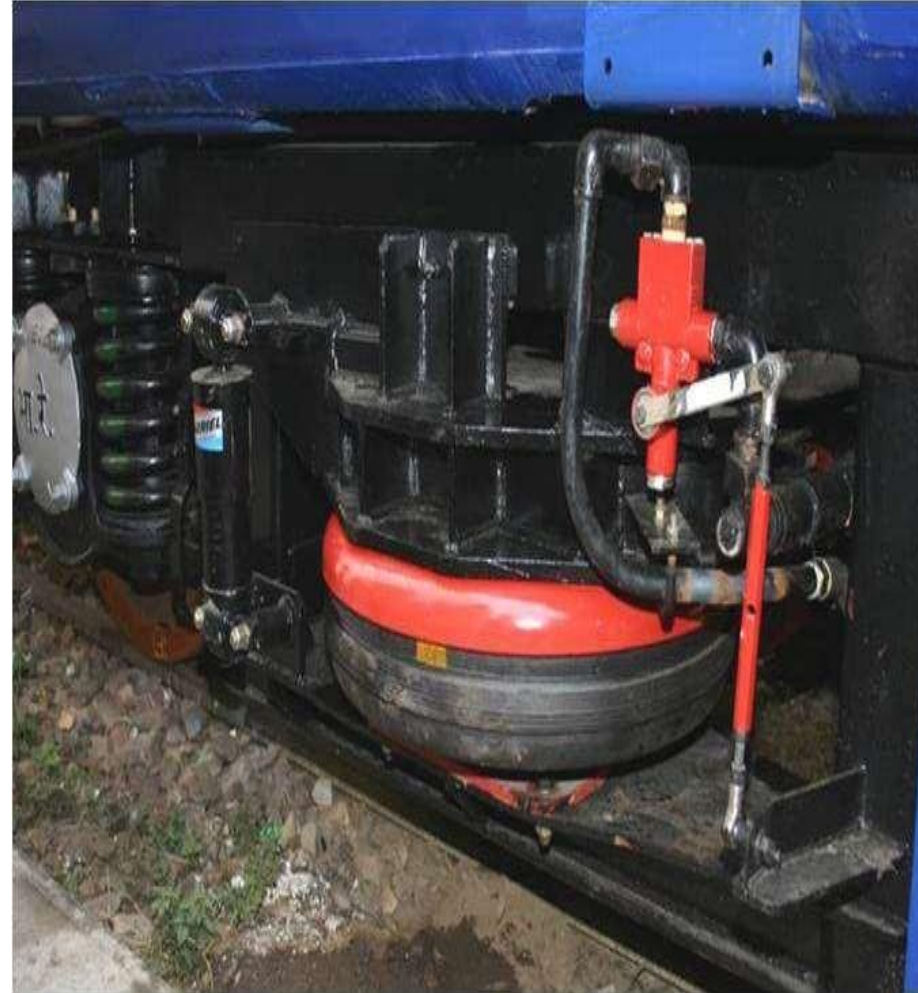
Levelling Valve

- ❖ Heart of the system.
- ❖ Mounted on bolster.
- ❖ It's link is connected with installation lever.
- ❖ It has three positions:
 - Dead Band Zone
 - Charging Mode
 - Discharging Mode

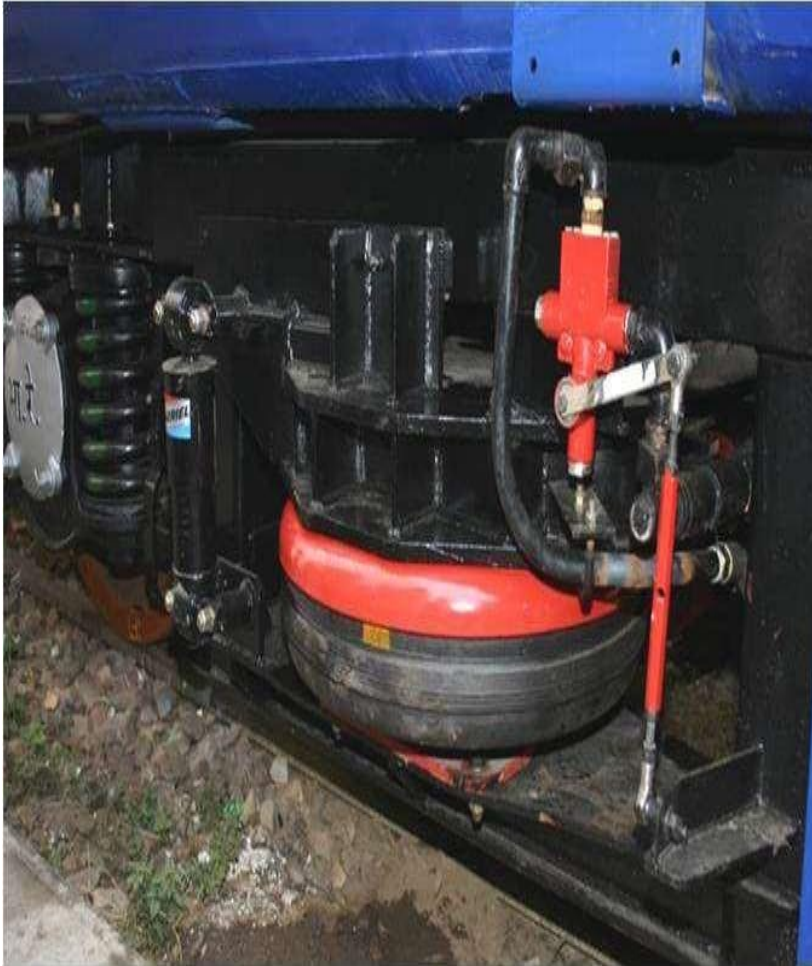
- ❖ Fitted between link of Leveling valve and bogie frame.
- ❖ The ball and socket joint at both ends are provided to give flexibility.
- ❖ Left and Right hand threads are there at its either ends to increase or decrease its length so that the bellow as well as coach height increases and decreases respectively.

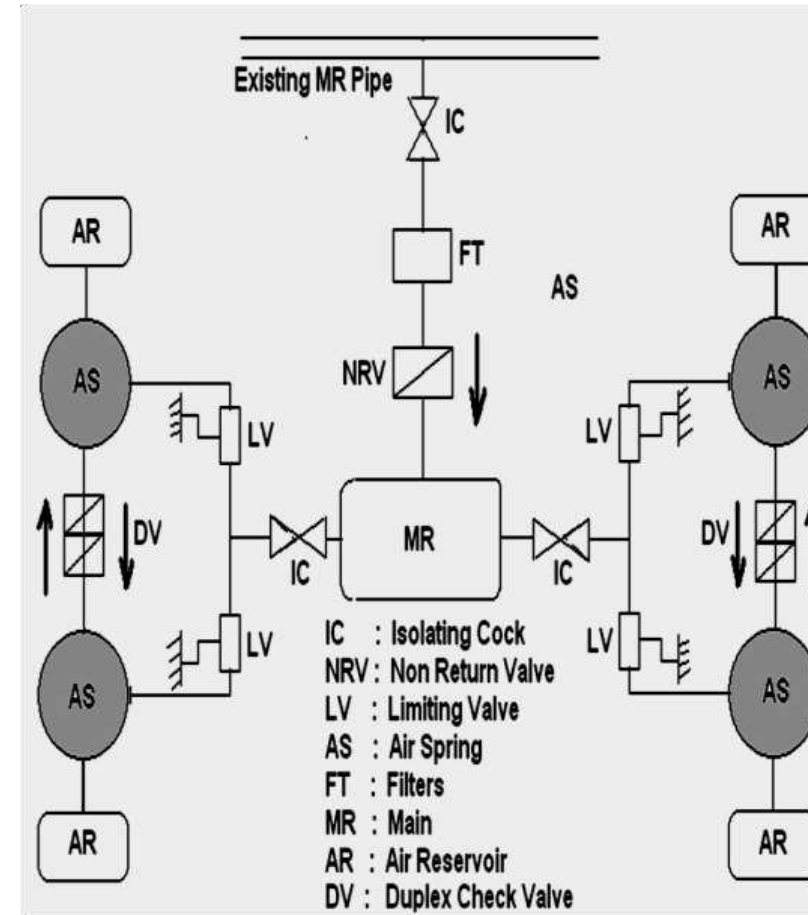
Duplex Check Valve

- ❖ Fitted between two air bellows.
- ❖ Comprises of two check valves side by side
- ❖ Air can flow in either direction when the air pressure differential exceeds the pre-set value at 1.5 bar.

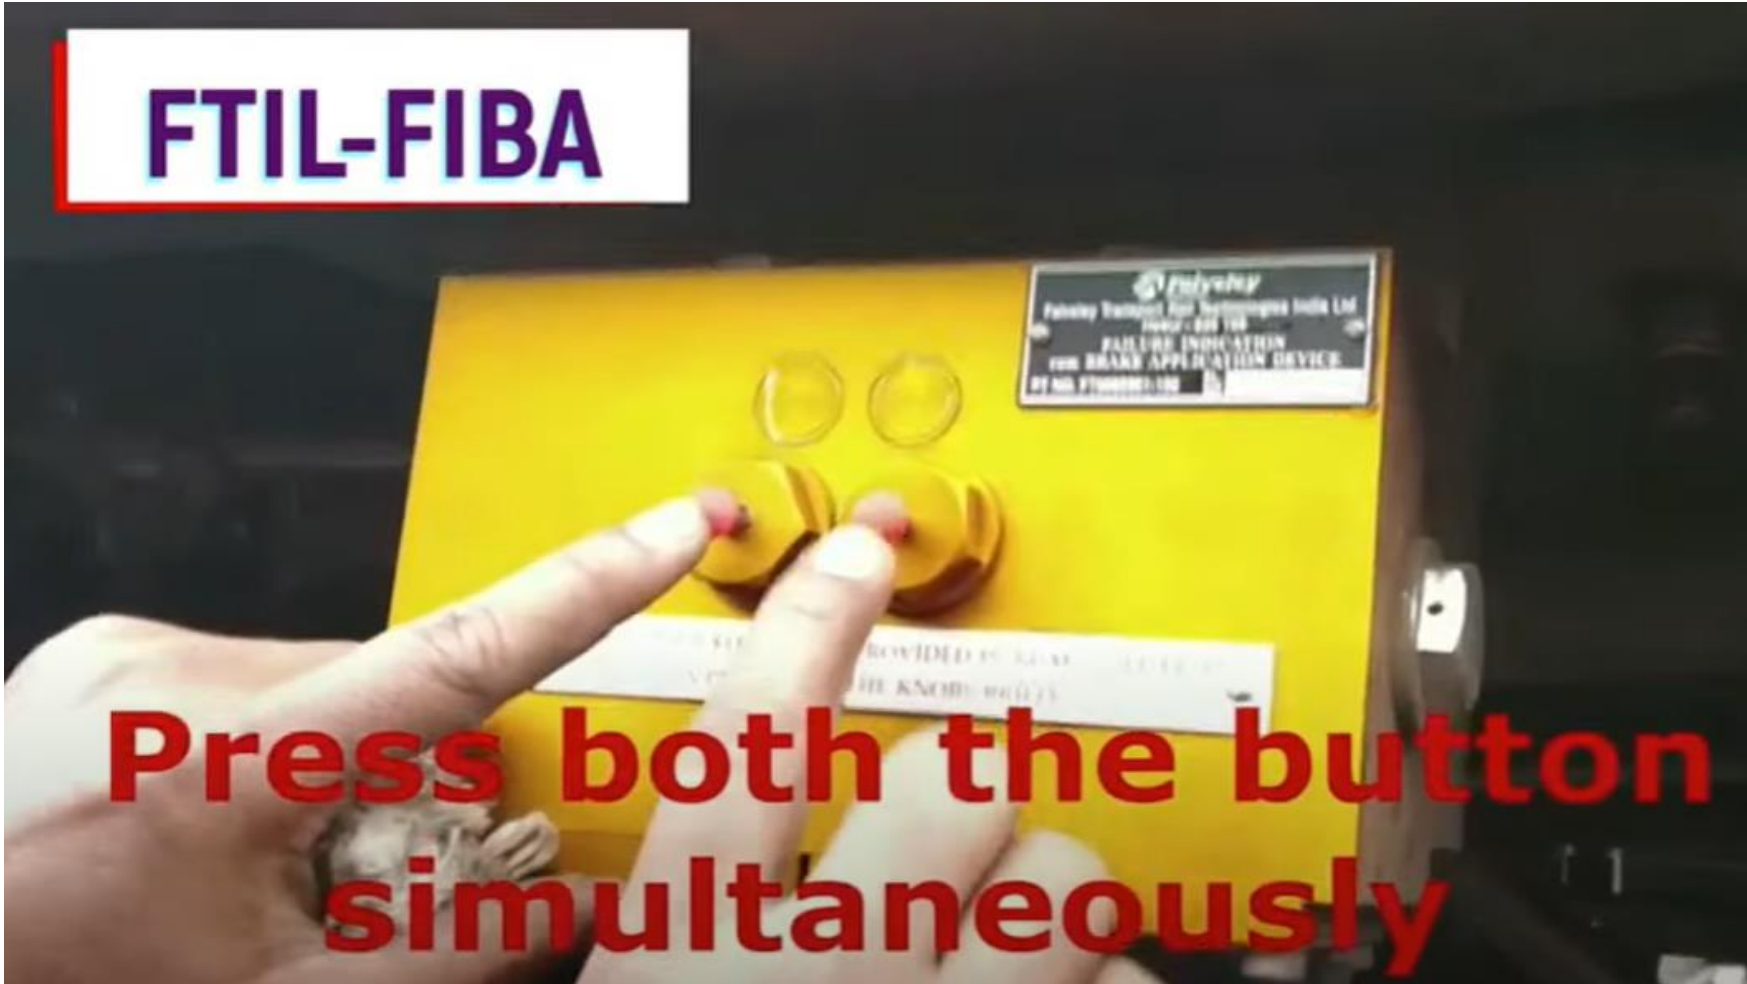
ESCORTS-FIBA

To Reset FIBA, Pull the two corner rings first then pull the centre ring

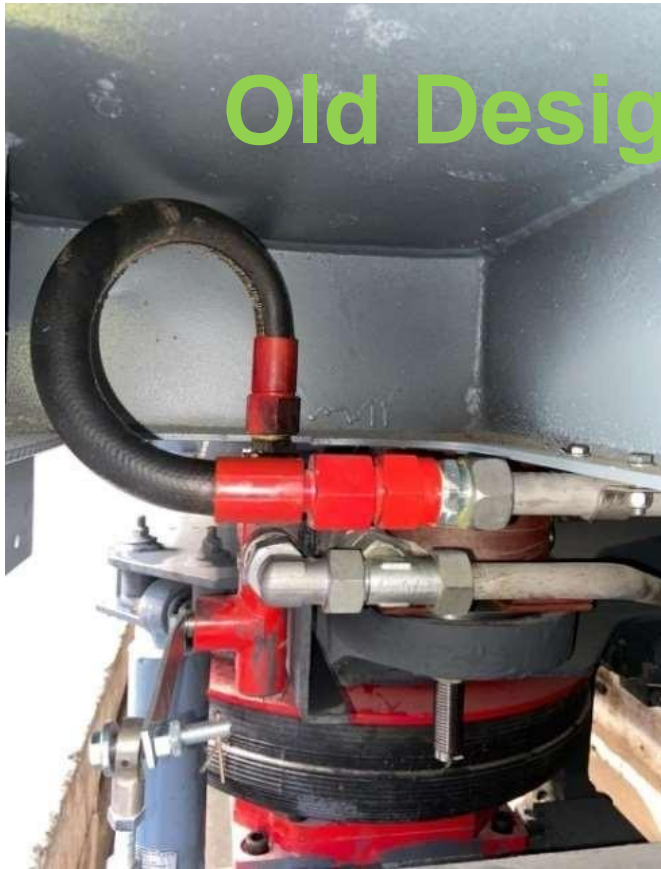
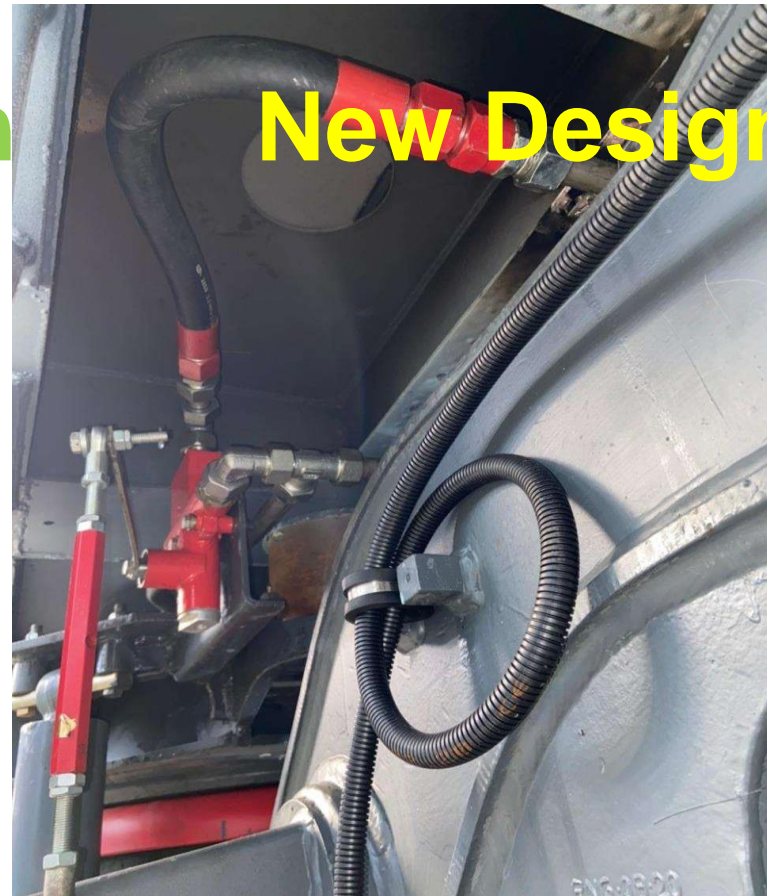
Flexible hose pipe between Auxiliary Reservoir & leveling valve touches with the coach body and has sharp bend

Steel pipe provided on under frame for connecting flexible hose to leveling valve has been redesigned and shifted towards end of coach. Elbow has been provided on leveling valve to ensure smooth loop which is not touching with car body and ensures that bend radius limits for the SAE100 hoses is not compromised

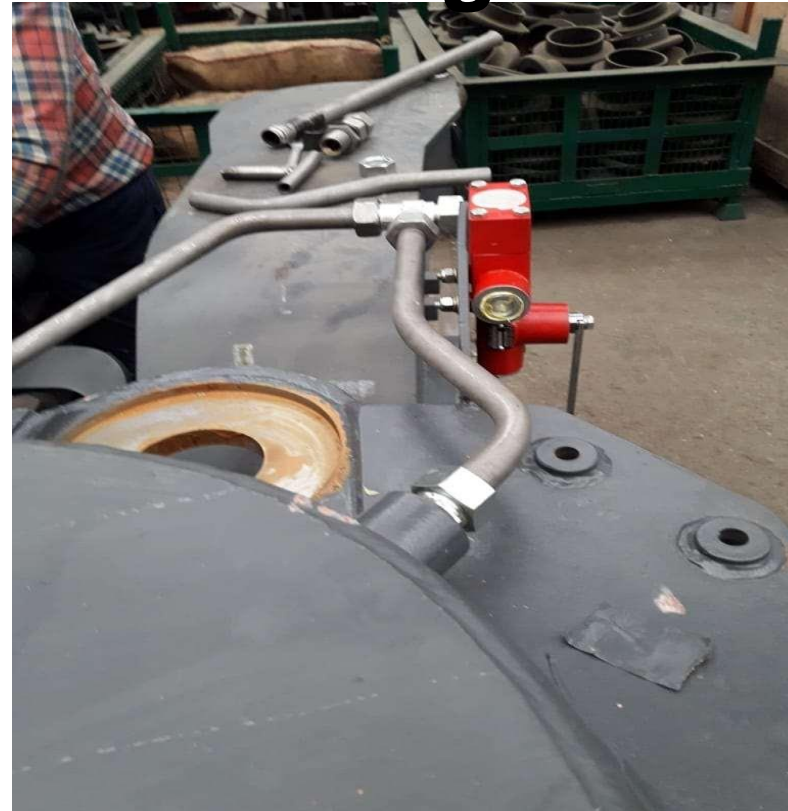
New Design

Bulkhead union eliminated

Piping layout of this area has been revised resulted into reduction of bulkhead unions

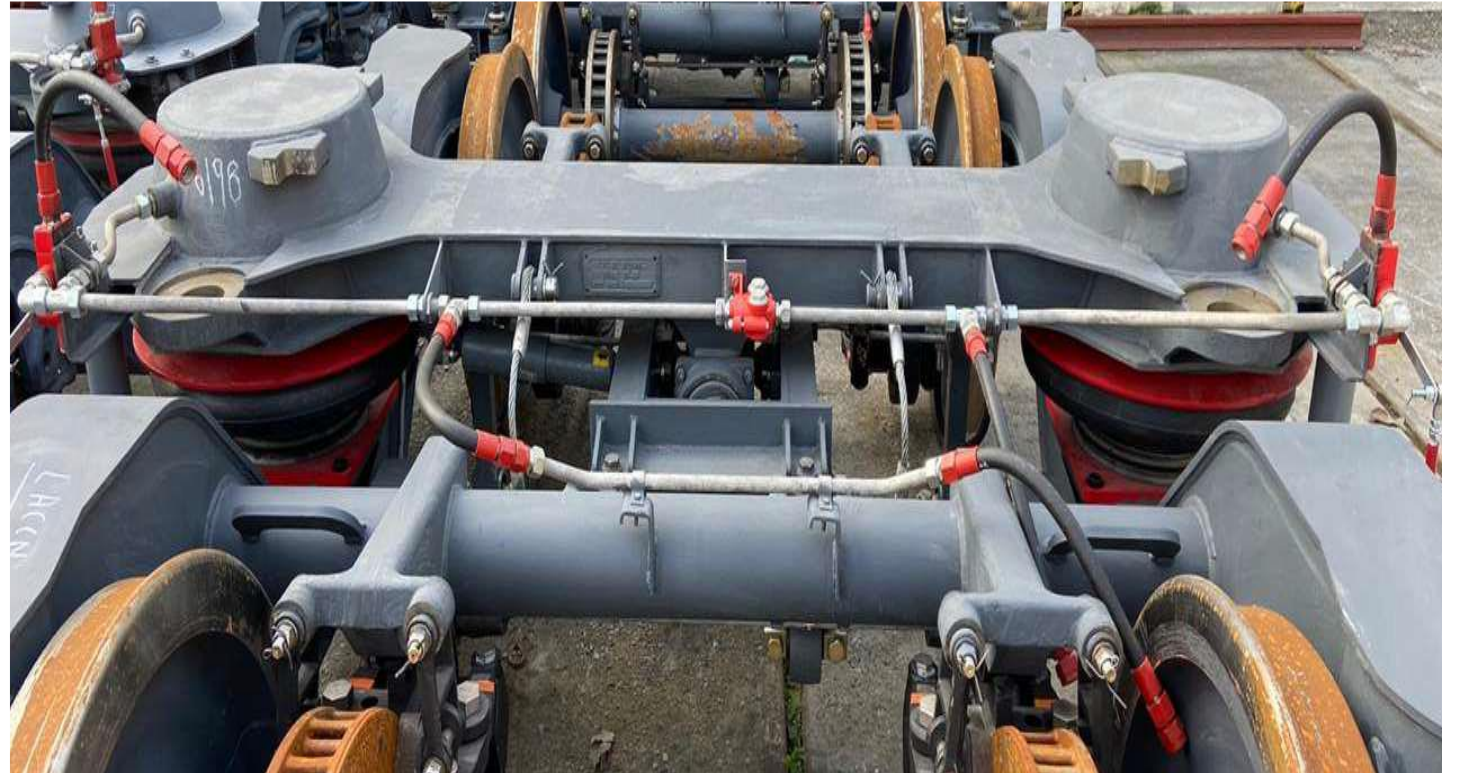
The piping arrangement provided on Cross beam of FIAT bogie frame has been shifted to bogie bolster. Hub flange of underframe and pin bracket of FIAT bogie bolster will work as a single unit after carrying out body bogie connection. Thus, this modification will result into no movement between joints of flexible hoses whose one end is connected to FIBA piping provided on underframe and other end connected with piping of bogie bolster.

- This failure was attributable to the following root causes: -
 1. Relative movement between the bolster and the bogie frame which is constantly moving the hoses.
 2. Grazing of flexible hose with steel pipe for connection of leveling valve.
- The piping arrangement provided on cross beam of FIAT bogie frame has been shifted to bogie bolster. Hub flange of underframe and pin bracket of FIAT bogie bolster will work as a single unit after carrying out body bogie connection
- Steel Pipe connected with leveling valve through flexible hose has also been redesigned and shifted towards coach end. This shifting resulted into clearance between flexible hoses and steel pipes. Moreover, loop of flexible hose is become smoothed by providing additional modified pipe with tee of duplex valve piping which is not touching to car body pipe.

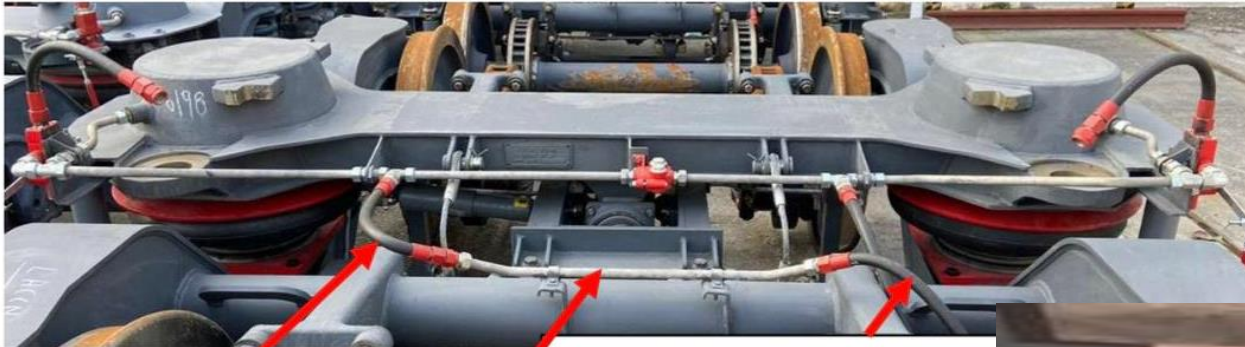
Old Design

Flexible Hose removed

Flexible Hose shifted to b

New pipe provided for smooth loop of flexible hose.

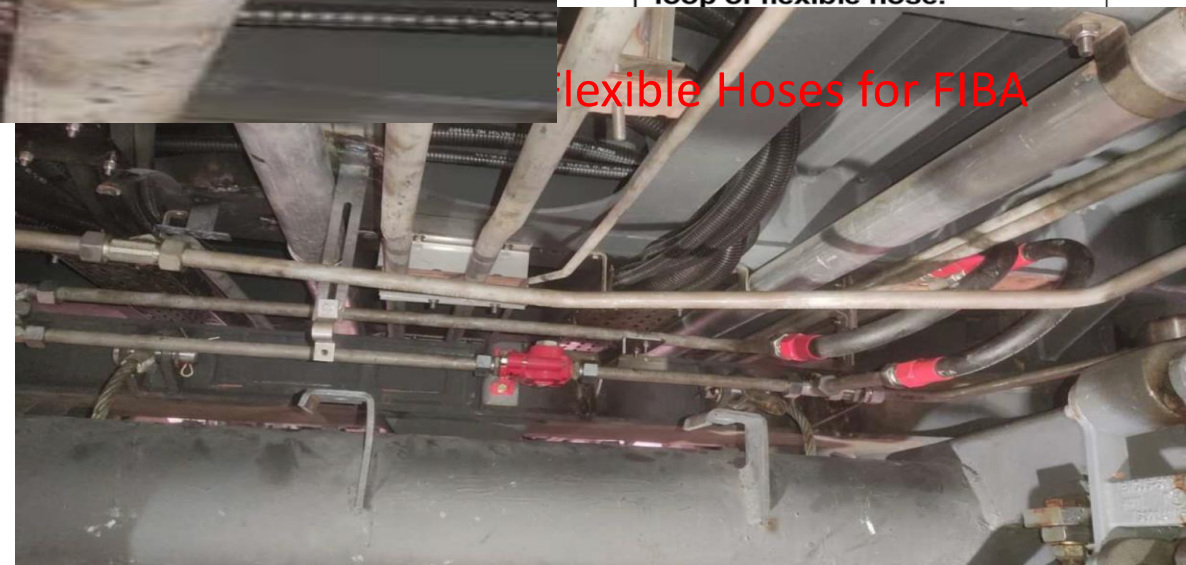
Flexible Hoses for FIBA

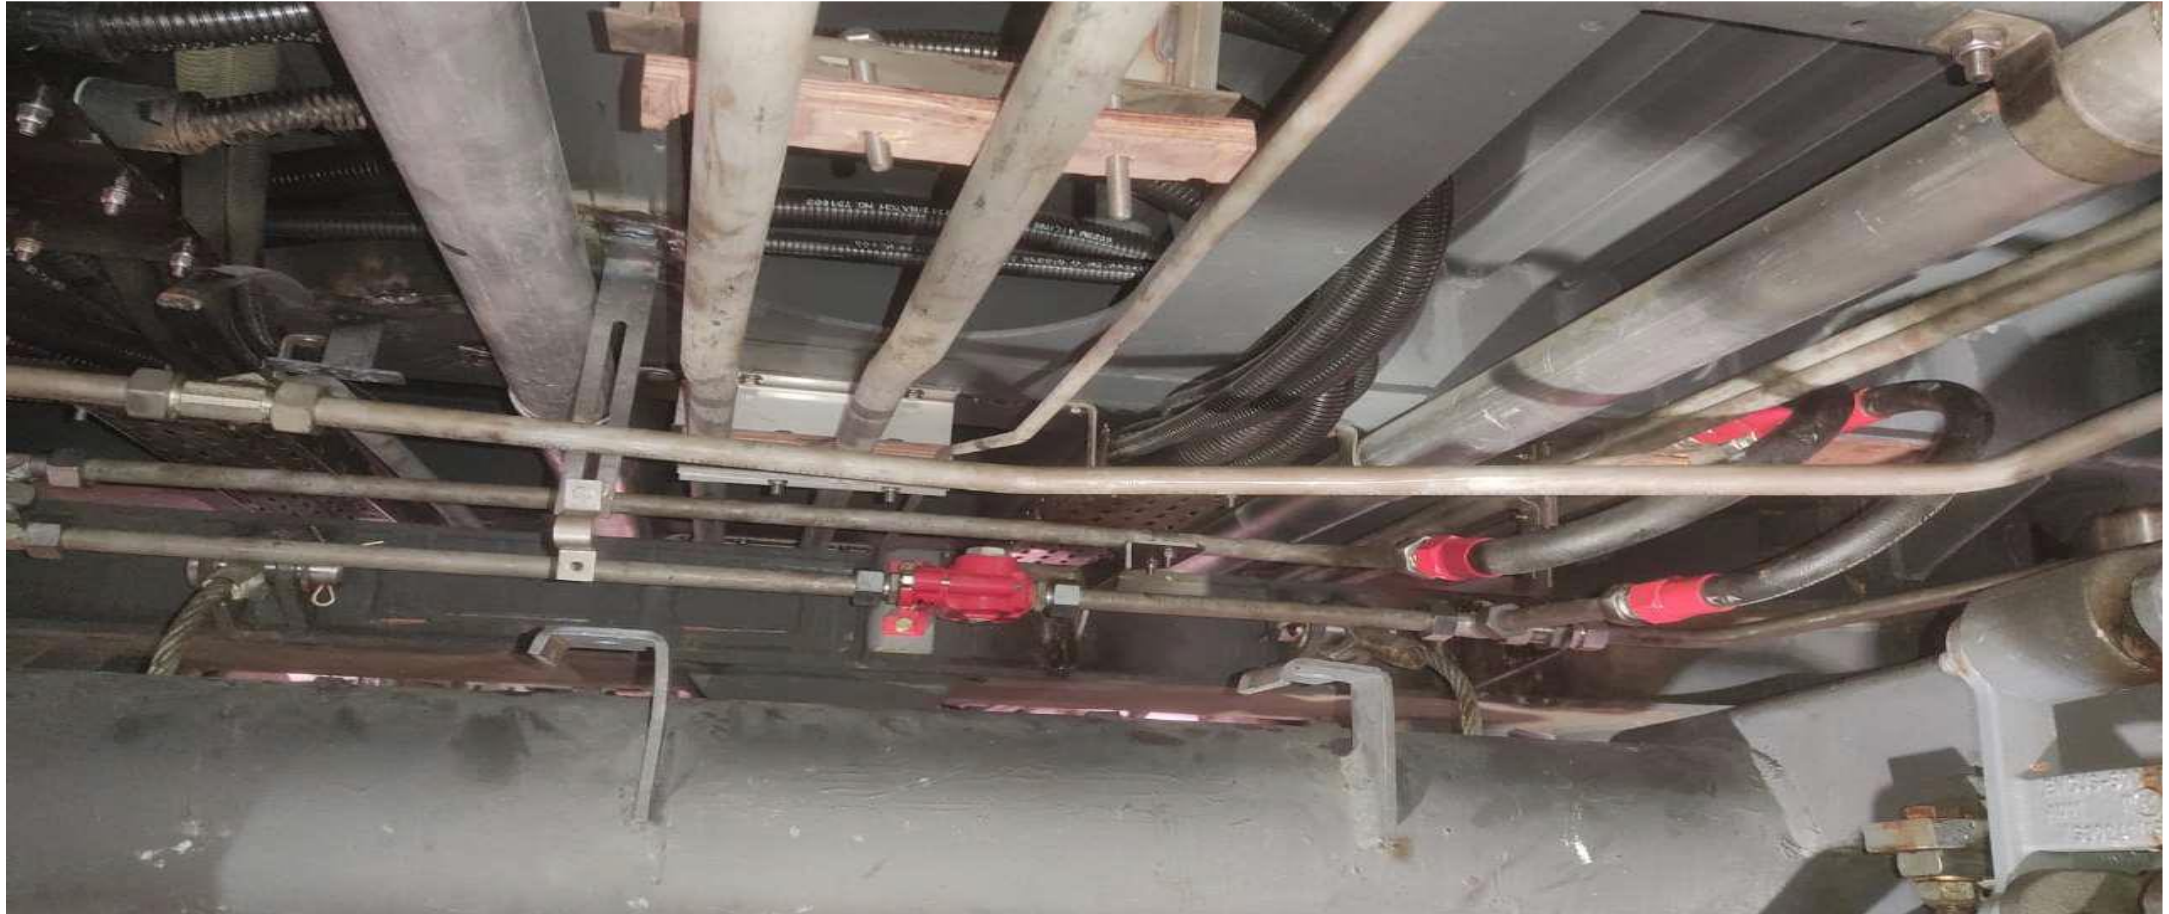
Remedy for avoiding Flexible pipe rubbing & ferrule joint failure

Leakage in Flexible pipe due to rubbing

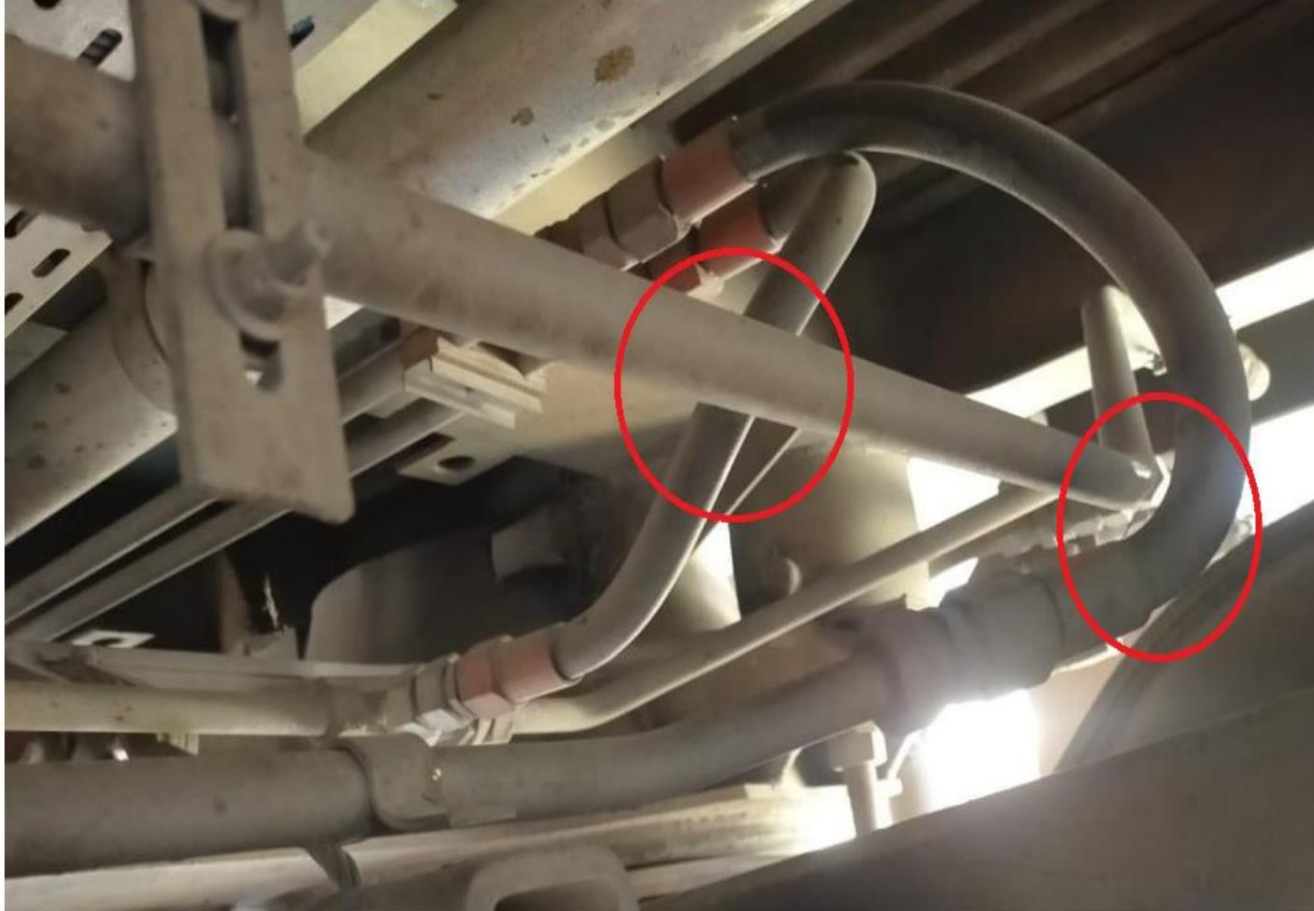
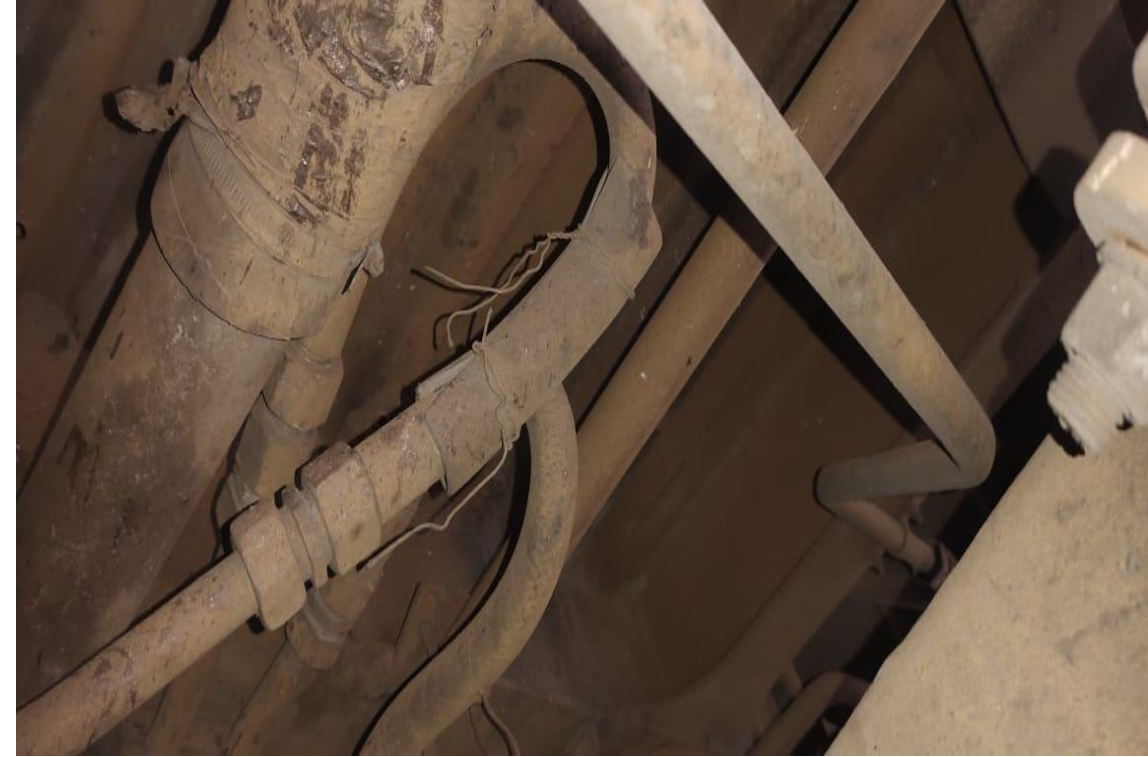
Rubber hoses covered with rexin

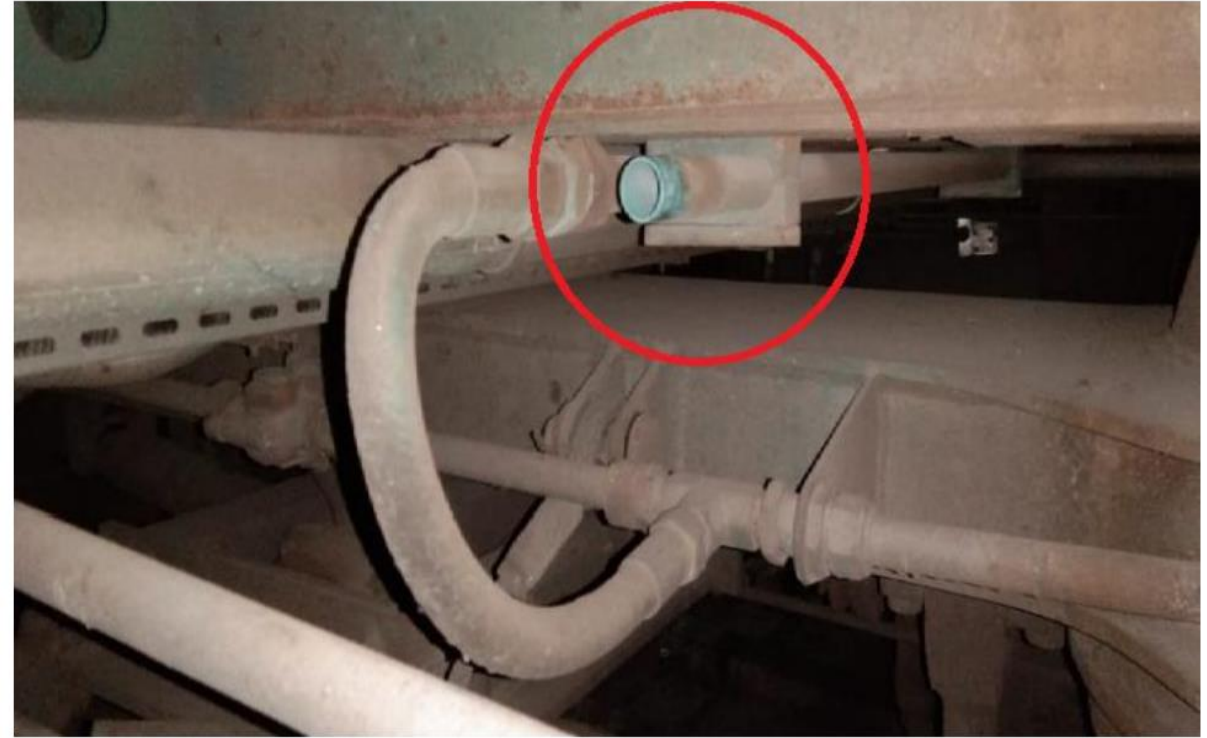
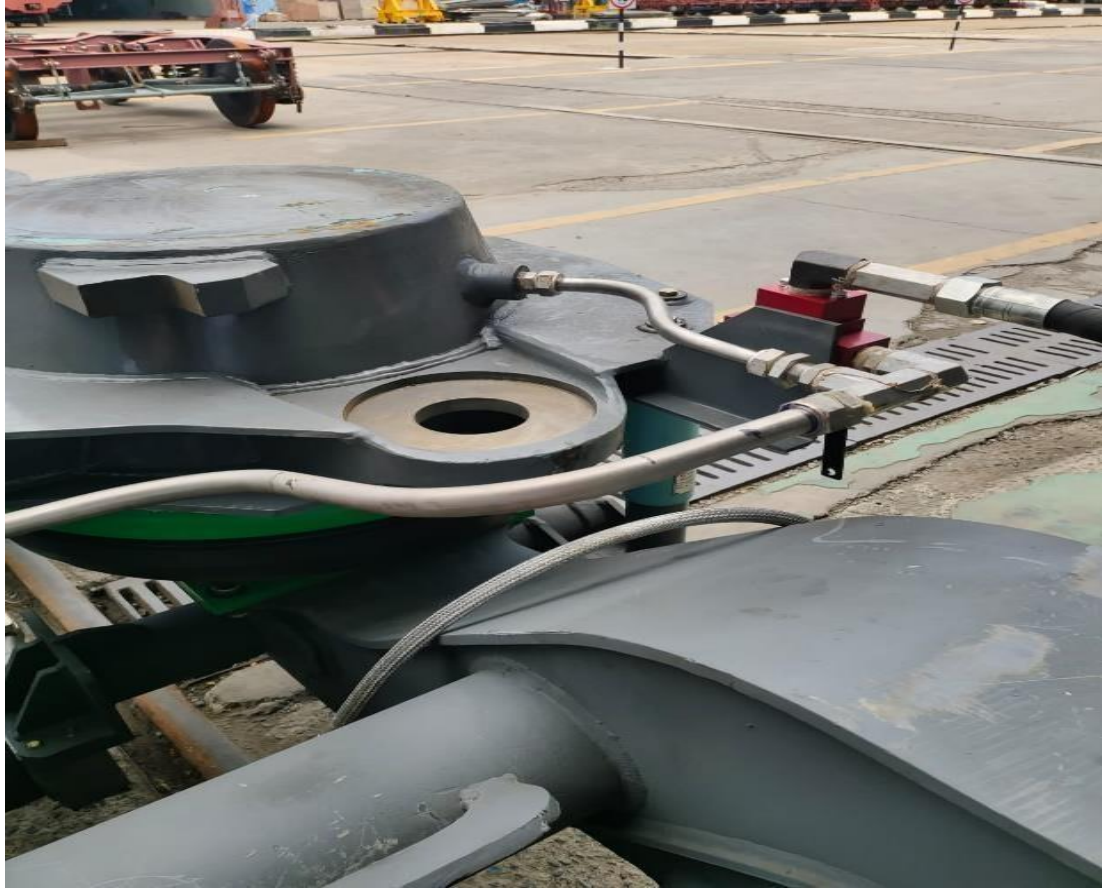
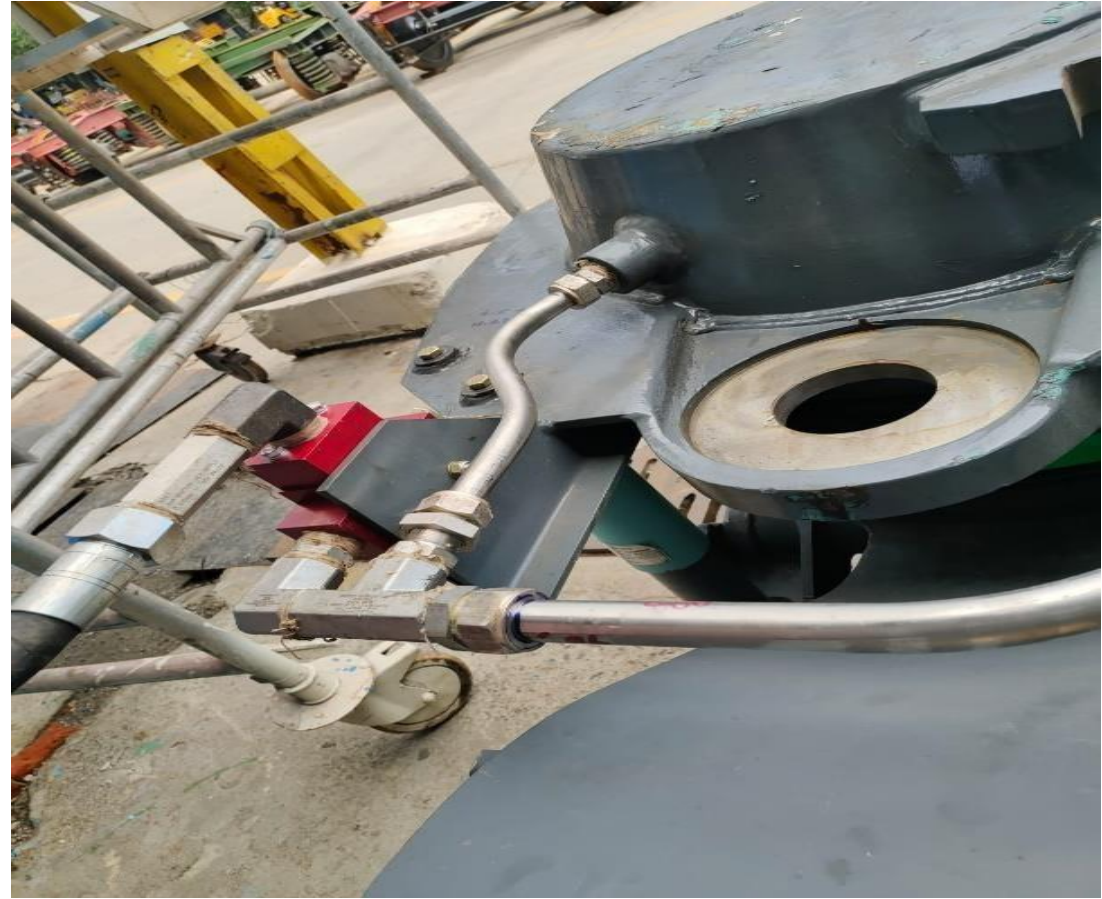
Ferrule joint failure/metallic pipe workout

- CAI circulated by RDSO (issued by RCF & ICF) vide this office letter No SV.AS. FIBA, dated.17.03.2021 & 04.02.2022 regarding piping layout of ASCE & FIBA yet not been implemented completely. Coaches are being turned out with old piping layout. As a result, failure/leakage in ferrule joint & flexible hose pipe etc. are continuously being reported by Zonal Railways

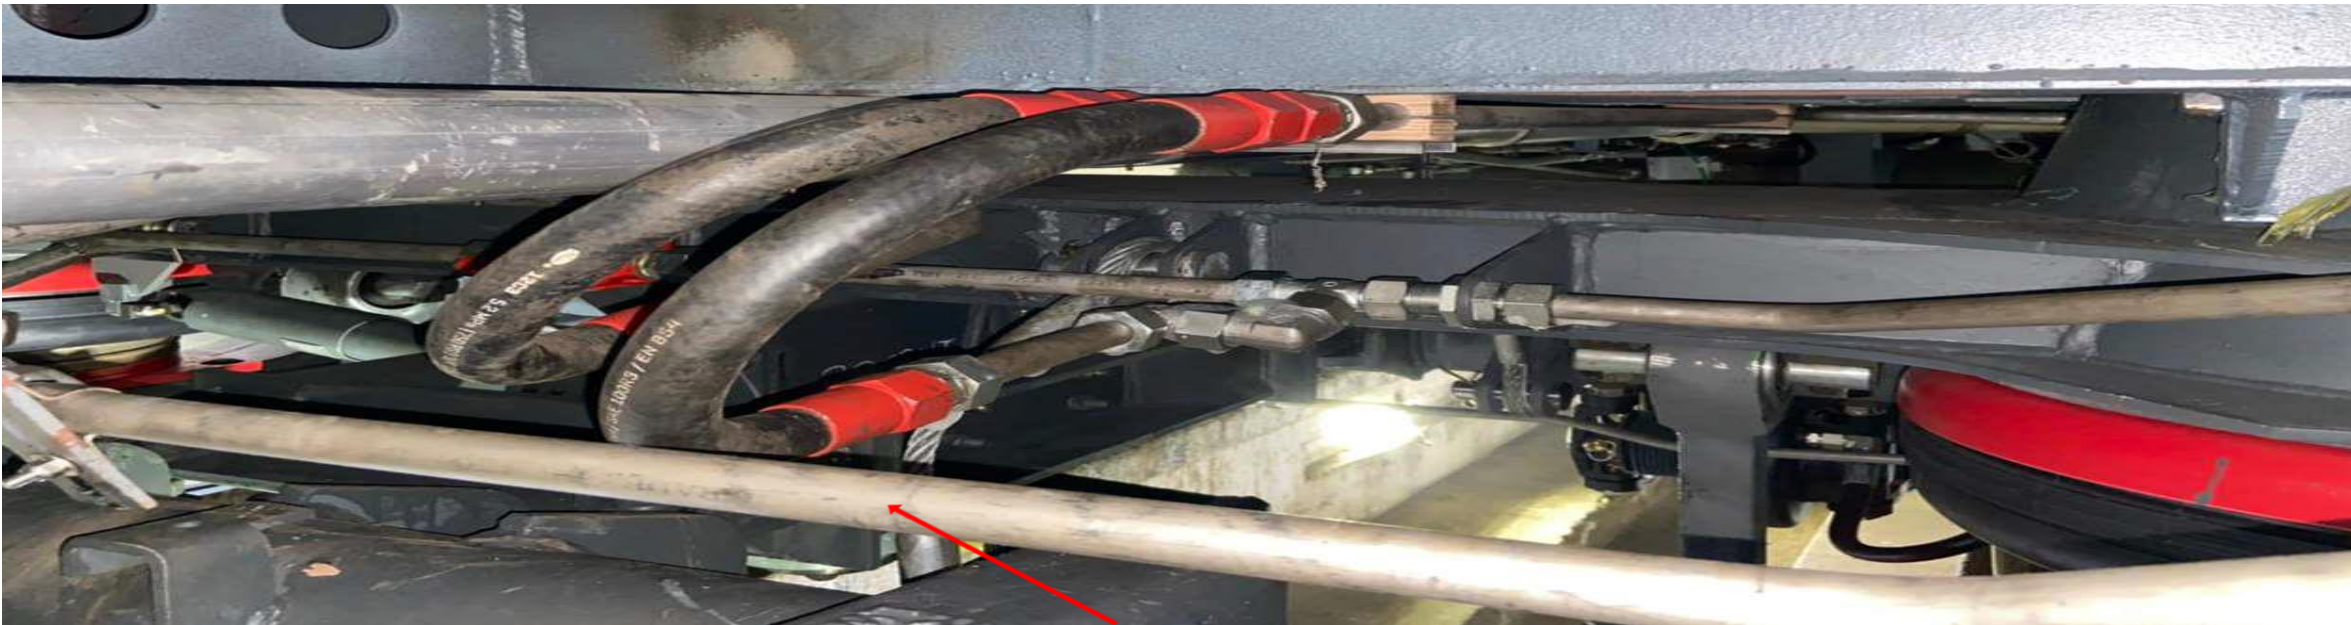
STEEL PIPE FOR CONNECTING FLEXIBLE HOSE PIPE TO LEVELLING VALVE

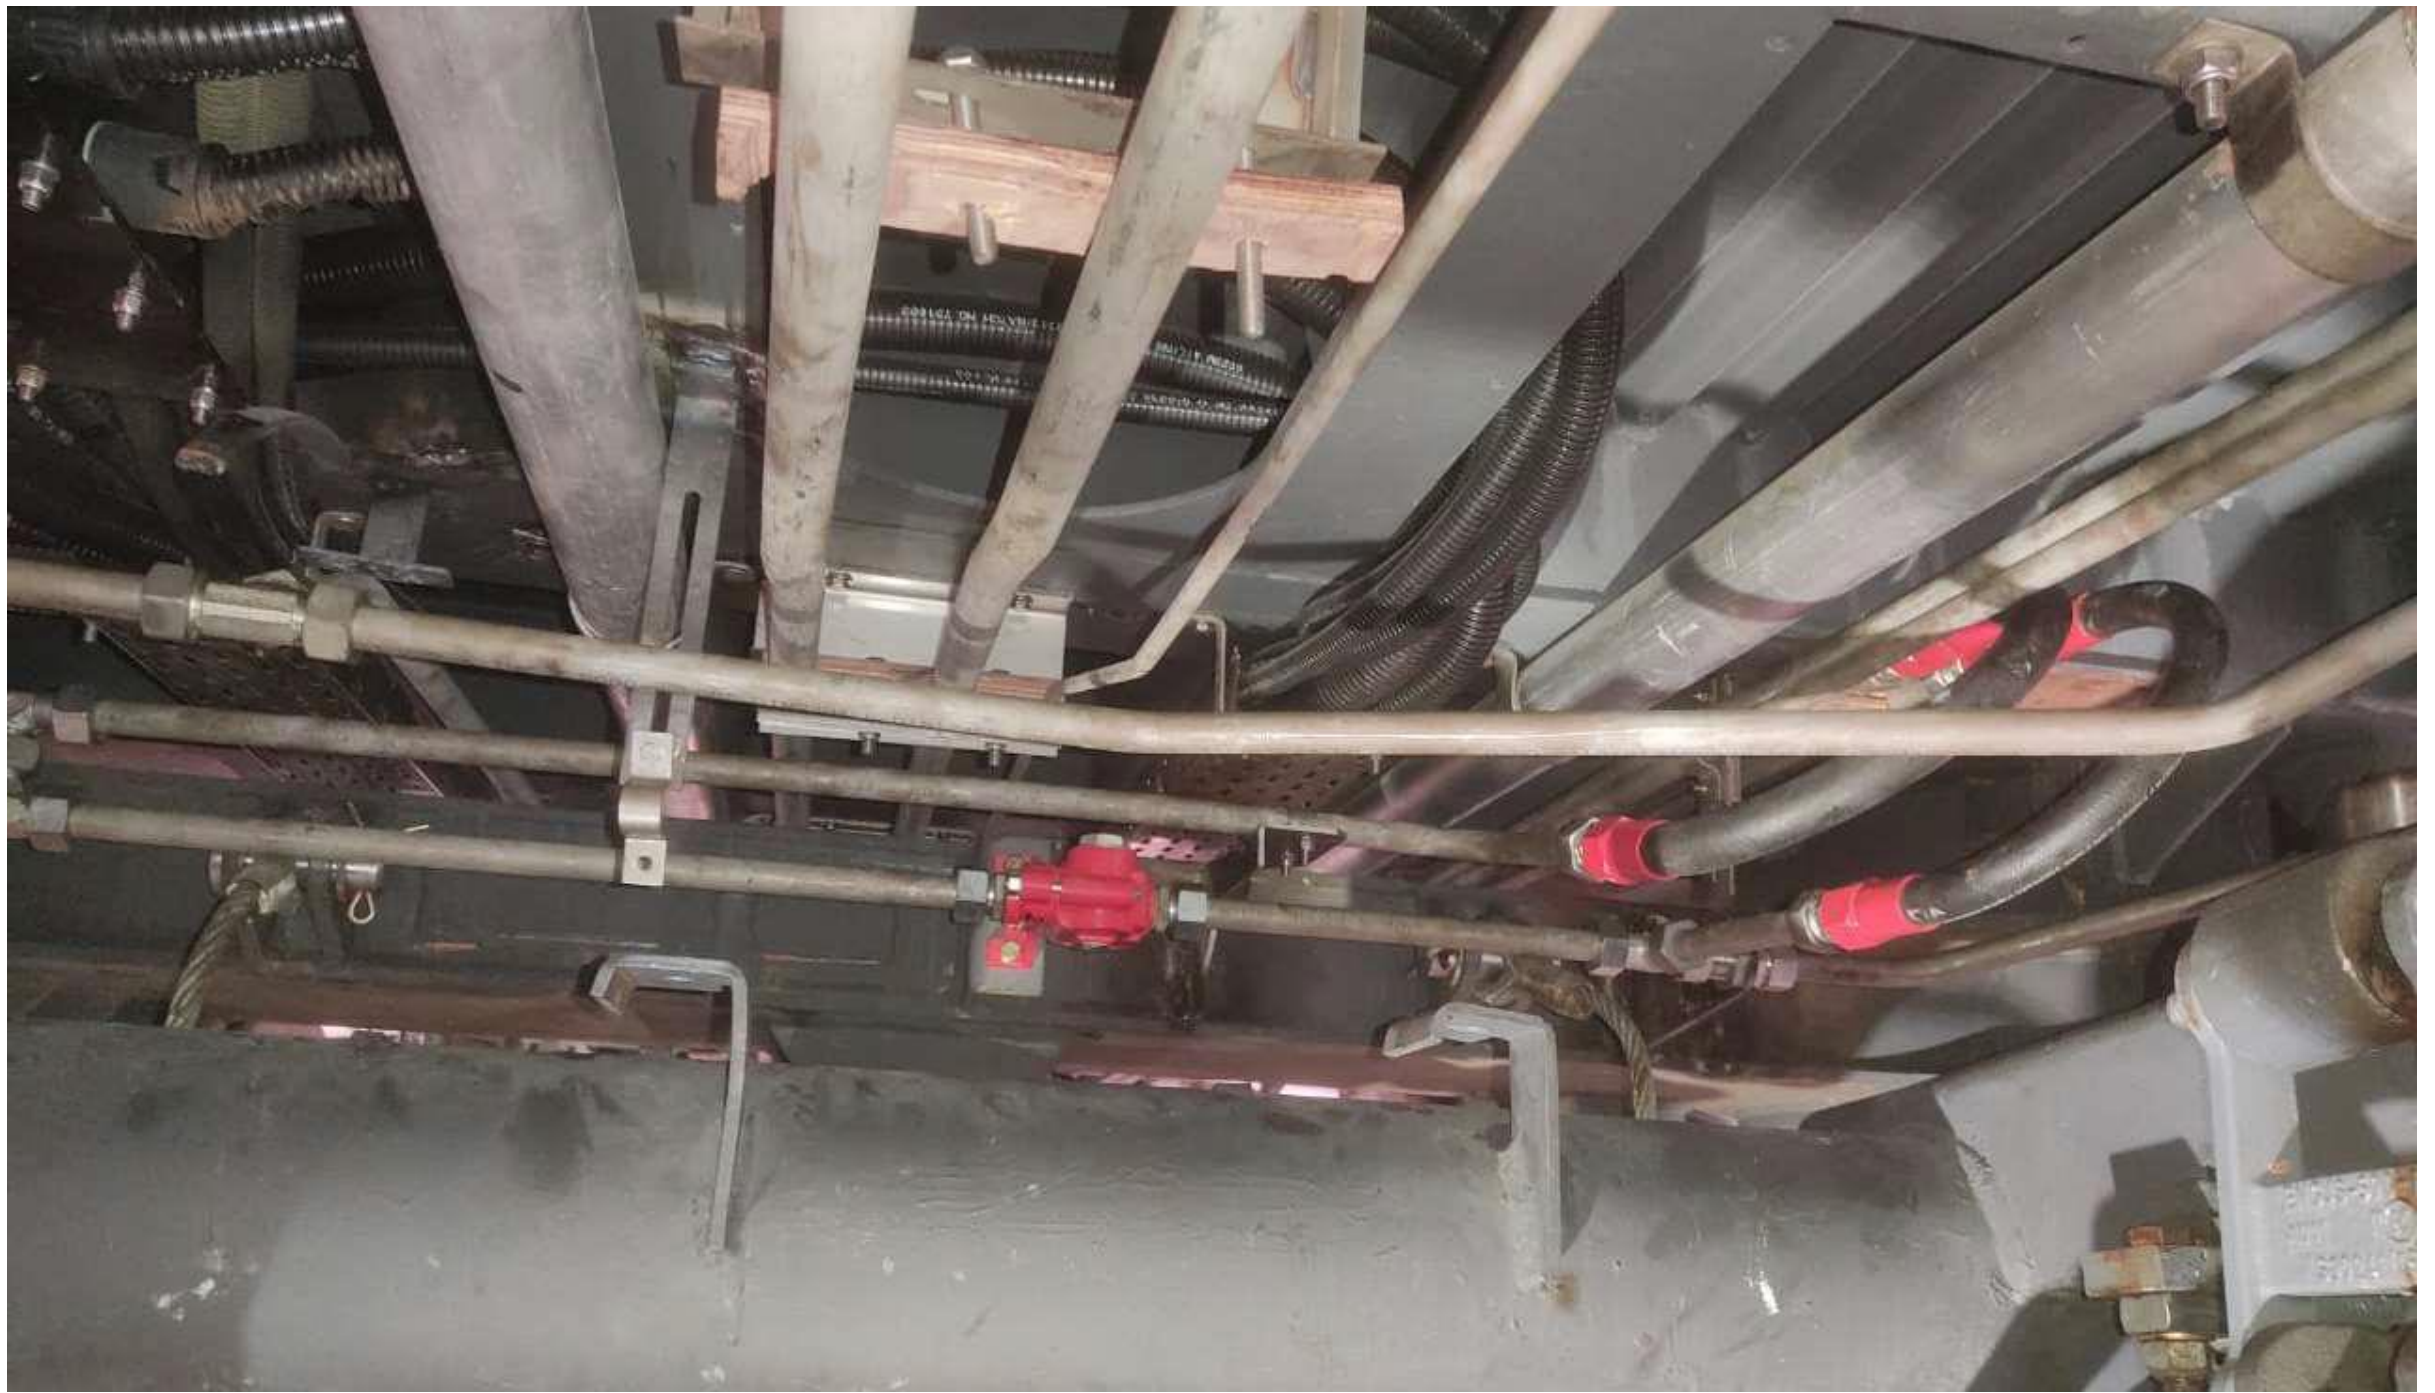
CLOSER VIEW OF SHIFTED STEEL PIPE TOWARDS COACH END

CLOSER VIEW OF FLEXIBLE PIPES CONNECTED WITH FIBA PIPING OF UNDERFRAME

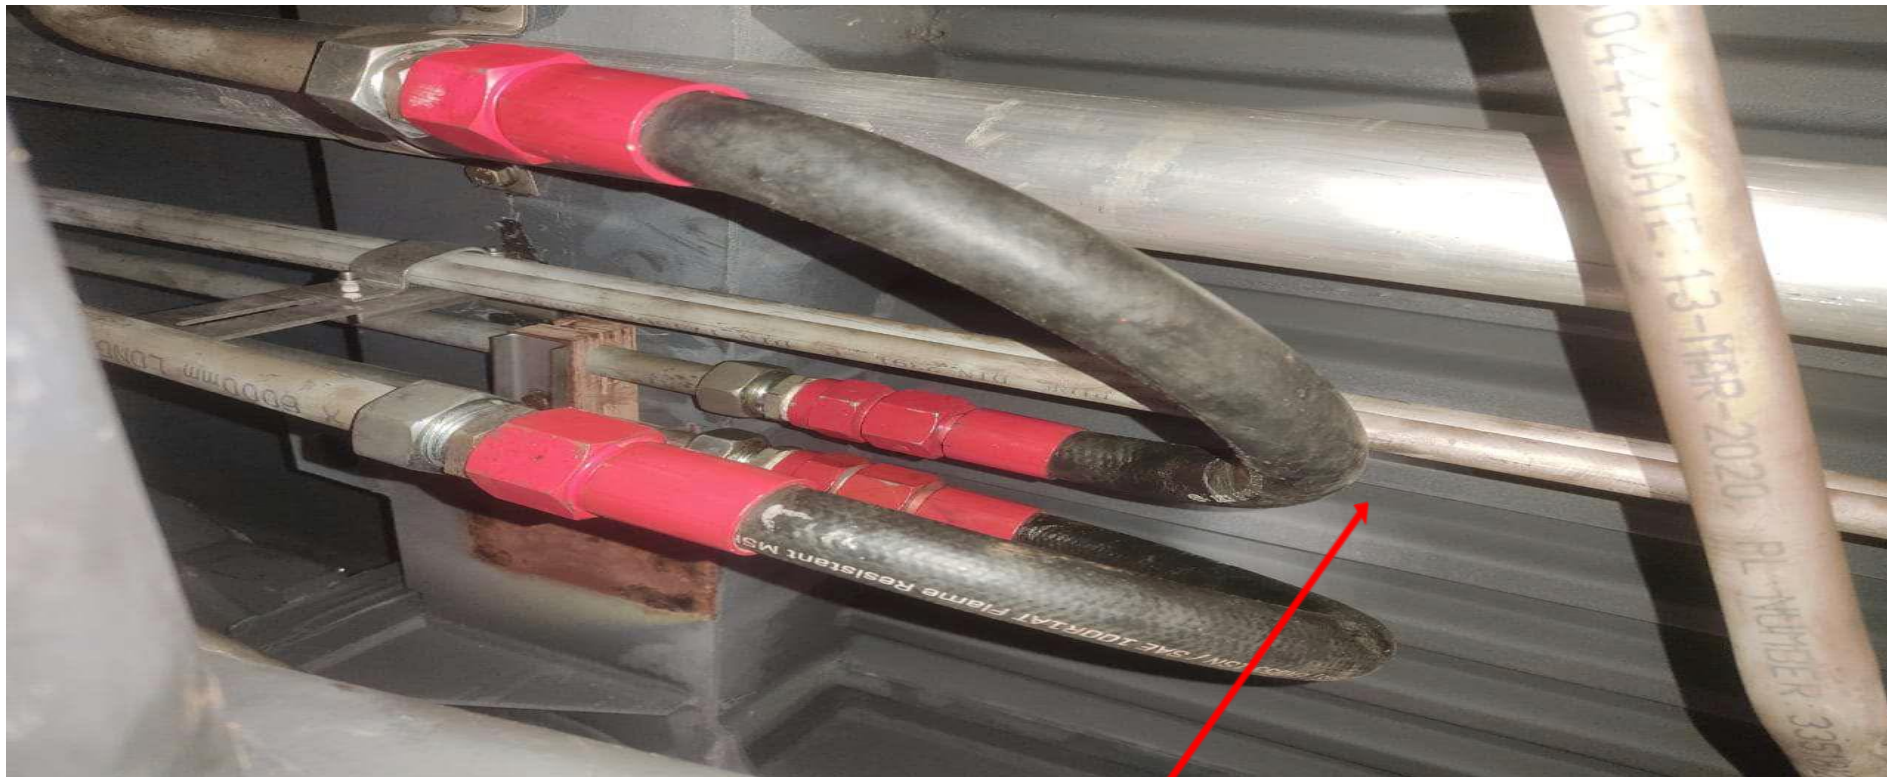
CLEARANCE FROM STEEL PIPE TO BE CONNECTED TO LEVELING VALVE
