Air Suspension in FIAT Bogie

LHB Coach with Air Suspension

Failure on account of FIBA Device and Associated Components till Sep.-2022

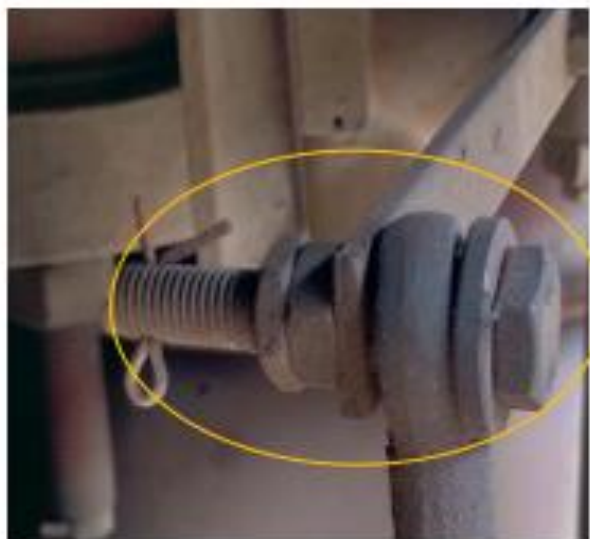
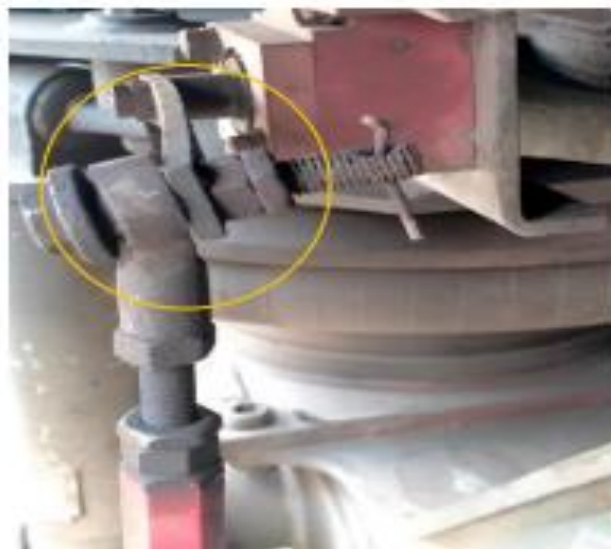
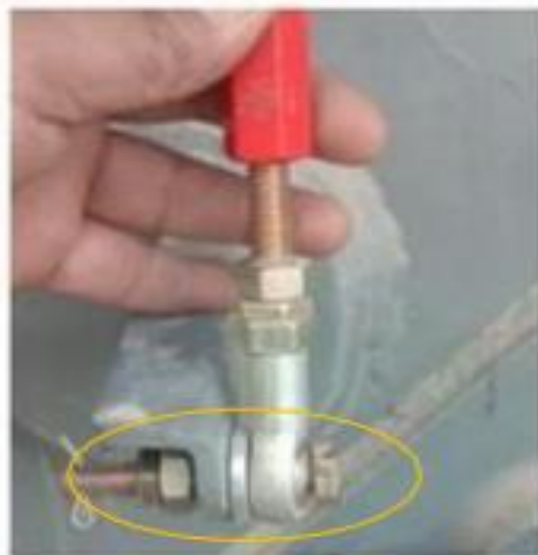
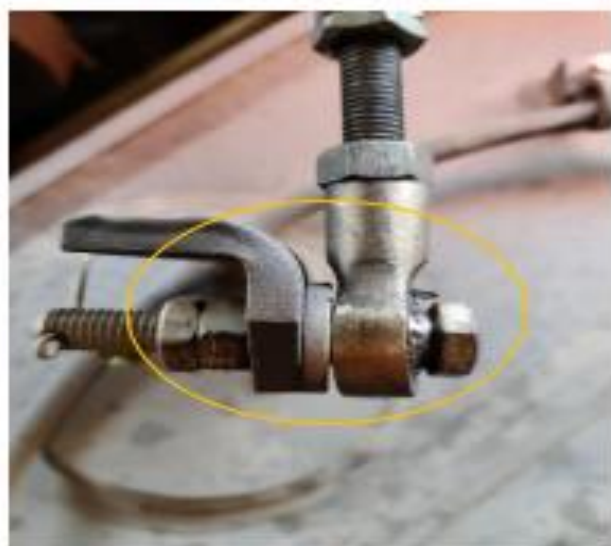
INCORRECT METHOD OF FITMENT

(No proper gap at top & bottom rod bearing to allow the free movement of installation lever)

CORRECT METHOD OF FITMENT

(Proper gap for installation lever movements)

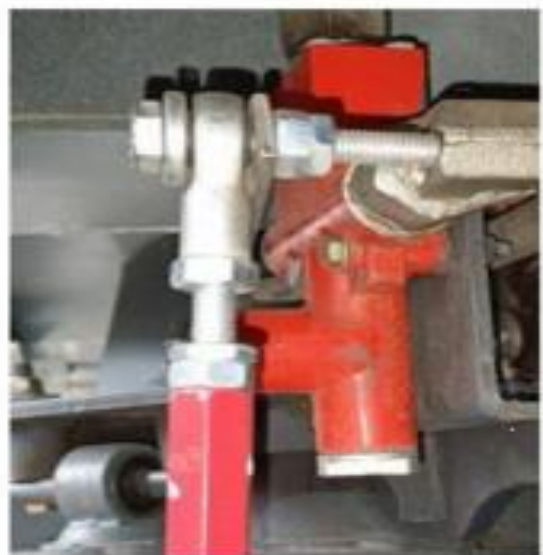
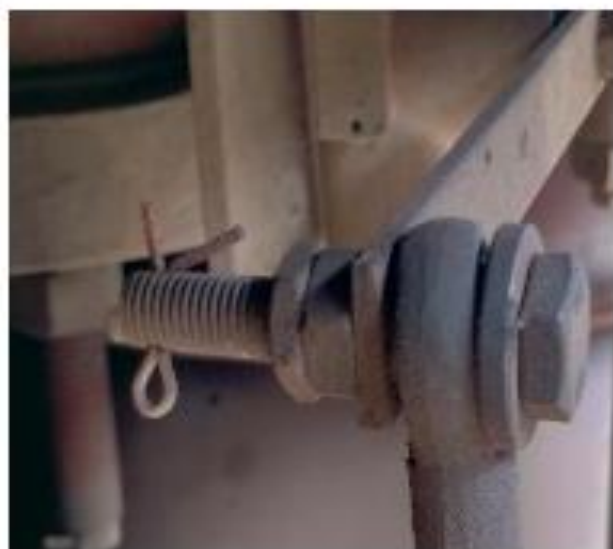
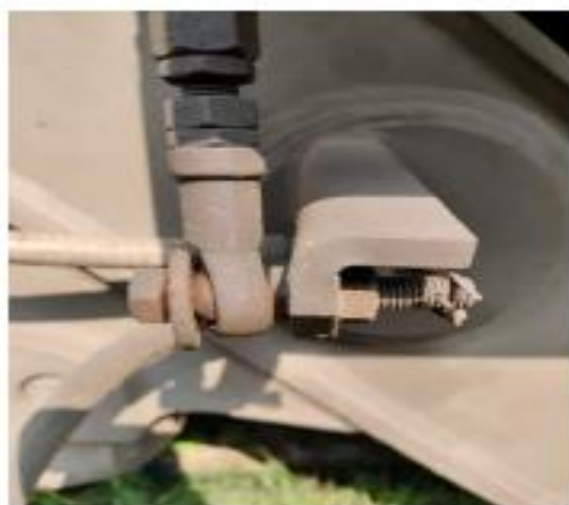
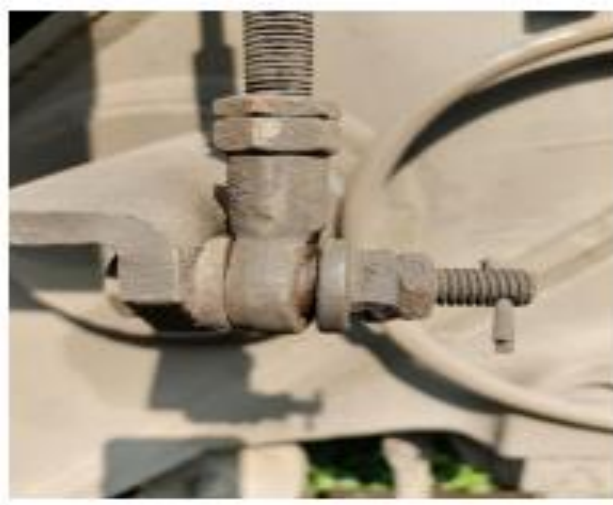
INCORRECT SEQUENCING OF NUTS, LOCK NUTS, WASHER & LEVELLING VALVE HORIZONTAL LEVER

(All the nuts & lock nuts are not placed in correct sequence during assembly for proper fitment/movement of installation lever & levelling valve handle.)

CORRECT SEQUENCING OF NUTS, LOCK NUTS, WASHER & LEVELLING VALVE HORIZONTAL LEVER

(All the nuts, lock nuts & washer should be as placed correct sequence as given below)

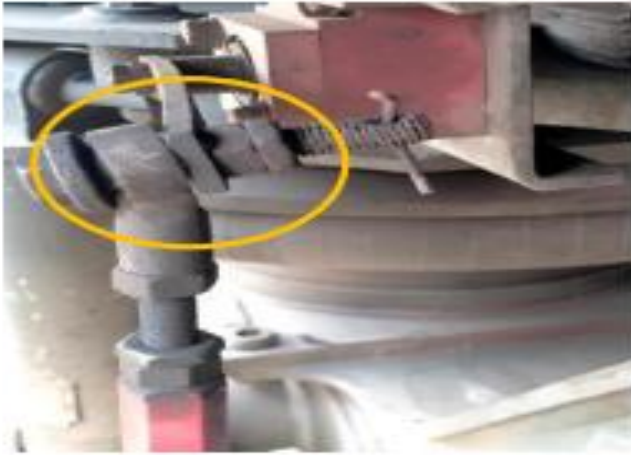
Cause no.01-Totally tightened. No space for ball movement

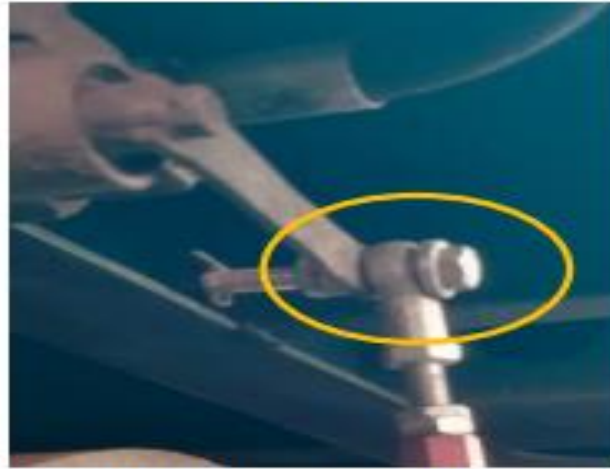
Cause no.02-Incorrect Fitment of washer, bolt & levelling valve horizontal lever etc.

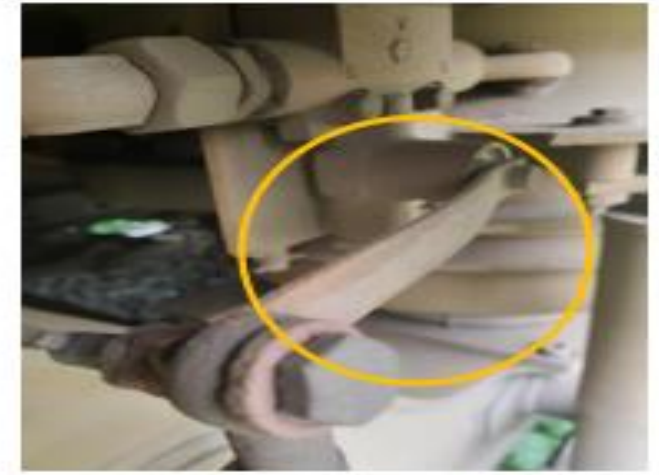
Resulting in-Leveling valve Handle in bent condition

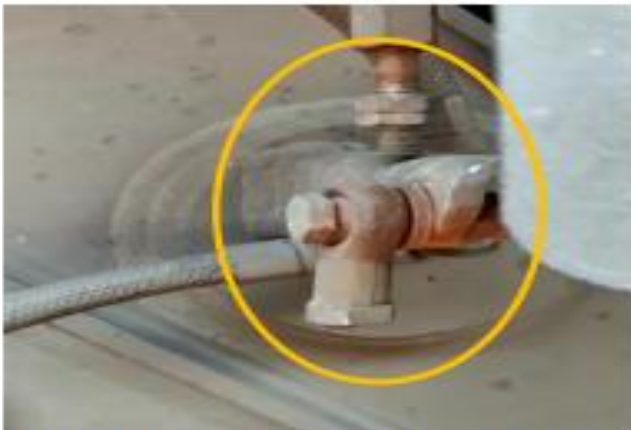
Resulting in-Installation Lever Broken

Result: -Undesirable forces are developing during train operation on installation lever & Levelling valve horizontal lever. As a result, levelling valve handle are getting bent and installation levers get broken.

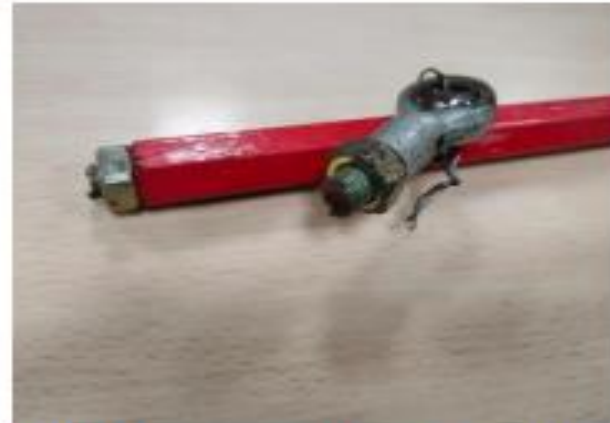
Resulting in -Installation Lever Broken

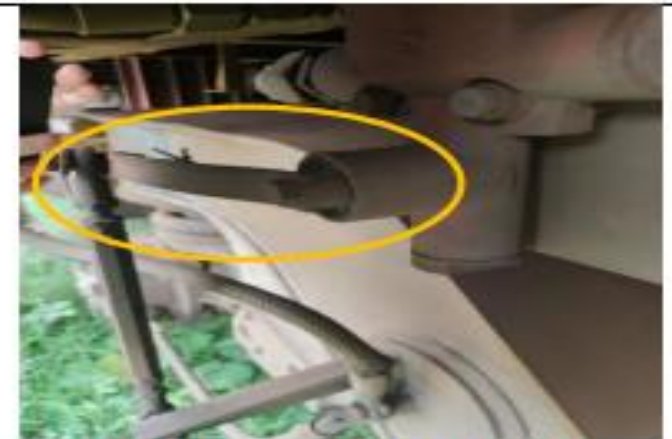
Resulting in-Leveling valve Handle in bent condition.

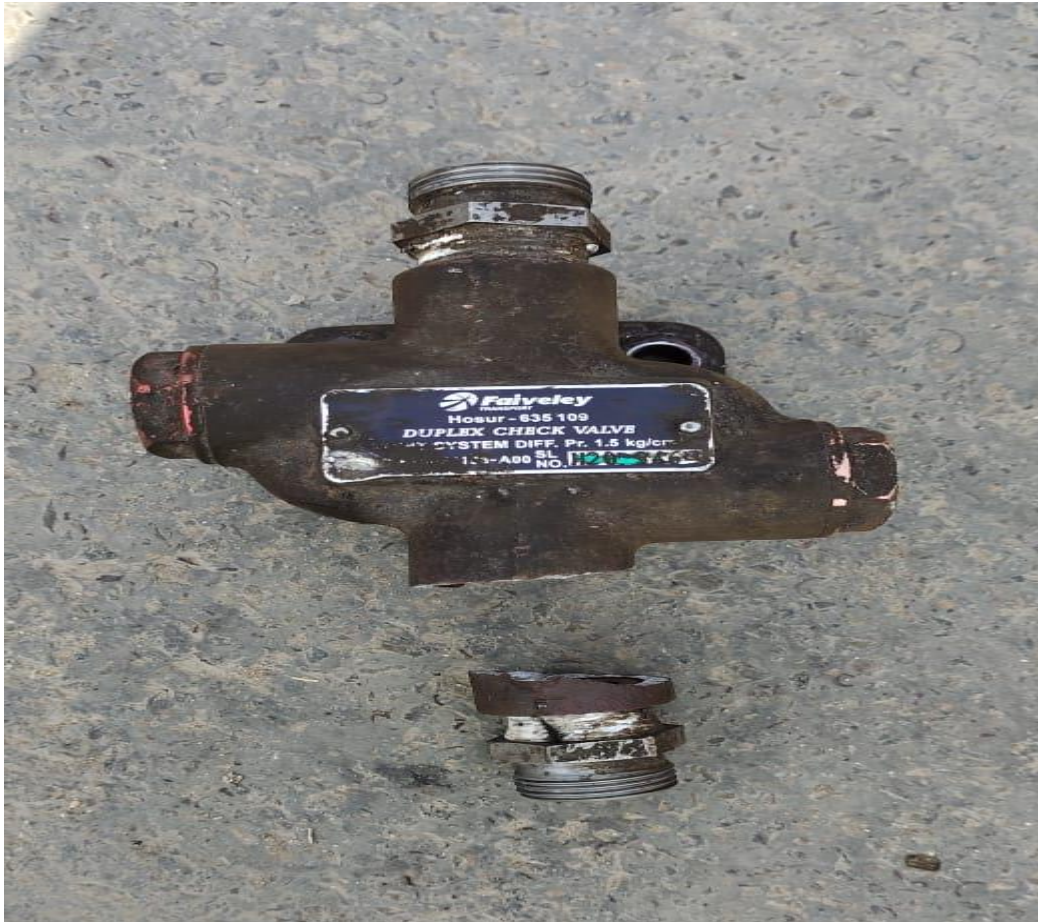
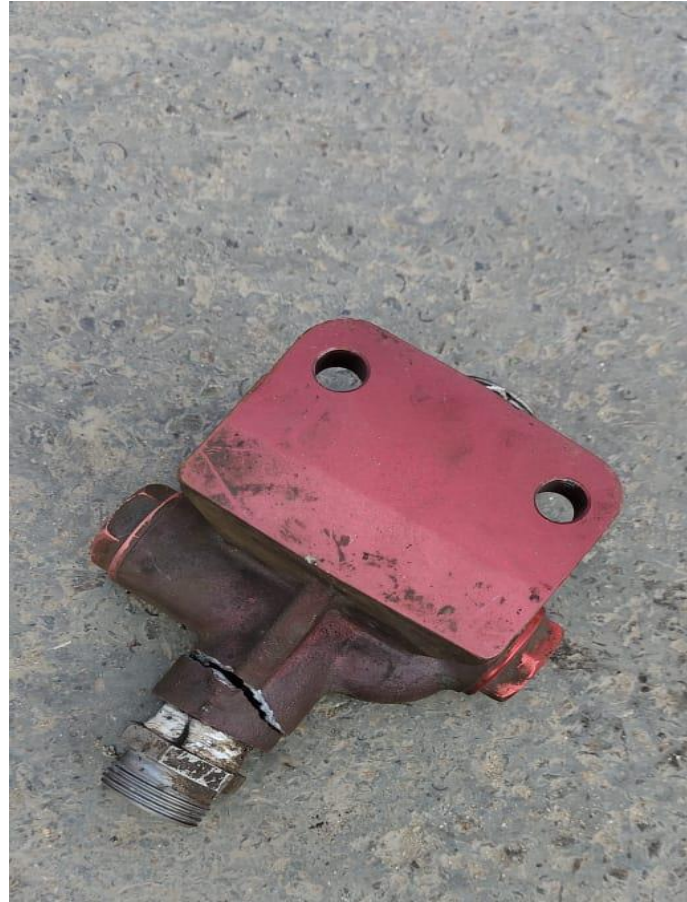
| st. No. | Reason Of FIBA actuation Enroute | No. of failures | Remarks & action taken |
|---|--|---|---|
| 5 | Levelling valve failure/leakage/broken | 9 | <p>(5.80 % of total investigated cases)</p> <ul style="list-style-type: none">• During the investigation, some of the cases of premature failure of levelling valve were identified due to wrong fitment of installation lever with horizontal lever of levelling valve (leakage observed during train operation).• Horizontal lever bent cases due to excessive loading (reason is wrong fitment of installation lever).• In this regard, fitments instruction are attached for proper fitment (fig. 1.1 & fig.1 .2) of installation lever to avoid premature failure during train operation as Annexure-C. |

Levelling valve failure/leakage/broken

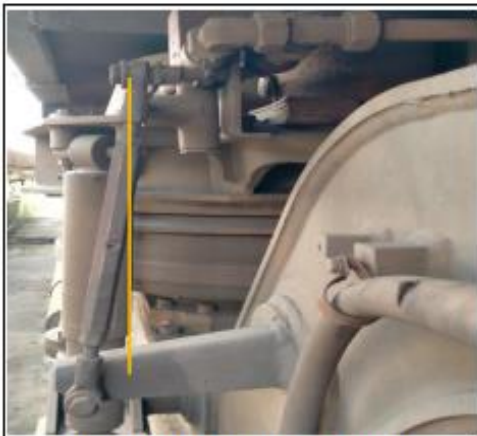
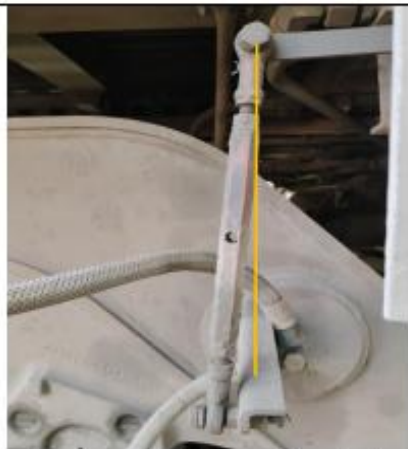
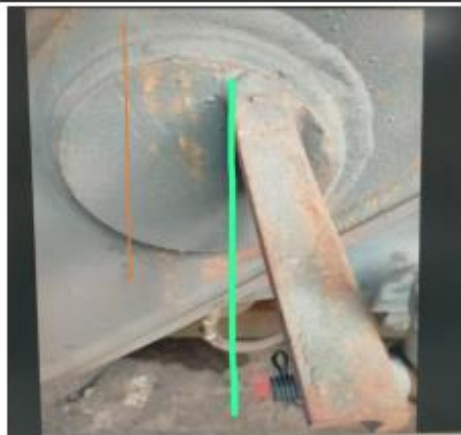
Improper Welding of Brackets

- Incorrect/Improper welding of upper & lower brackets for leveling valve and installation lever, which resulting in misaligned/inclined position of installation lever (Not at right angle). Lower bracket should be perpendicular to bogie frame side face after welding & machining.
- Upper bracket for levelling valve on bogie bolster must be perfectly aligned in longitudinal direction with its axis parallel to level track.
- Misalignment of mounting holes for leveling valve.
- Center to center distance between ball socket joint of installation lever and leveling valve lever hole is varying in different coaches (It should be fixed to 160 mm approx.).
- Horizontal lever of levelling valve is getting bent due to transfer of undesirable forces during service

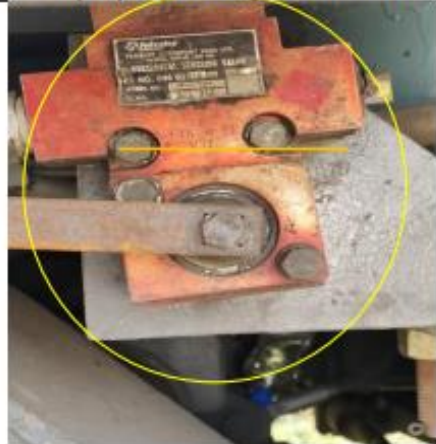
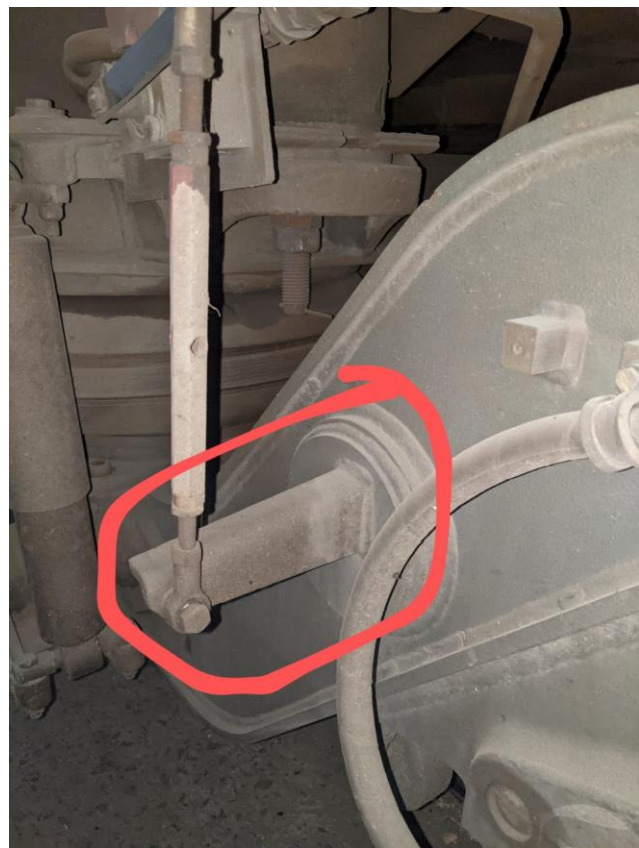
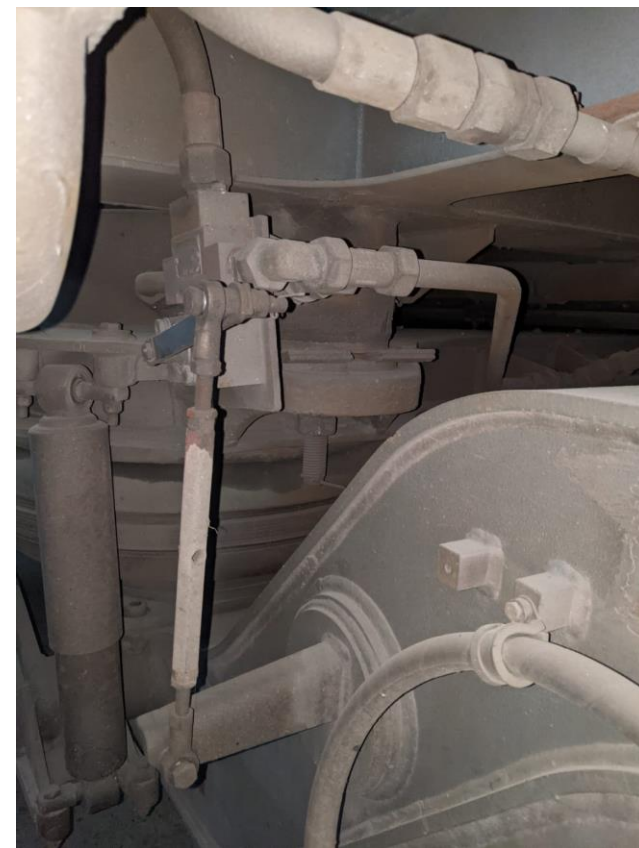
Misalignment of mounting Holes

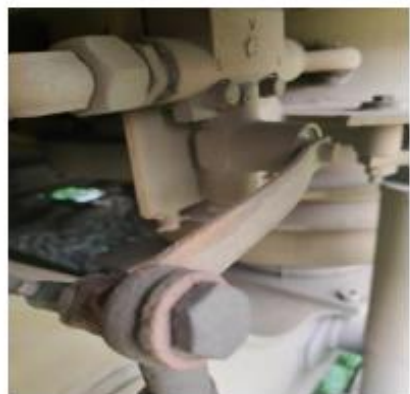
Leveling valve handle in bent position

Improper orientation causes excessive forces on leveling valve & installation lever
