Trouble Shooting Guide on Brake Binding in Coaching Stock

IRCAMTECH/2013/Mech/BB/1.0

**Indian Railways
Centre for Advanced Maintenance Technology**

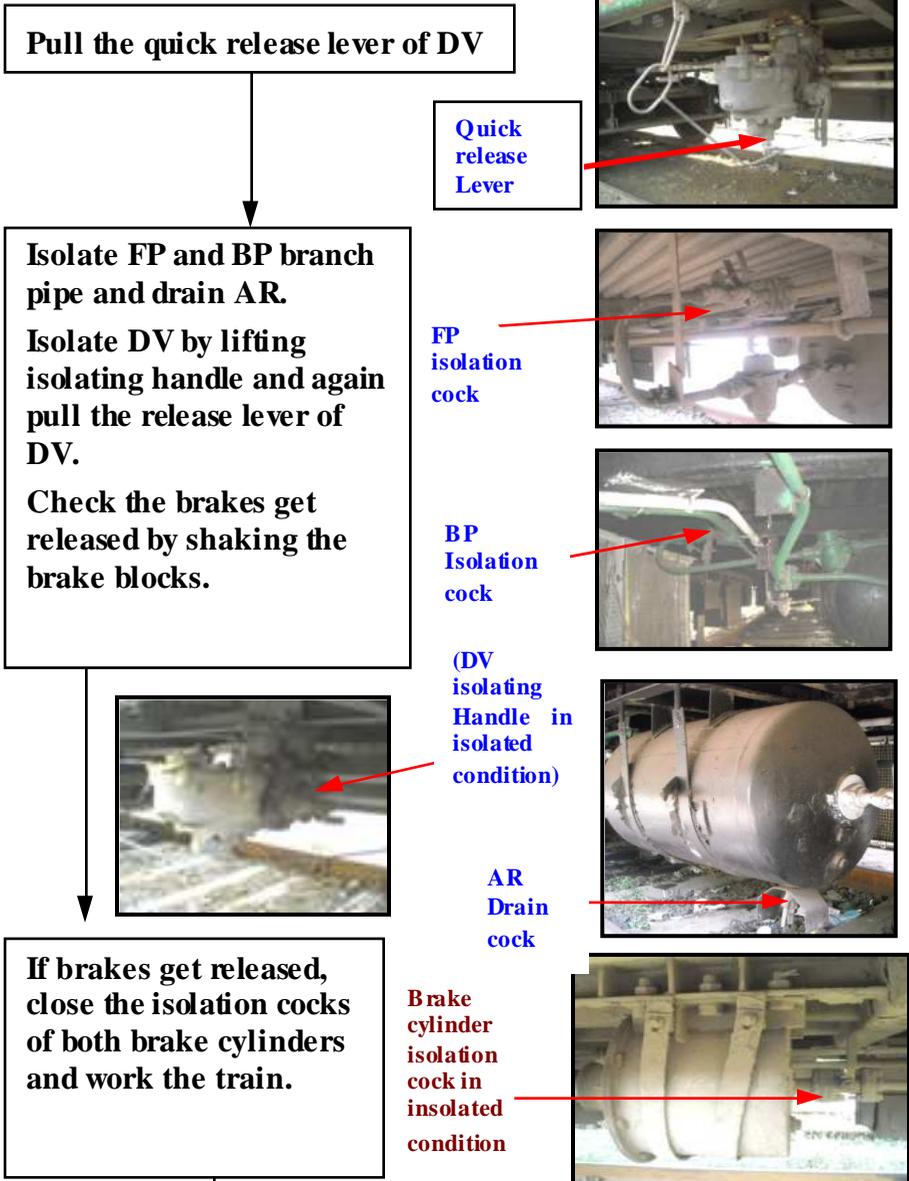
Procedure to Release and isolate Brake Binding at enroute stations (for Conventional Air Brake Coaches)

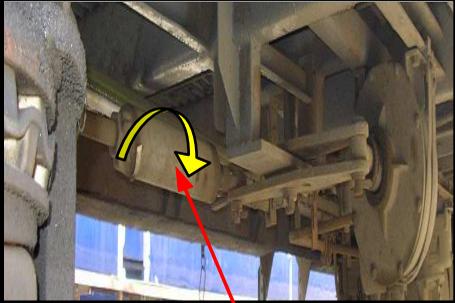
Slack adjuster

If brake blocks are gripping the wheels in one bogie, then close the isolation cock of the brake cylinder and rotate the slack adjuster of the affected bogie in anti-clockwise direction while facing the bogie.

Ensure that brakes are released by shaking the

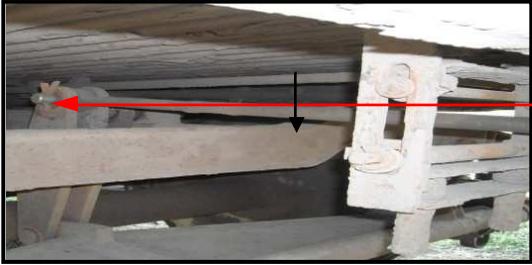
In case brake blocks are still gripping the wheels of a particular bogie, remove the SAB pull rod pin of the affected bogie, secure the SAB pull rod and work the train.

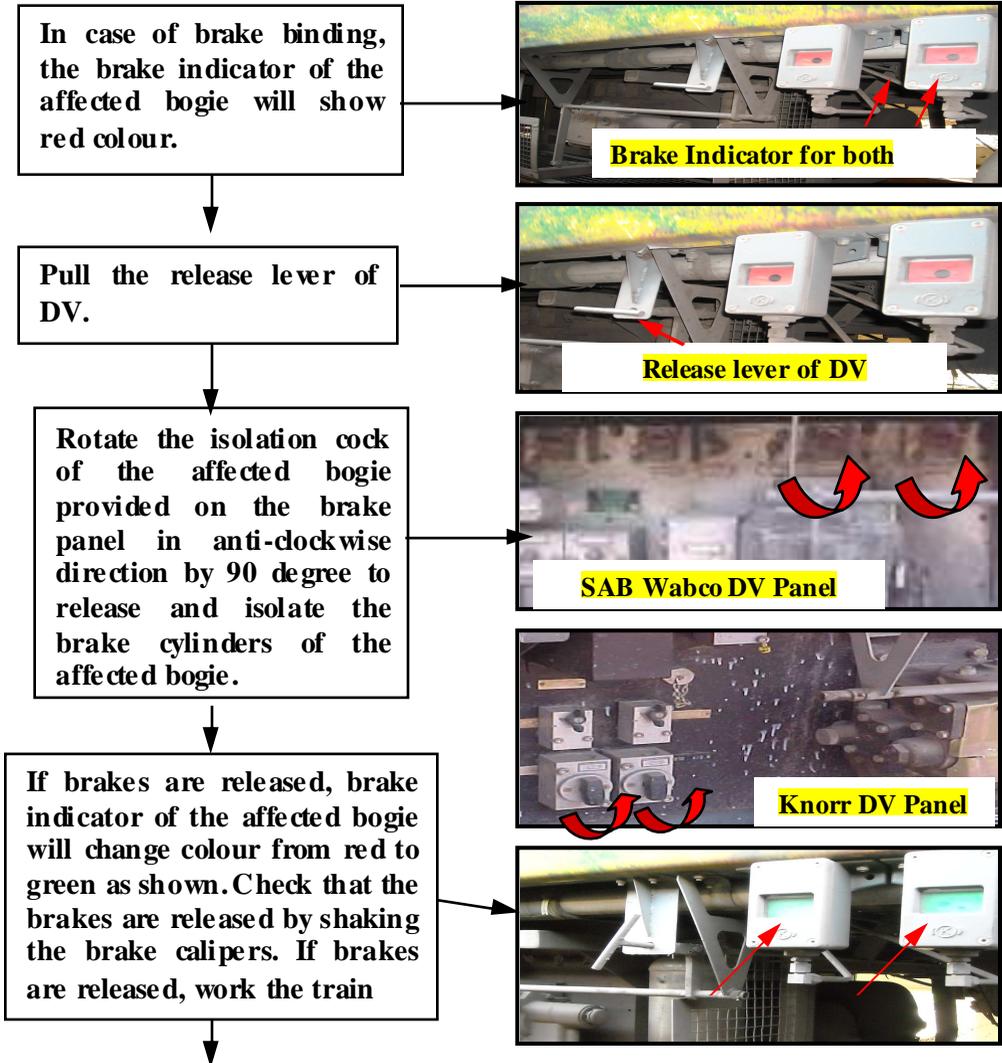
Procedure to Release and isolate Brake Binding of LHB Coach with FIAT trolley at enroute stations (for Loco Pilots & Guards.)

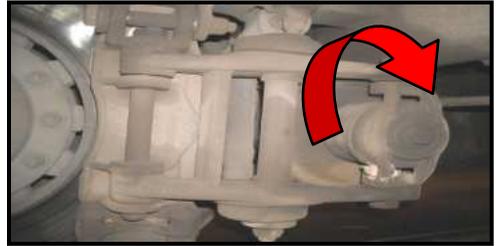
Loosen the hexagonal nut of the brake cylinder by 27 no. or 46 no. spanner. Check that the brakes are released by shaking the calipers and work the train.

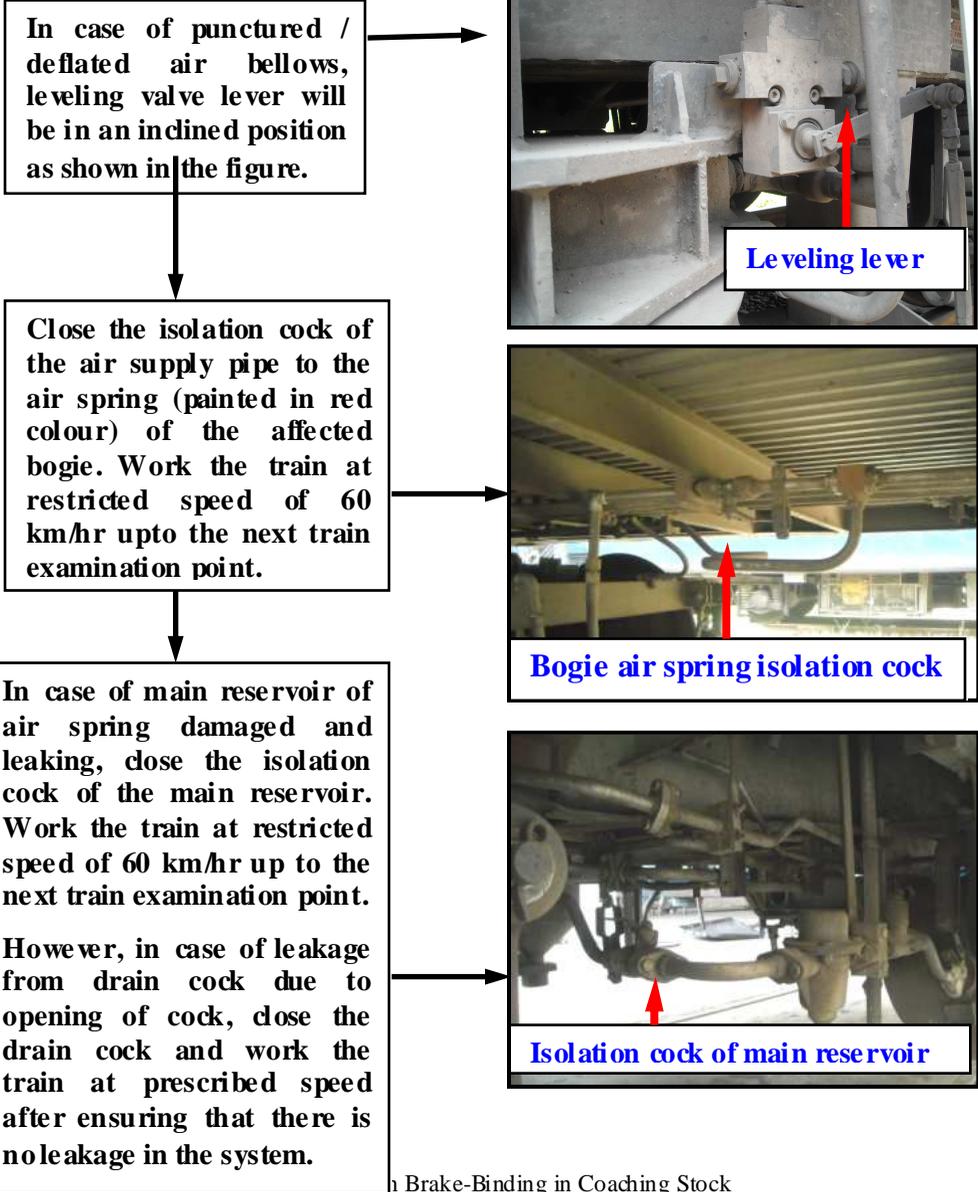
Trouble shooting of Air Springs provided in Secondary Suspension of Bogies

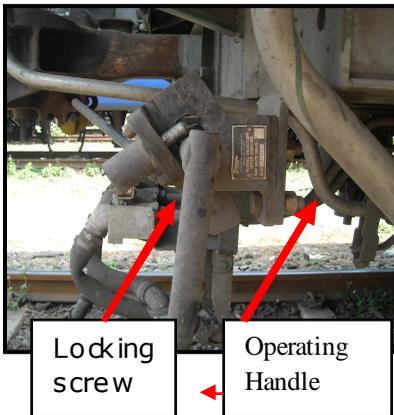
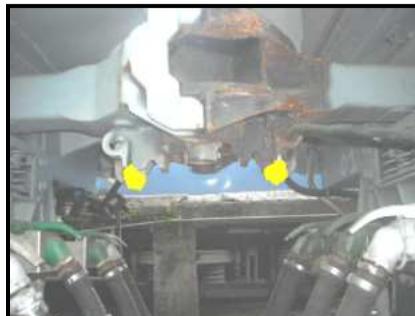
- 1) Bring the coaches near each other at a slow speed and stop the coach at approximately one meter distance of each other.
- 2) Ensure that locking screw is in unlocked position otherwise unlock the operating handle by rotating locking screw anticlockwise with key.
- 3) Lift the operating handle and turn it in clockwise direction (by minimum 90°) to a horizontal position to open the CBC.
- 4) Check alignment and position of coupler centers and attach at approximately 2 to 3 km/hr speed.
- 5) Check position of tell tale device for proper coupling (location of the tell tale is shown in figure).

Tell tale sign should be clear after coupling of loco/coaches as indicated to ensure proper coupling.

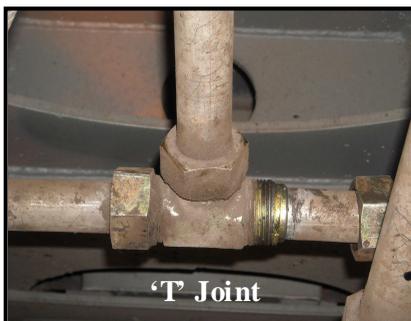
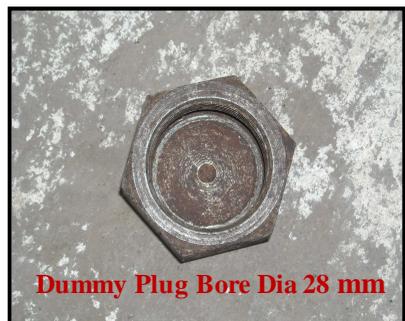
3. Trouble shooting in case of BP-FP cut off angle failure on the last coach (LHB coach FIAT Bogie)

1. Close rear Cut off angle cock of adjacent coach of the affected pipe.
2. Loosen the check nut fitted on 'T' joint and affected angle cock pipe.
3. Disconnect the affected pipe from 'T' joint by loosening holding clips.
4. Tighten the Dummy plug to that end.

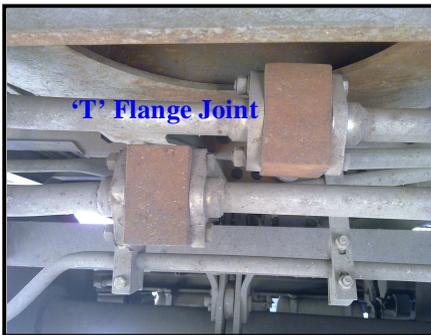
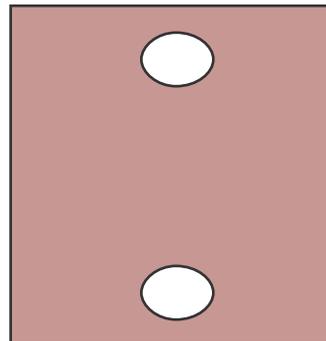
MS Dummy Plate
(98x65x2 mm)

4. Trouble shooting in case of BP-FP cut off angle cock failure on the last coach (Hybrid coach)

1. Close rear Cut off angle cock of adjacent coach of the affected pipe.
2. Loosen and remove the both bolts.
3. Make gap between block and affected angle cock pipe.
4. Insert Dummy plate between block and affected pipe flange.
5. Insert and tighten both bolts.

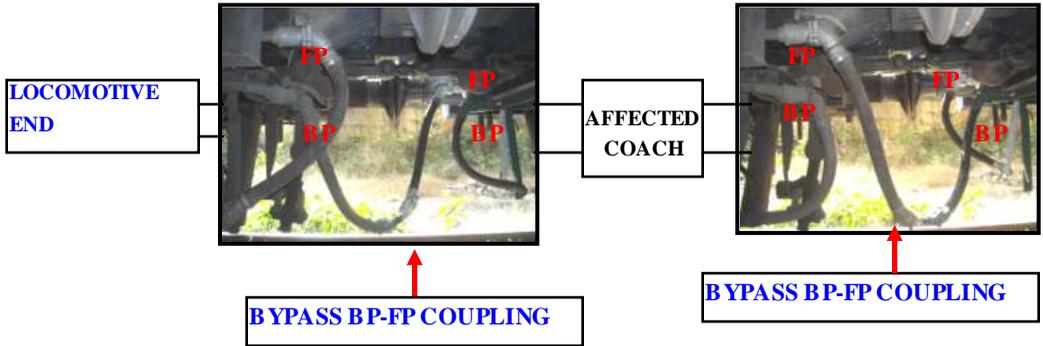
**Procedure for By-passing BP pressure of a coach in case of
Brake pipe failure at enroute stations (for Loco Pilots &
Guards.)**

- a. Collect two nos. of BP-FP BY-PASS Coupling from Pantry Car/AC II or Guard cab as per provision made.
- b. Close the FP and BP cut off angle cocks of loco end adjacent coach and the affected coach respectively. Wait till pressure of both air hoses releases. Uncouple BP and FP air hoses. Couple BP-FP BYPASS coupling between BP air hose of loco end adjacent coach and FP air hose of the affected coach. Place the spare hanging air hoses on hooks as in Fig. 1

- c. Similarly close cut off angle cocks of FP and BP of rear end adjacent coach and the affected coach. Uncouple BP and FP air hoses. Couple BP-FP BYPASS coupling between BP air hose of rear end adjacent coach and FP air hose of the affected coach. Place the spare hanging air hoses on hooks as in Fig.2

- d. Open cut off angle cocks of BP of rear end adjacent coach, both FP cut off angle cocks of affected coach and BP cut off angle cock loco end adjacent coach respectively.

- e. Manually release and isolate the affected coach.
- f. Conduct air pressure continuity test and work the train.
