Presentation on UIC 130 CTRB

MMVGK RAJU
SSE/WHEEL/LGDS

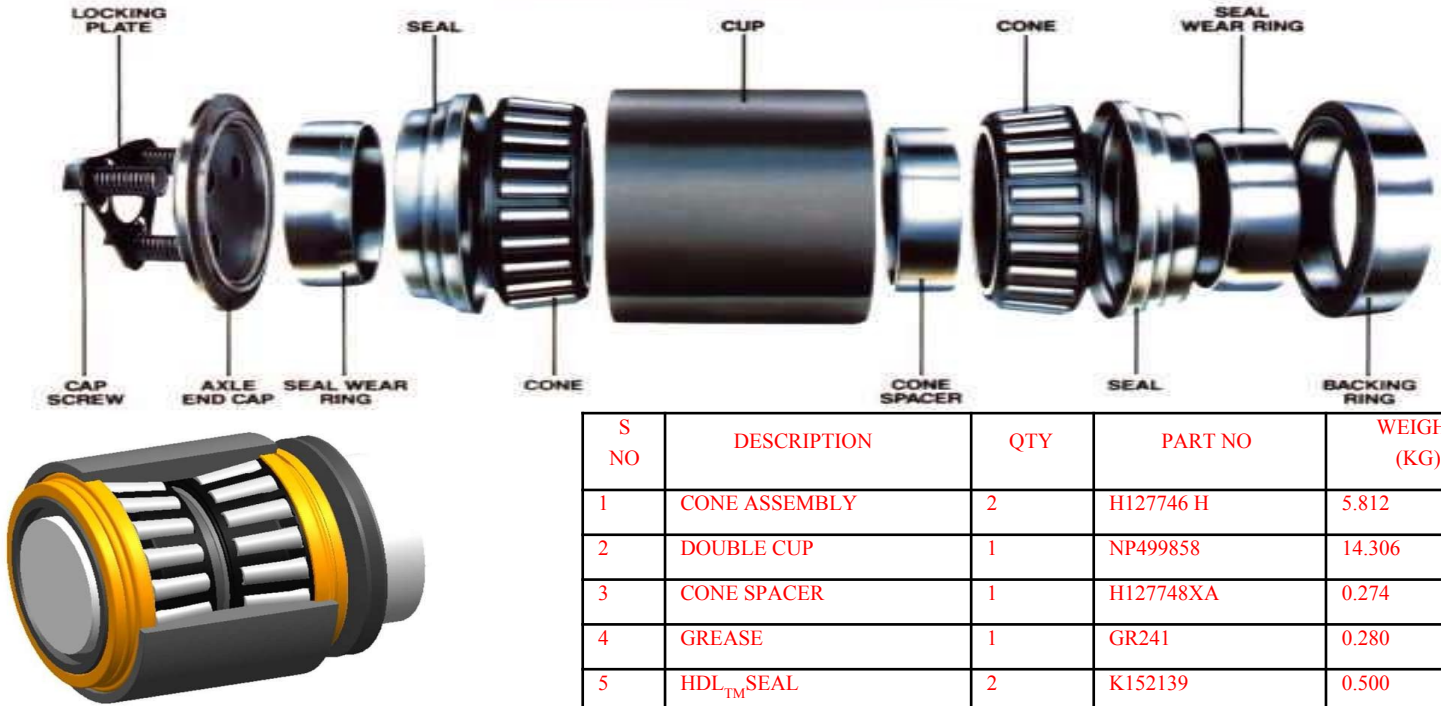
Bearing components

S NO	DESCRIPTION	QTY	PART NO	WEIGHT (KG)
1	CONE ASSEMBLY	2	H127746 H	5.812
2	DOUBLE CUP	1	NP499858	14.306
3	CONE SPACER	1	H127748XA	0.274
4	GREASE	1	GR241	0.280
5	HDL TM SEAL	2	K152139	0.500
6	BACKING SPACER	1	K153064	1.393
7	SEALING RING	1	K157653	0.910
8	BACKING RING	1	K798870	3.012
TOTAL WEIGHT				32.799

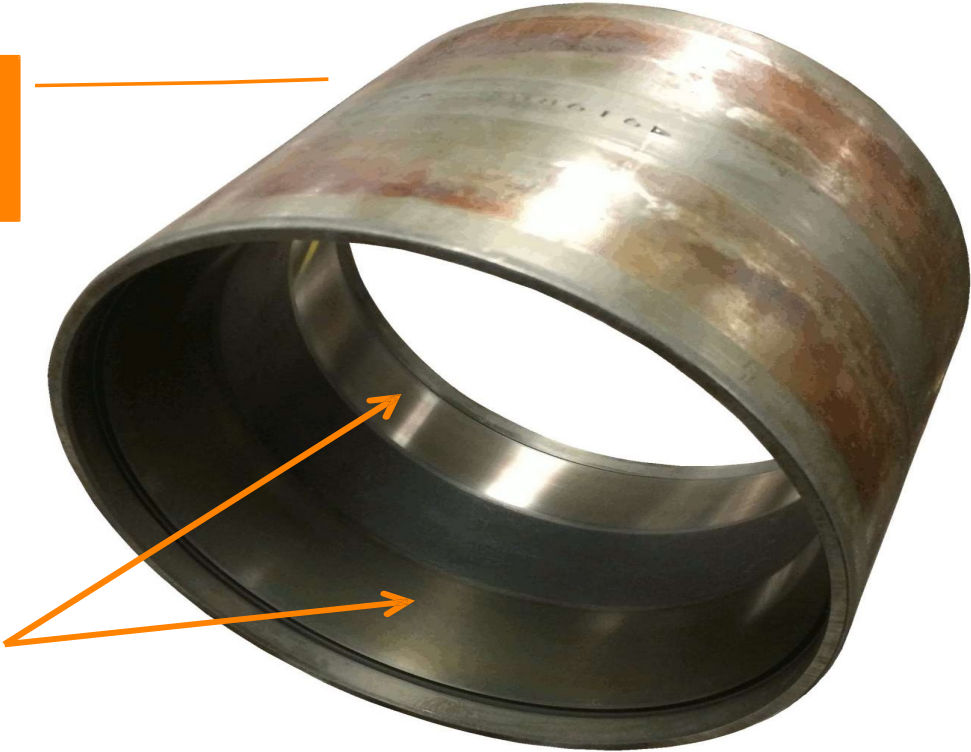
BEARING CUP

Cup outer diameter will have a part number, manufacturing date, and serial number

Two tapered raceways

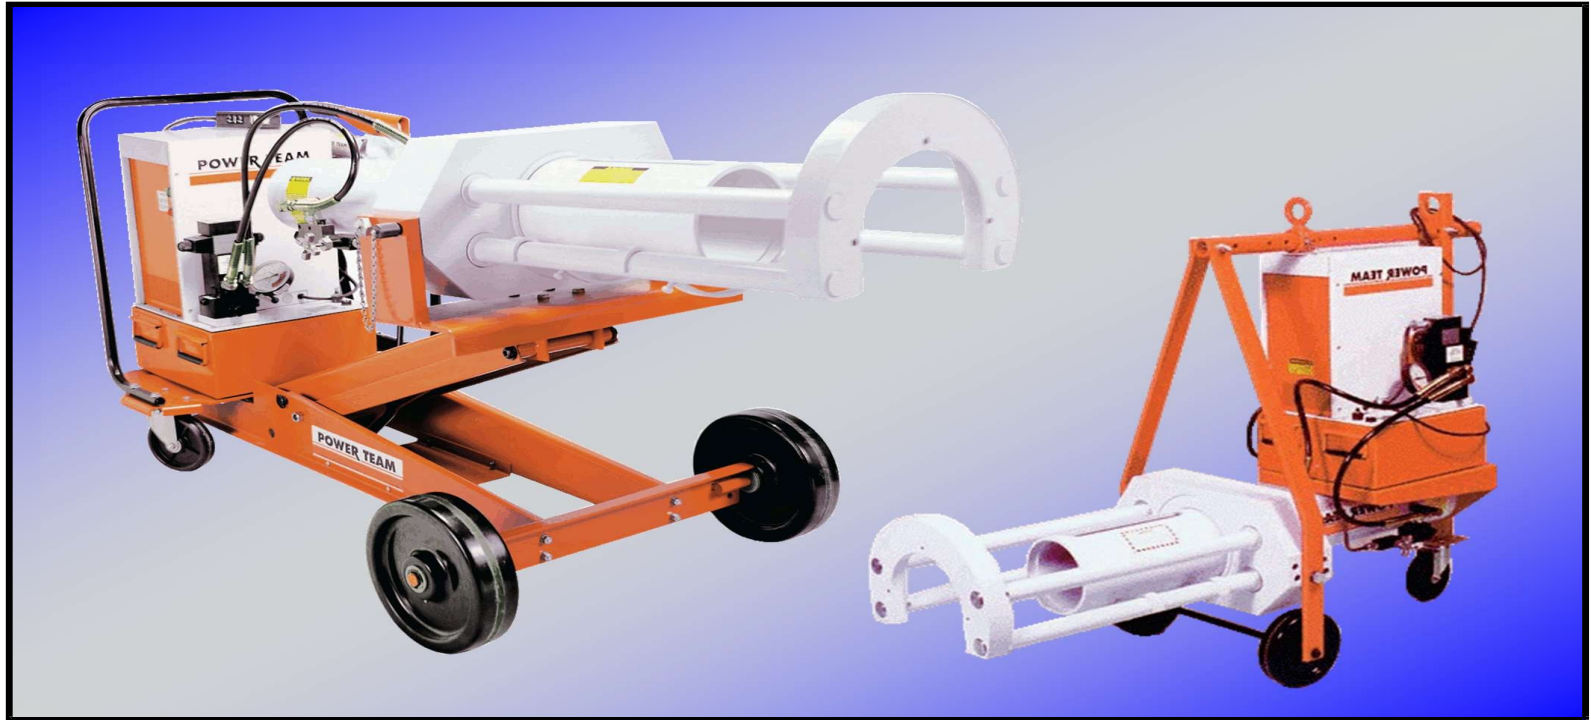
Portable Press (OTC)

BEARING REMOVAL

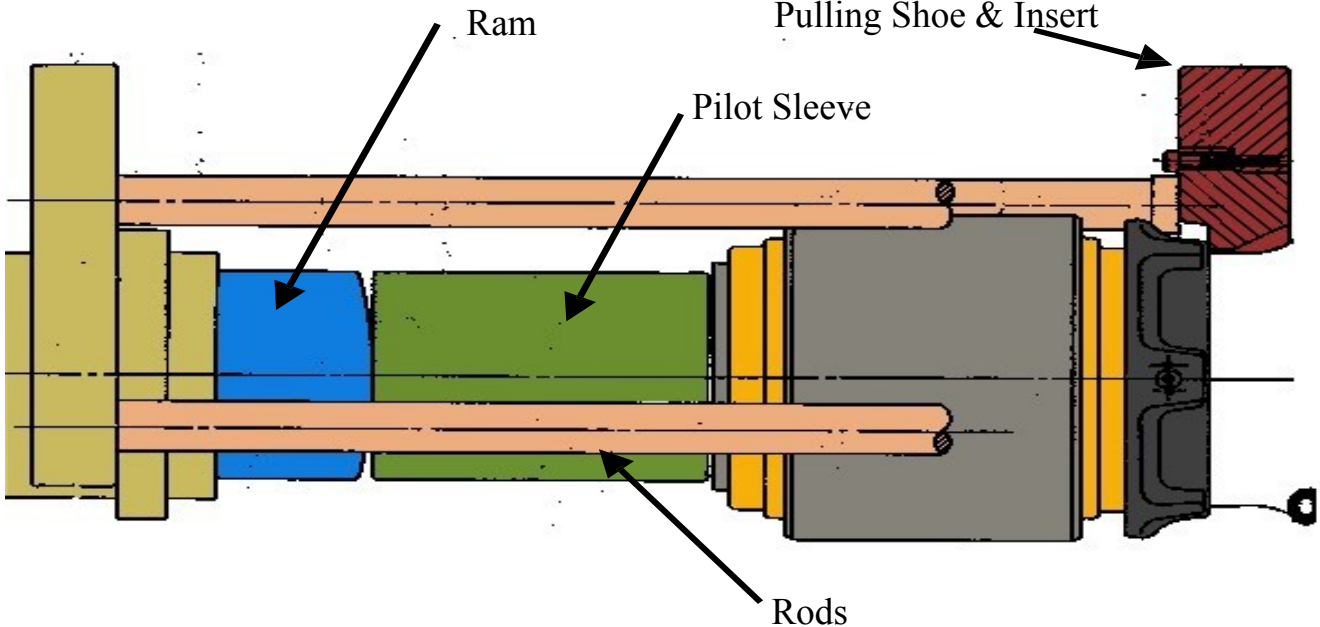
Removal schematic

BEARING REMOVAL

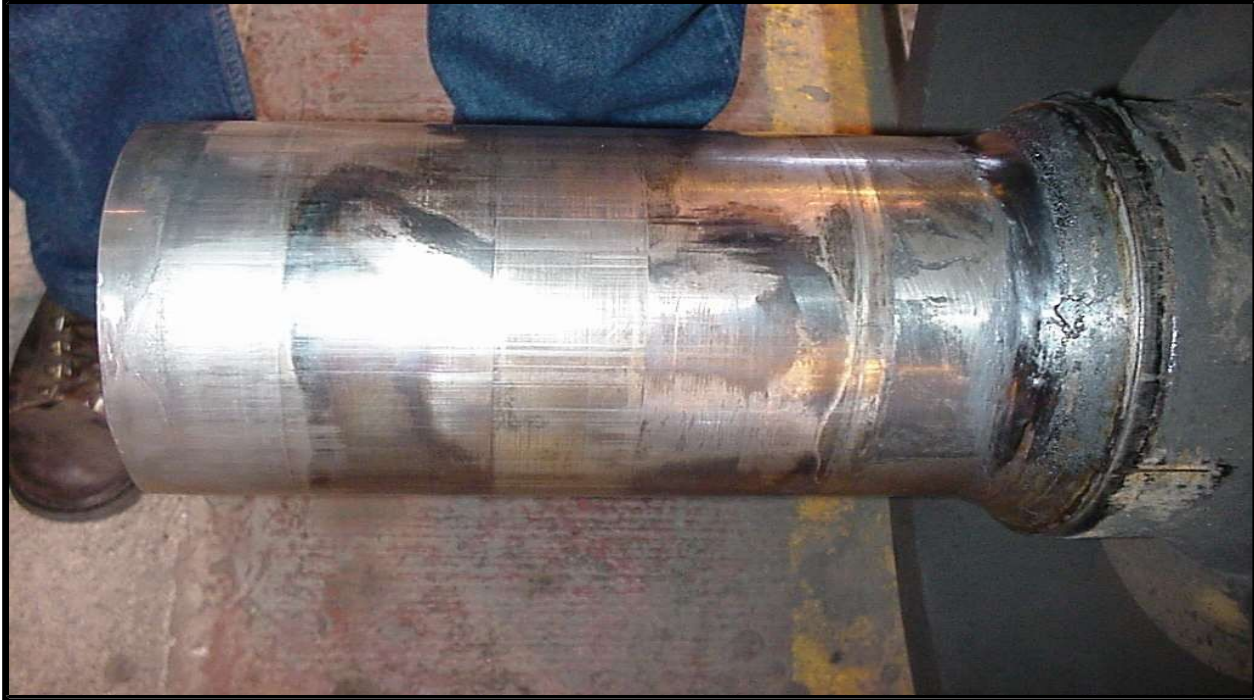
Axle condition

- Things to check:
 - Axle journal condition
 - Average axle journal size
 - Upset journal
 - Dust guard condition
 - Dust guard size (fitted applications)
 - Fillet radius condition
 - Cap screw threads

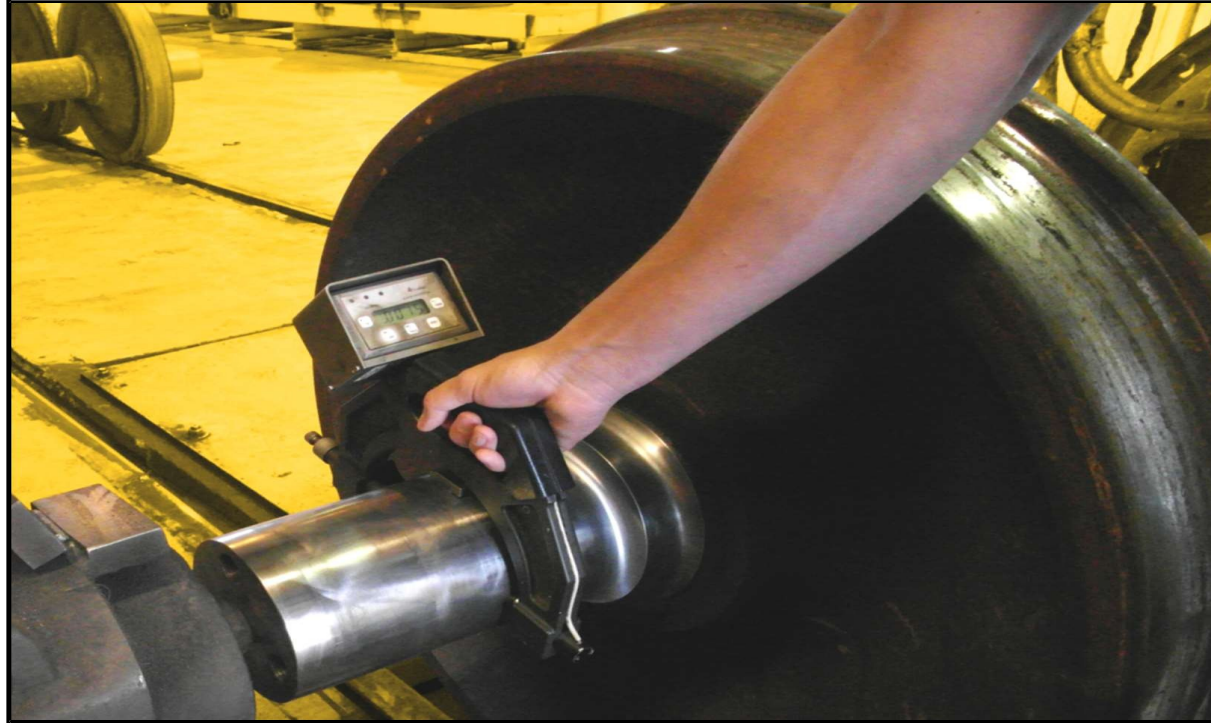
Thermal Compensating Journal Gauge

cone seats: 130.043mm to 130.068mm

Shoulder seats: 160.174 mm to 160.134mm

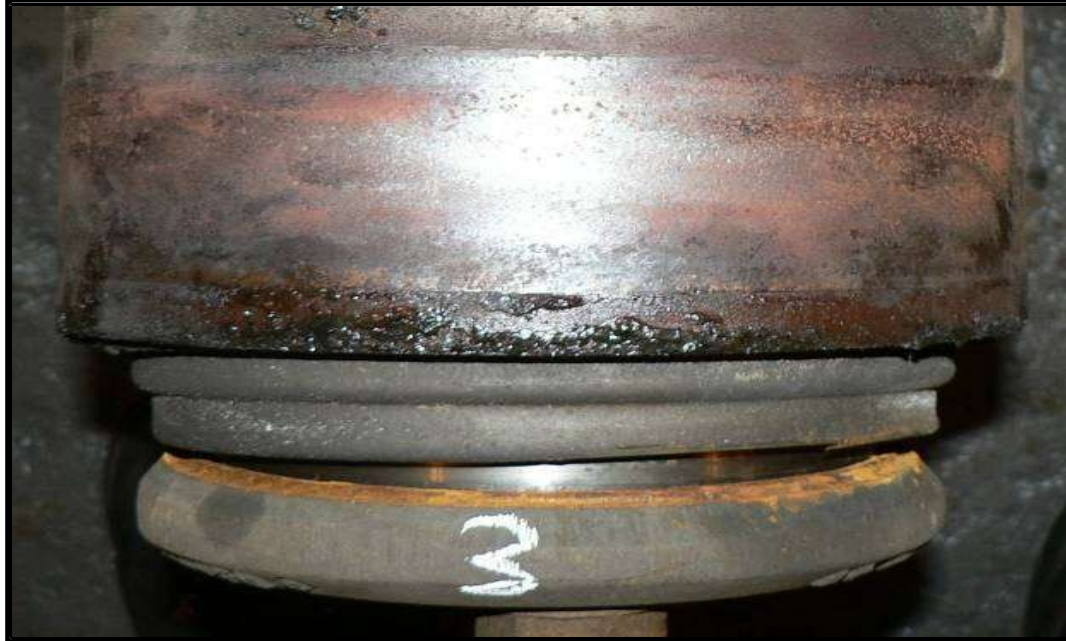
WHAT CAN AN UPSET END LEAD TO?

- Displaced Seals

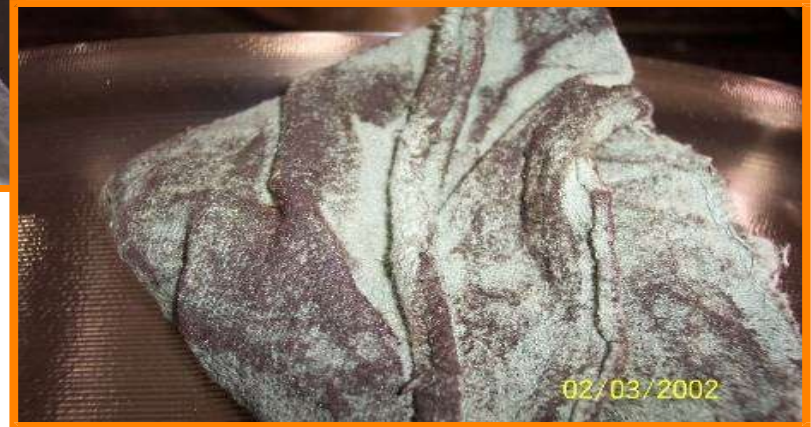
Foreign material on the axle will cause lubricant to be ineffective

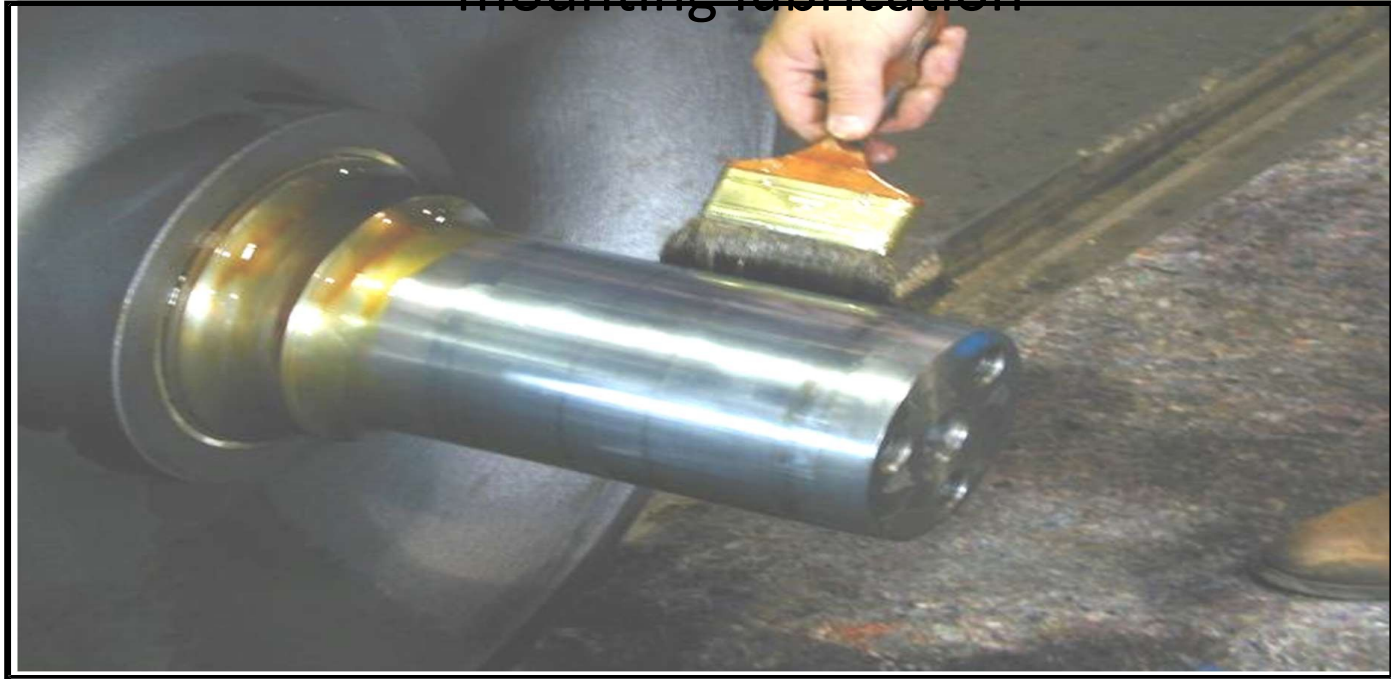
Journal fillet and Dust Guard rust preventative and mounting lubrication

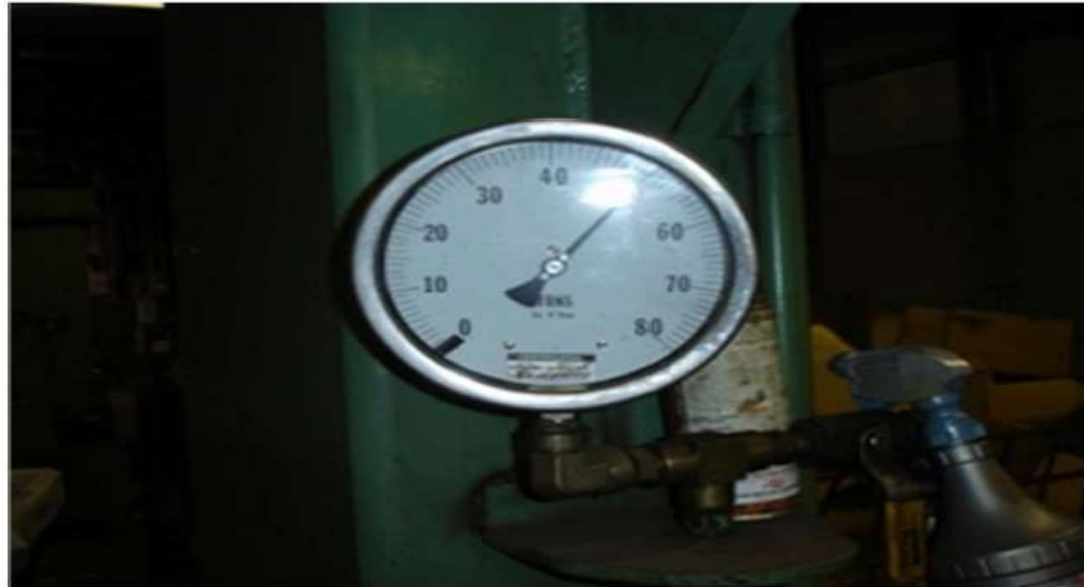
- Has to overcome total contact pressure due to interference fit.
 - Seating force is 50% more than the total pressing force.
 - Ensure all components are equally tight
-
- UIC-130 seating force = 37-42 tons

Calibrated pressure gauge on Hydraulic press

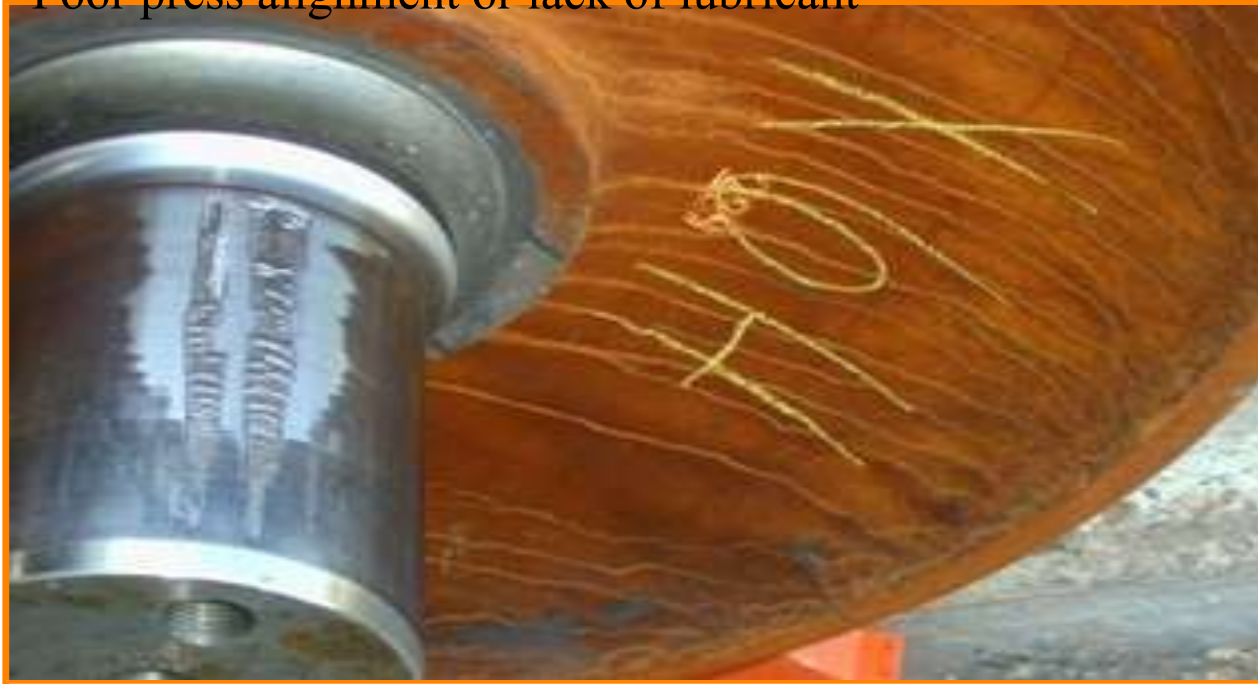
AXLE GALLING

Poor press alignment or lack of lubricant

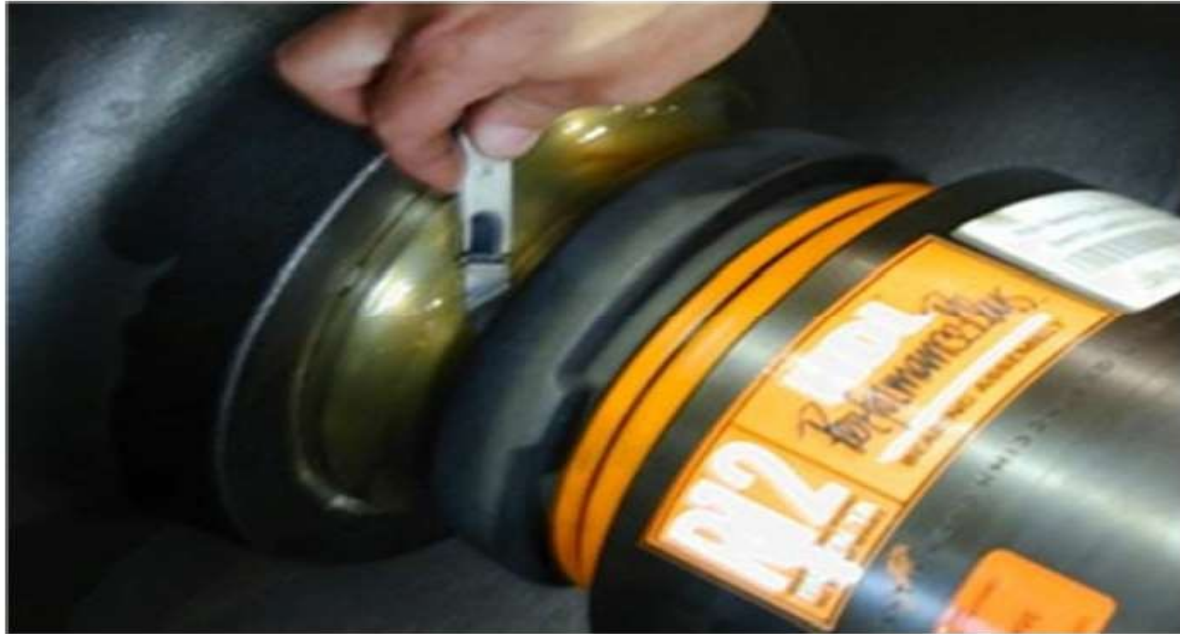
Use feeler gage to check backing ring is properly seated

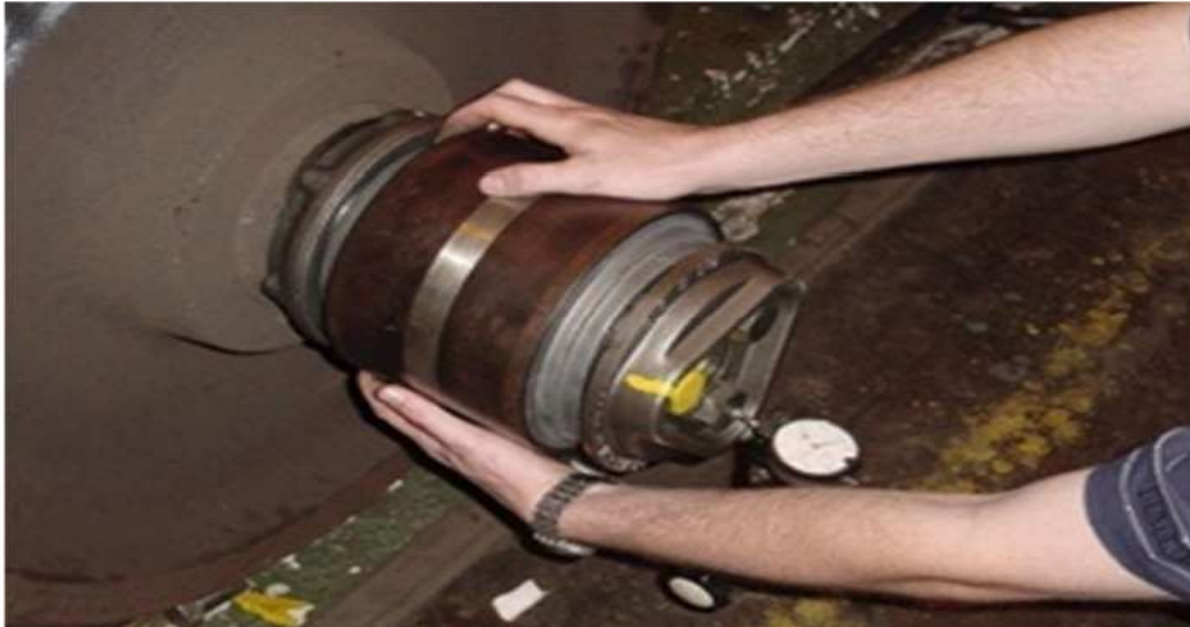
Bearing Mounted clearance check

0.025-0.330mm for new bearing and in service bearing 0.025 to 0.500 mm.

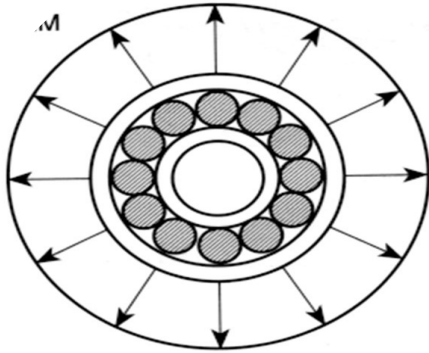
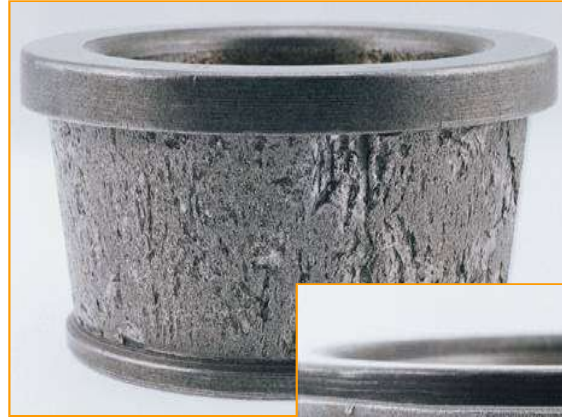
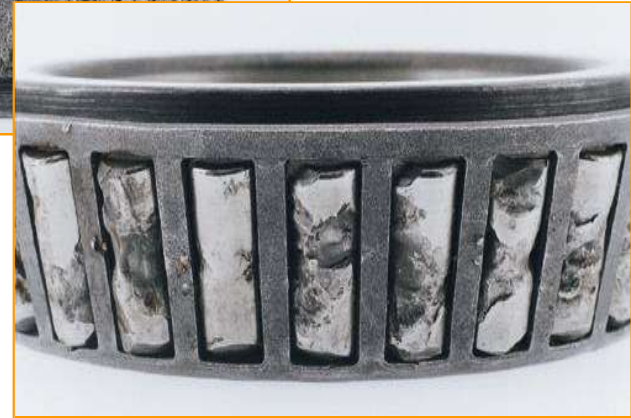
PRELOADING (NEGATIVE LATERAL)

- A large preload could mean that all the rollers are constantly loaded.
- This does not allow a proper lube film between rolling components.
- Leads to heavy fatigue spalling very quickly.

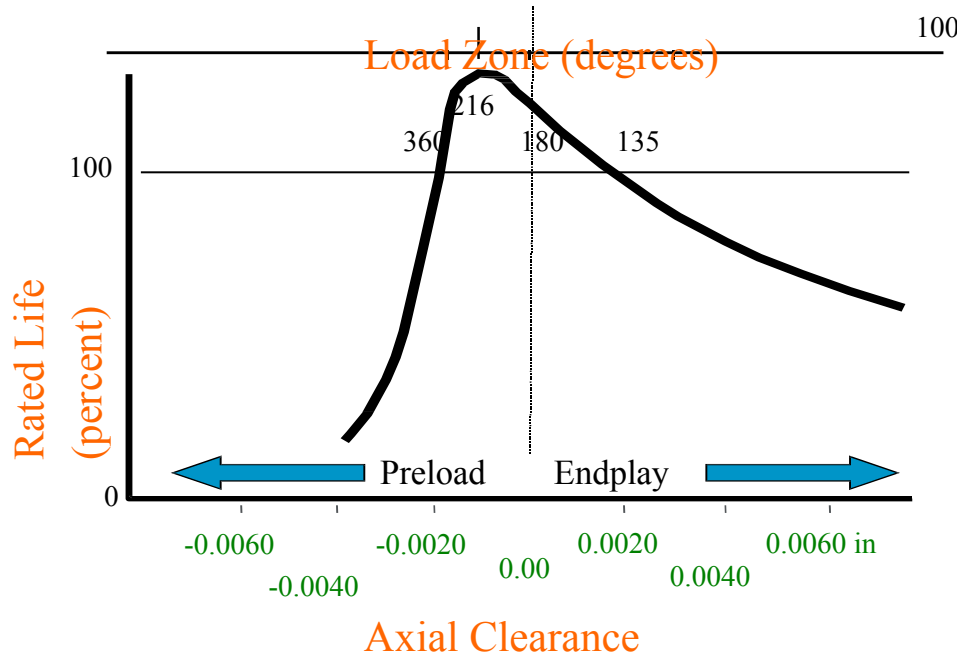
WHY ALLOW A ZERO LATERAL?

- Experience and testing has found that allowing a small amount of preload extends bearing life.
- The loads applied to the bearing are shared among more rollers without inhibiting lube film

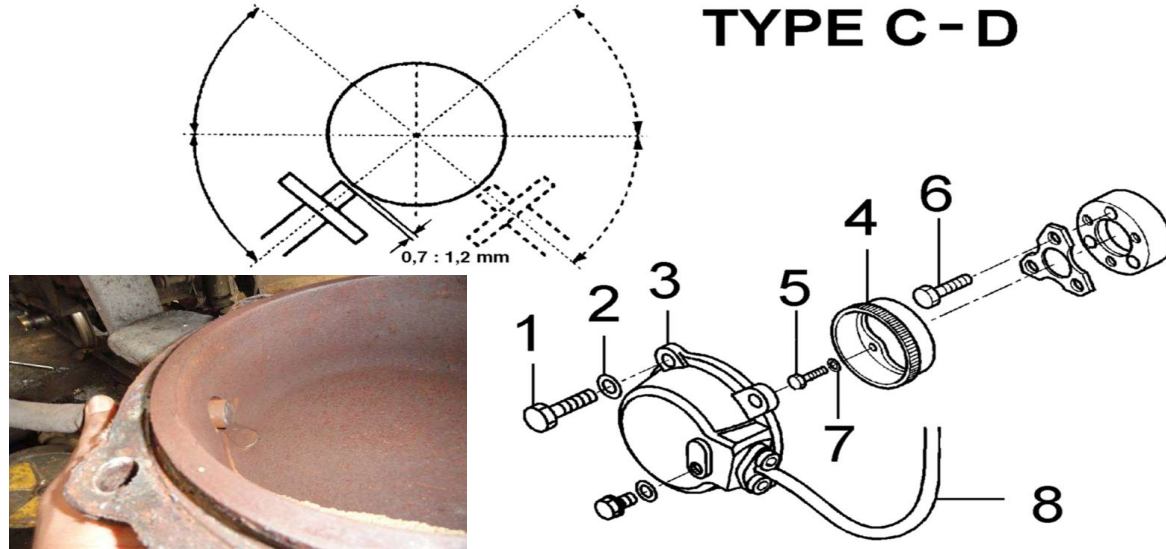
SPEED SENSOR / PHONIC WHEEL

This hole provided here is to check the gap between the probe and the phonic wheel which is to be $0.9 - 1.5 / 2 \text{ mm}$

This check needs to be done whenever the reassemble the bearing

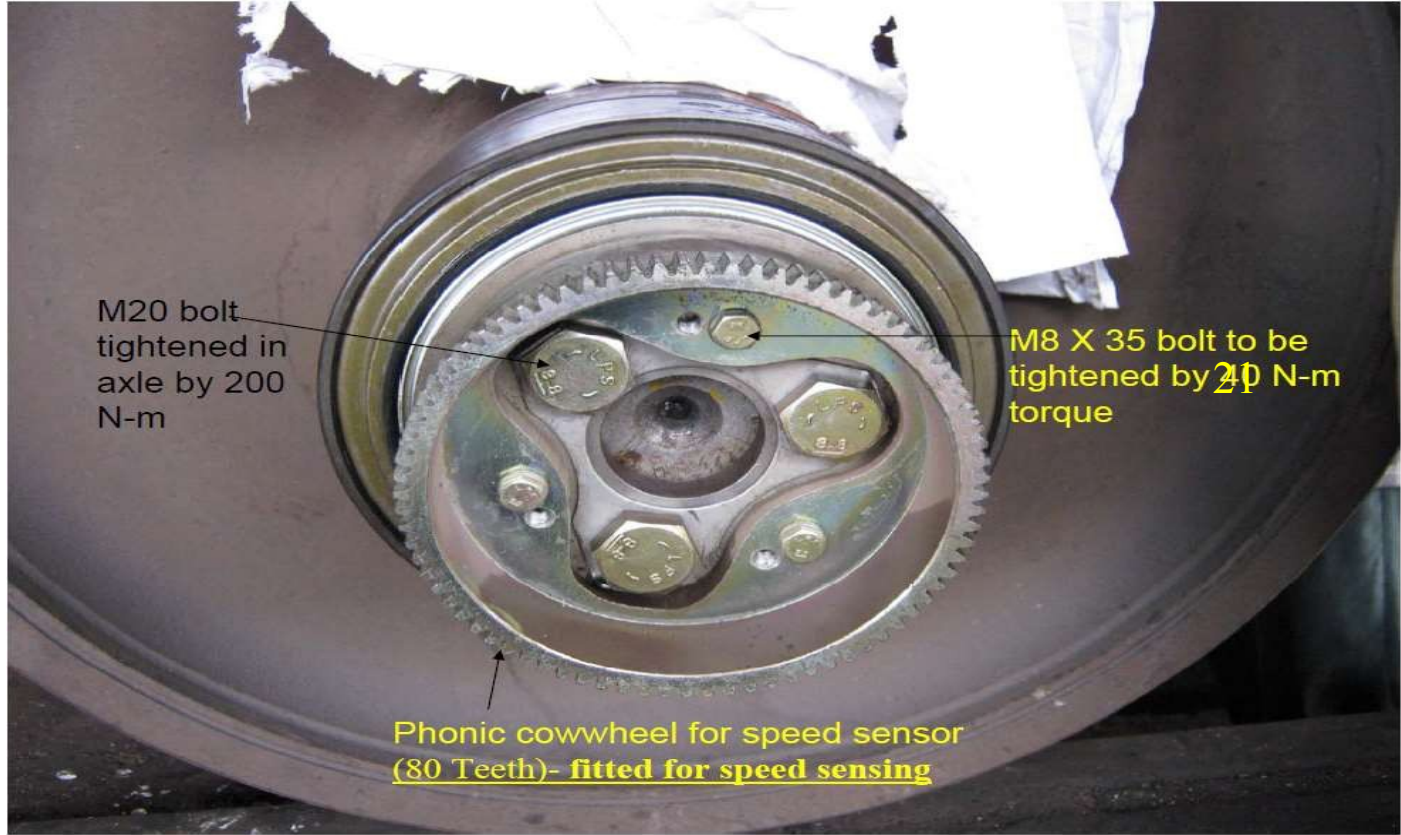
KB make Speed sensor

Gap between sensor and teeth:

0.9 mm to 2 mm

M20 bolt
tightened in
axle by 200
N-m

M8 X 35 bolt to be
tightened by ~~20~~ 21 N-m
torque

Phonic cowwheel for speed sensor
(80 Teeth)- fitted for speed sensing

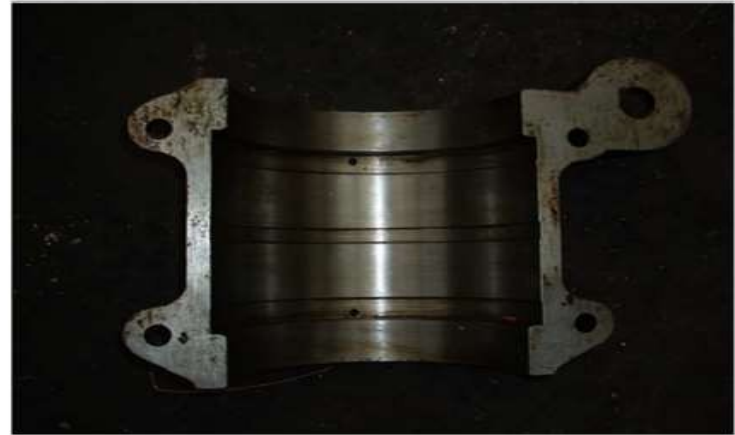
Inspect the control arm housing

- Control arm must be free from cracks or any kind of physical damages
- Both upper and lower control arms must have proper edge chamfer

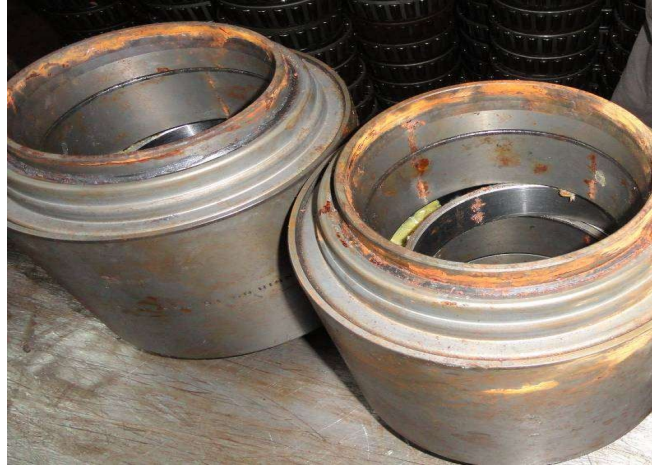
Bearings stored in moisture place

Bearings in stock should be kept at closed dry place.
Stored bearings should be inspected periodically, any undesirable condition like above If found should be intimated to The Timken Company.
Stored bearings should be used in the order in which they were stored, oldest stock first.

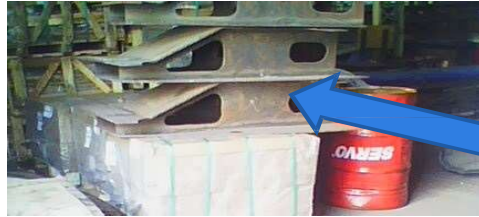
IMPROPER STACKING

Heavy weight of Channel
might damage seals

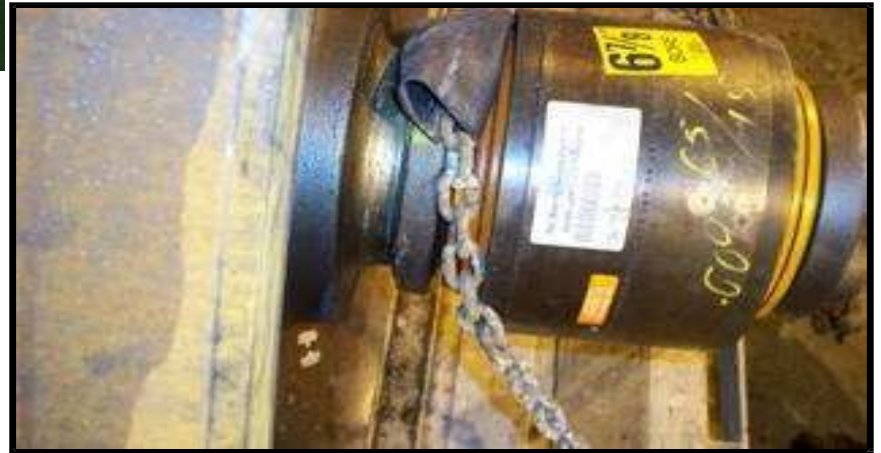
Do NOT chain a wheelset across bearings during shipping

Following such practices will damage the grease seal of the bearing which further result en-route damage of the bearing

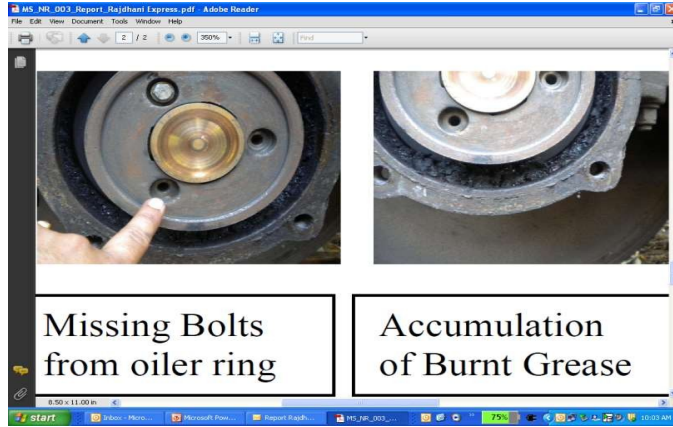
Missing Bolts/Accumulated Burnt Grease/Damage Carbon Brush/displaced oiler ring call for removal of wheel sets. Please do not put the bearing back in service if seal damage or temperature rised.

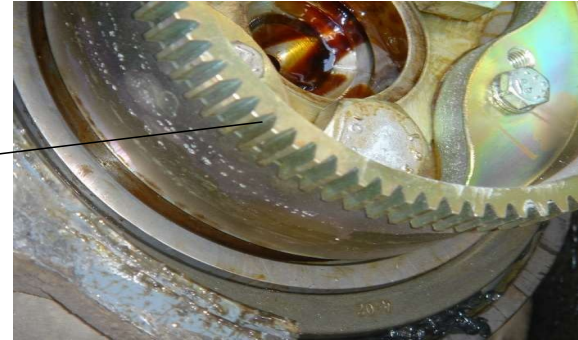
Missing /Broken Phonic /Missing phonic wheel bolt Wheel calls for wheel set removal

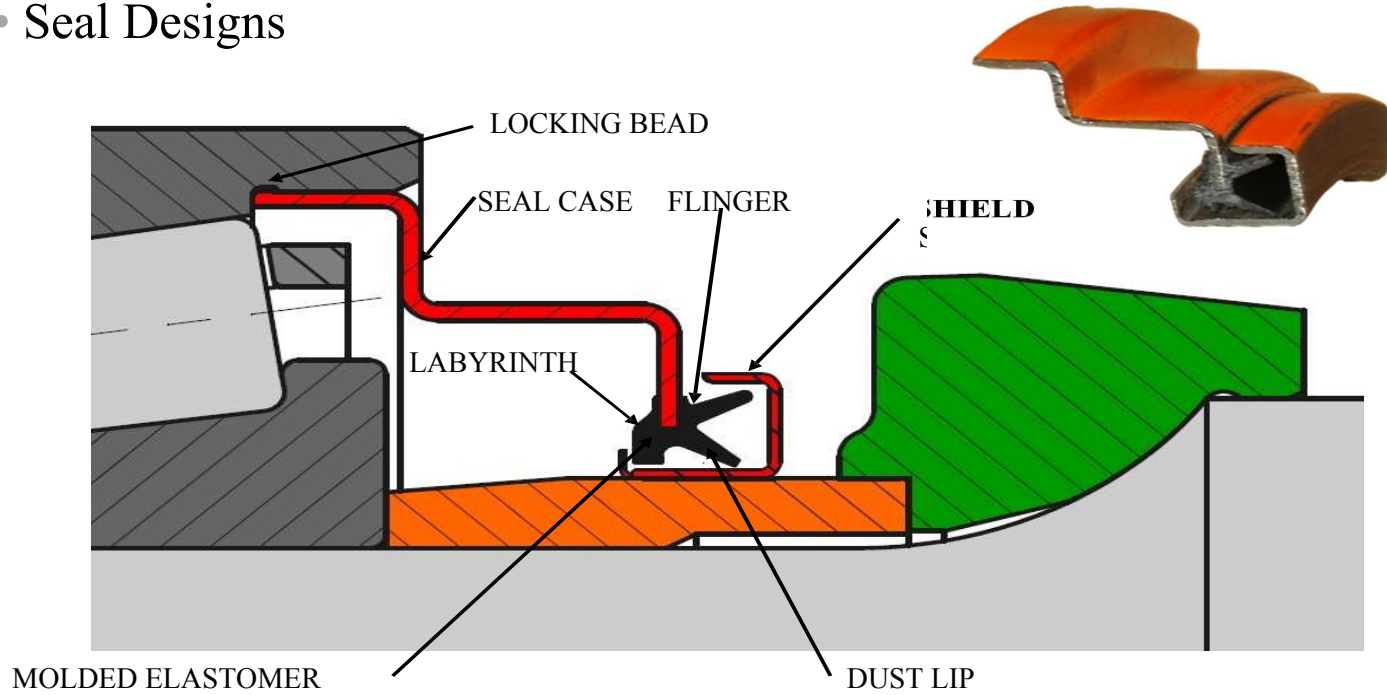
HDL Seal – Rubbing Lip – Two Piece Design

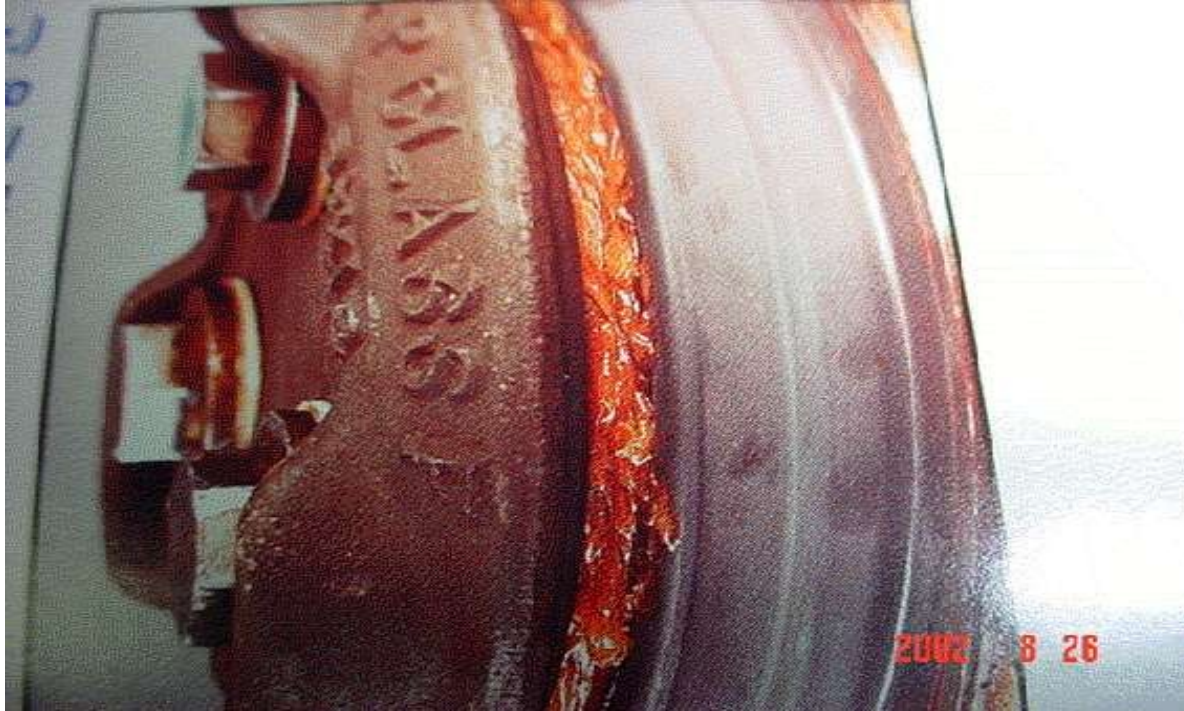
How Much Does 10 gms of grease look like.?

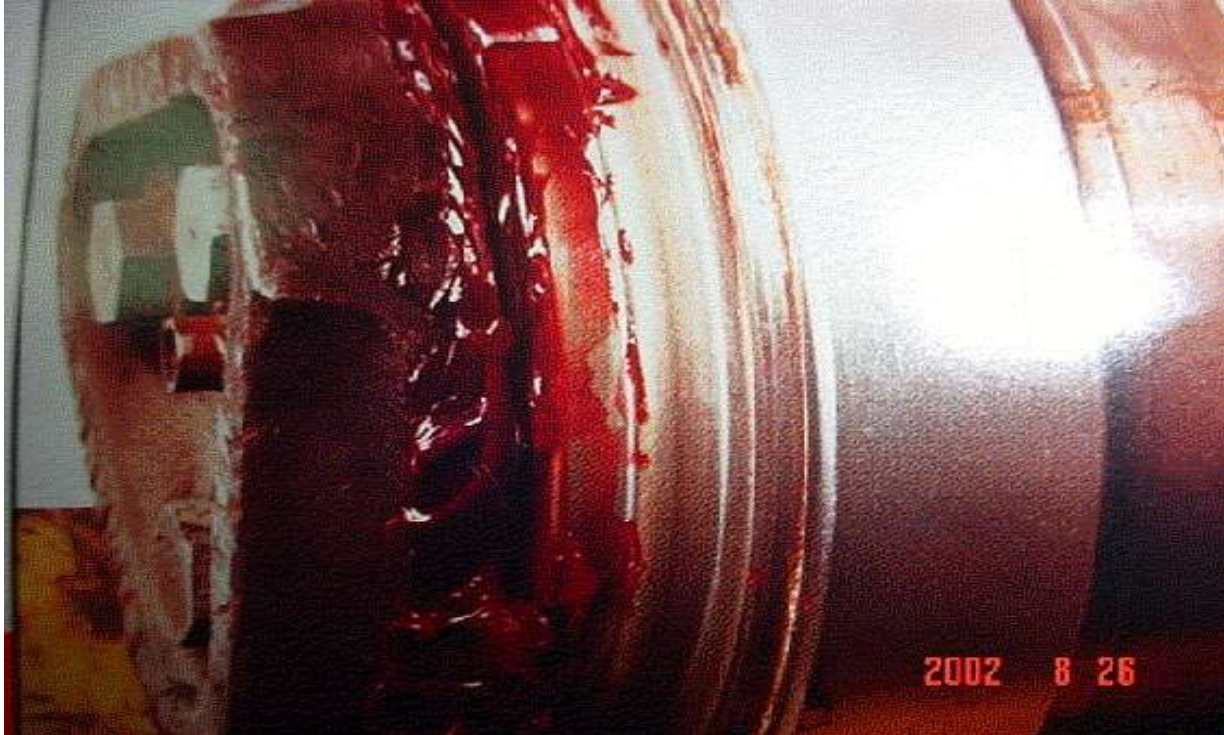
How much 60 gms of grease look like ?

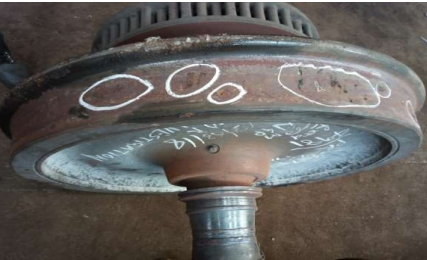
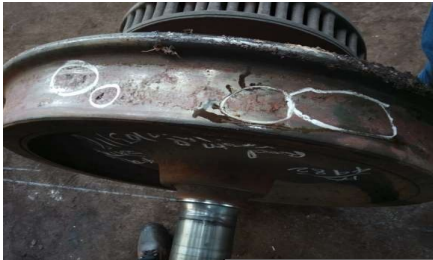
Affected side wheel

Non Affected side wheel

- Shelling found at many places on the affected and non-affected side wheel. Size measured as (affected side) length 45 mm x width 30 mm x depth 1.5 20x 20x2, 45x15x2.5, 70x25x2.5, 17x12x2. Non affected side 8x13x3, 25x25x3.5

Wheel shelling - found on the wheel which caused excessive vibration and severe impact on the bearing while the train was in running. The excessive vibration due to wheel shelling will affect for the grease oozing from the bearing and regular temperature rise which cause of a premature bearing damage,

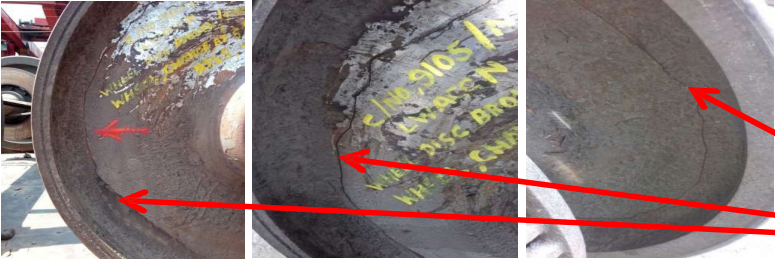
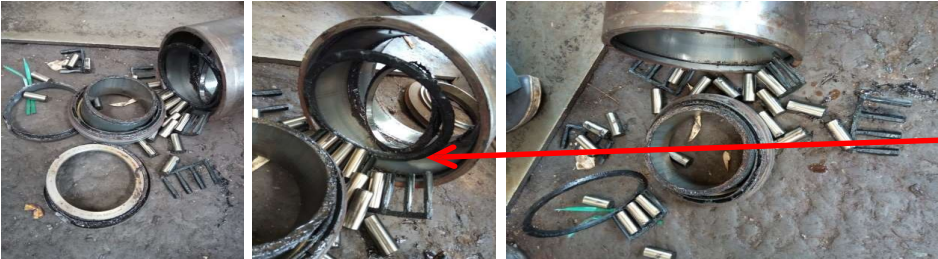
Wheel disc Crack

Wheel Disc Crack - found on the wheel which caused excessive vibration and severe impact on the bearing while the train was in running. The excessive vibration due to wheel will create chances of cage breakage which is generally associated with extreme torsional vibration arising from rail – wheel interactions.

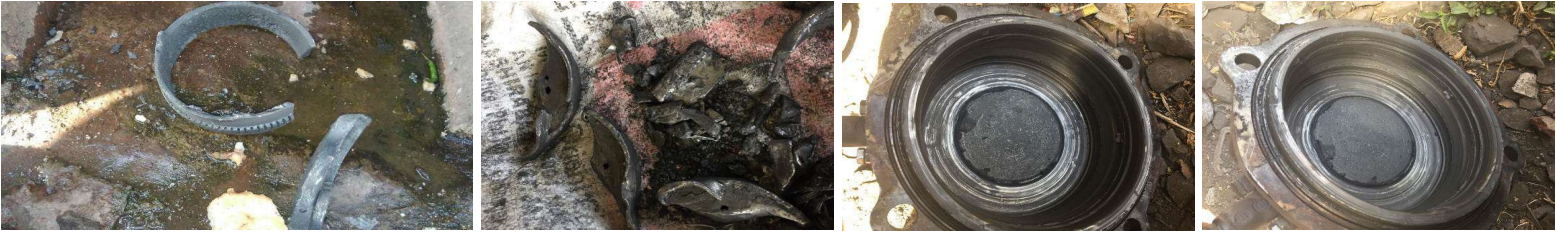
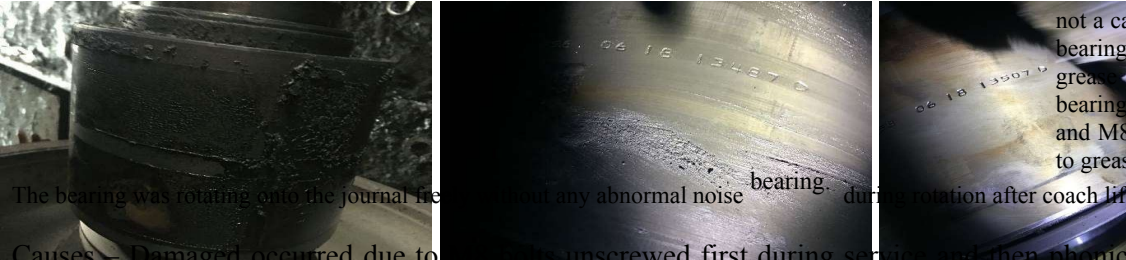
phonic wheel found damage and broken into pieces and the tooth of phonic wheel was worn out, Rubbing marks & grooving found inside the axle end cover.

The bearing was rotating onto the journal bearing without any abnormal noise during rotation after coach lifting.

not a case of bearing hot axle, the rise in temperature of bearing was occurred due to the bearing outboard side grease seal damage and the outboard grease seal of bearing damaged due to rubbing of the phonic wheel and M8 bolts causing temperature rise and further lead to grease oozing out from

Causes — Damaged occurred due to M8 bolts unscrewed first during service and then phonic wheel free from its position & rubbed inside the housing with bearing and other components consequentially which result temperature rise of the axle box.
