# **BOGIE GENERAL ARRANGEMENT**

# **FIAT BOGIE**

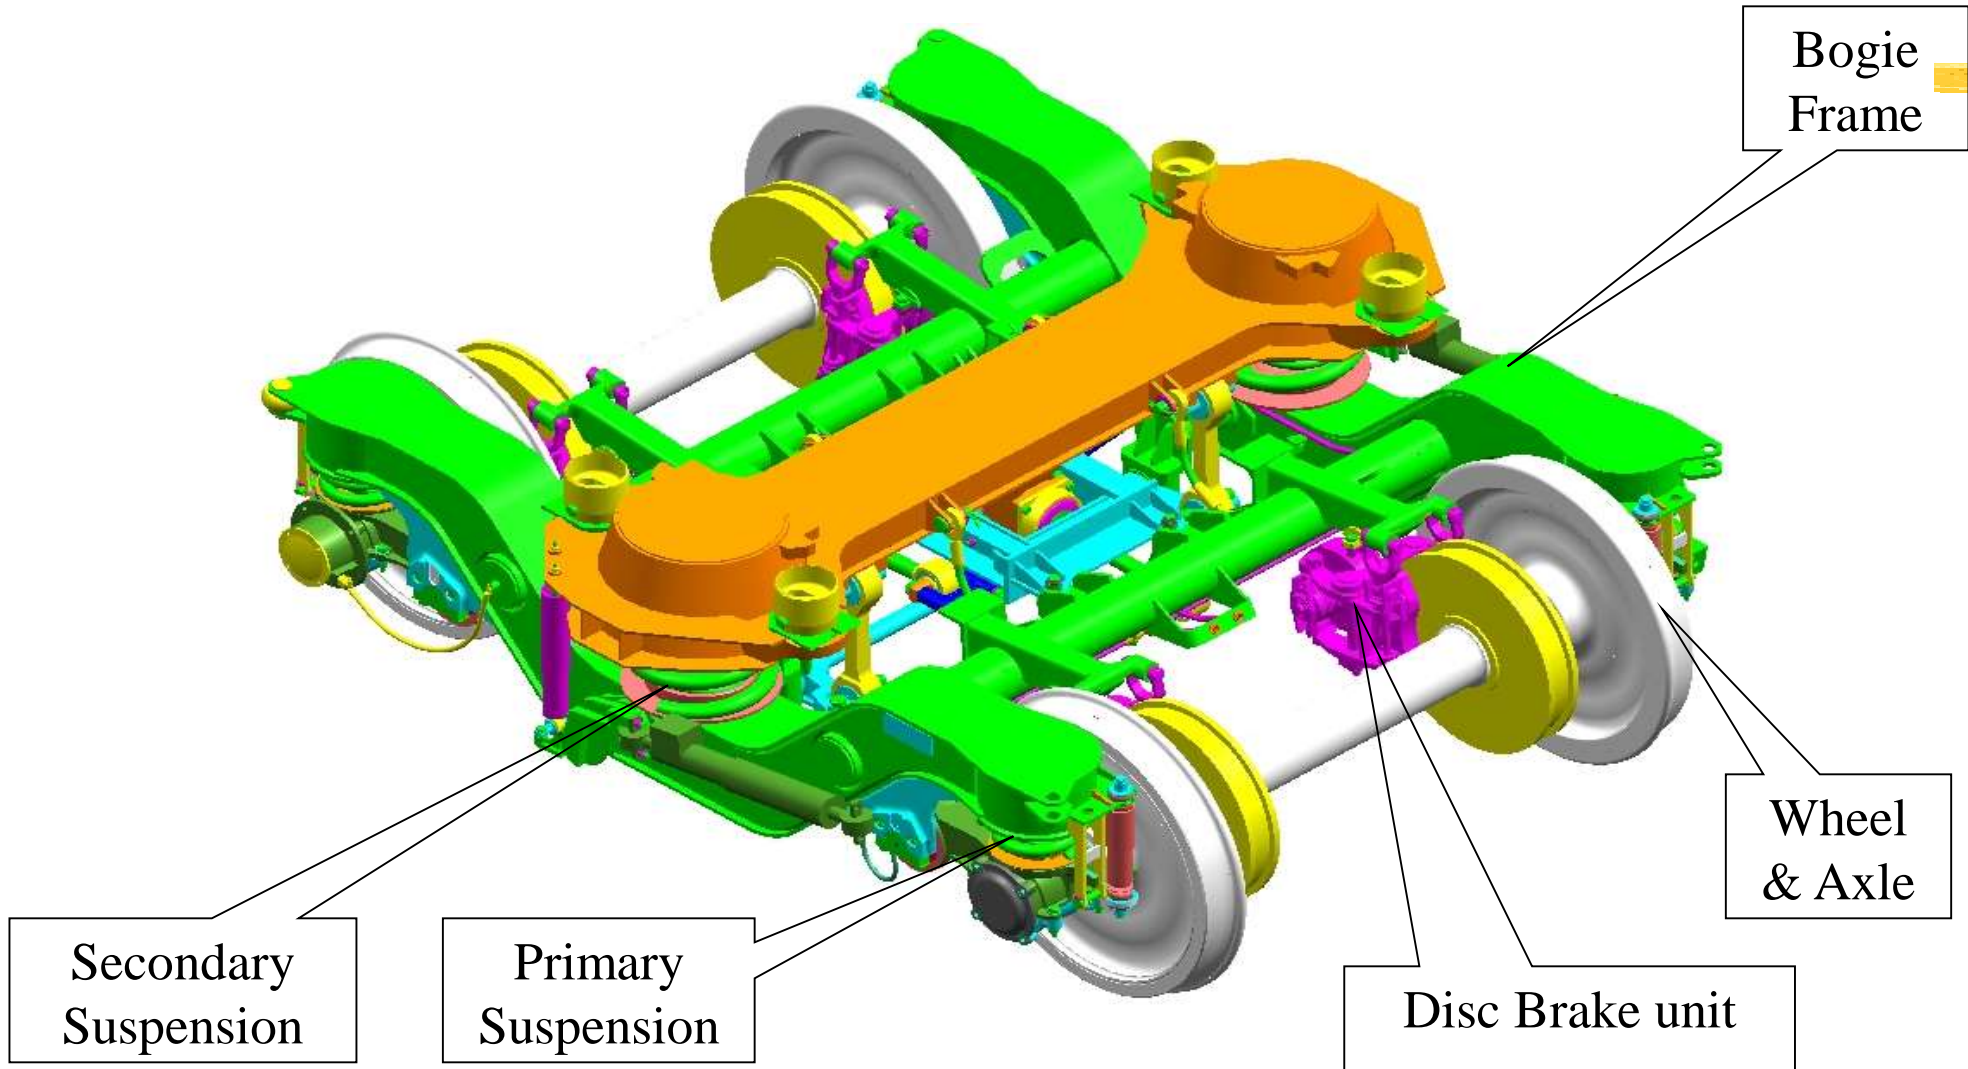
(Complete Assembly)

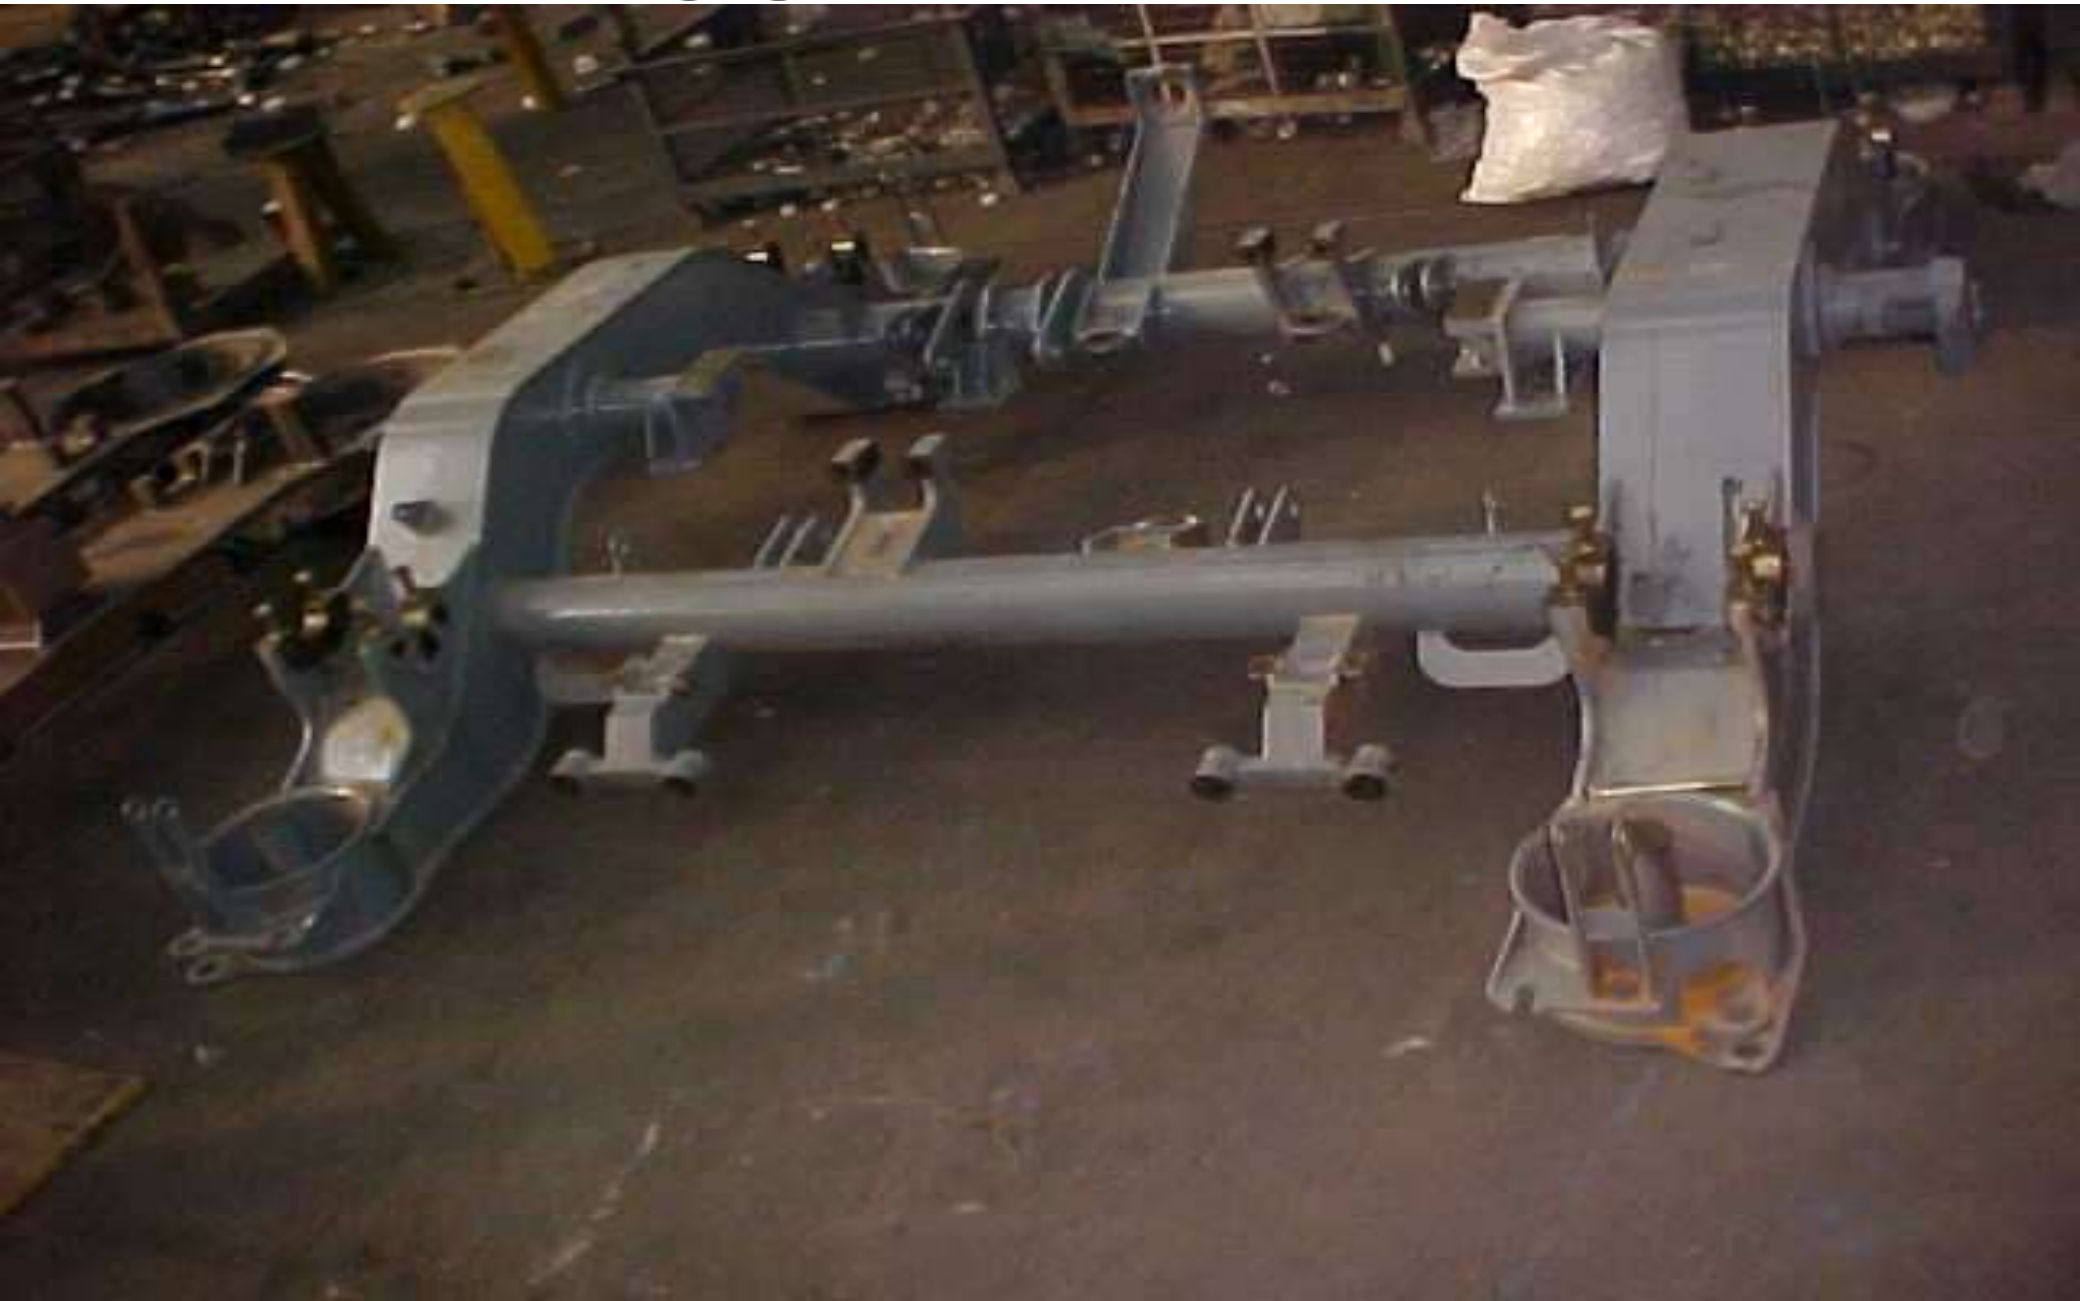
# **BOGIE FRAME**

- Solid welded frame -steel sheets(st-52) and forged, steel cast parts to material gs20mn5v;din 17182 (weldable).
- Two side frames connected by two cross beams - support brake units.  
various brackets on frame.
- The bogie frame rests on the primary suspension spring units and supports the vehicle body by means of a bolster beam. the bolster beam is connected to the bogie frame by secondary suspension.

1.-SIDE FRAME

2.-CROSS BEAM

(Ø140X Ø168X2506  
SEAMLESS PIPE)

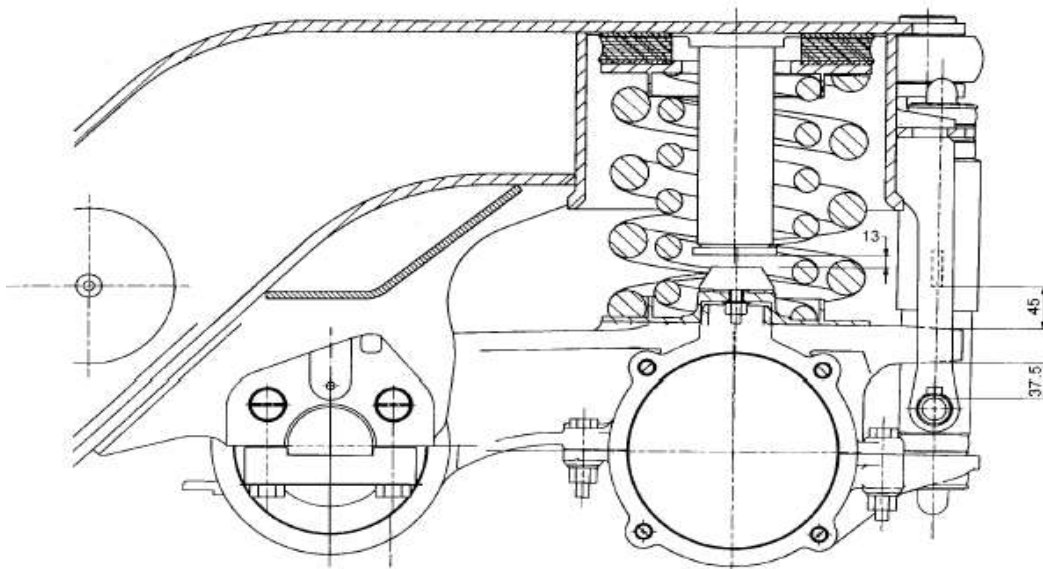
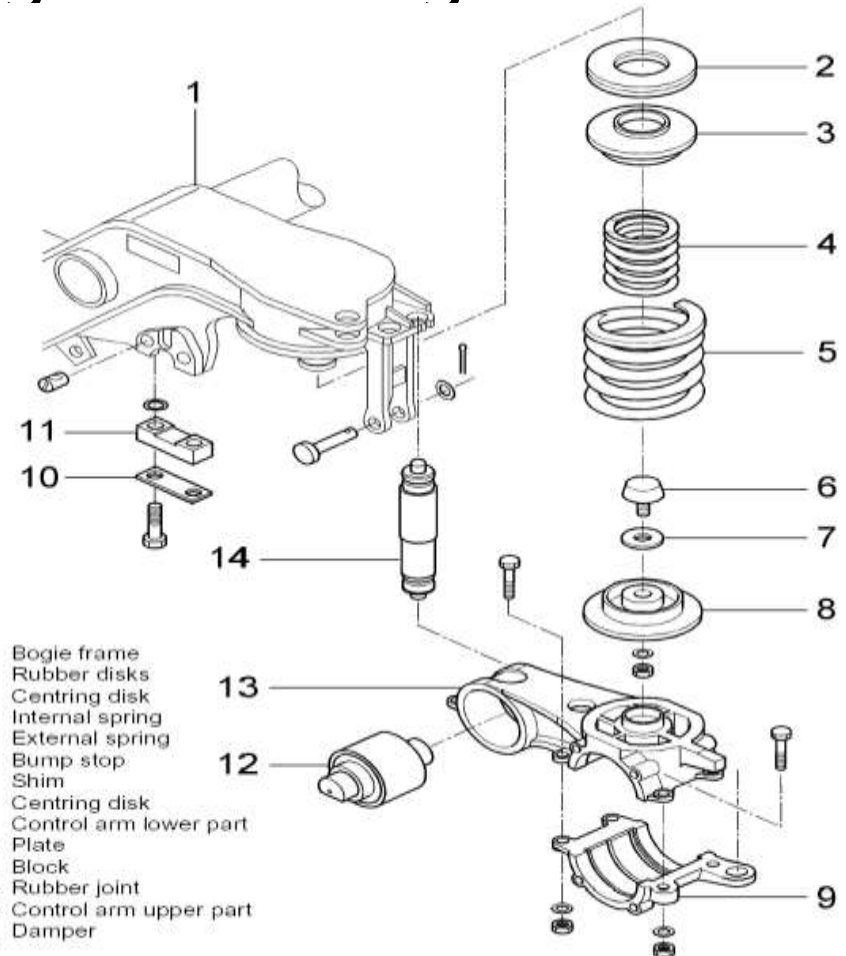
FIG. 1-8 PRIMARY SUSPENSION

- ⌘ Two coil springs, one vertical damper, articulated control arm, elastic joints connecting the axle bearing to the bogie frame
- ⌘ Better curve negotiation.

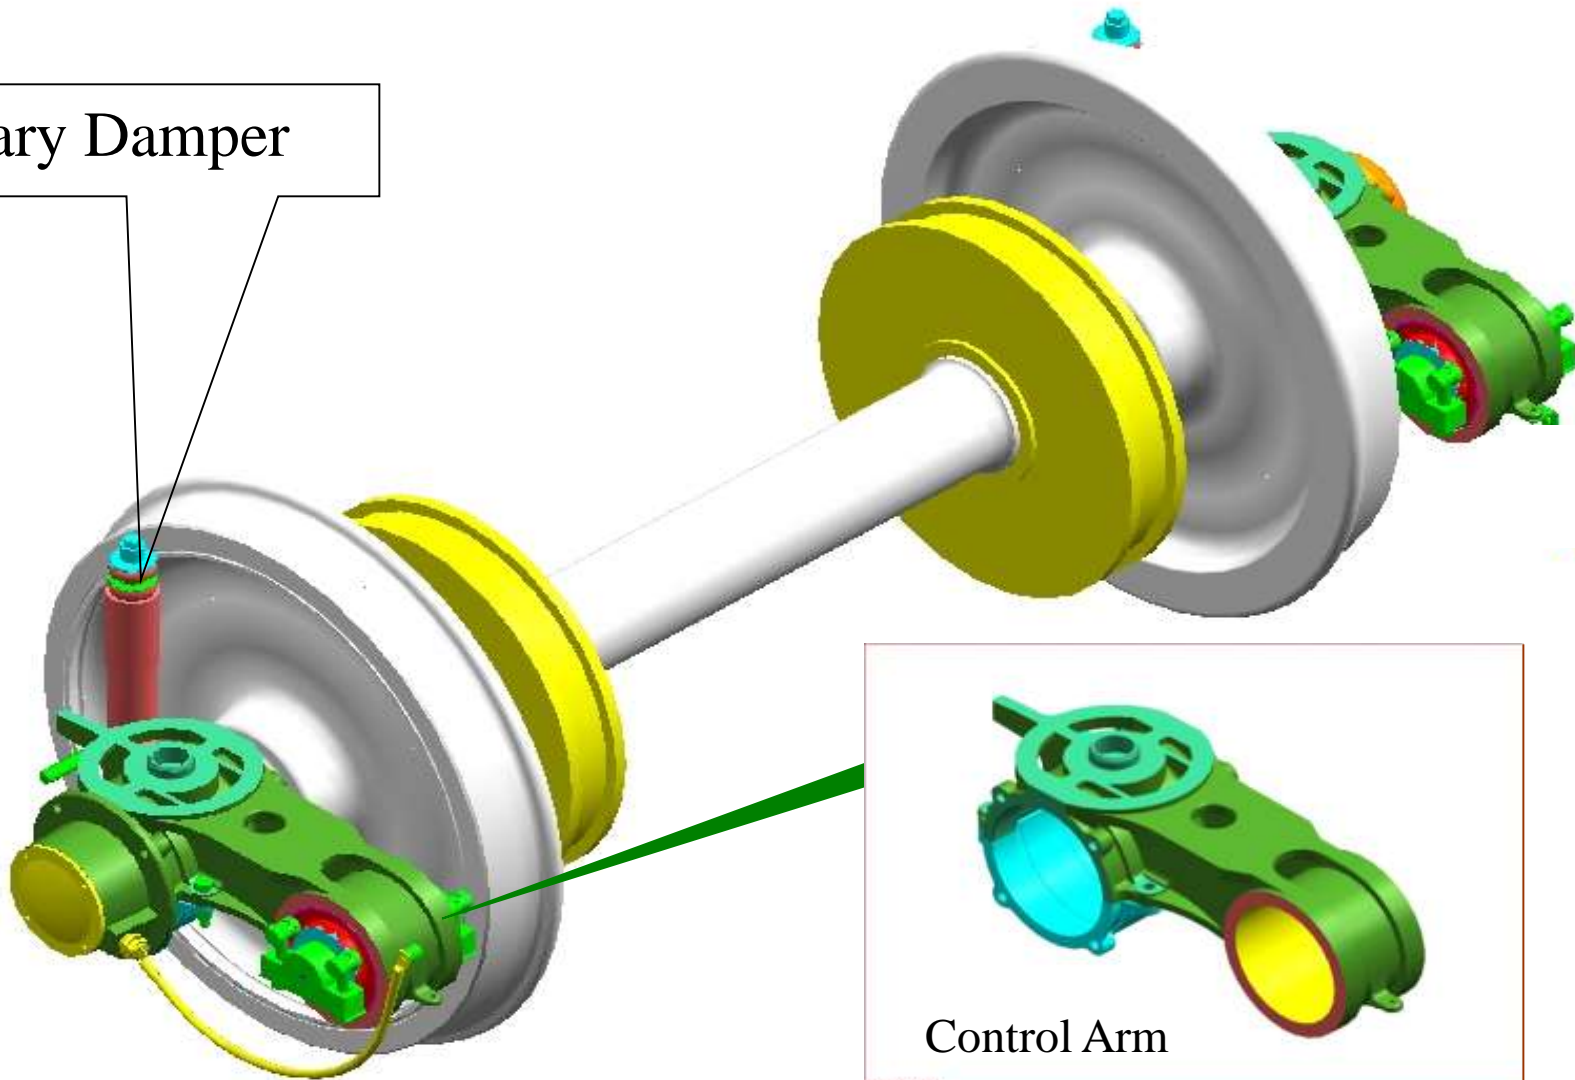
(Wheel set with Primary springs removed)

Primary Damper

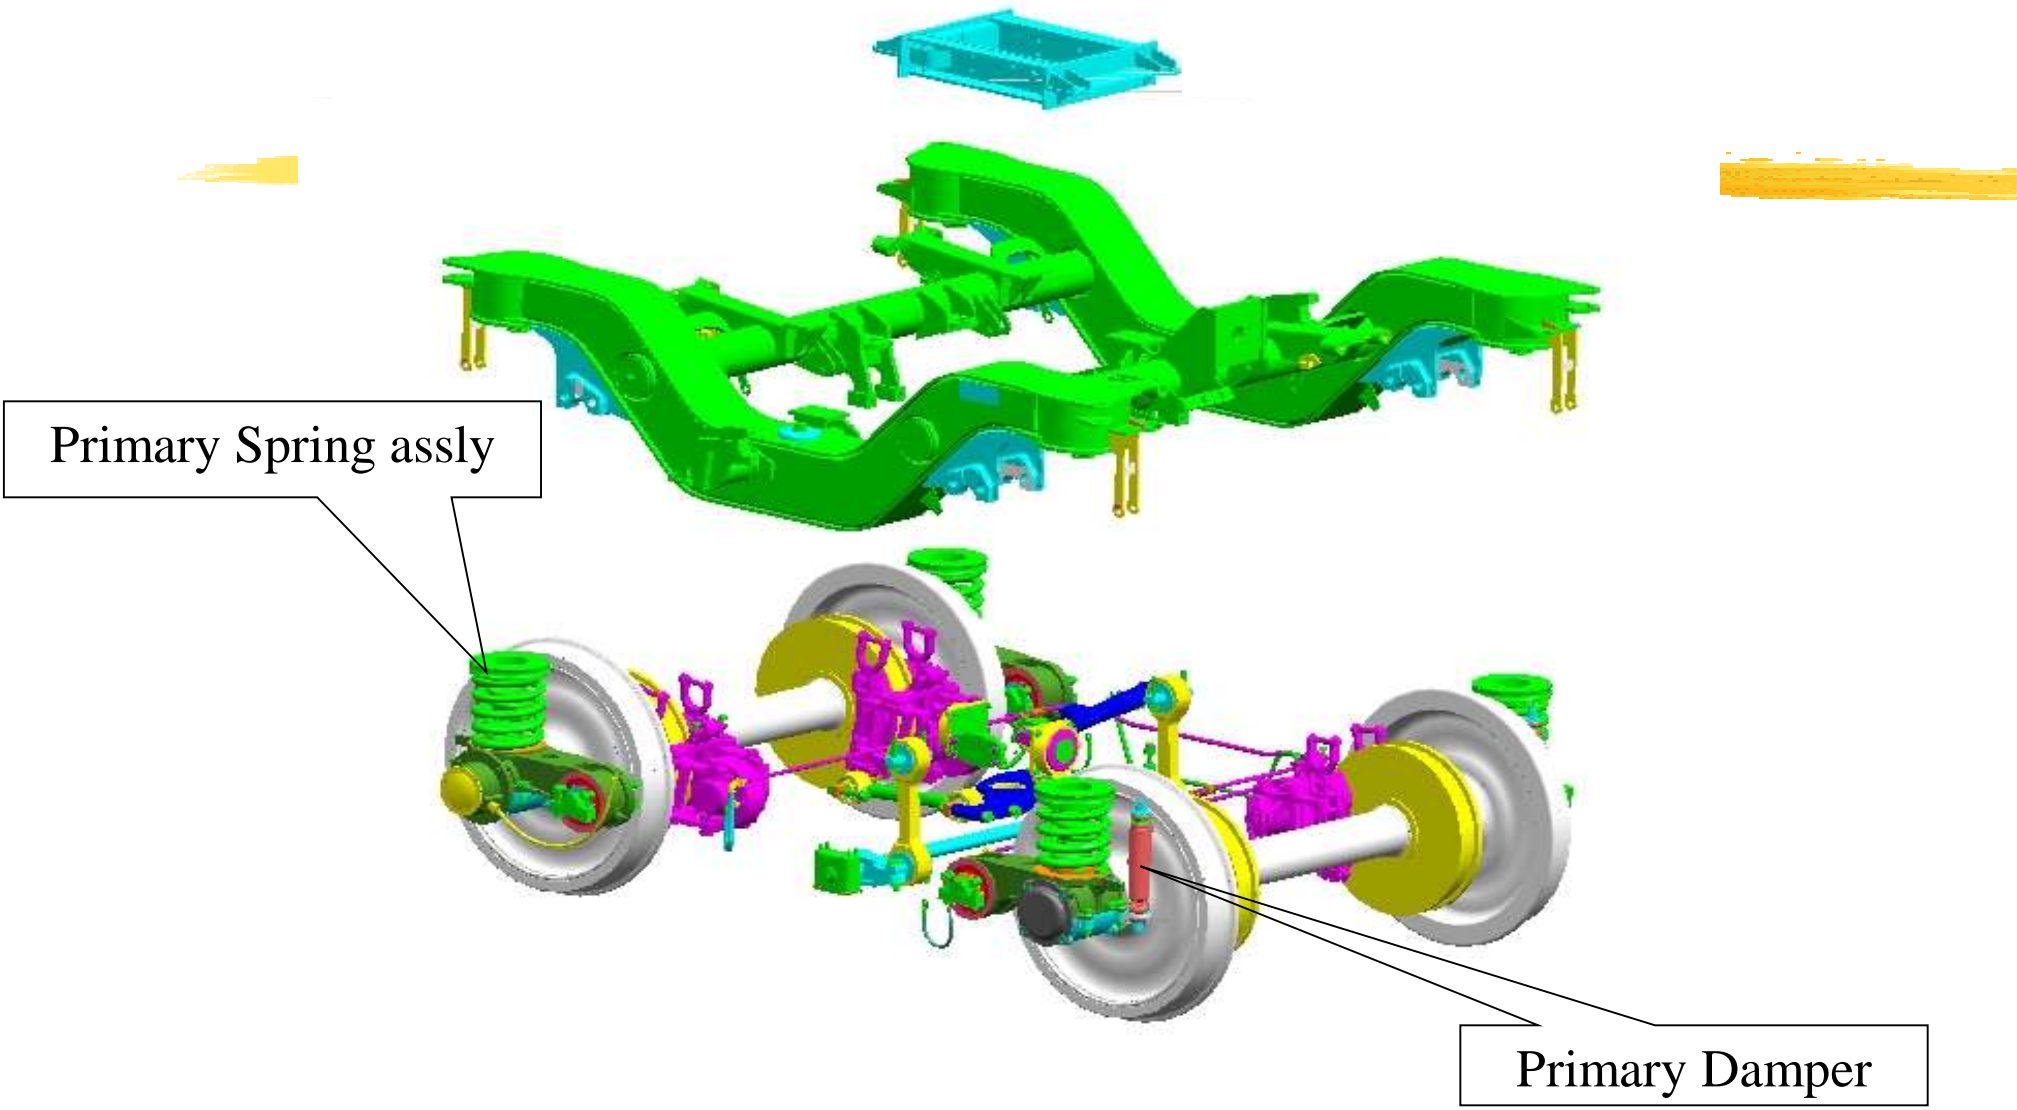
(Bogie frame lifted)

Primary Spring assly

Primary Damper

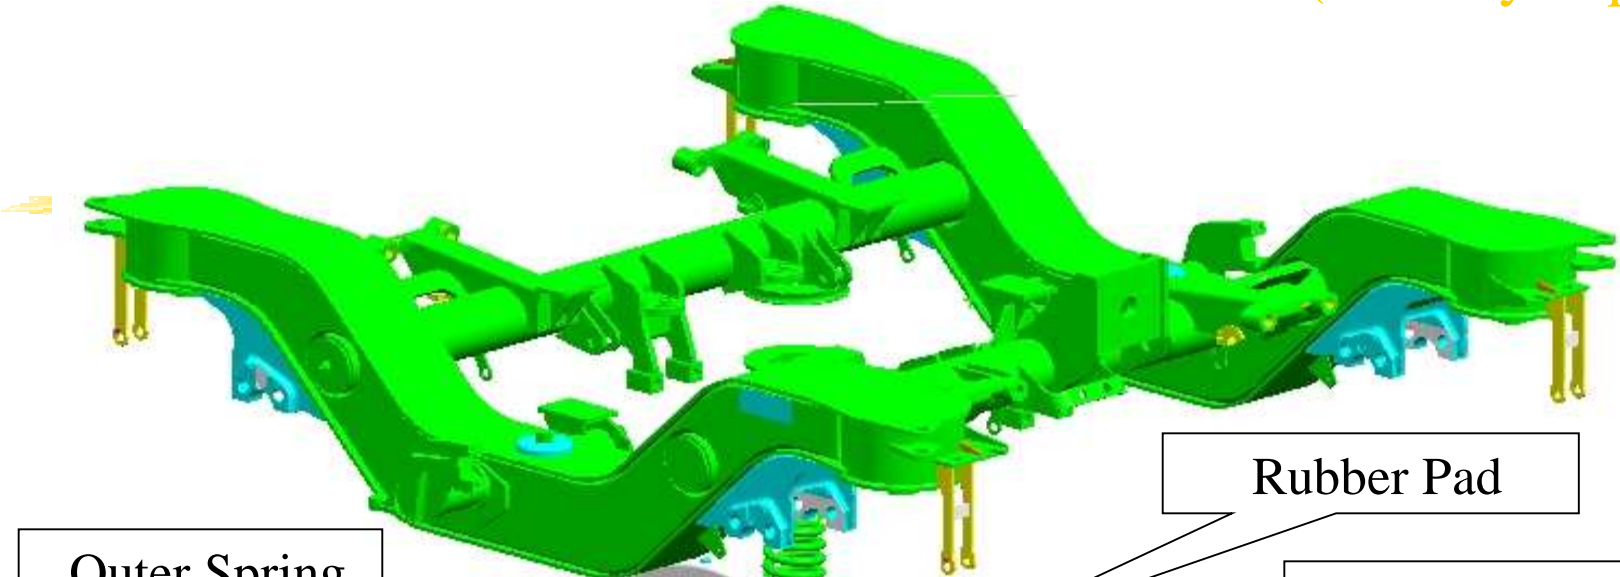
(Primary exploded)

Rubber Pad

Outer Spring

Spring Guide

Inner Spring

Lower Spring Guide

Bump Stop

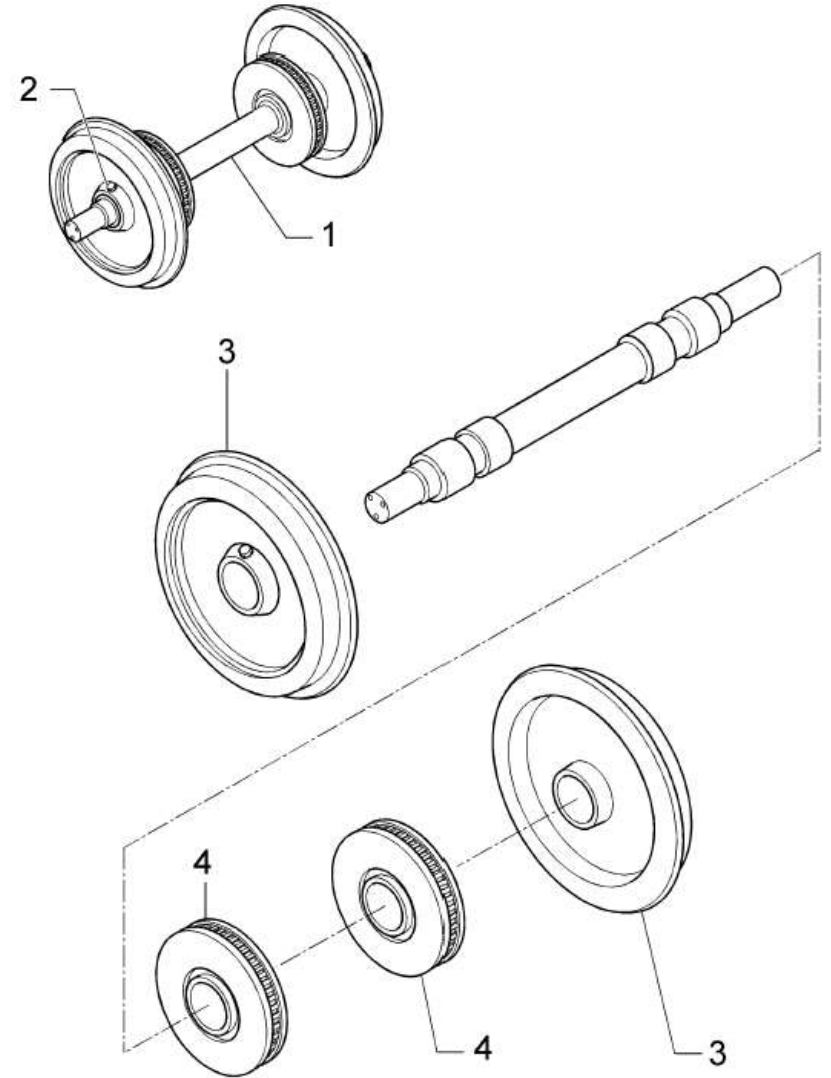
- ⌘ Two brake disks (4), diameter 640 mm and width 110 mm.
- ⌘ Two wheel disc of tread dia 915mm (New), 855mm (worn).

1. Axle
2. Plug
3. Wheel
4. Brake disk

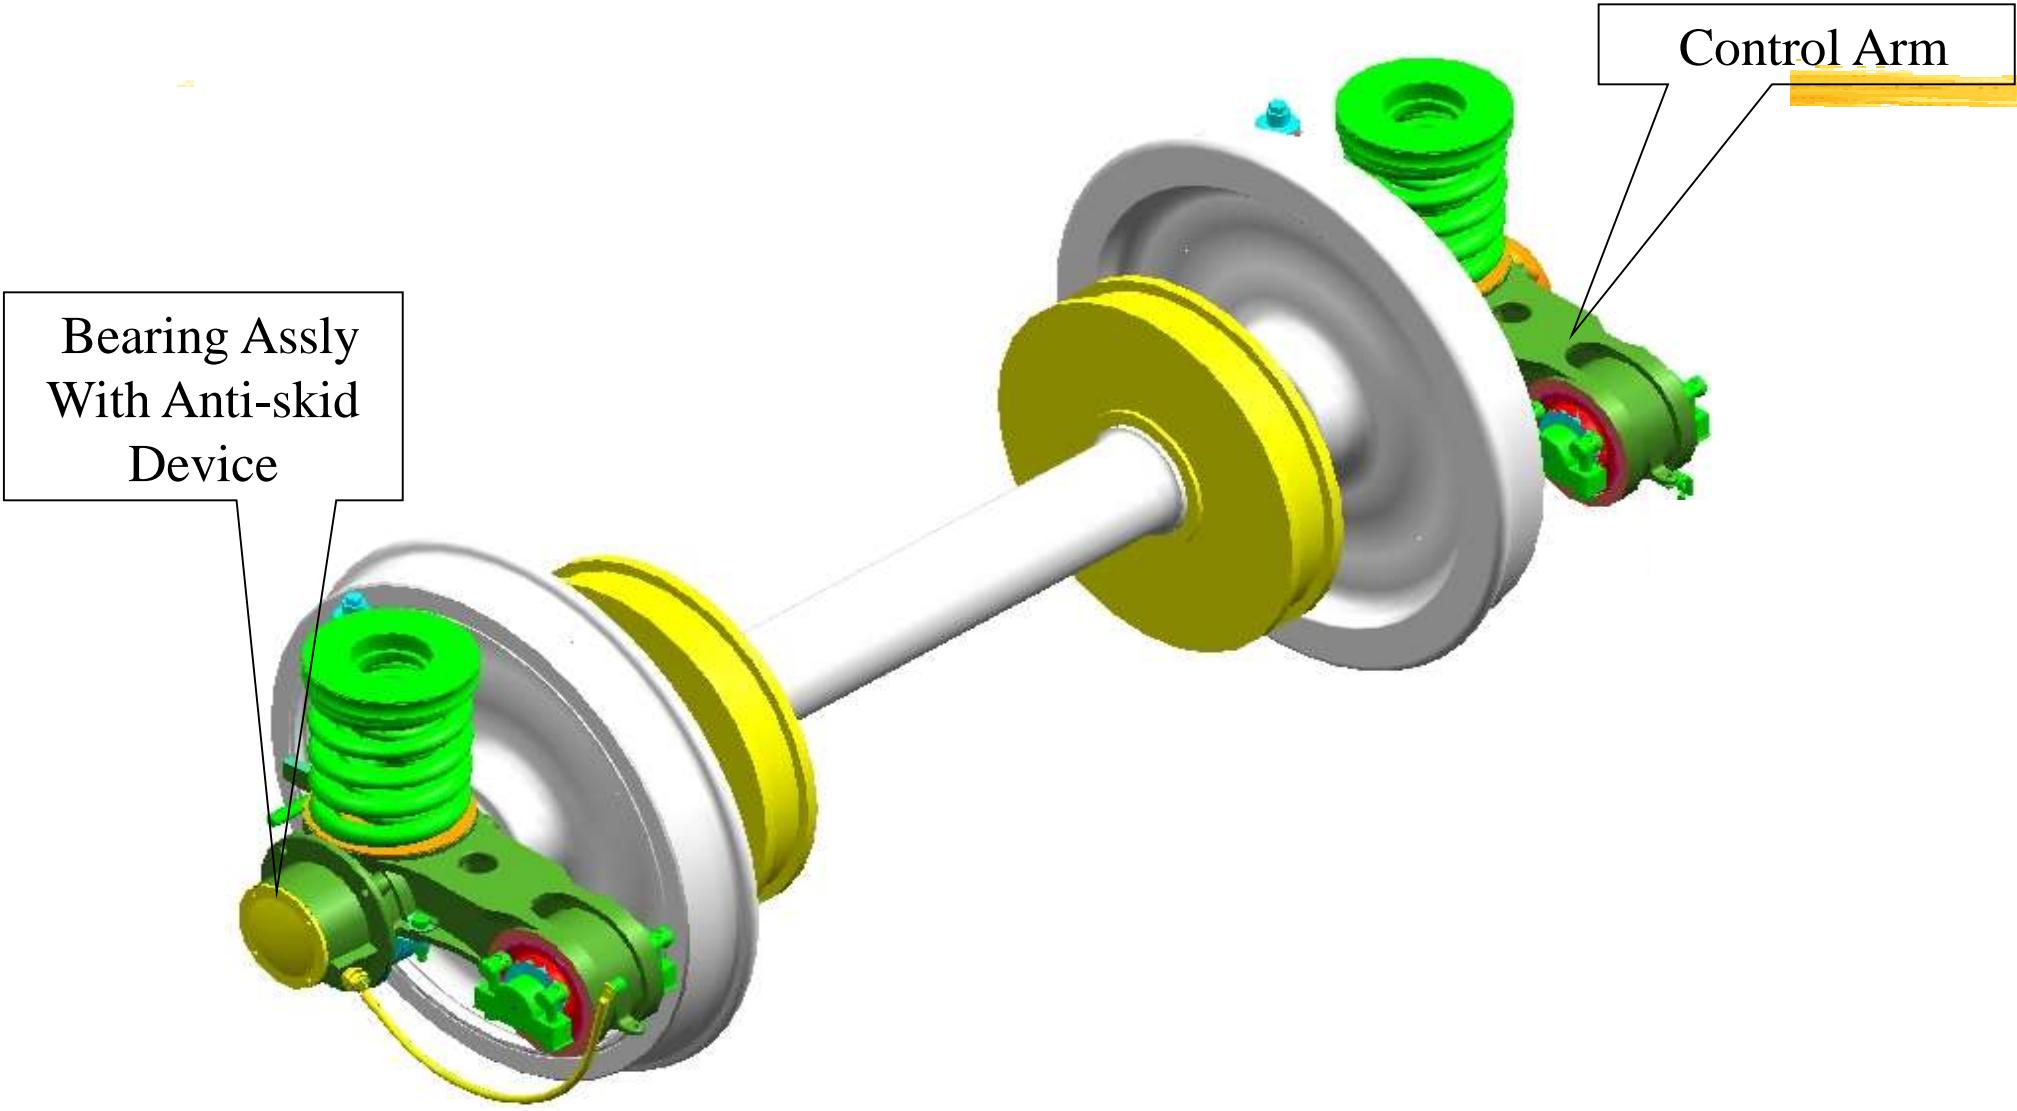
(Wheel set with Primary suspension)

Bearing Assly  
With Anti-skid  
Device

Control Arm

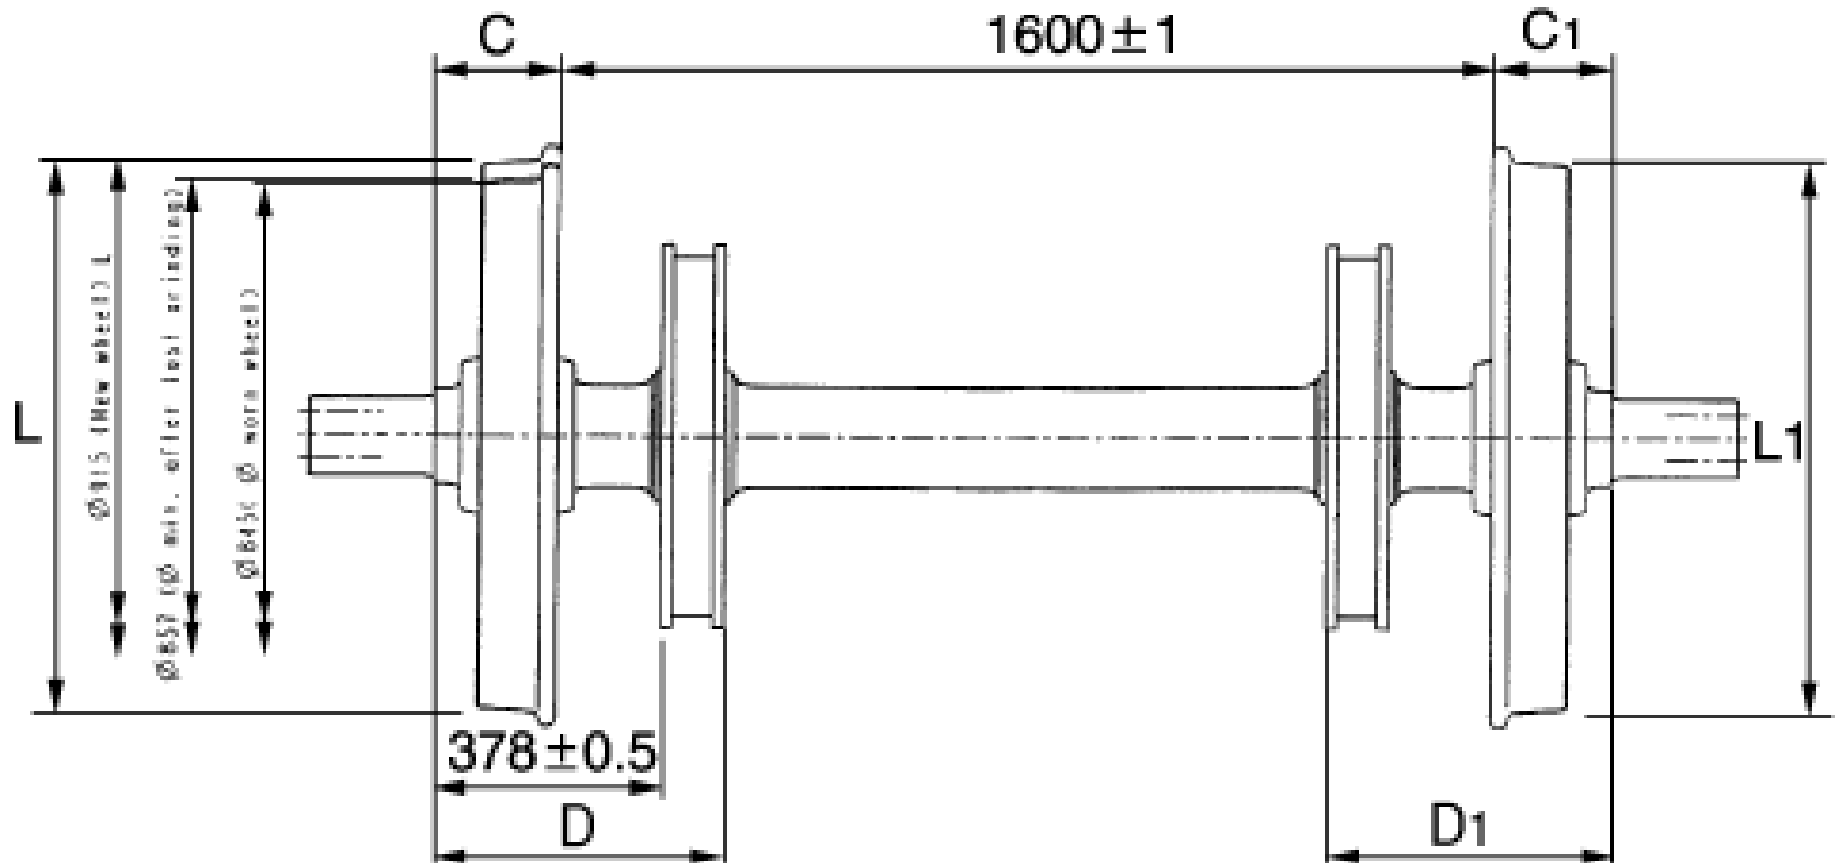
# DIMENSIONS OF WHEEL SET:

The following differences must be respected:

$$|L - L_1| \leq 0.5 \text{ mm}$$

$$|C - C_1| \leq 0.5 \text{ mm}$$

$$|D - D_1| \leq 0.5 \text{ mm}$$

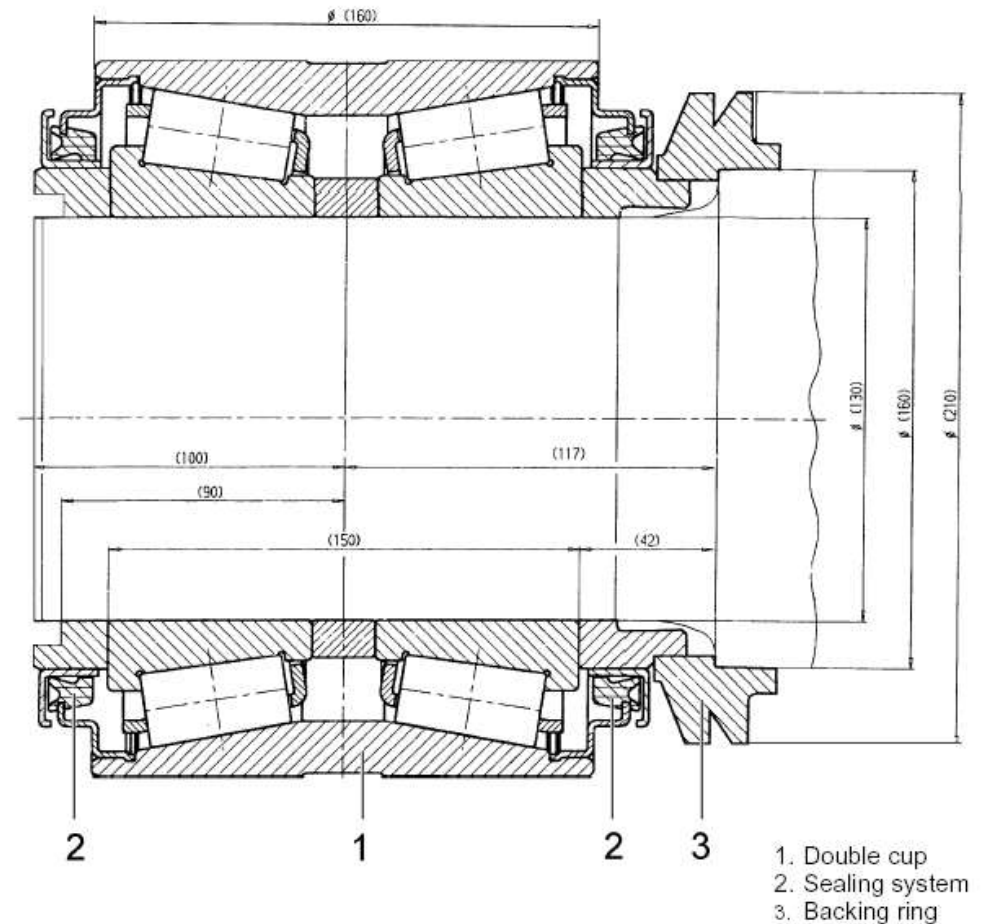
FIG. 1-4 AXLE BEARING LONGITUDINAL SECTION

- ⌘ Taper roller cartridge type bearing
- ⌘ Pre-assembled unit.
- ⌘ Maintenance free- overhaul 1.2 million km.
- ⌘ Sensors for detecting speed

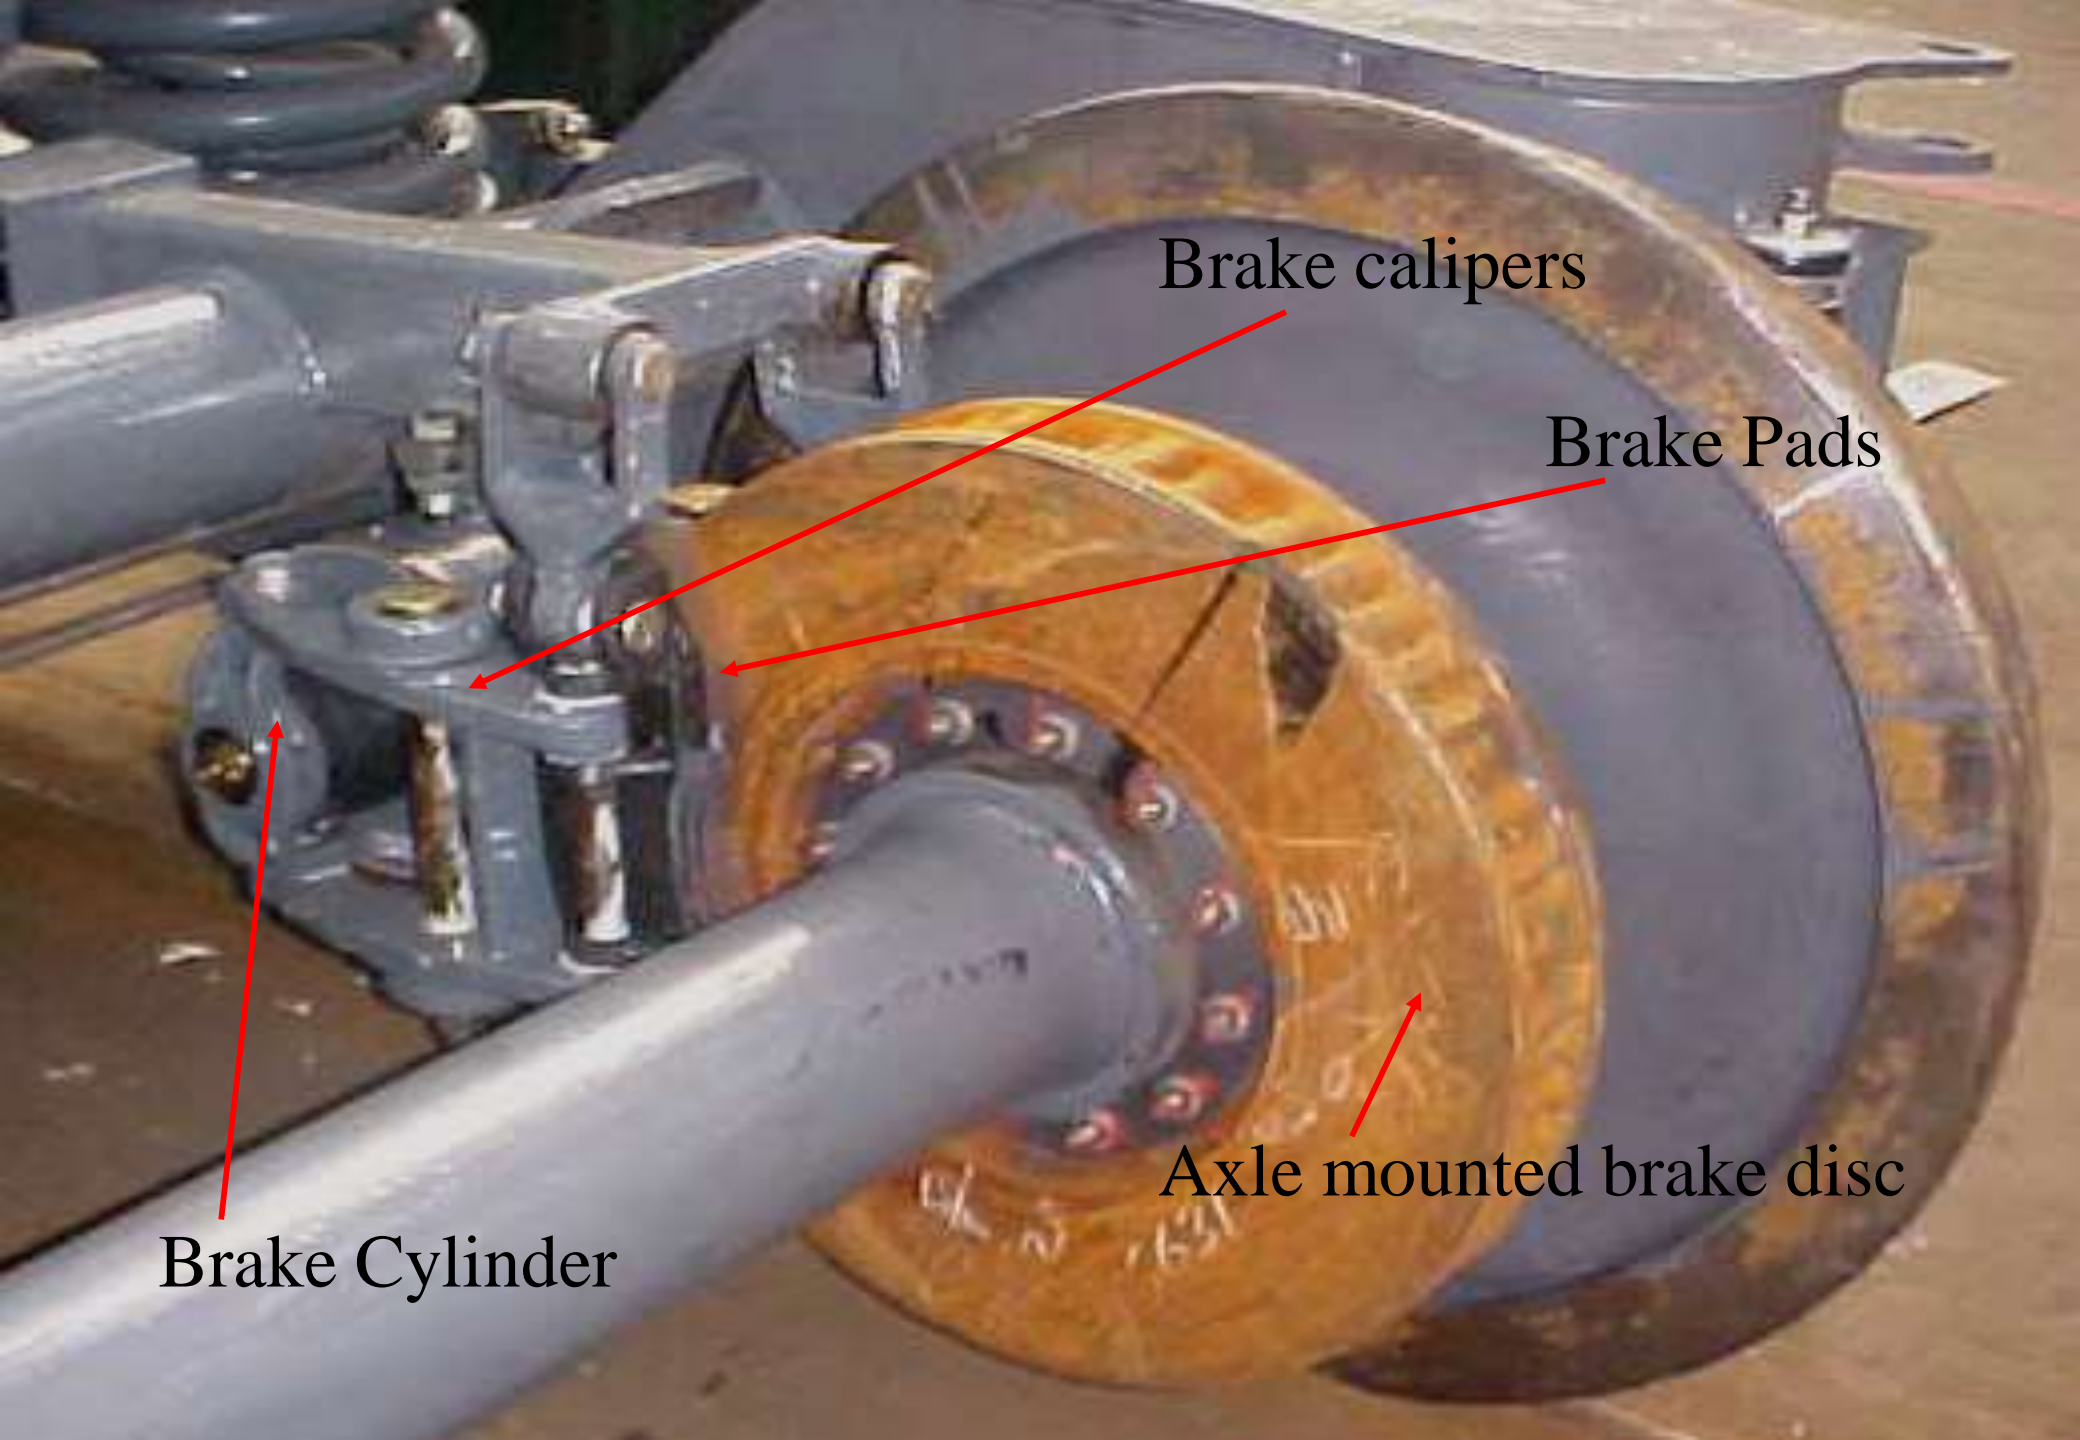
# BRAKE CALLIPER UNIT

- ⌘ Axle mounted disc brake
- ⌘ Two discs per axle of dia. 640 mm
- ⌘ Inbuilt slack adjuster in brake cylinders
- ⌘ Caliper ratio 1:2.17 for all coaches except ACCN/SG & power car which is 1:2.48
- ⌘ 35mm brake pads

Brake calipers

Brake Pads

Axle mounted brake disc

Brake Cylinder

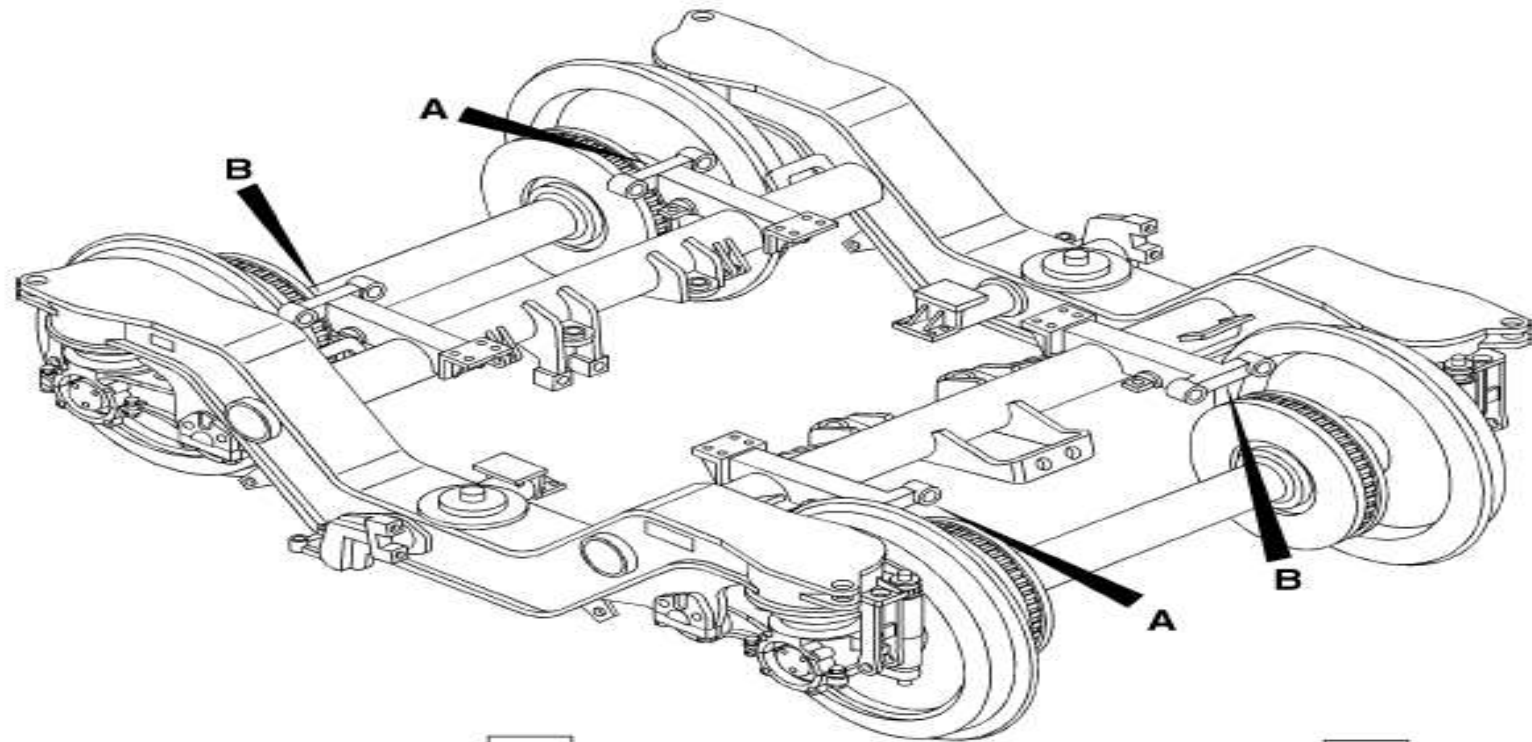
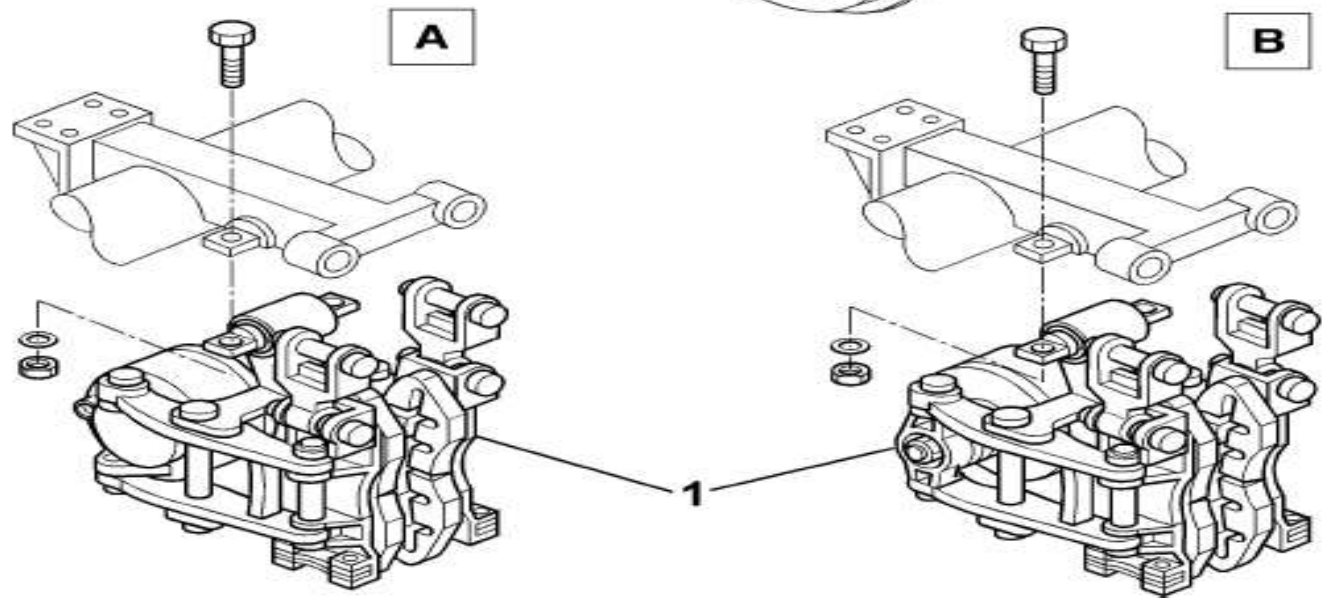
FIG. 1-14 BRAKING SYSTEM FOR BOGIES 1267400 AND 1267700

1. Brake unit
