# **BOGIE GENERAL ARRANGEMENT**

# **FIAT BOGIE**

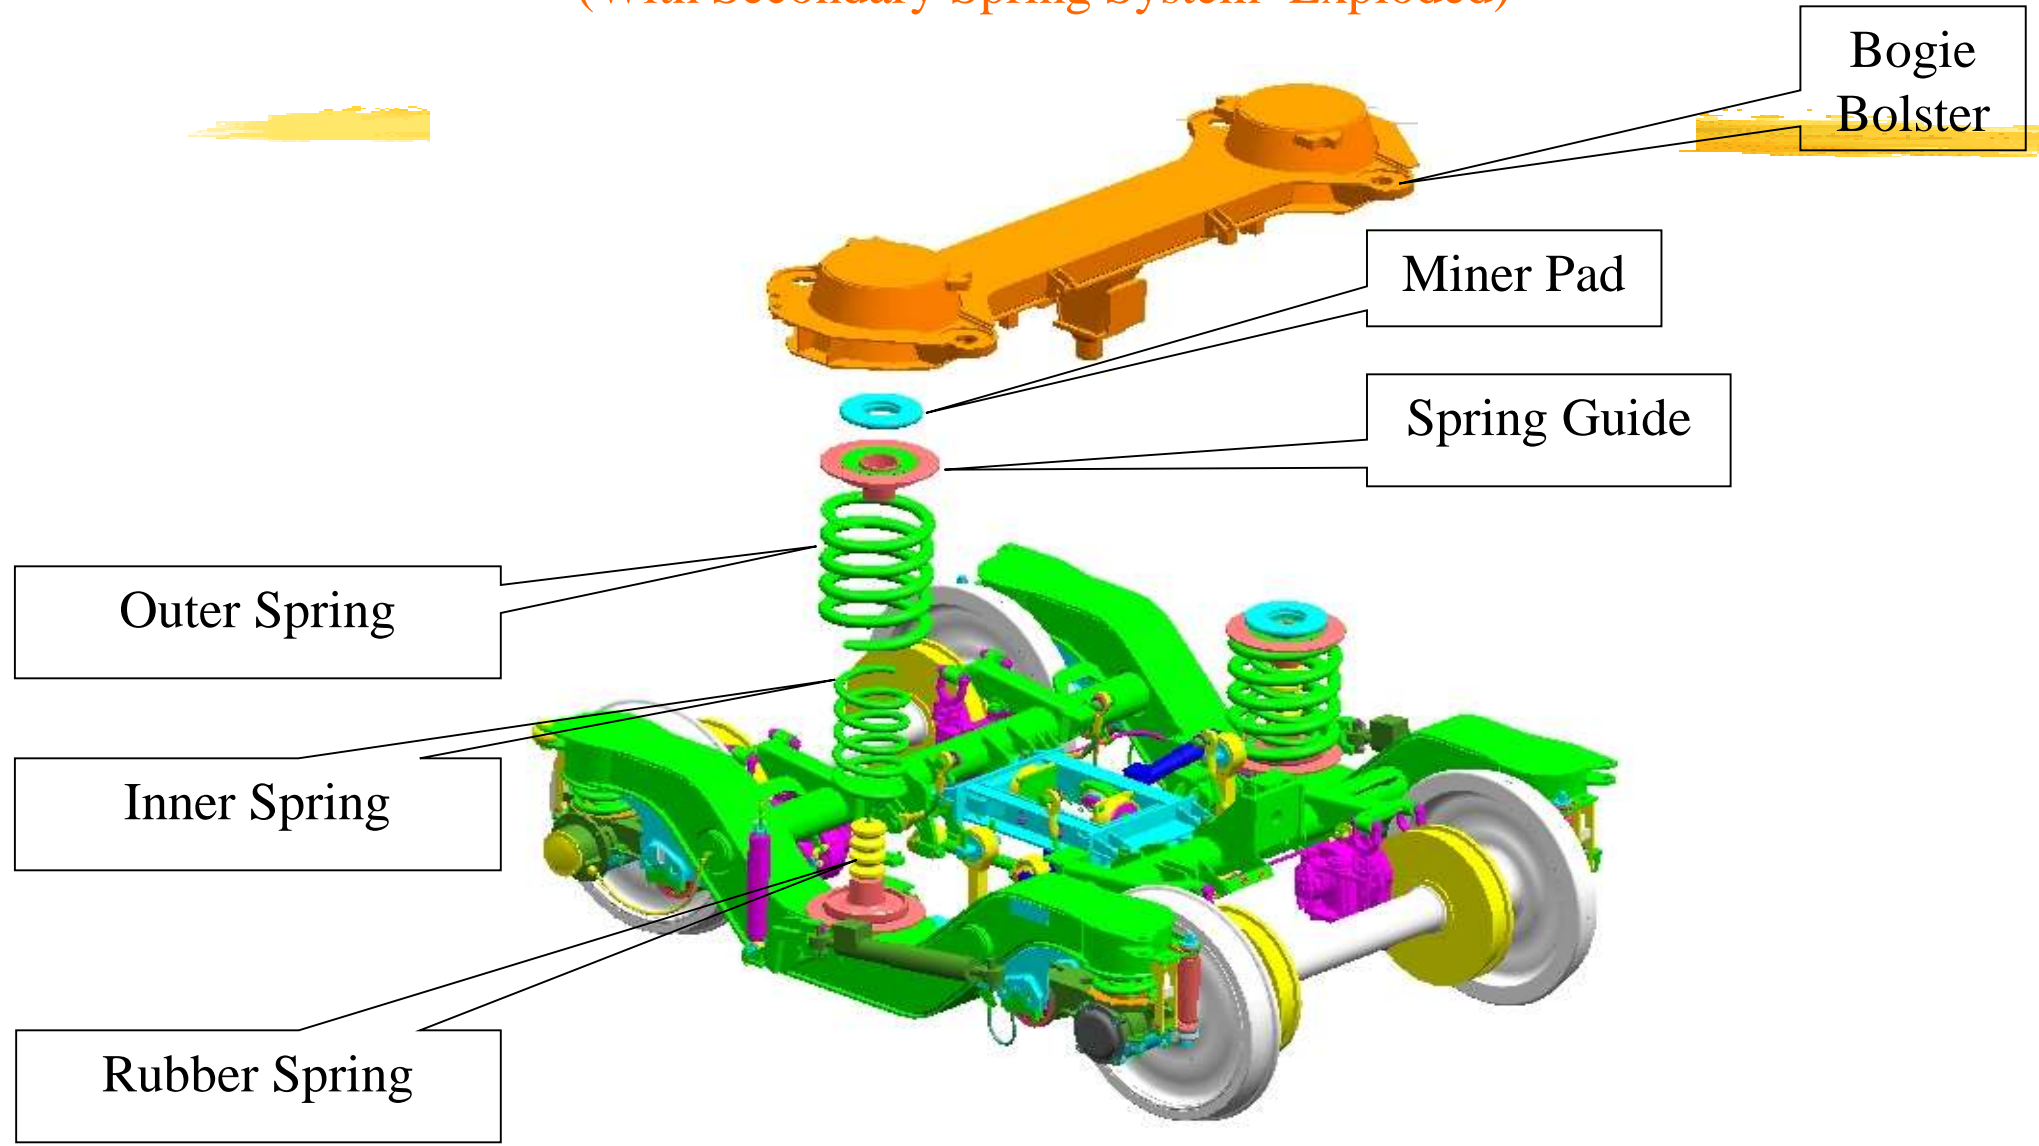
- ⌘ Nest of flexi-coil springs inner and outer, rubber spring and secondary pad
- ⌘ Vertical dampers
- ⌘ Lateral dampers
- ⌘ Yaw dampers
- ⌘ Anti-roll bar
- ⌘ Anchor links

(With Secondary Spring System Exploded)

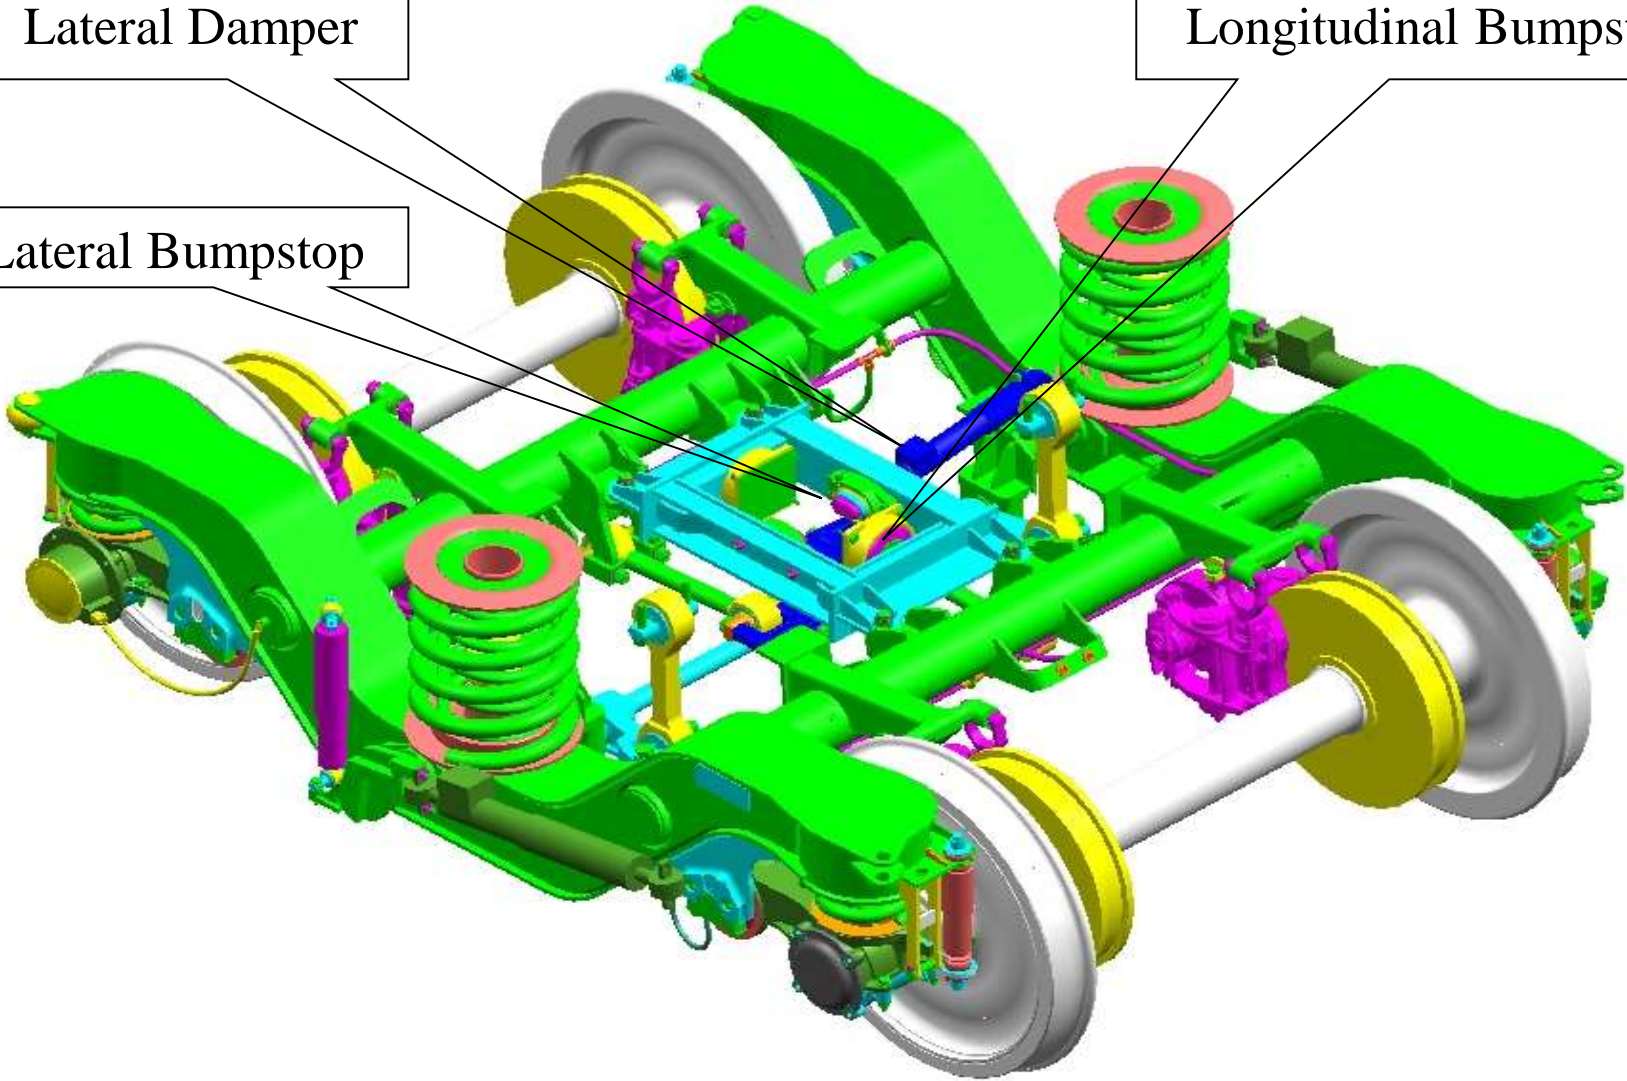
(Bolster removed)

Lateral Damper

Longitudinal Bumpstop

Lateral Bumpstop

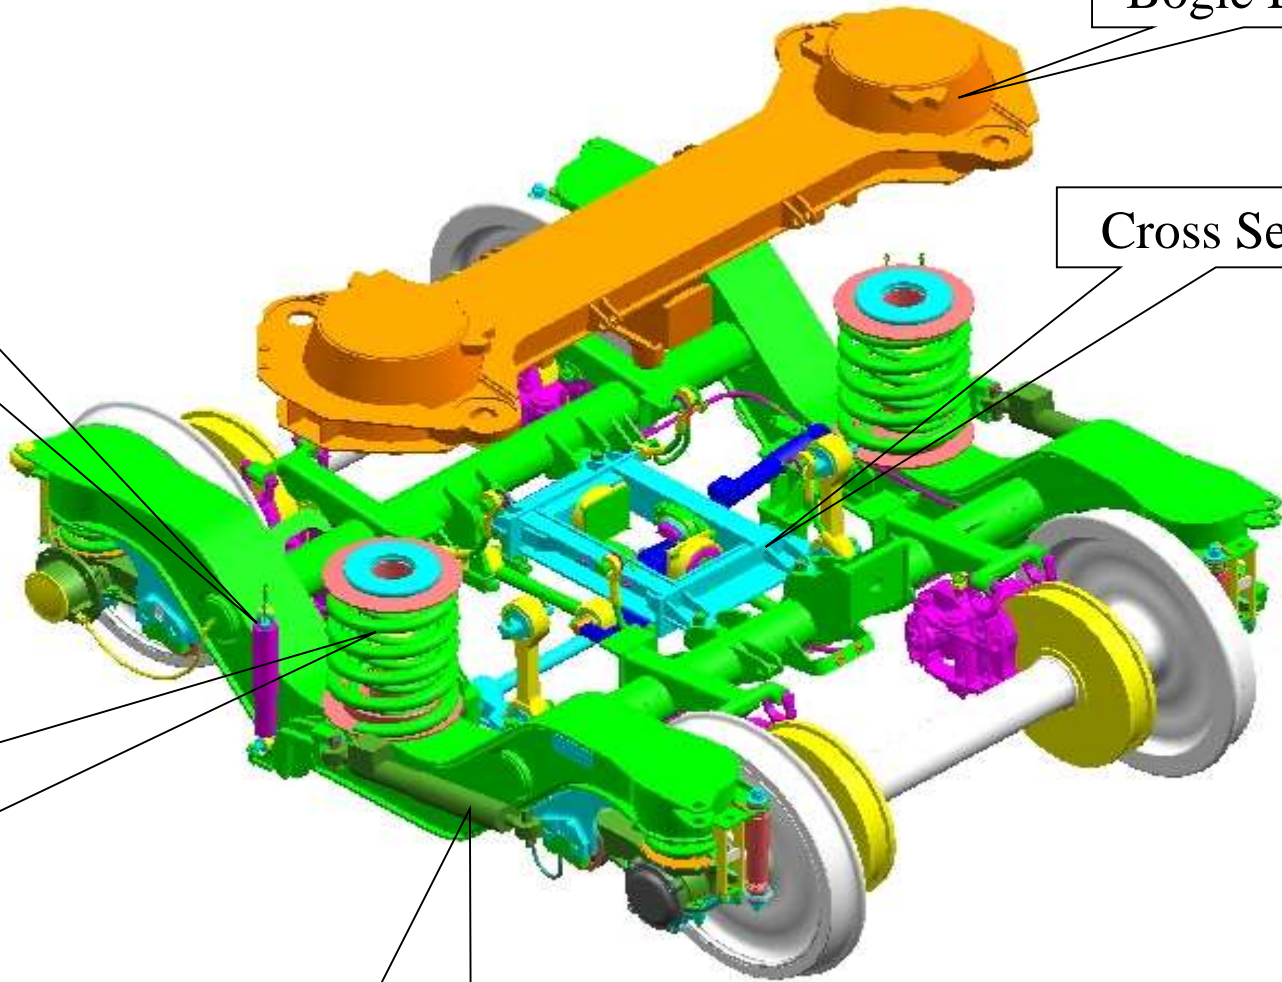
(With Bolster Lifted)

Bogie Bolster

Sec. Vertical  
Damper

Cross Section

Nested  
Secondary  
Spring  
Assembly

Yaw Damper

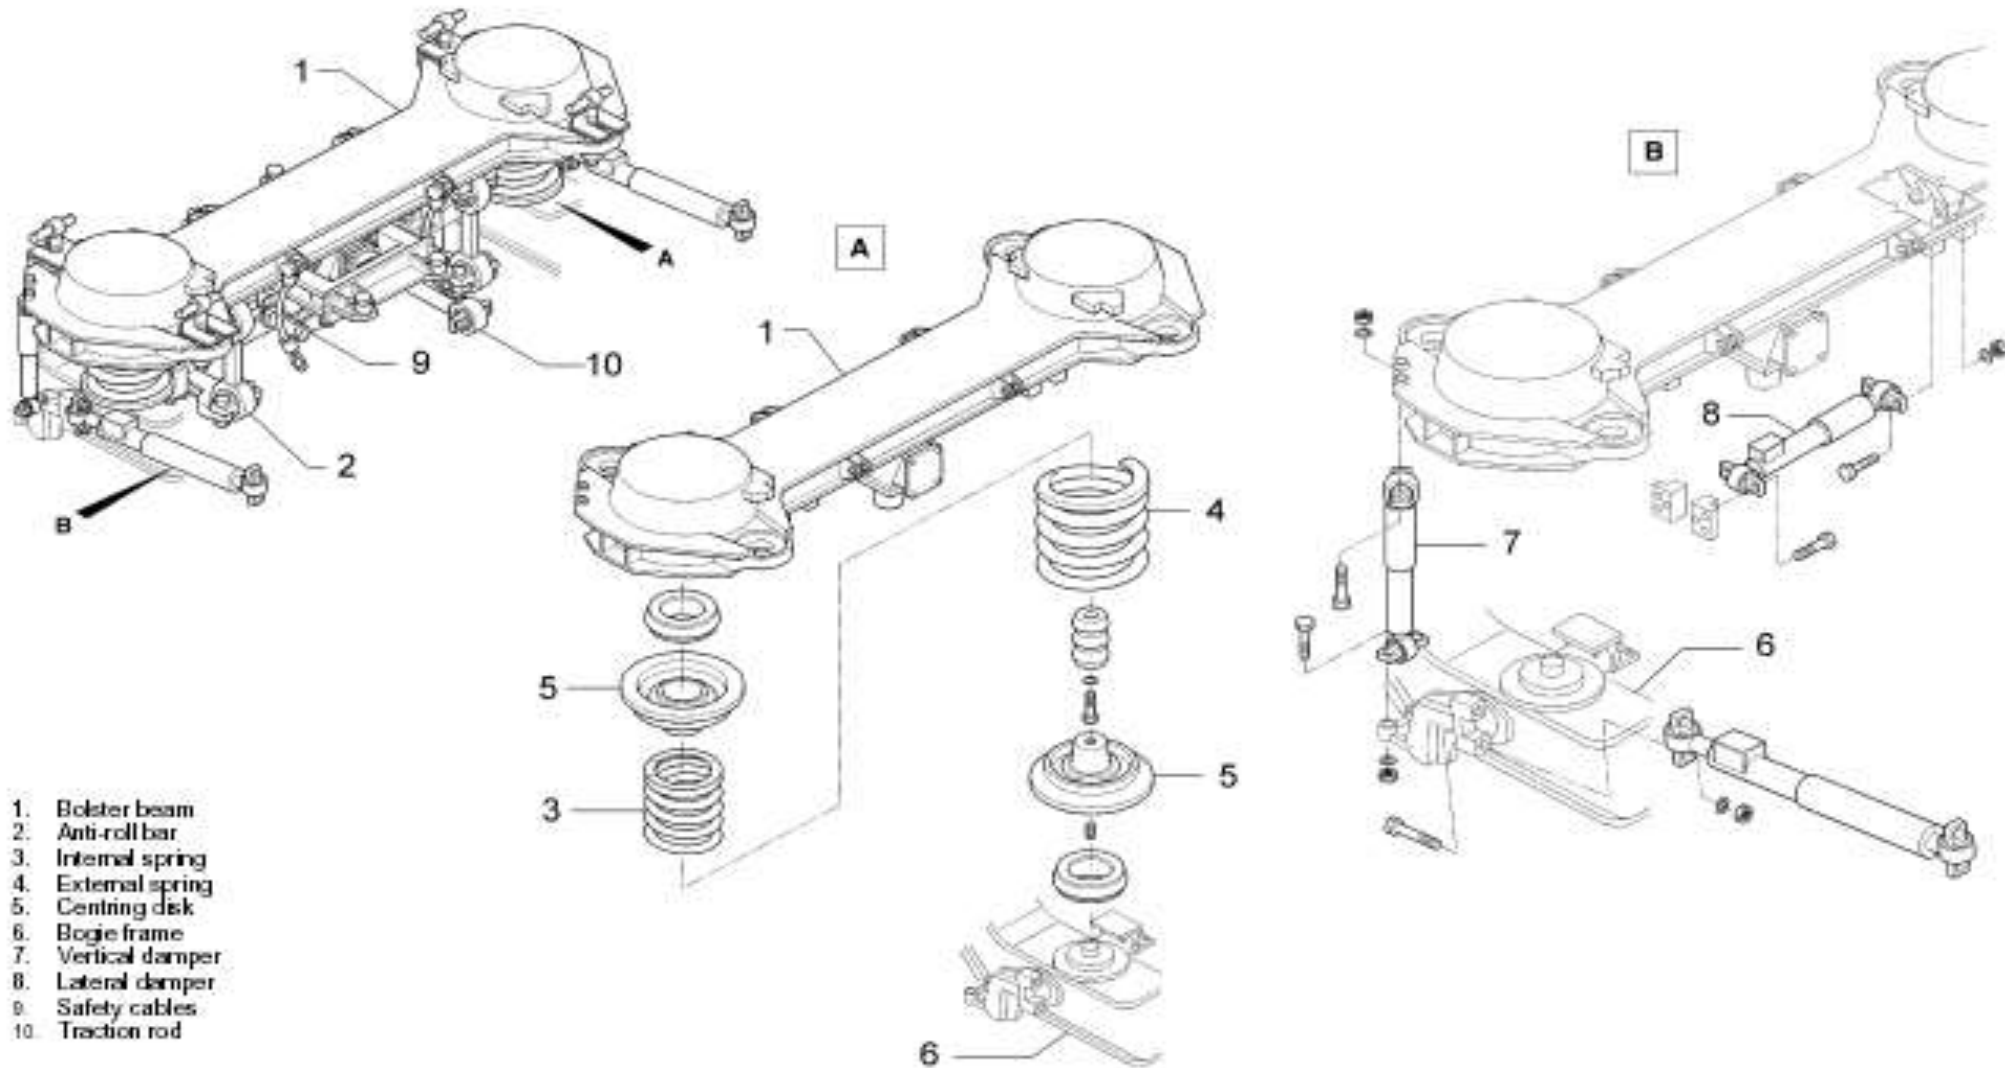
FIG. 1-10 SECONDARY SUSPENSION UNIT

1. Bolster beam
2. Anti-roll bar
3. Internal spring
4. External spring
5. Centring disk
6. Bogie frame
7. Vertical damper
8. Lateral damper
9. Safety cables
10. Traction rod

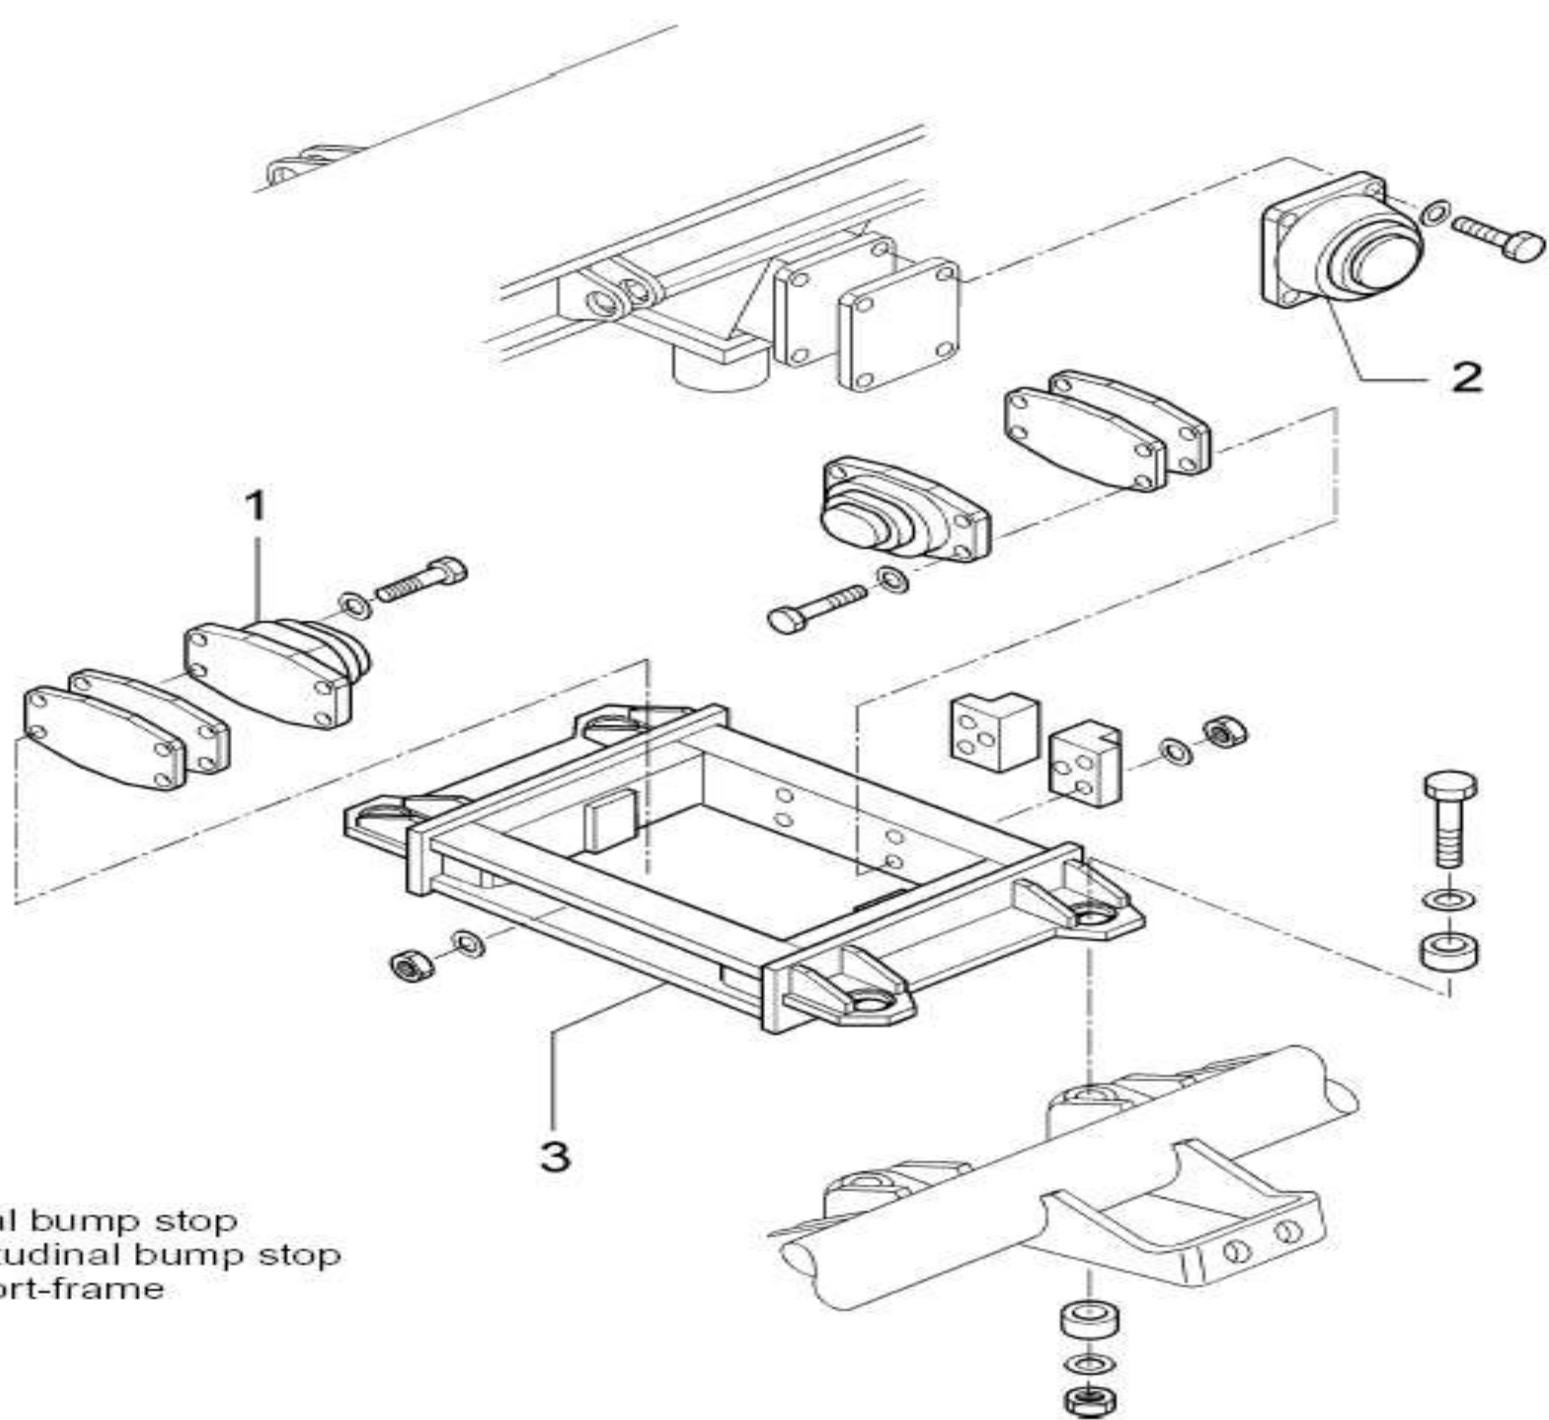
1. Lateral bump stop
2. Longitudinal bump stop
3. Support-frame

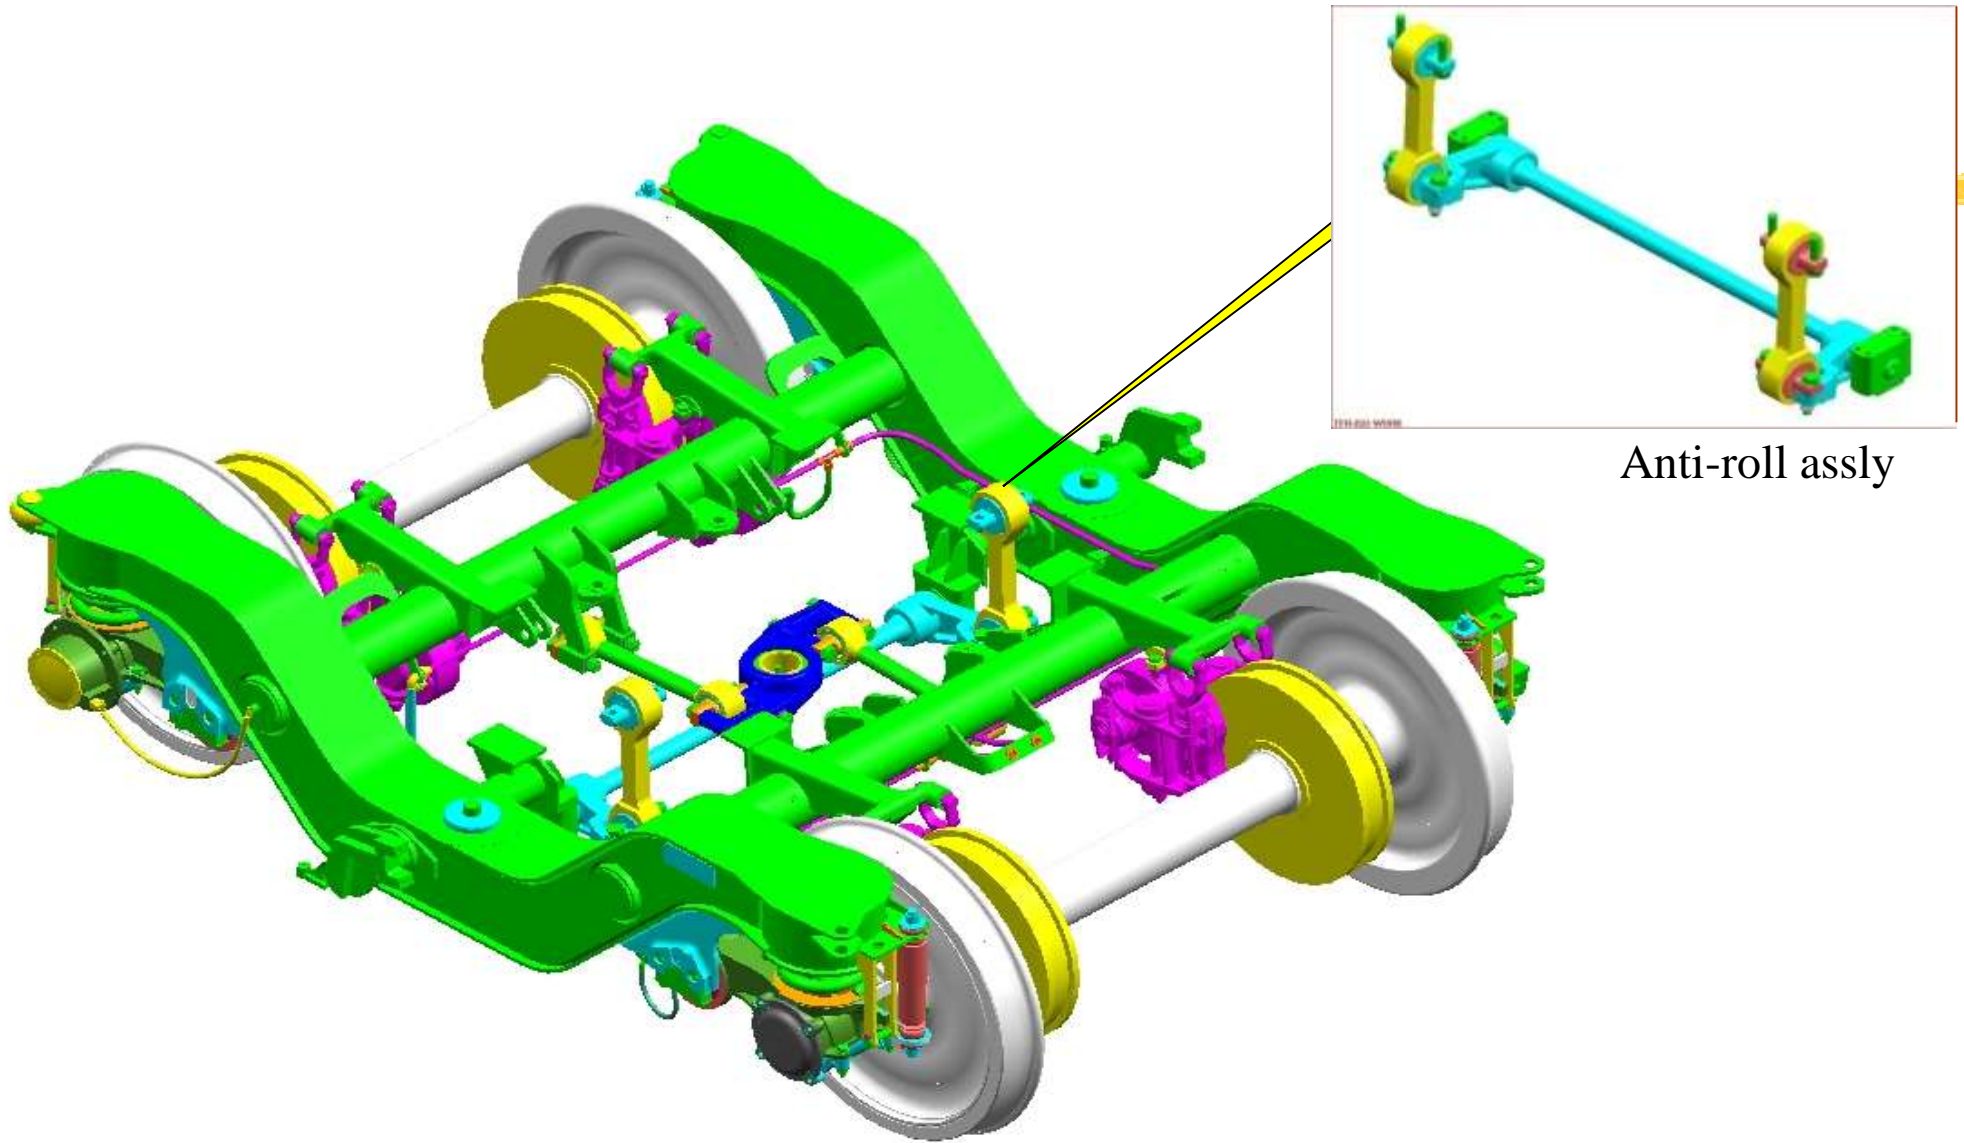
Anti-roll assly

⌘ A torsion bar having two forks is provided between bogie frame transvers beam with the help of two links to resist rolling motion of coach

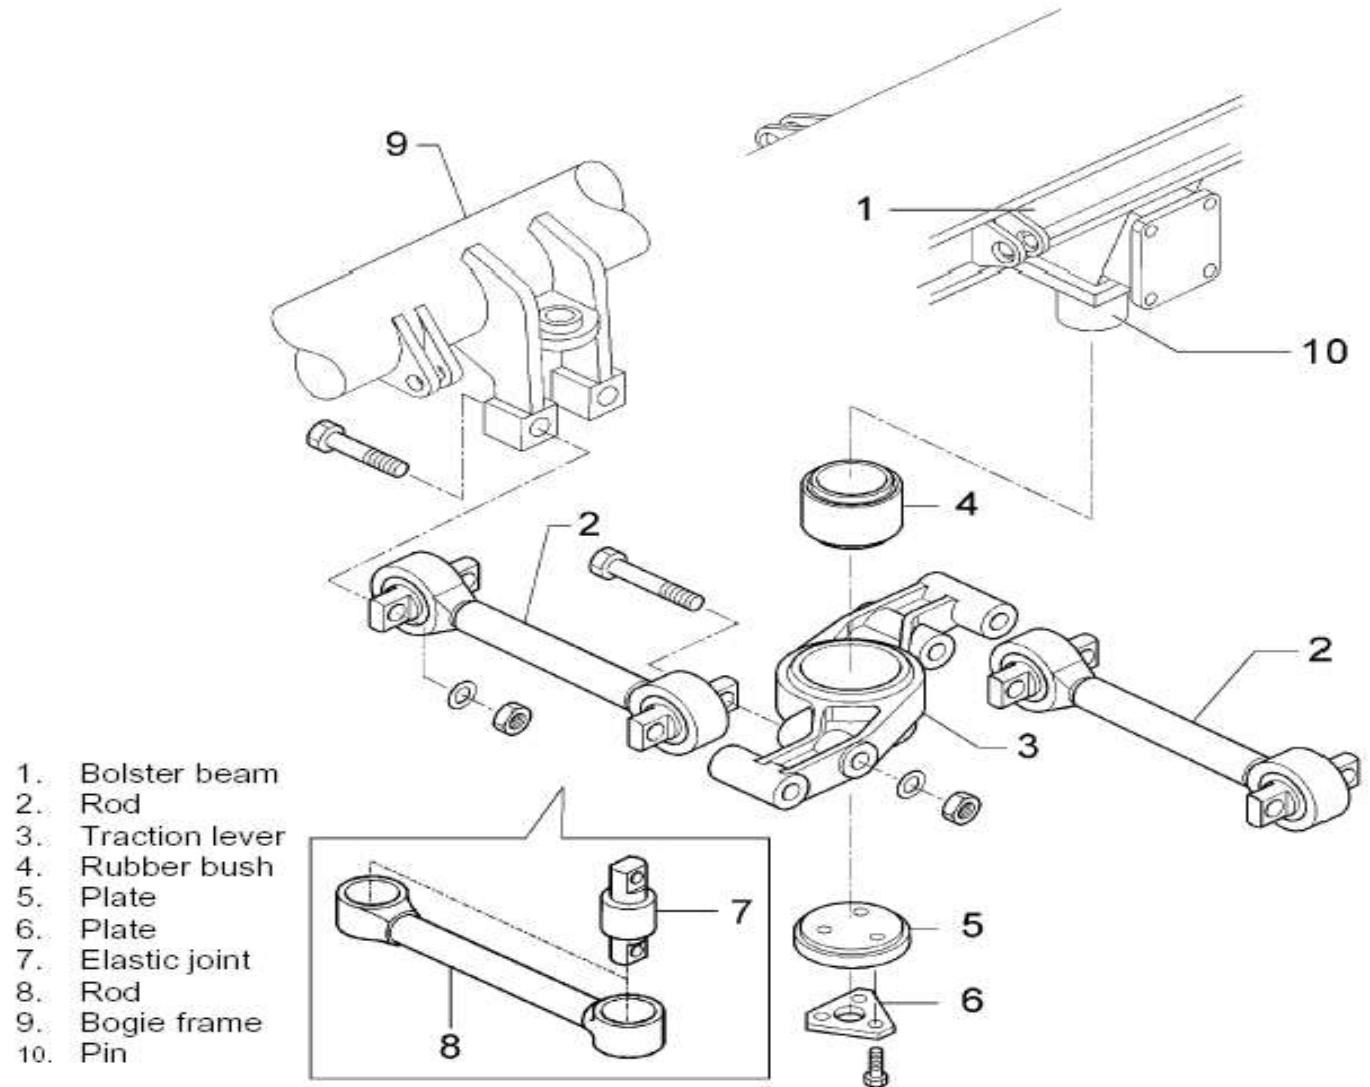
FIG. 1-11 TRACTION CENTRE

⌘ Body-traction  
centre-traction  
rods-traction  
lever-bogie  
frame-control  
arm-axles.

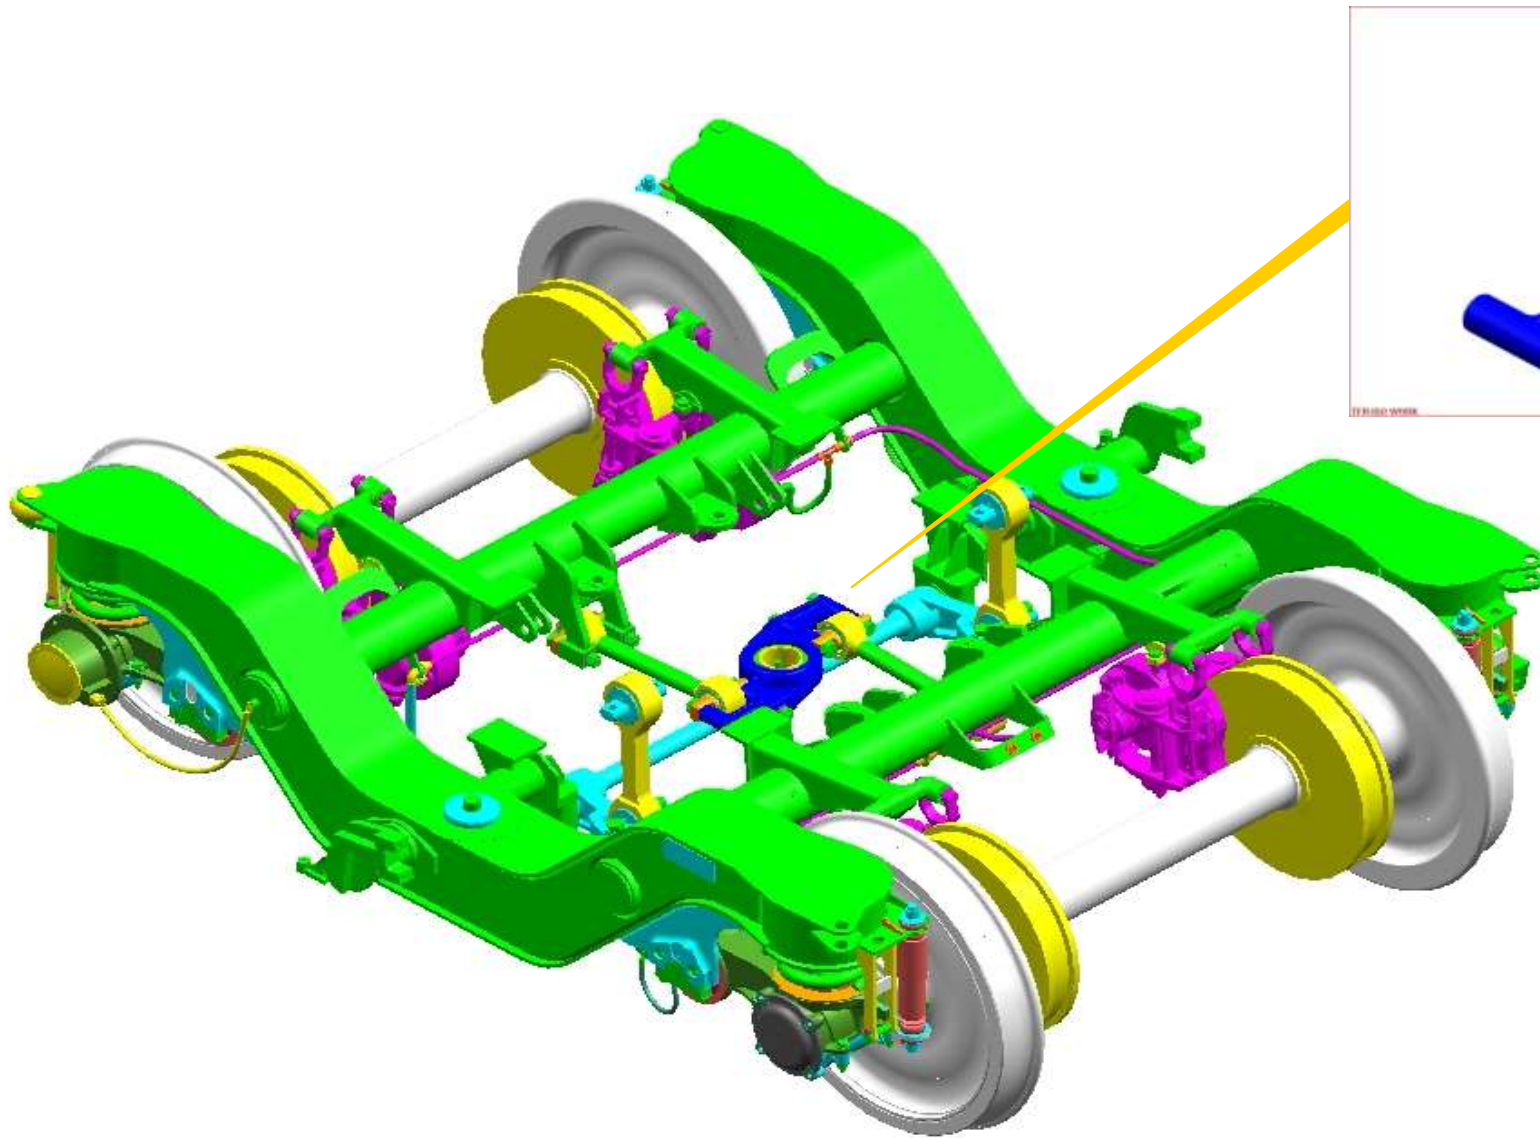
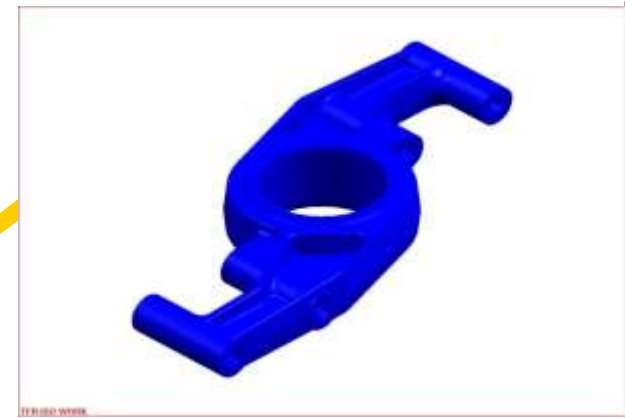
Traction Center

(X-section lifted)

Traction Lever

Anti Roll Assly

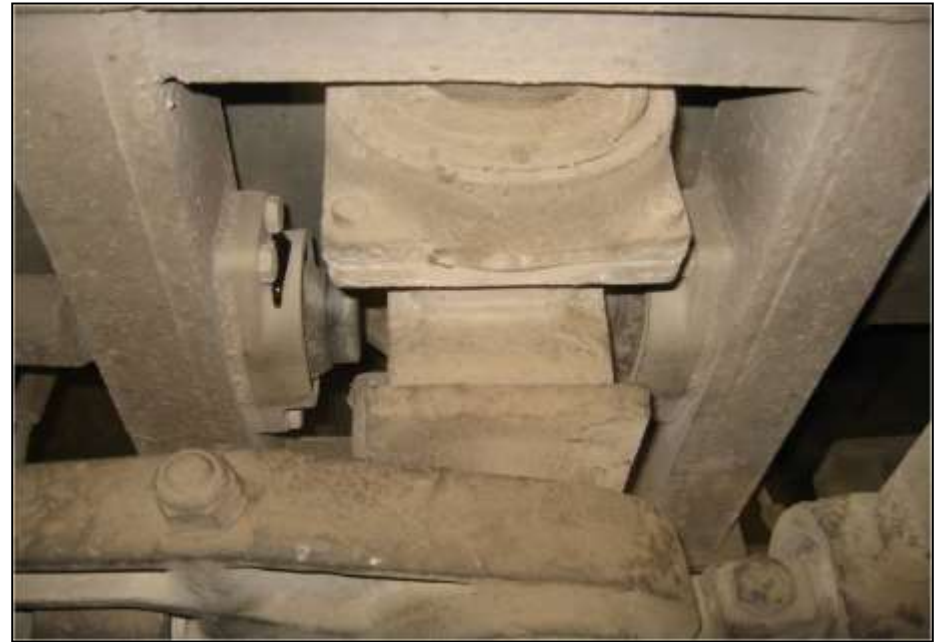
# Uneven Lateral Bump Clearance

- ⌘ Due to improper orientation and matching/changing of secondary suspension spring.

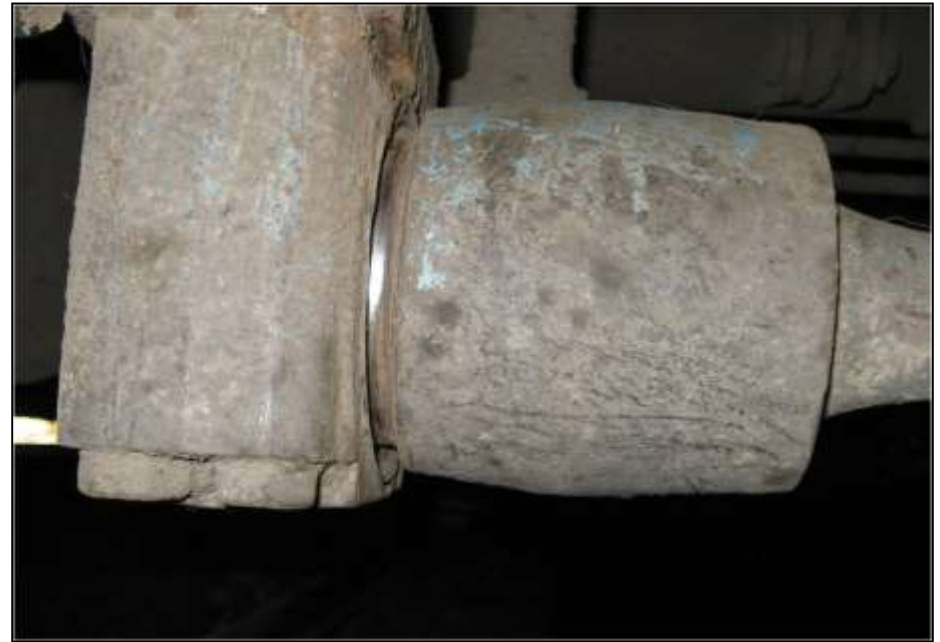
# Anti roll bar mechanism failure

- ⌘ The cases of shifting of anti roll bar considerably high.
- ⌘ The permissible gap is max. 5 mm.
- ⌘ In some cases this gap observed 10 to 12 mm.
- ⌘ One case of Anti roll bar breakage noticed on date 01.09.2007 at HNKM on coach No. 07110/LACCW within 6 month of manufacturing after earning 165794 KM.

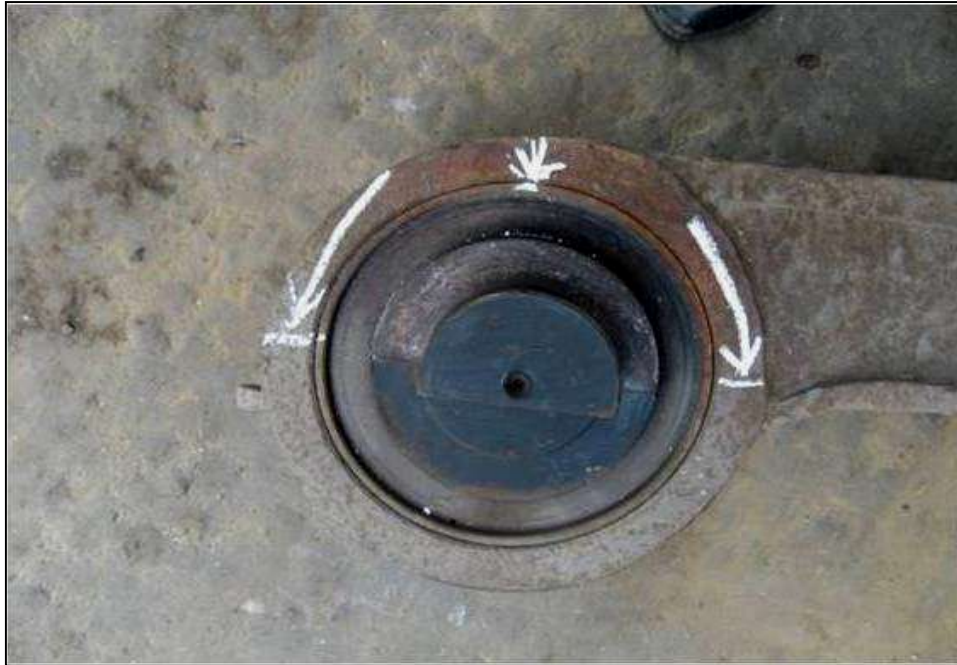
Control arm rubber joint at ends in upper half round portion worn out.

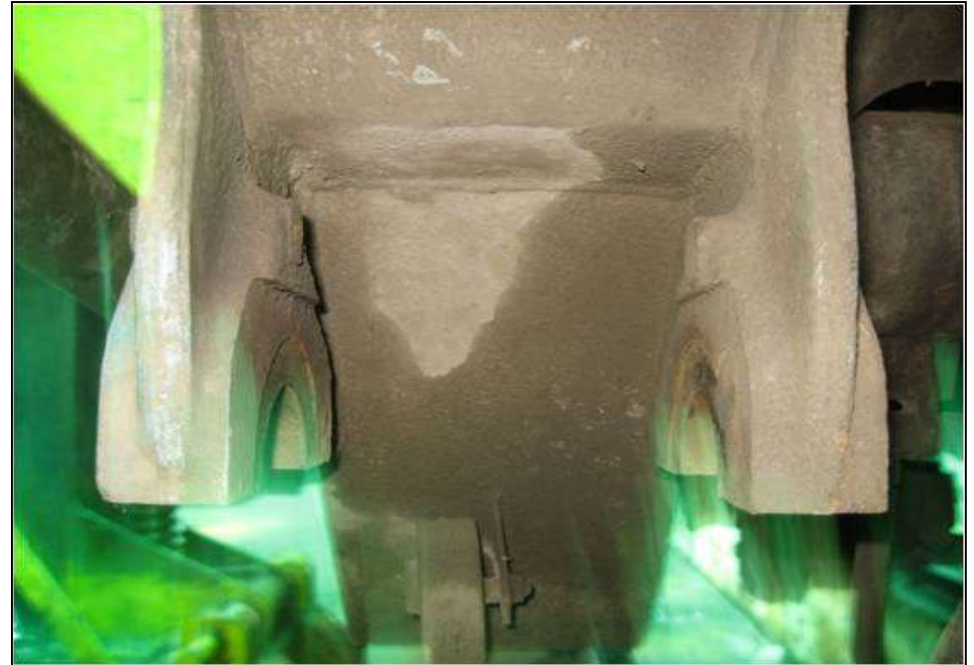
Mating part at frame location worn out.

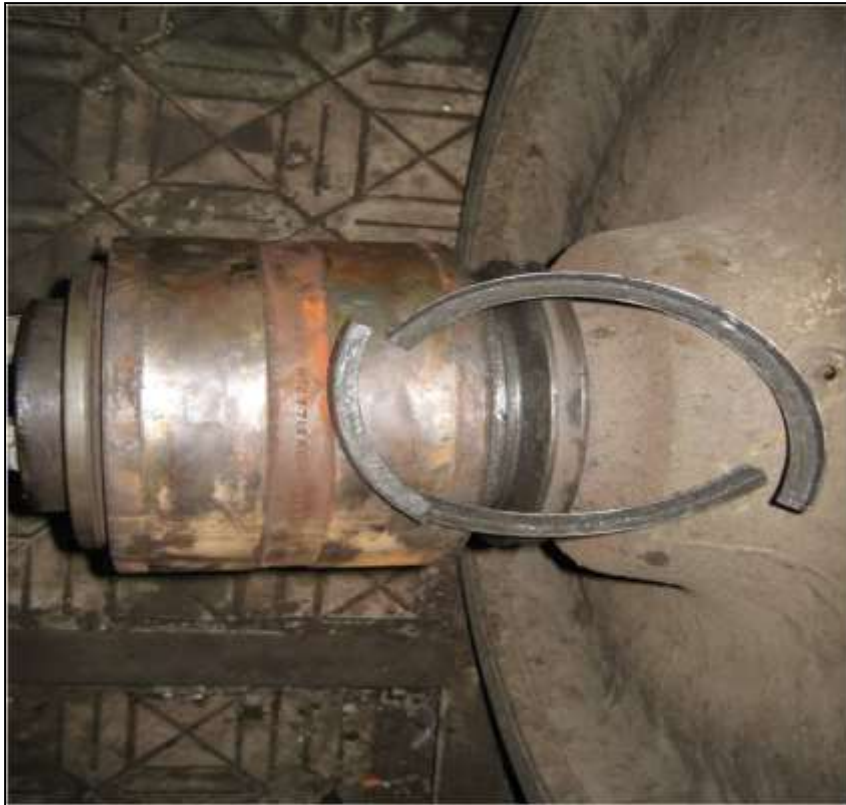
Bearing back seal broken in three pieces

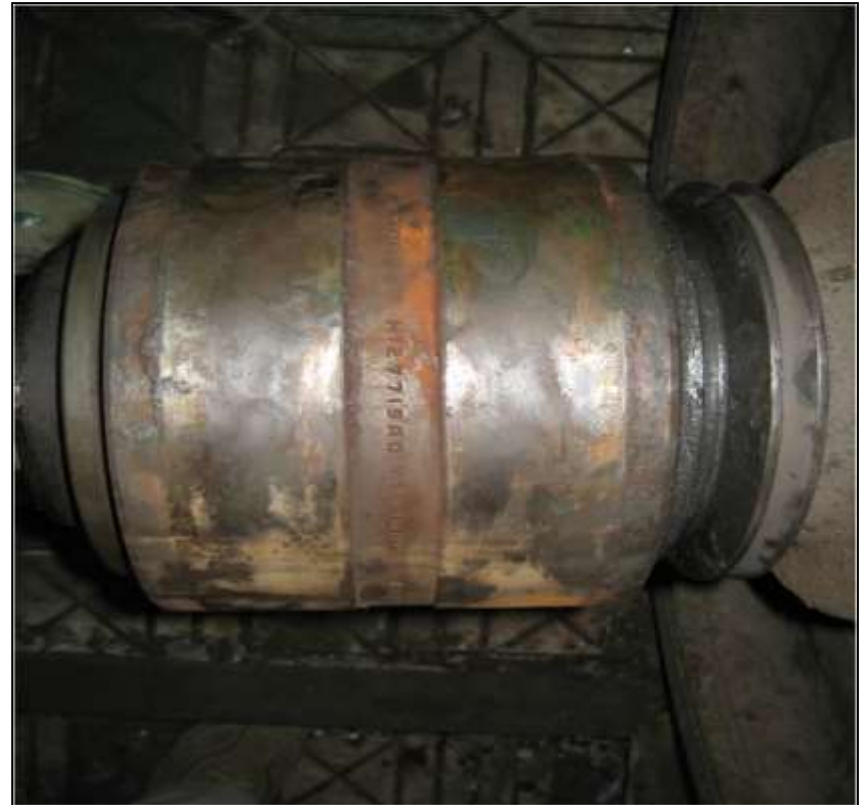
Backing ring rotating freely on Axle soldier
