# HOT AXLE

S.K.SUMAN (CI/C&W)

# FAILURE INVESTIGATION REPORT OF CTRB FAILED ON 02.01.2023 OF DHANBAD DIVISION

# Failure Investigation of Hot Axle CTRB

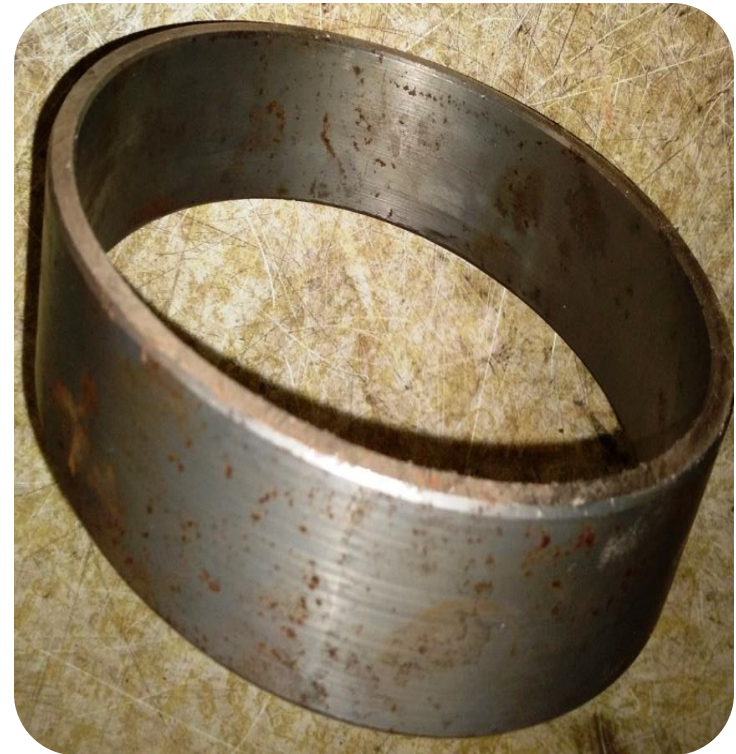
SPACER

- Spacer is inspected visually to detect different defects *i.e.*, dent, flaking, brinelling, rust, peeling, spalling etc.

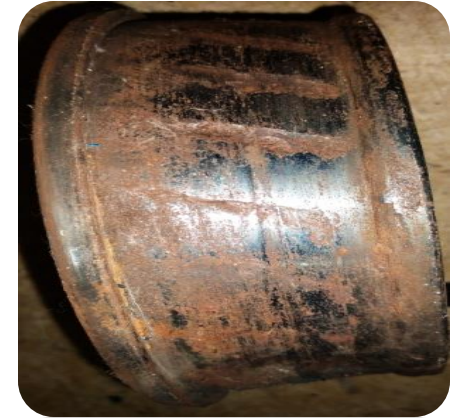
CONE

- Consists of cone, cage and rollers.
- Cone assembly is inspected visually to detect different defects *i.e.*, dent, flaking, brinelling, rust, heat discoloration
