FAILURE ANALYSIS-II

Case study of different failures

M.Chandra
Lect./EM

AN EXAMPLE OF THE INVESTIGATION REPORT

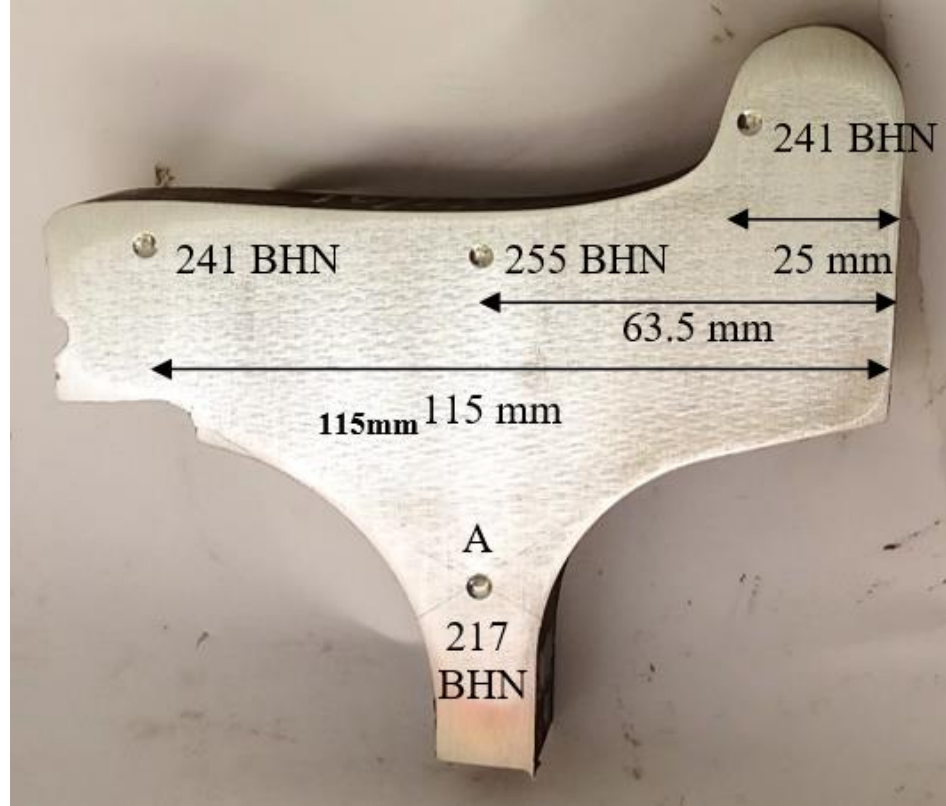
Hardness survey was conducted on transverse slice at a depth of about 7 mm ($28.5 + 7 = 35.5$ mm) from the existing tread surface at three different locations as per IRS R-19/93 Pt.-II (Rev.4) and the results are given as under:

(Depth of Rim wear is about 28.50 mm.)

Fig.5: Photograph showing hardness survey on transverse slice of fractured piece as per IRS R-19.

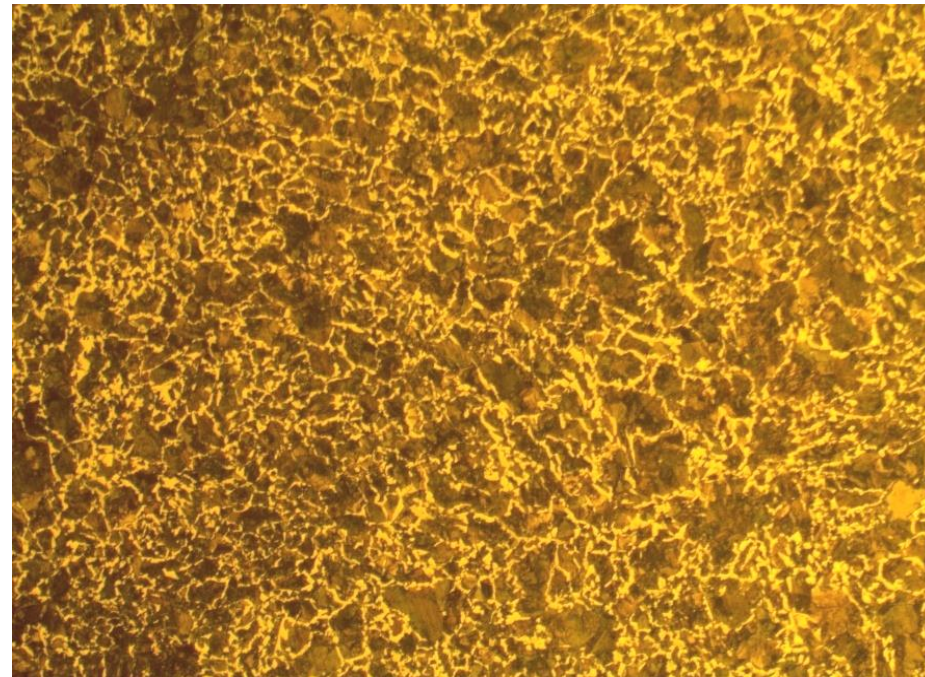
| Sample No. | Location | Observations |
|---|---|---|
| 10/19 | Rim | Pearlite within network of ferrite. Average Grain size is ASTM No. 6. (fig.7) |

Fig.7: Photograph showing pearlite within network of ferrite in rim adjacent to tensile location.

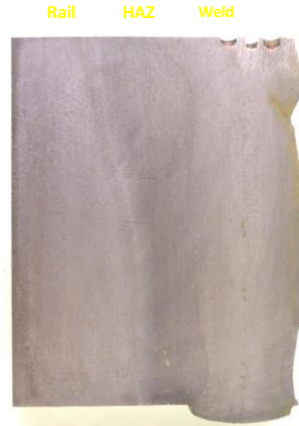
A longitudinal slice of the weld, HAZ and parent rail was etched and macro-examination was conducted. It revealed no inherent abnormality (**fig. 7**).

Fig.7: Photograph showing weld, heat affected zone & parent metal of sample no 76/2022.

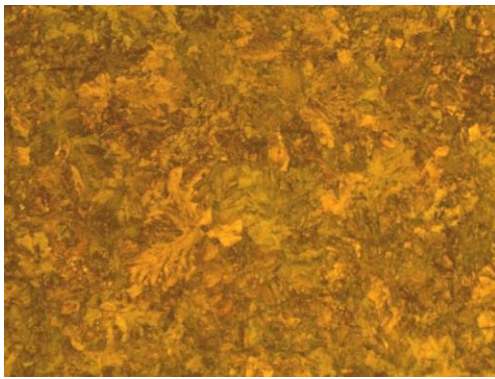
X100

| Sample no. | Location | Observations |
|---|---|--|
| 76/2022 | Parent Rail | Revealed pearlite structure with specks of ferrite at places (fig. 8). |

Fig.8: Photomicrograph revealed pearlite with specks of ferrite at places in parent rail.

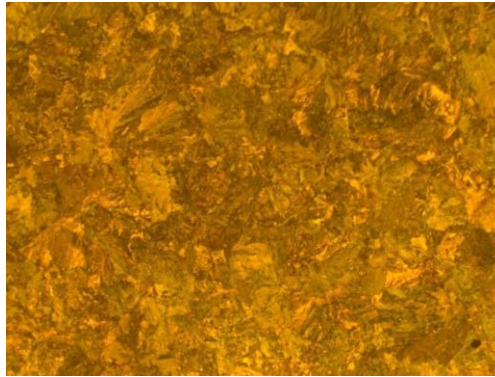
X100

| Sample no. | Location | Observations |
|---|---|--|
| 76/2022 | HAZ | Revealed fine pearlite with specks of ferrite at places (fig. 9). |

Fig.9: Photomicrograph revealed fine pearlite with specks of ferrite at places in HAZ.
