Wheel shelling

(mechanism, cause and preventive measures)

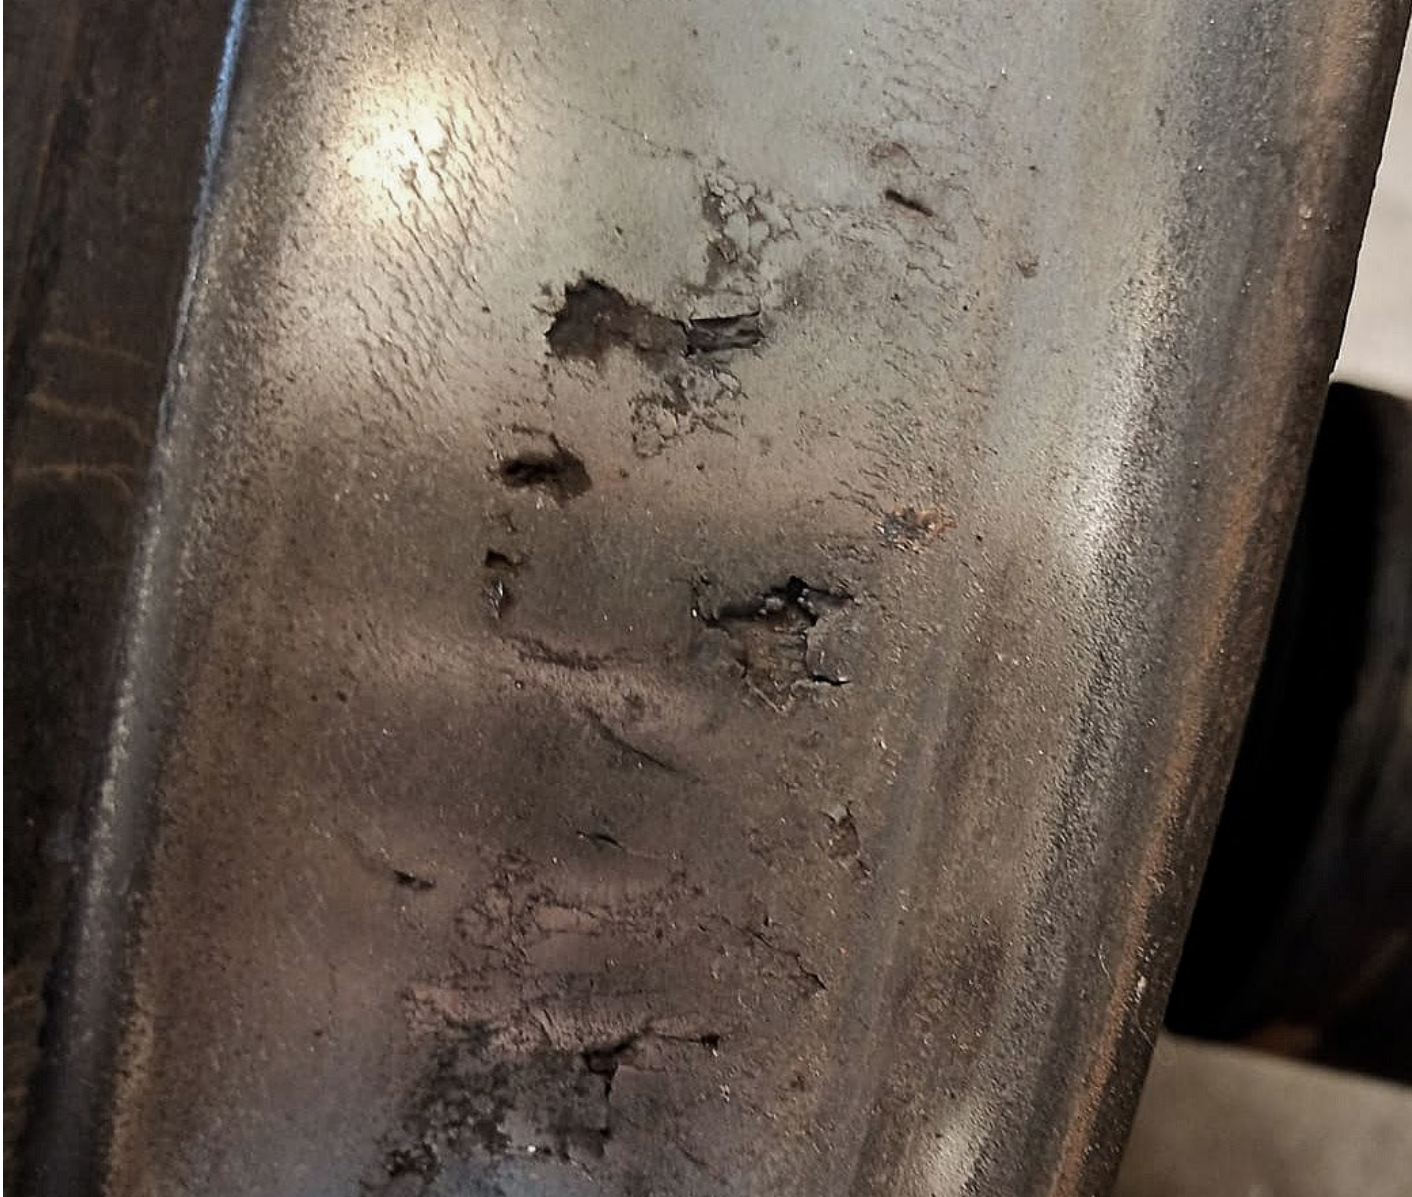
All in one

Spalling

Flaking

Shelling

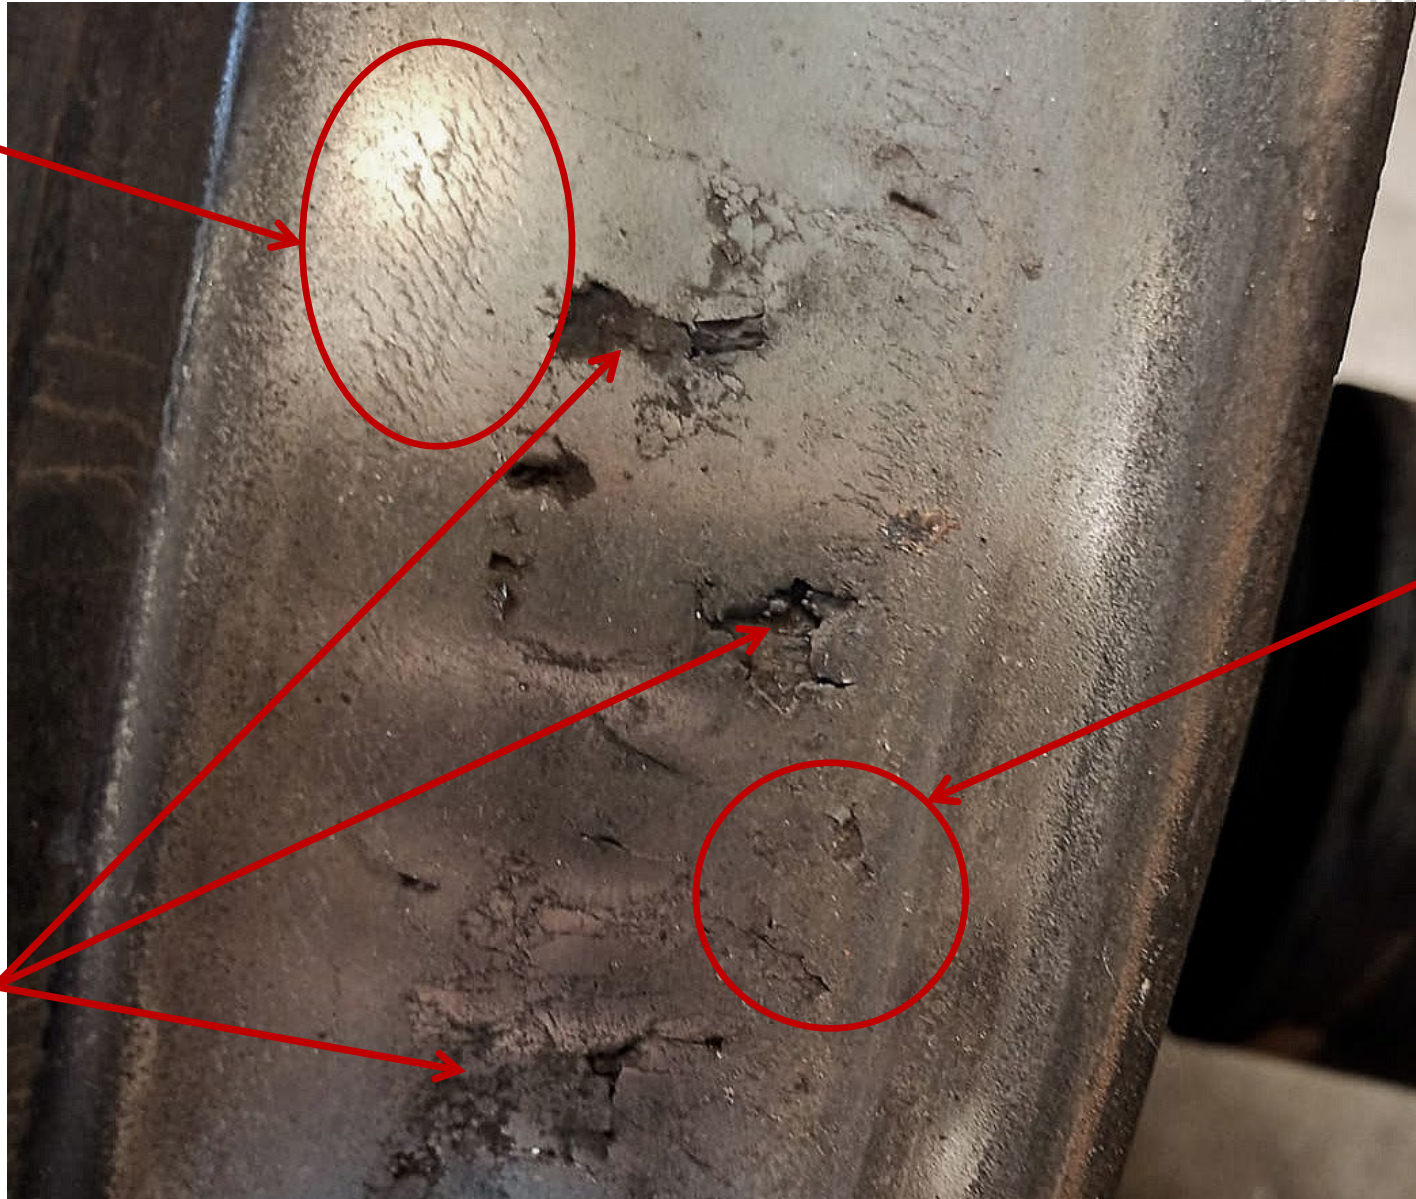
All in one

Spalling

Shelling

Flaking

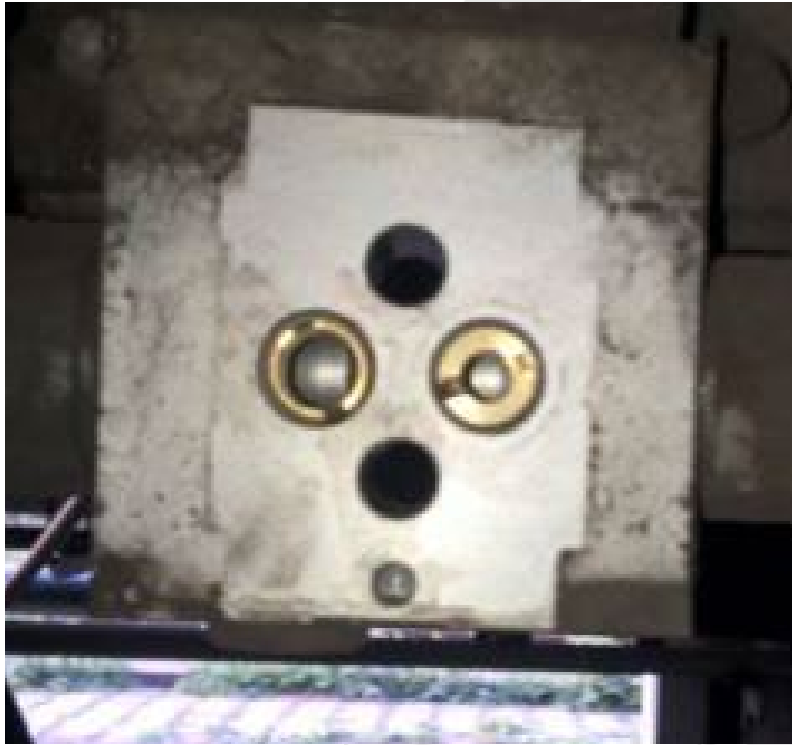
FTRTIL (9 mm, 6 mm)

- No.MC/LHB/Brake, dated: 28.03.2018
- Effect of choke size of Dump Valve on Wheel shelling

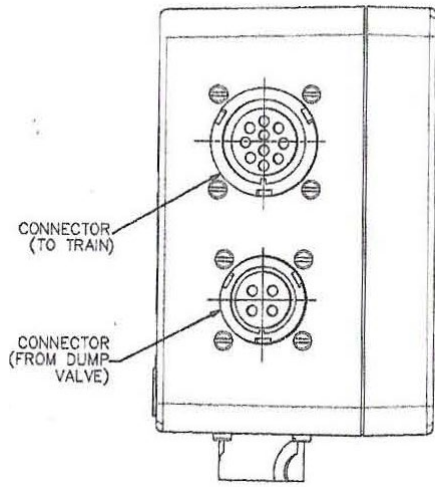
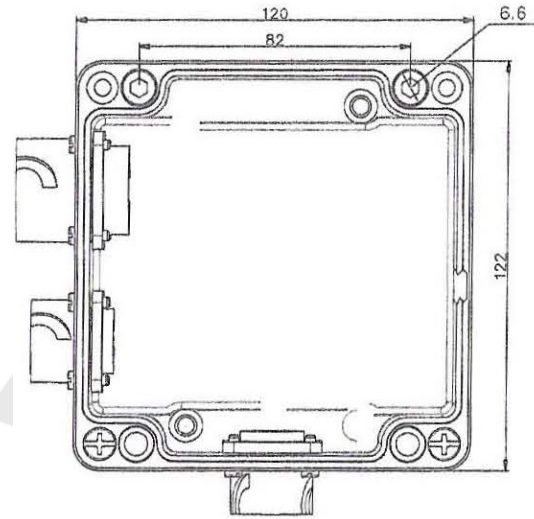
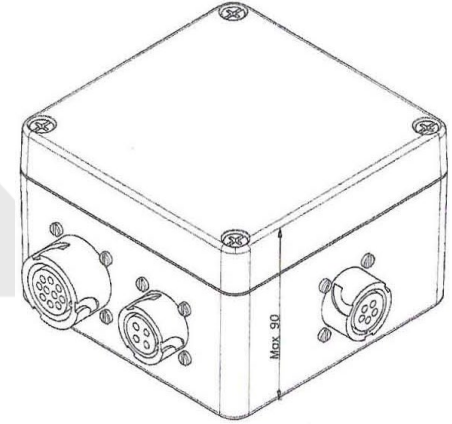
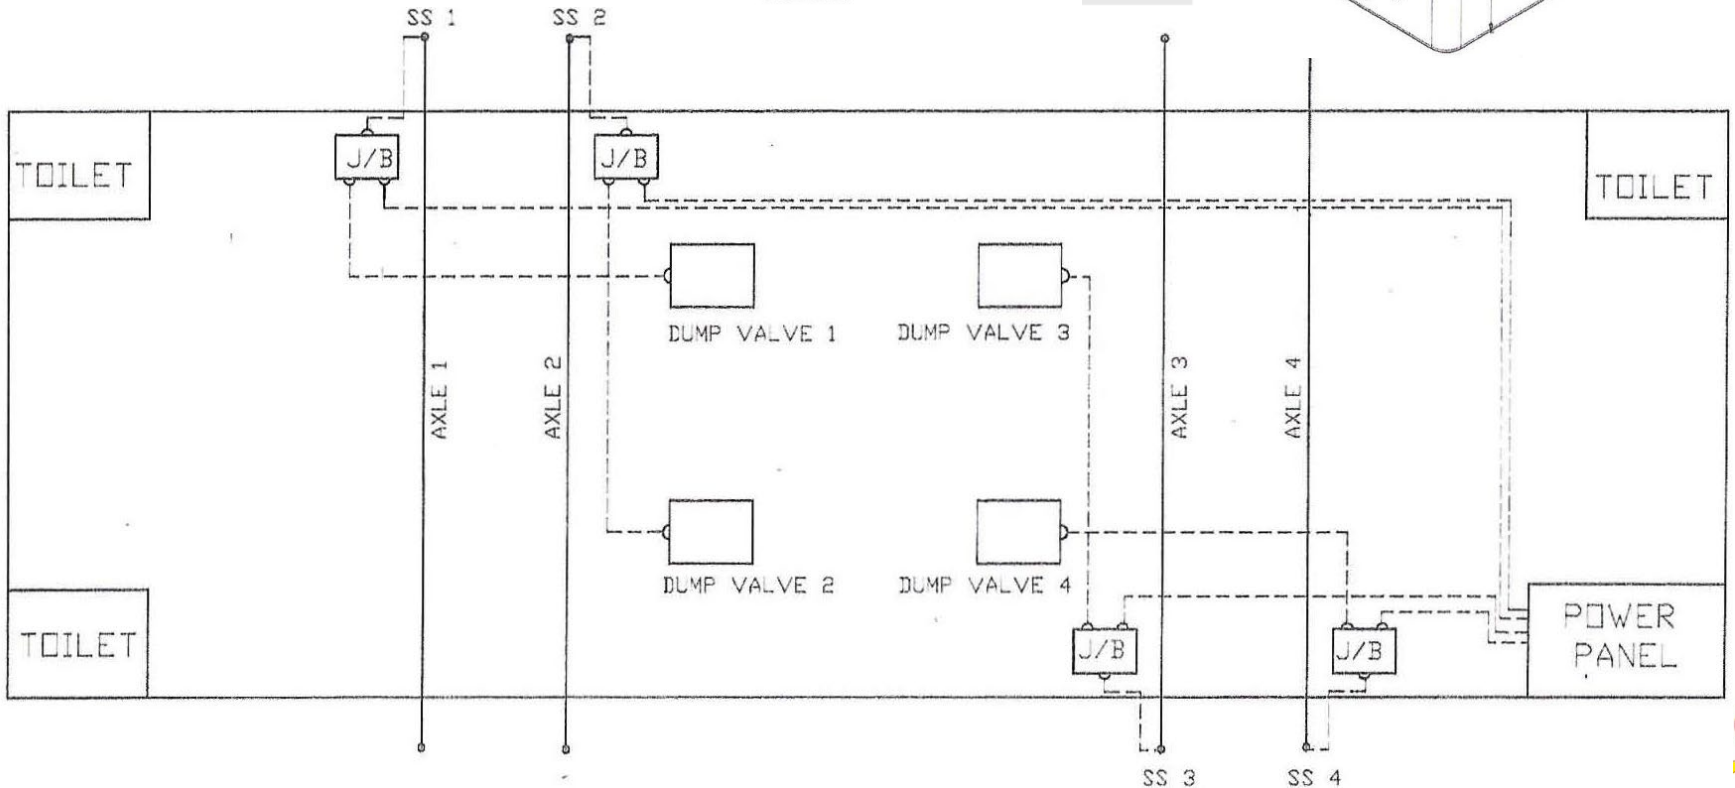
Damaged Speed Sensor Junction Box

- MC/LHB/Brake, dated: 27.02.2019
- RDSO developed revised WSP wiring and Junction Box – for all LHB coaches
 - IP 67 grade junction box (DRG No. CG-19005 Alt.1)
 - Junction box reduced from SIX to FOUR (all connections in one box per axle - valve, sensor and power)
 - **MIL – grade connectors**
 - Revised wiring layout (DRG No. CG-18246 Alt.0)

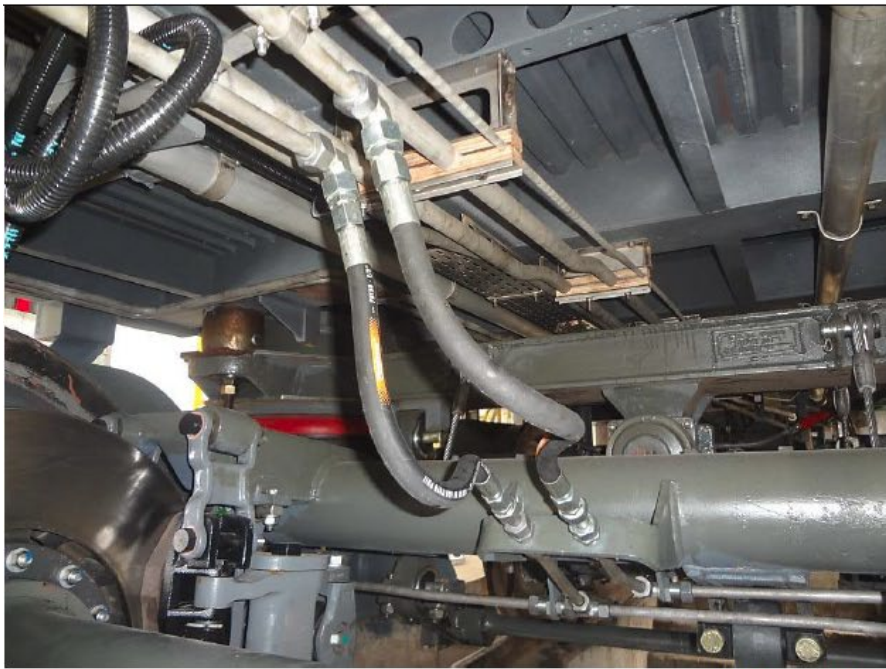
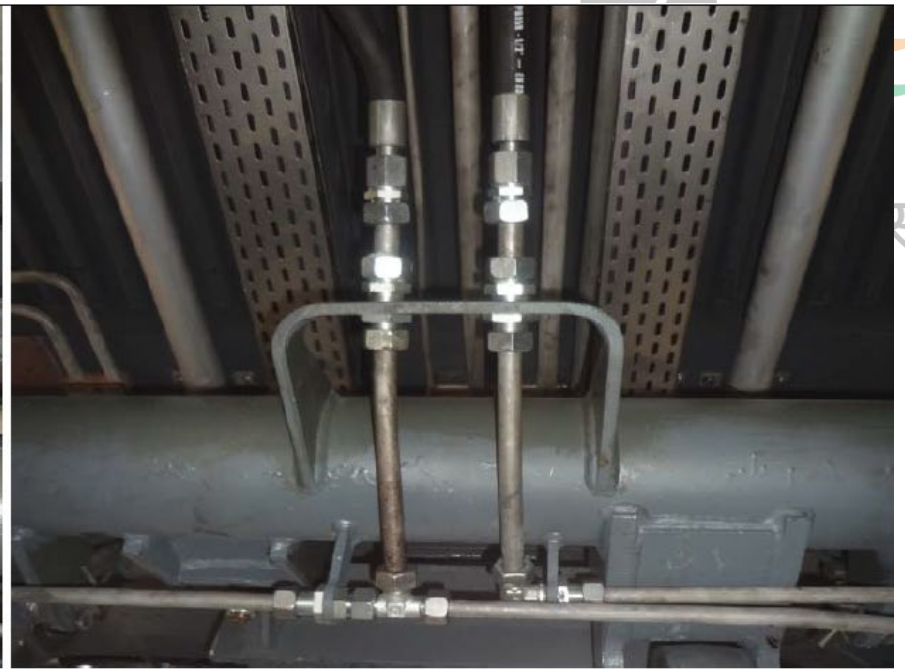
Existing piping arrangement

- No.MC/LHB/Brake, dated: 08.03.2019
- No.MC/LHB/Brake, dated: 12.04.2019
- BC line fittings to be standardized (found 8mm, 9mm, 12mm instead of 18mm OD/15mm ID – specified in Alstom manual)
- Bite joints – excess in number – w.r.t. manual
- Washers used in flexible hoses gets shrunk & perished – only Nylon-66 washers to be used

- No.MC/LHB/Brake, dated: 24.06.2019
- Study by RDSO carried out BCT/WR & SBC/SWR on wheel shelling
- Flexible air hose (600mm) body to bogie with washer (Nylon/Teflon) at hose ends affect the post-dump release time by upto 300ms
- Washers getting perished/shrunk due to over tightening and routine maintenance leads to blockage of air passage and thus causes brake binding/wheel shelling
- The existing flexible pipeline joints are also not metal-to-metal joints as recommended by M/s Alstom

- RDSO standardized design of flexible hose (Drg.No.CG-19036) interchangeable across LHB brake suppliers
- Pipe joint fittings reduced from 9 to 6
- Upgraded flexible air hose advantages:
 - Bigger Inner diameter: increased from 9mm to 12mm
 - No washers: The new hose has M26 (F) type ferrule arrangement at both ends
 - Less pipe joints/fittings: joints/fittings were reduced from 9 to 6 nos
 - Increase in hose length: Avoids stretching & rupture - The length of hose was increased from 600 to 650mm, as in original Alstom design
