COOLING WATER SYSTEM OF ALCO LOCOMOTIVES

COOLING WATER SYTEM OF ALCO LOCOMOTIVE

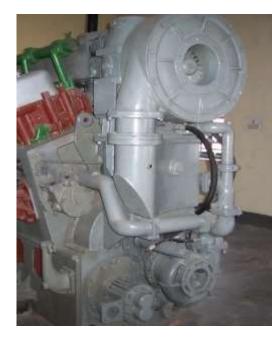
WATER FLOW – FIRST PATH

Water Pump

- Pumps water in the cooling water system
- Discharge pressure approx 25 to 35 psi.
- Its outlet has three branch lines.
- First branch line
 - To TSC through a flexible pipe
 - Cools
 - Intermediate casing,
 - Bearing on both side of the rotor and
 - Turbine casing.
 - Water returns to the inlet side of the pump.
 - Not required in locos fitted with AIR COOLED TSCs.

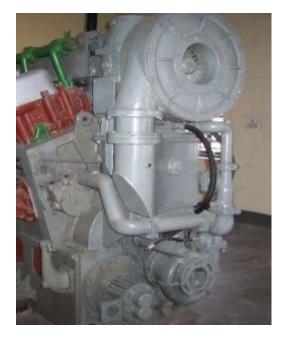
SECOND PATH

- Leads to left bank of the engine block
 - One branch pipe to after cooler
 - Conventional WDM2 locos
 - Enters the engine block for cooling
 - Cylinder liners &
 - Cylinder heads.
 - Gets collected in a common header
- From Header proceeds to the right side radiator core.
- Outlet of this core is connected to suction of water pump
- One branch enters the after cooler.
 - For cooling the charge air
 - Only in New Generation FE Locos).

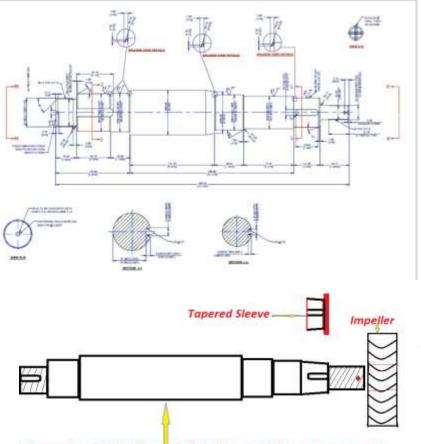
Stainless Steel shaft without

Conventional Water Pump shaft with tapered sleeve arrangement

- Any failure of this pump will cause
 - Loss of water circulation
 - Rise in temperature of critical components
 - Increased failure.
- Recently RDSO has changed the drawing and material specification of water pump shaft to Stainless Steel retaining the taper sleeve arrangement to prevent cases of shaft failures. (Modification Sheet No. MP-MOD-ES-01-13-11 April 2012)

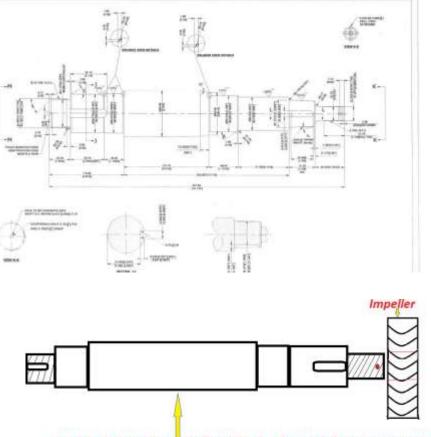
Stainless Steel shaft with taper

Modified Water Pump shaft without tapered sleeve arrangement

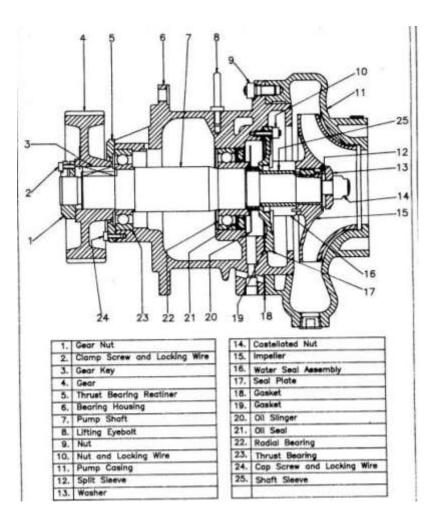
DETAILS OF WATER PUMP

- Overhauling has to be done
 - M24 schedule or
 - Out of course repairs.
- All the gaskets & seals replaced.
- Shaft and impeller

Checked for cracks/ defects.
- Gear teeth
 - Checked for any signs of wear
 / burrs etc.
- Condition of both bearings
 - Checked for excessive sound/ play.

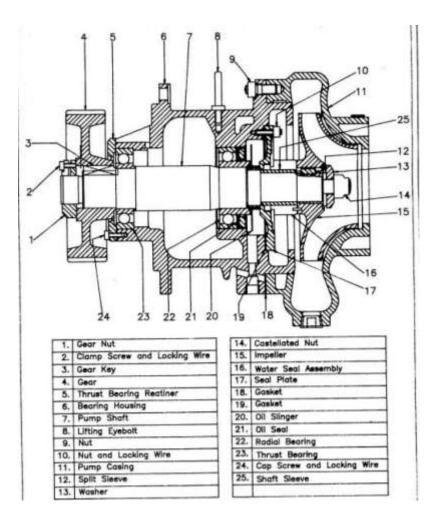
WATER PUMP DETAILS

- Maintain specified interference between impeller and shaft.
- Tighten impeller nut to specified torque value.
- Renew stainless steel split pin every time.
- Check assembled water pump on test bench before fitment on engine.
- Maintain proper backlash during its fitment on engine.

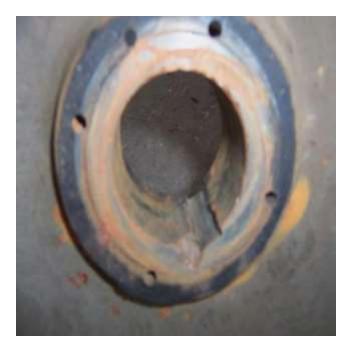
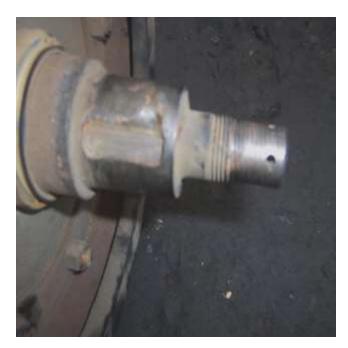
Water Pump Failure (Case No.1)

The shaft key slot got damaged due to Cast metal chipped off which subsequently damaged Impeller Key slot, Nut & split pin. As a result Impeller became free.

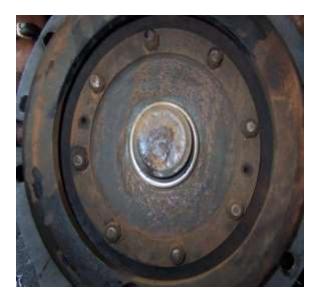
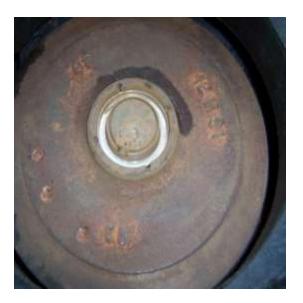
Water Pump Failure (Case No.2)

The Water Pump shaft broke into two parts near Impeller side. A blow hole was found at broken face of the shaft. This blow hole has weakened the strength of the shaft at that portion, resulting shaft broken.

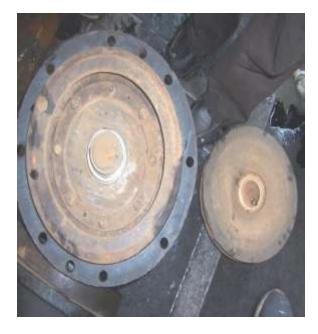
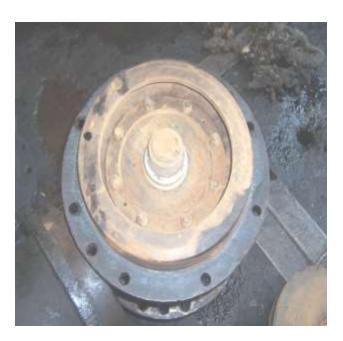
Water Pump Failure (Case No.3)

After dismantling of water pump it was found that the W/P shaft was broken in two parts.

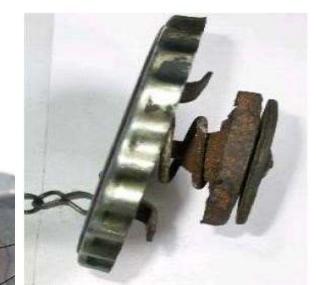
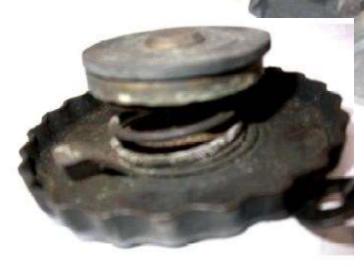
DEFECTS IN CAP ASSEMBLY

Use of mild steel instead of brass/stainless steel in cap supporting plate and

> Corroded portion of the pressure cap assembly.

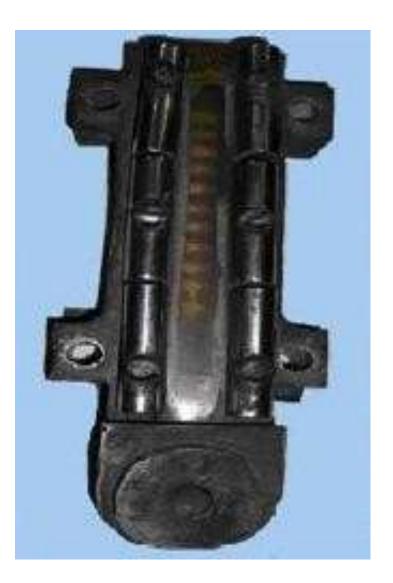
WATER LEVEL GAUGE

- Provided on the rear expansion tank for checking the level of water in expansion tanks.
- Impurities and corrosion inhibitor present in the water discolors the Perspex sheet cover and it becomes difficult to assess the water level in the tanks.
- The gauge should be checked & reconditioned during M12 schedule.

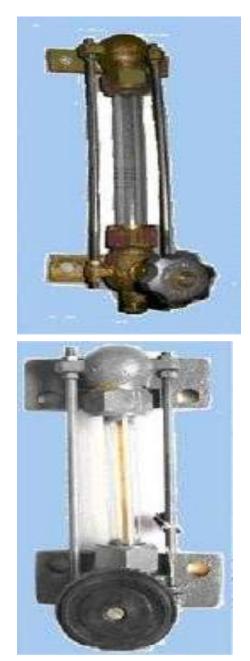
EMD TYPE GAUGES

- RDSO has advised to change all the conventional glow rod type water level gauges with glass tube type level gauges originally fitted on EMD locos.
- Advantages over glow rod gauge
 - Better visibility,
 - Ease in change of glass tube
 - No need of draining whole water from tank,
 - Less time and man power involvement etc.

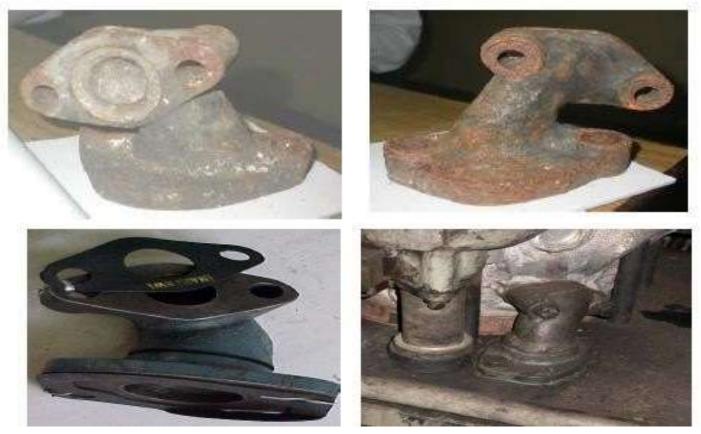
MODIFIED WATER JUMPERS

• For obtaining better leak proof joint even in case of slight misalignment between the engine block and the cylinder head.

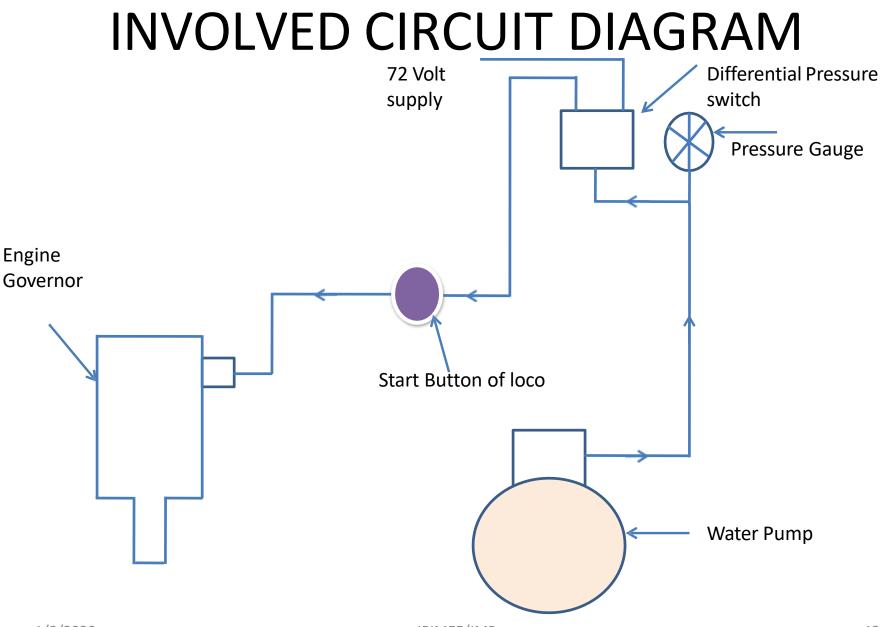
Modification for engine shut down after water pump failure

- A modification is to be done in water system to avoid the consequent failure of power pack.
- Loco gets shut down with help of this modification after failure of water pump.

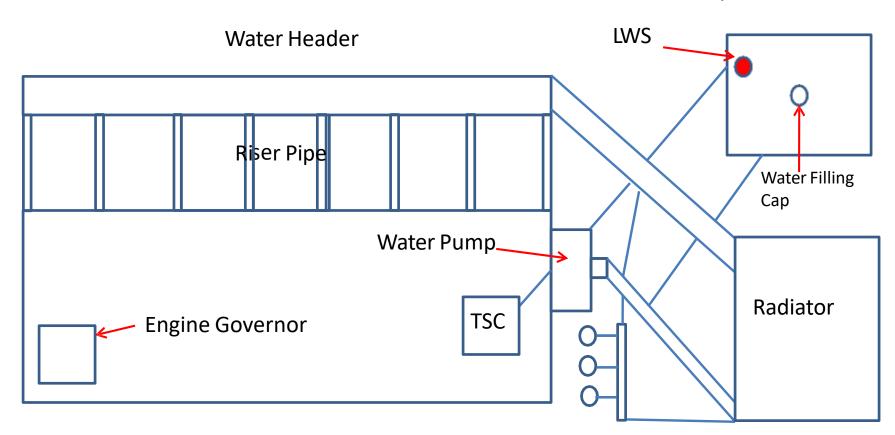
EXISTING ARRANGEMENT

Expansion tank

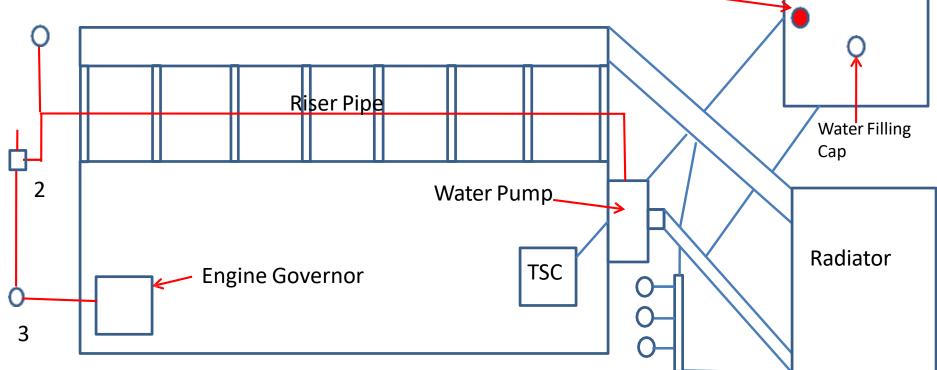
MODIDIED ARRANGEMENT

Pressure Gauge
 Differential Pressure Switch

LWS

- Picking up at 0.1 kg/cm2
- Dropping at 0.4 kg/cm2
- Range of differential pressure gauge: 0.1 0.4 kg/cm2
