Presentation on AAR type H-type tight lock Center buffer coupler

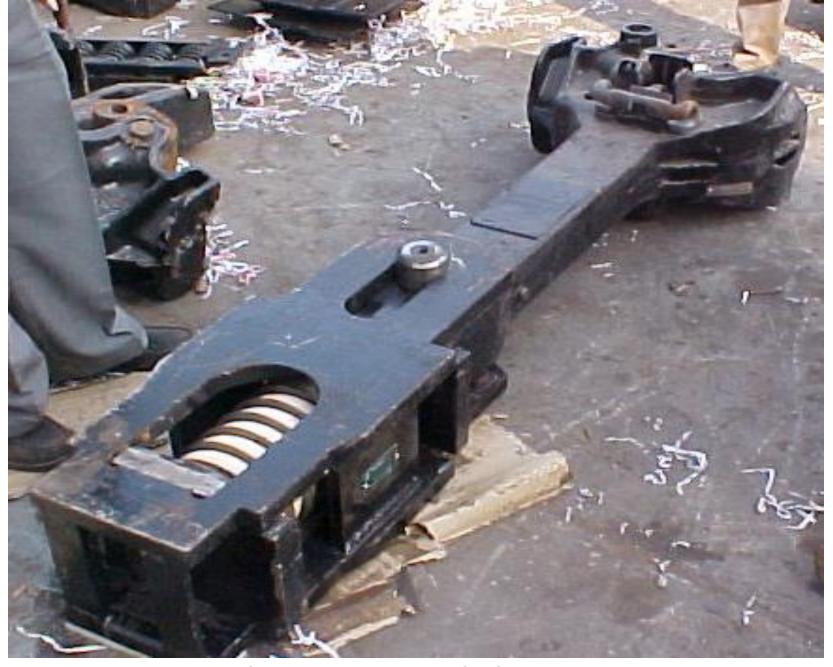
Complete fitment of CBC

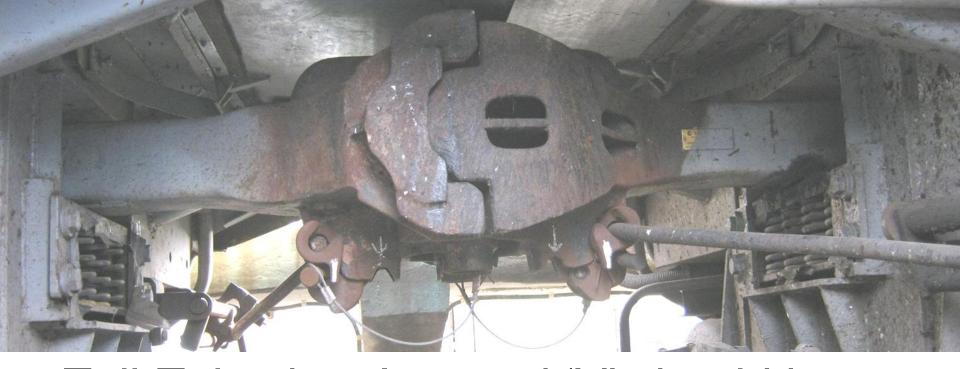
- a. Tell-Tale sign. Inverted 'V' should be clear of obstruction
- b. Rotary lever in vertical position
- c. Cross pin (Diameter-18 mm) to ensure full coupling of CBC

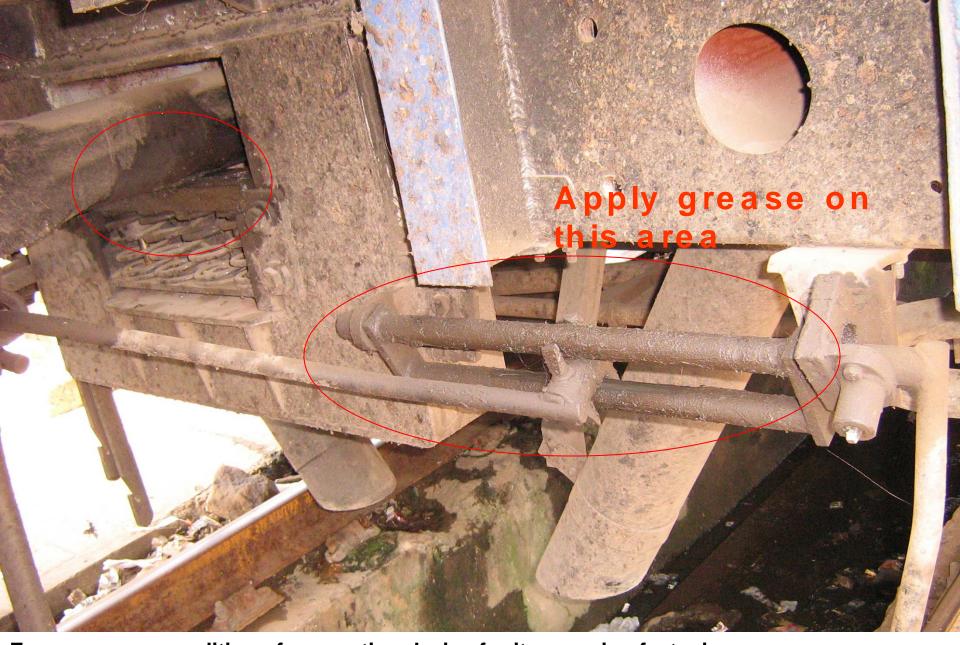
Ensure proper condition of supporting device for its securing fastenings

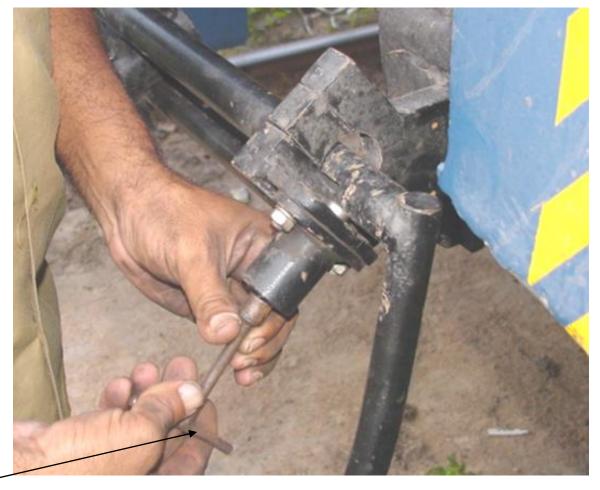
Key for opening of manual uncoupling device Locking mechanism is provided for operating lever to ensure perfect locking of operating rod.

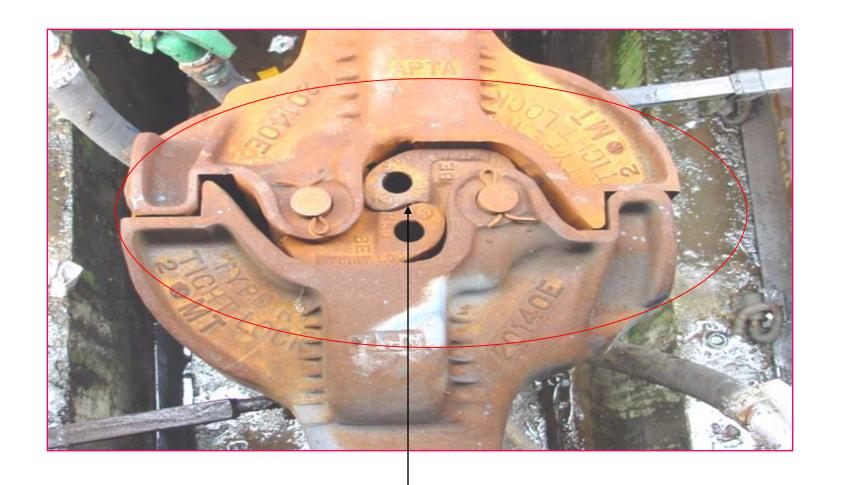
Knuckle mating surface

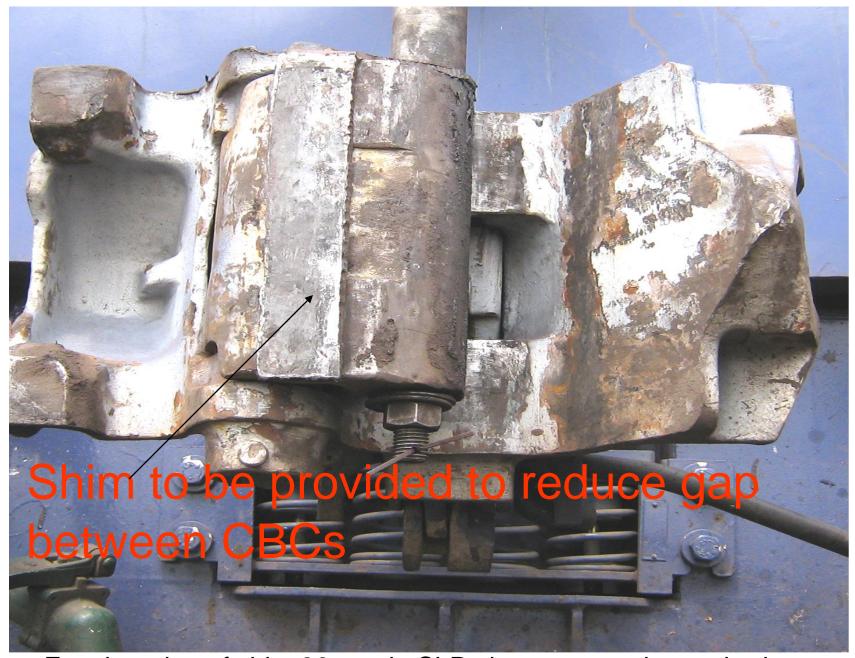
For changing of shim 36 mm in SLRs box spanner is required

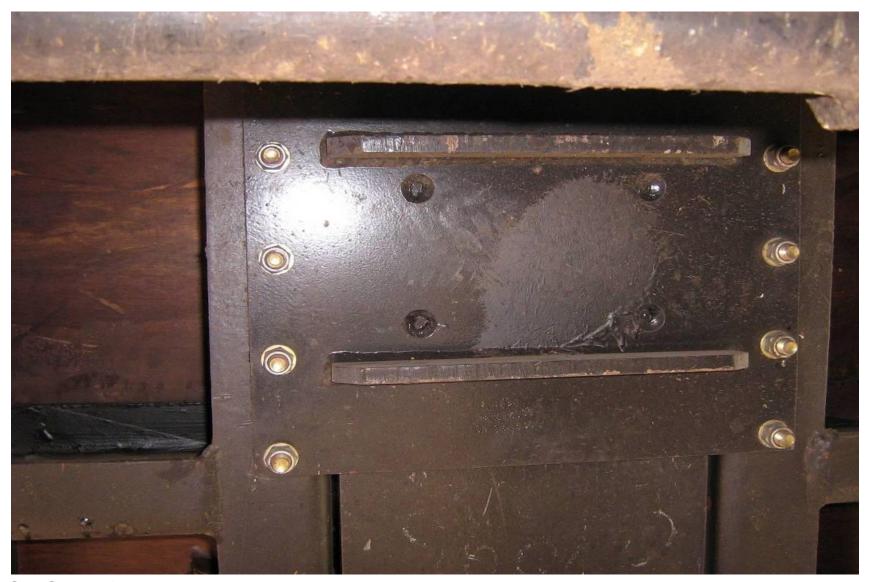
CBC draft gear support plate and tighten with 16x50 mm nut and bolt (use 24 mm socket spanner)

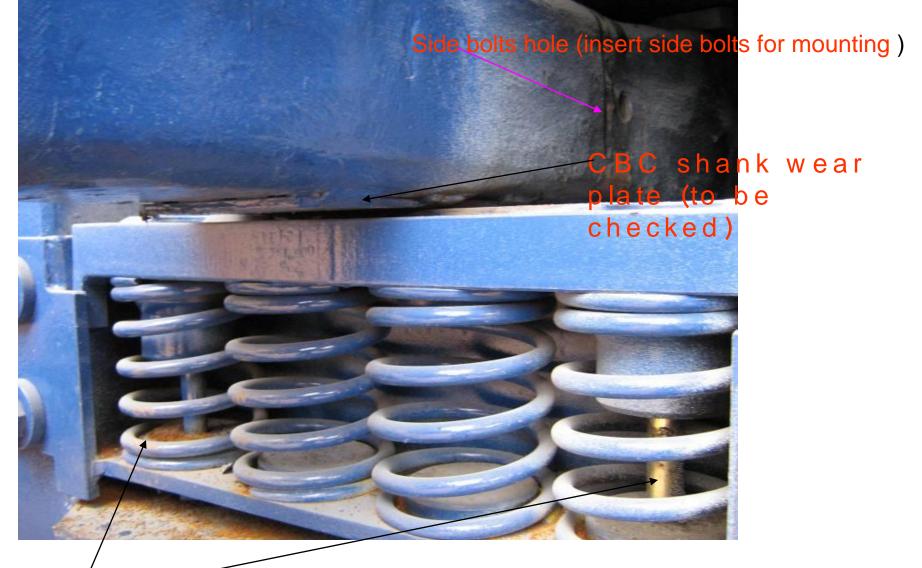
Preloaded compression springs, FTIL make (to be checked) and special type Allen bolt must be checked).

14 mm allen key & 19 mm socket spanner is required for FTIL Make.

17 mm allen key & 24 mm socket spanner is required for Escort Make

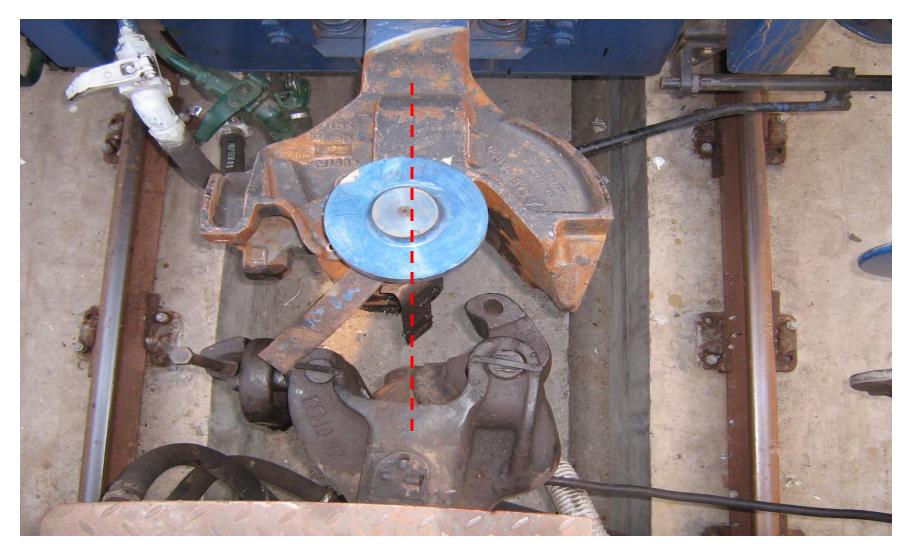
During coupling of CBC it must ensure position of CBC, it must be in center position and coupling of CBC should not be done in the curvature of track

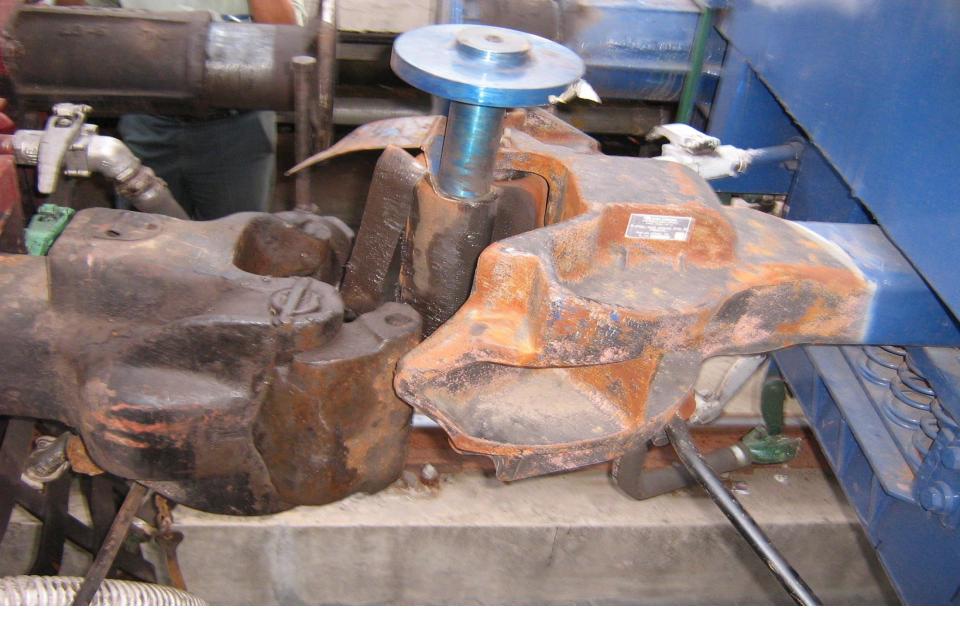
Difference of height between CBC's more than 75 mm is not allowed

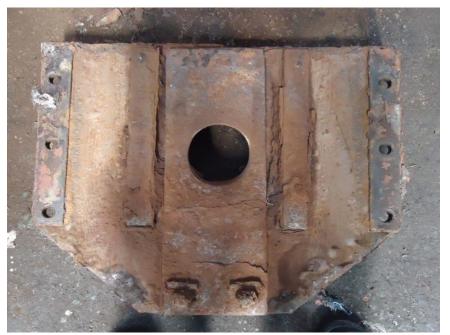
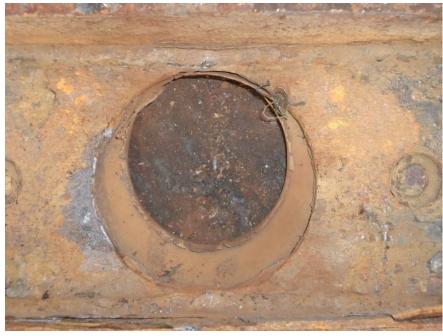
CBC Central pin base plate along with axial stiffner plate punctured

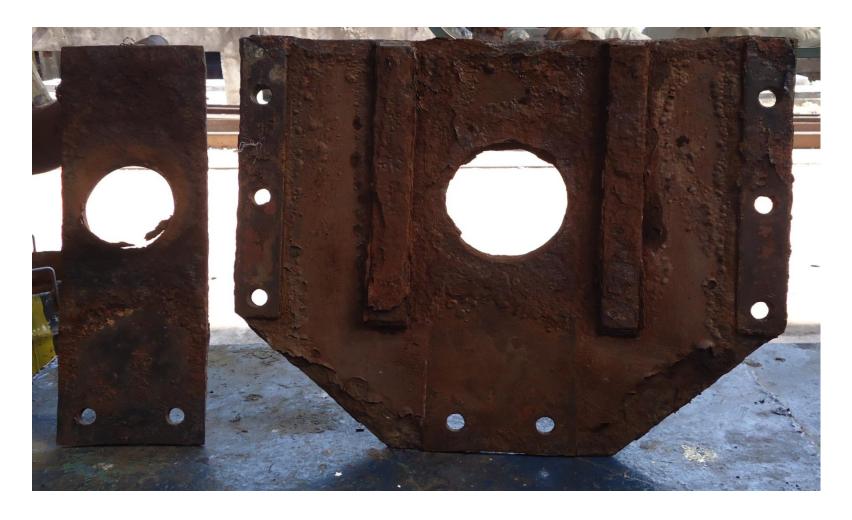
Central pin base plate and axial stiffener plate shown separately. The punctured hole on axial stiffener plate matching with existing hole on base plate allowing central pin to drop down wards causing coupler body to come out and parting.

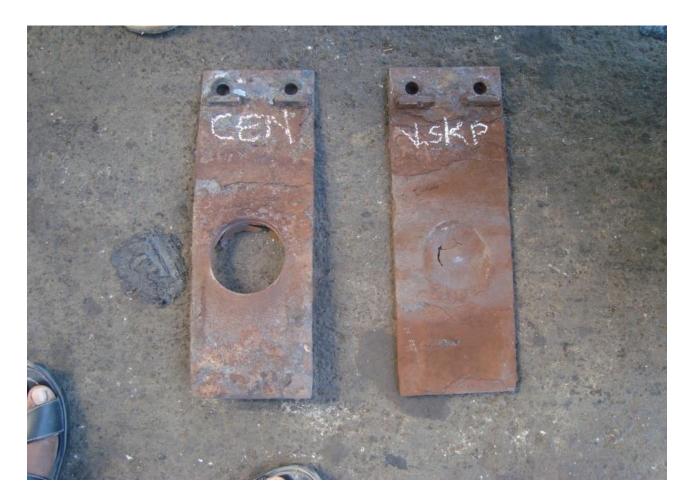
Parting took place towards CEN end of the coach where the axial stiffener plate fully punctured and a hole formed. The axial stiffener plate on VSKP end of the coach also removed for inspection. It may be seen that the development of hole is in the formative stage due to rubbing and hitting of yoke pin which is a potential case for parting.

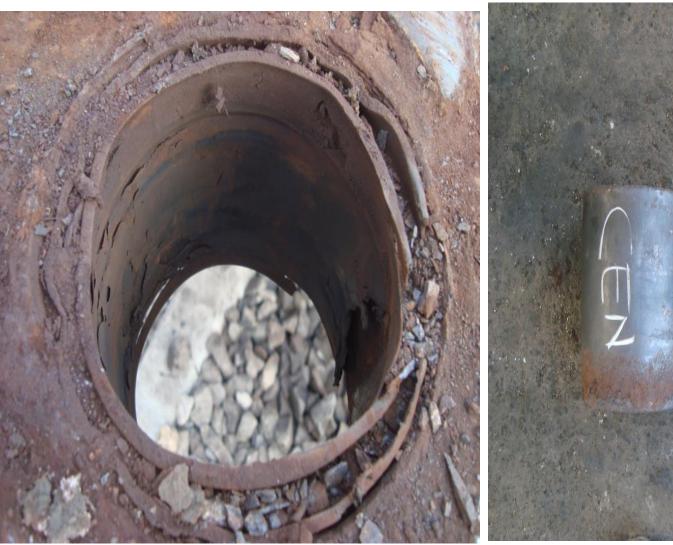
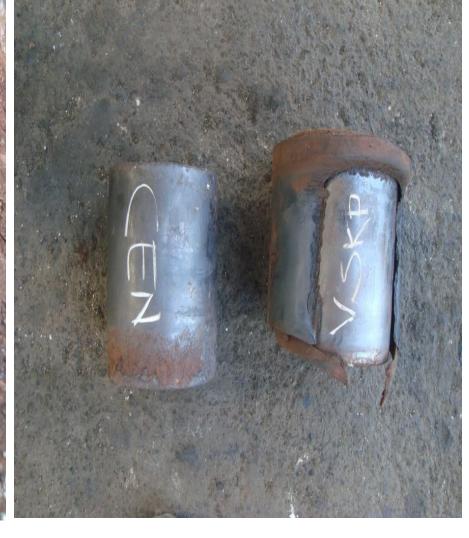
The silent block bush of coupler body CEN end of coach rubber bonding is completely given up due to which sleeve worked out as shown above.

The silent block of coupler body VSKP end also given up partially as shown above.
