# **Presentation** **on** Engine Block Maintenance Practices

**P.K.Ramani**  
SSE /Power Pack  
Diesel Shop Ajmer

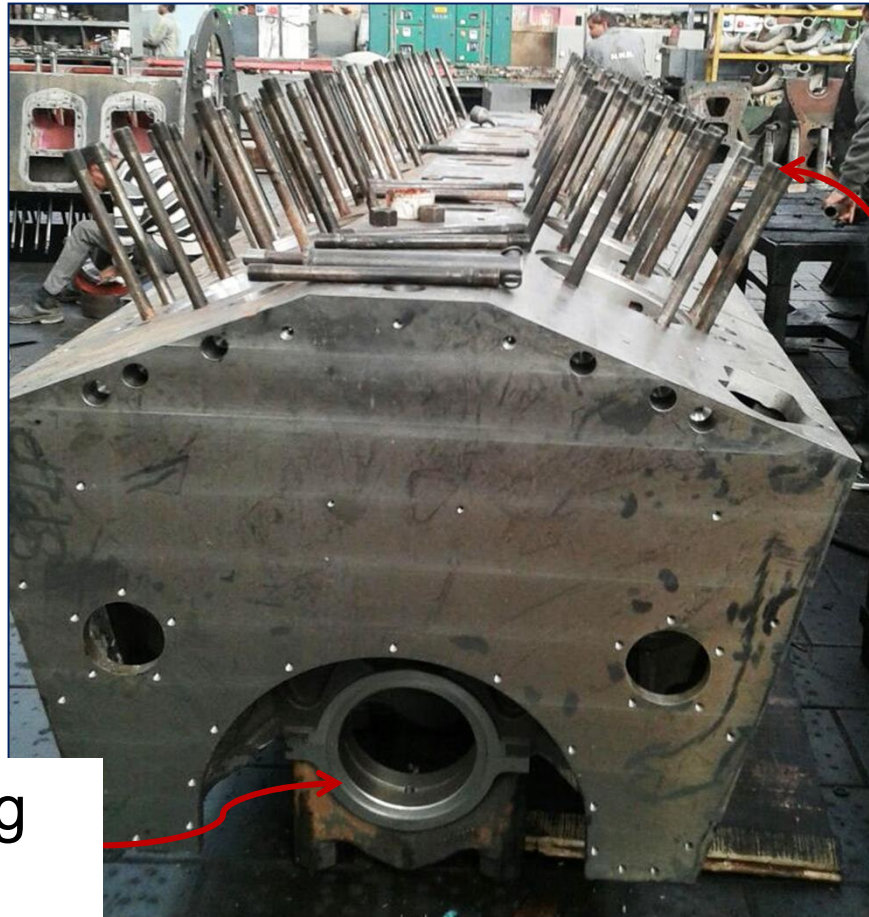
# ENGINE BLOCK

Stud Cyl.  
Head

Main Bearing  
Cap

# Engine Block

➤ **Constructed from steel weldment which houses and supports**

- Engine crankshaft & main bearings
- Camshafts
- Piston & connecting rods
- Cylinder liners & cylinder heads
- Governor
- Generator
- Turbo supercharger, exhaust manifold etc
- Fuel pump support & its other parts etc

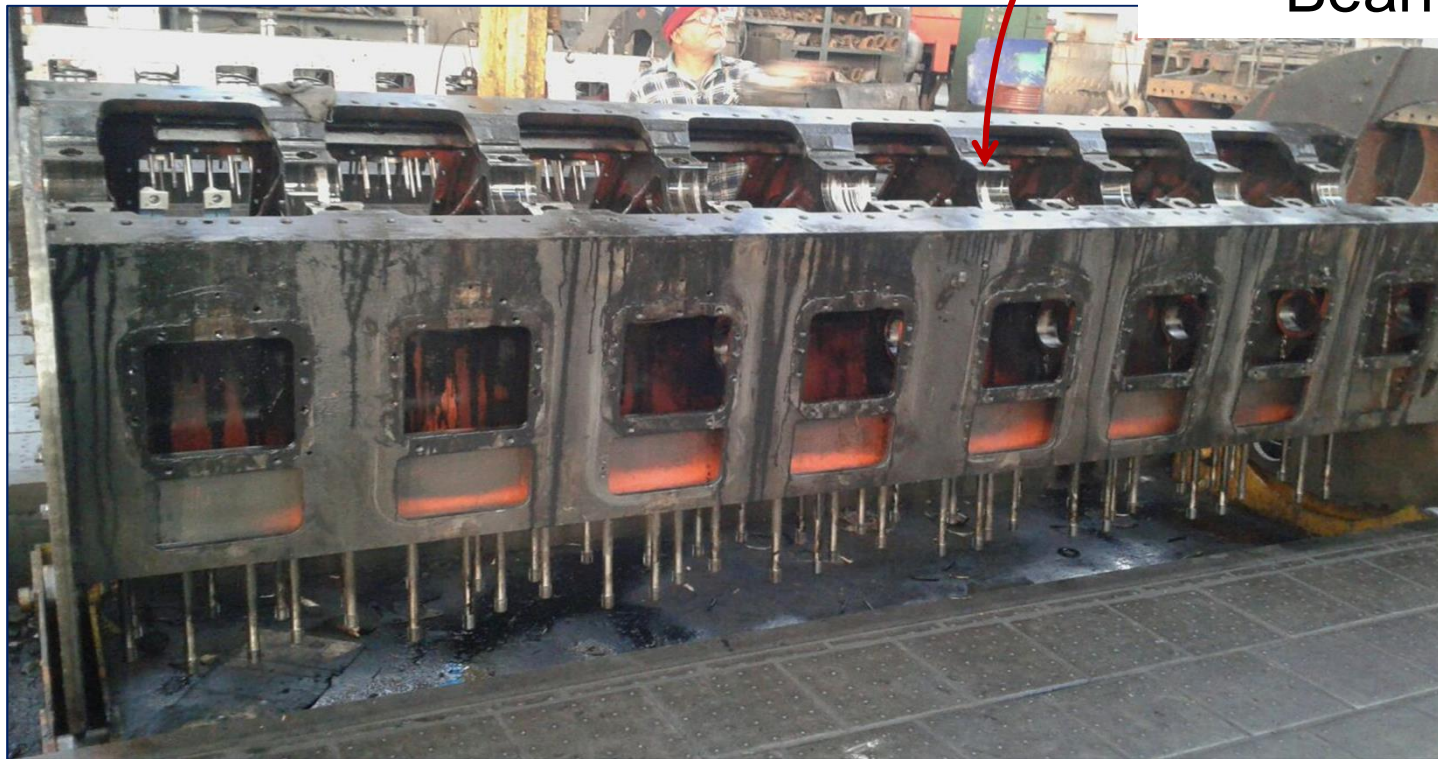
# ENGINE BLOCK

Saddle Main  
Bearing

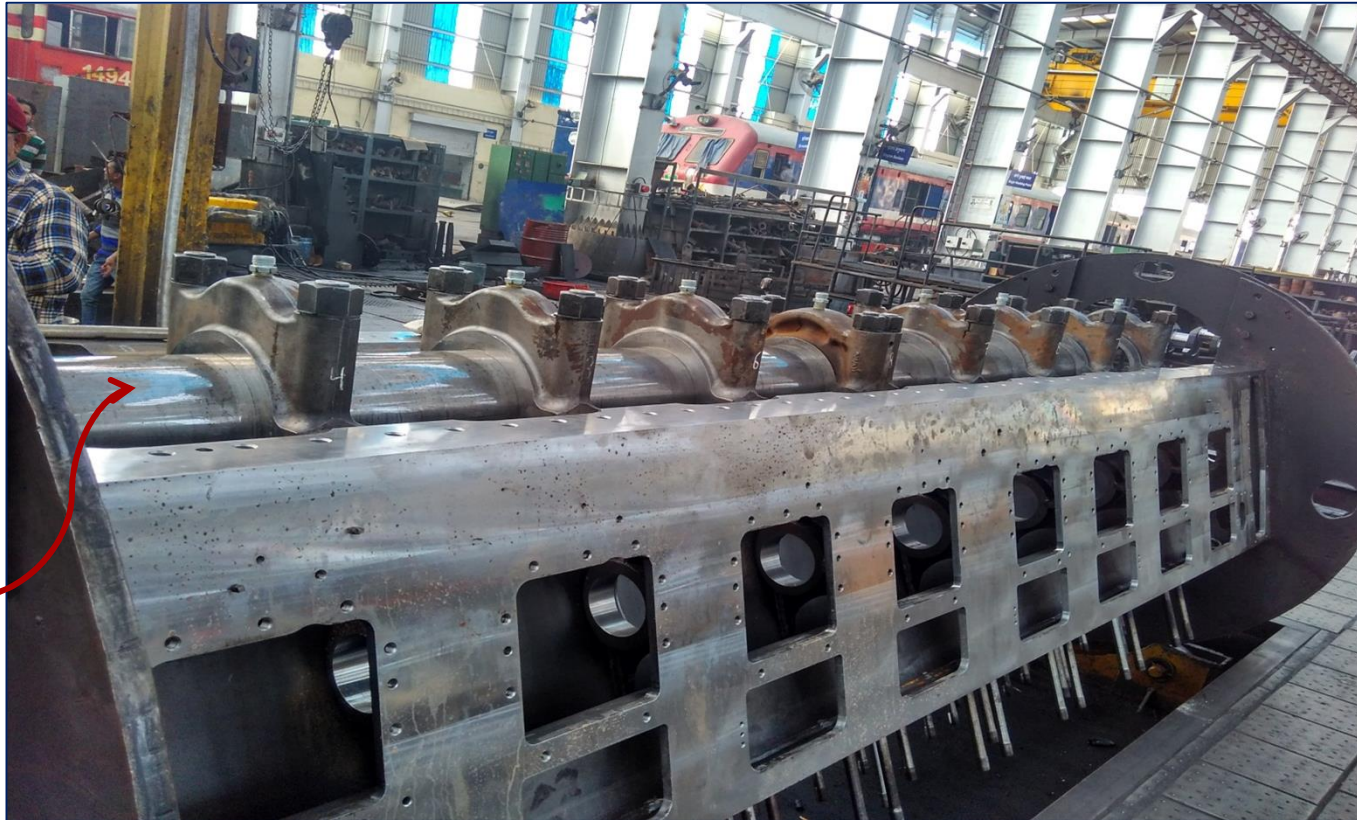
## Checking misalignment of Main Bearing Bores

Mandrel

- DPT of Main Bearing Saddle for cracks
- DPT of CAM eye Bore for Cracks
- DPT of Main Bearing CAP
- DPT of Water Jacket Area and Air Box
- Check CAM eye Bore Size
- Check Main Bearing Bore
- Check misalignment of Main Bearing Bores
- Check Size of lower and Upper Pilots Bores of Block
- Any other damages and defects observed

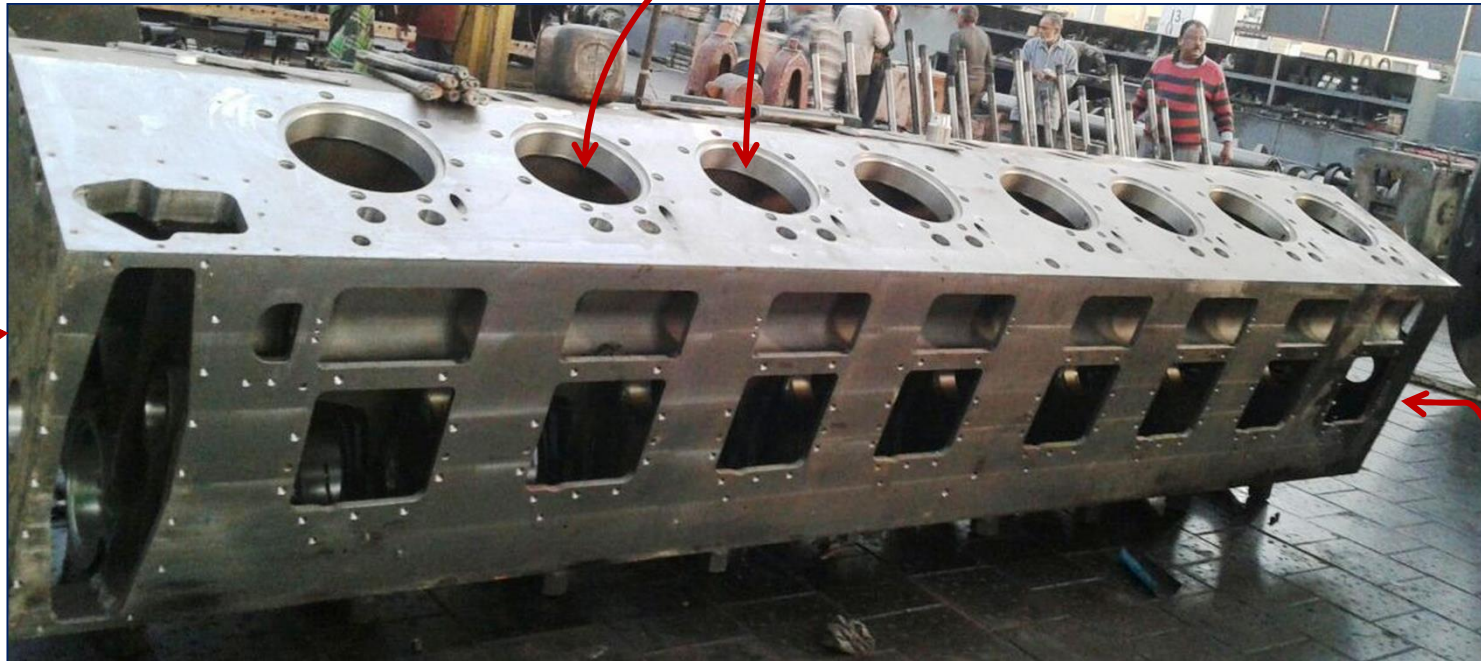
# ENGINE BLOCK

Upper Pilot for Cyl. Liner

Generator End

Free End
