1. **Dashpot testing device**

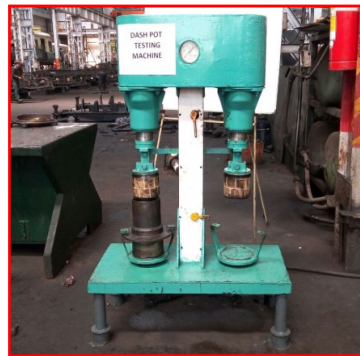
In order to identify the dashpot oil leakages of EMU coaches during POH, a device has been made in-house for testing the dashpot at Car shed/ Tambaram. The dashpot, to be tested, should be kept in the device duly filled with water and gradually air pressure to be applied to the brake cylinder fitted in the device. Axle guide fitted with the Brake cylinder's piston will go inside the dashpot and create pressure inside. If any blow holes or improper welding exists in the dashpot, leakages will appear and can be attended further.

In some of the EMU coaches in service condition, leakage of oil from bottom of dashpot from welded locations is being noticed in spite of thorough checking during POH.
