DEVELOPMENT OF C&W DEPOT INFRASTRUCTURE

DEVELOPMENT IN C&W INFRASTRUCTURE

LESS DETACHMENT SMART YARD

INTEGRATED COACHING MAINTENANCE CONCEPT

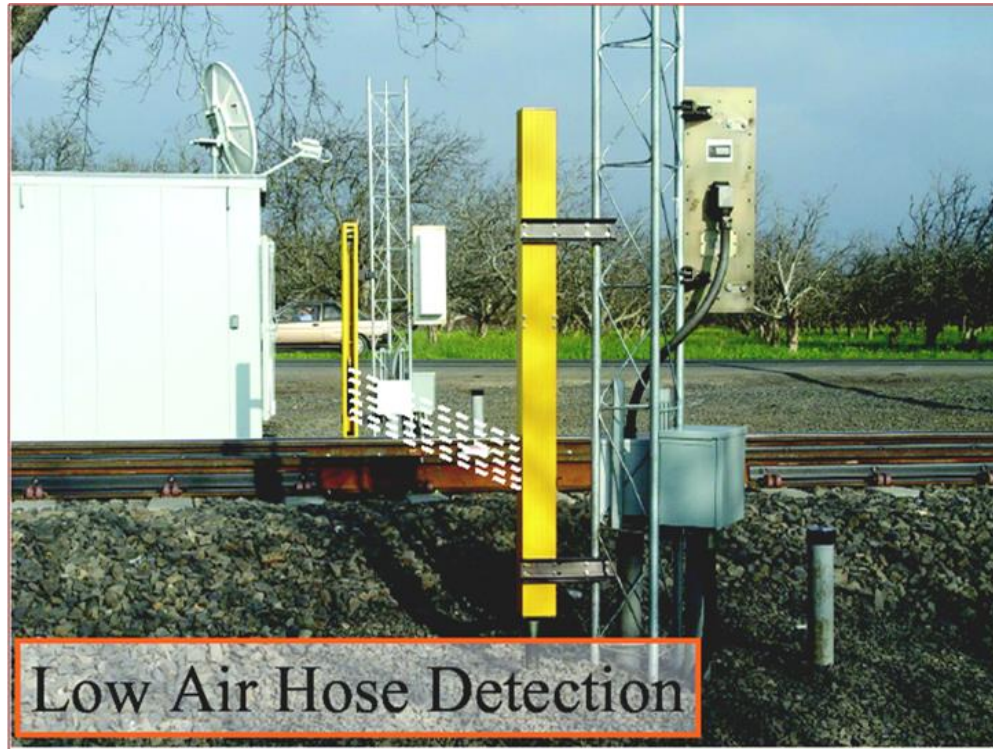
LOW AIR HOSE DETECTION

- Low Air Hose Detection (Hanging Part Detector)

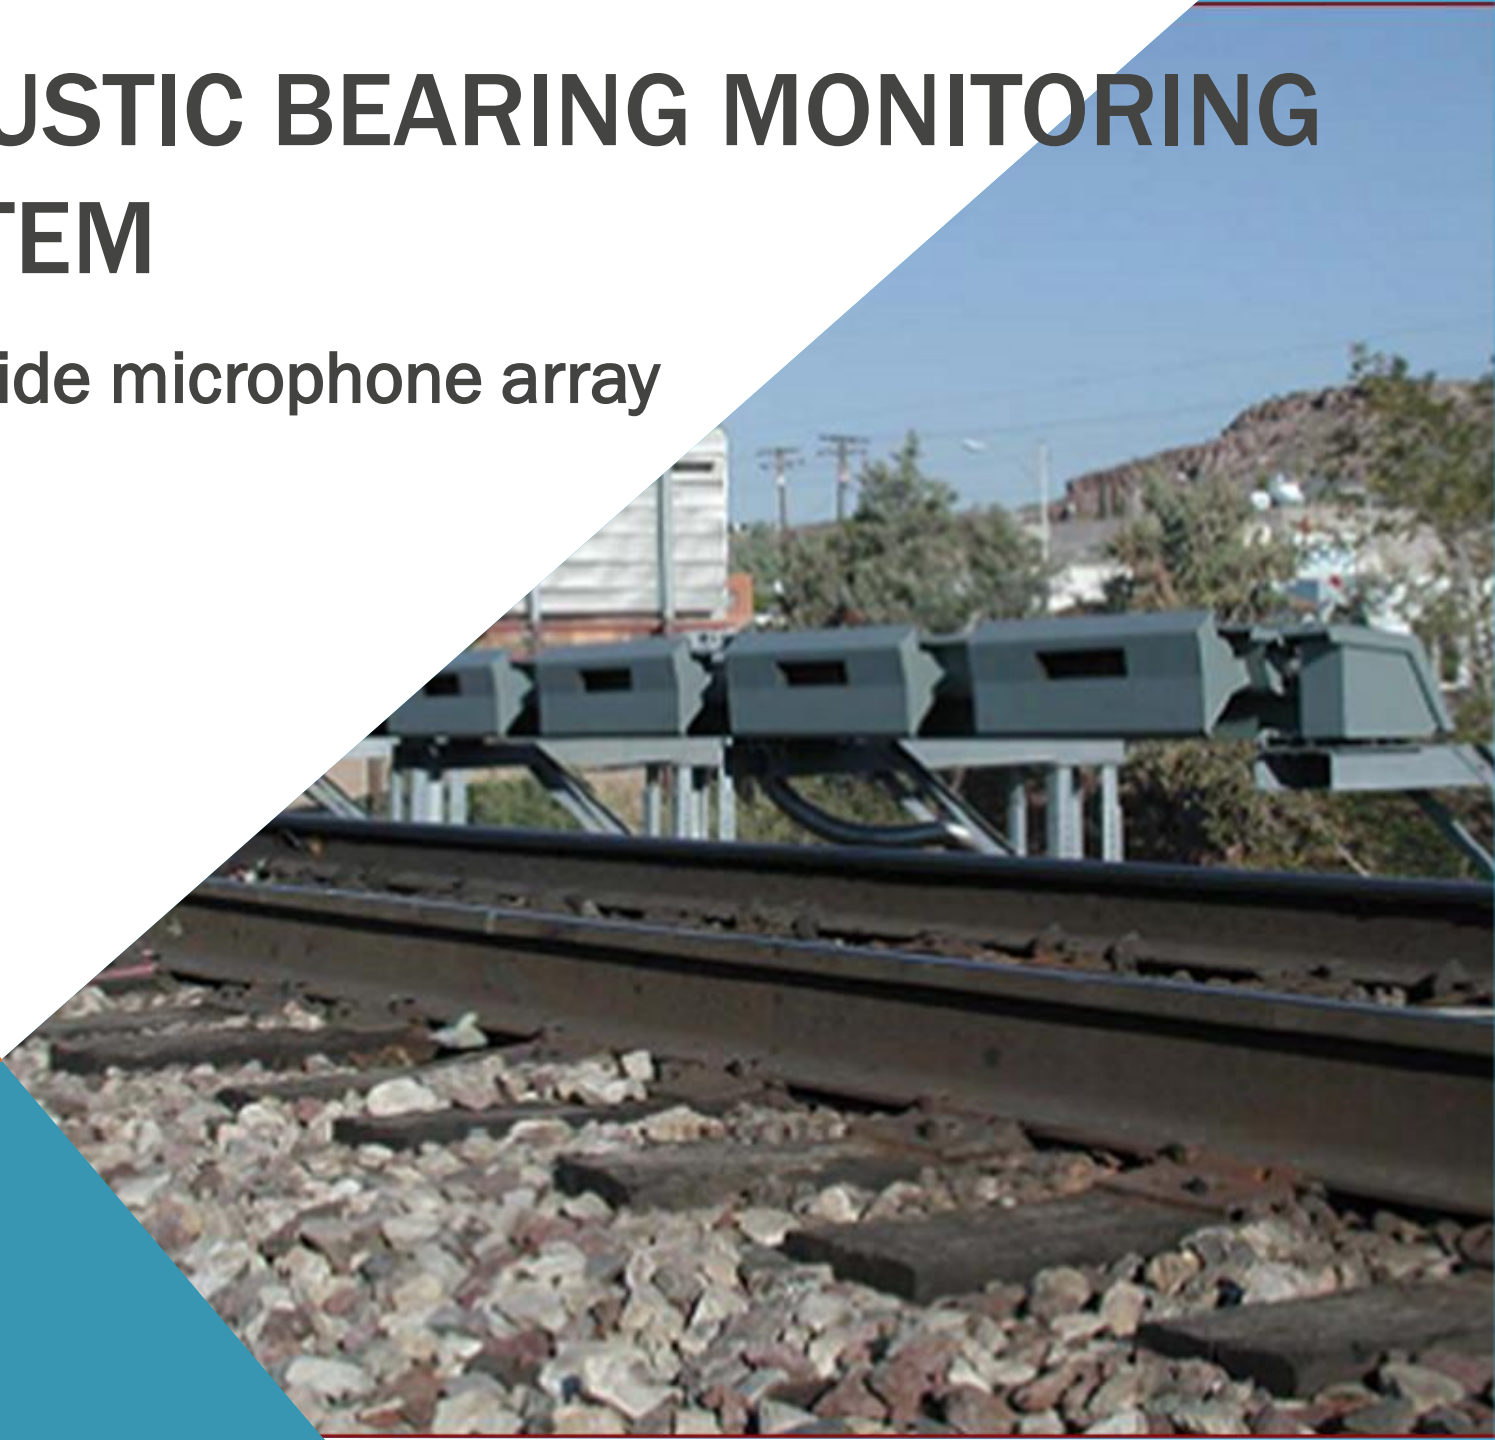
ACOUSTIC BEARING MONITORING SYSTEM

Trackside microphone array

Acoustic Bearing Monitoring System

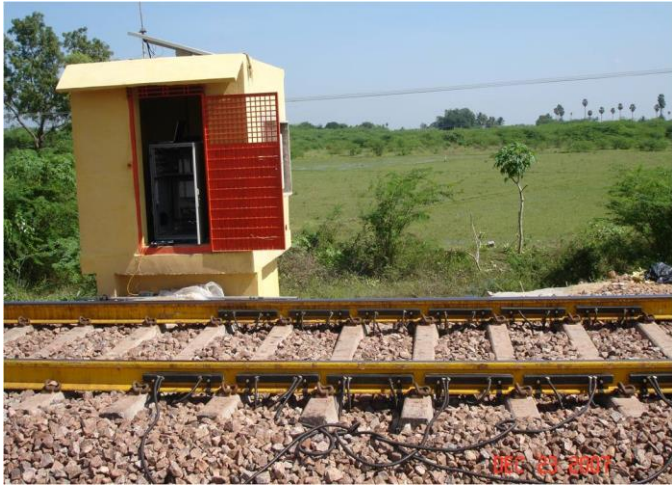
WHEEL IMPACT LOAD DETECTOR

AT ARAKONAM

Wheel Impact Load Detector

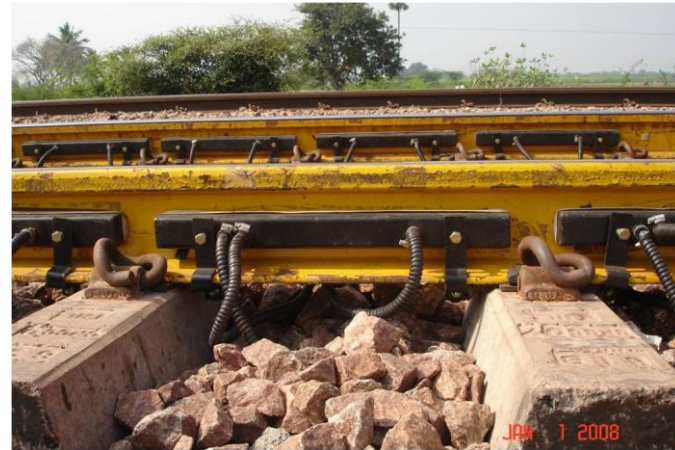
TRACK CLOSEUP

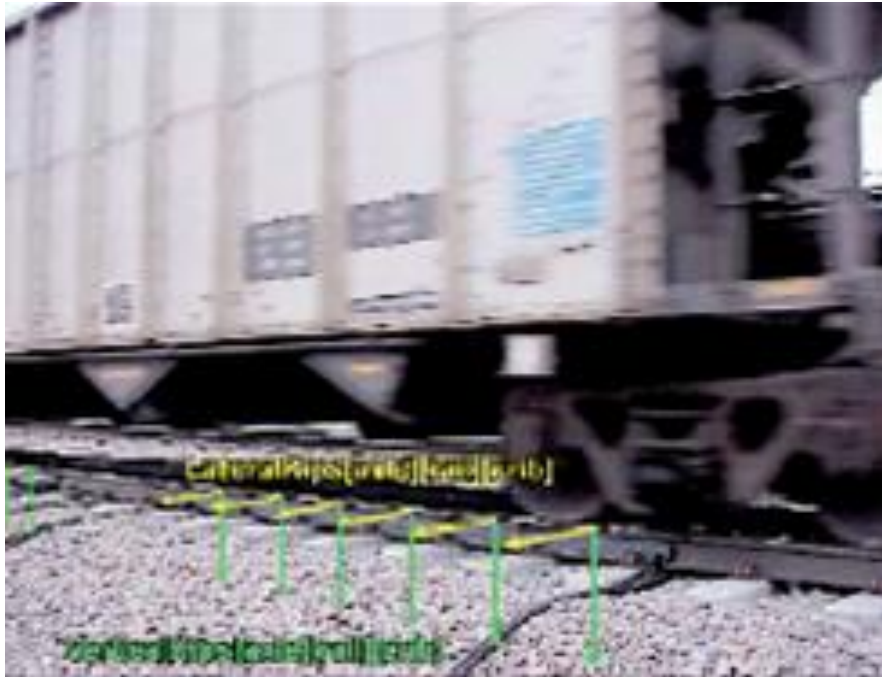
TROLLEY PERFORMANCE DETECTOR

- Angle of Attack (axle)
- Lateral Wheel Load
- Vertical wheel load
- L/V (lateral/ vertical) ratio
- Automatic Equipment Identification

Trolley Performance Detector

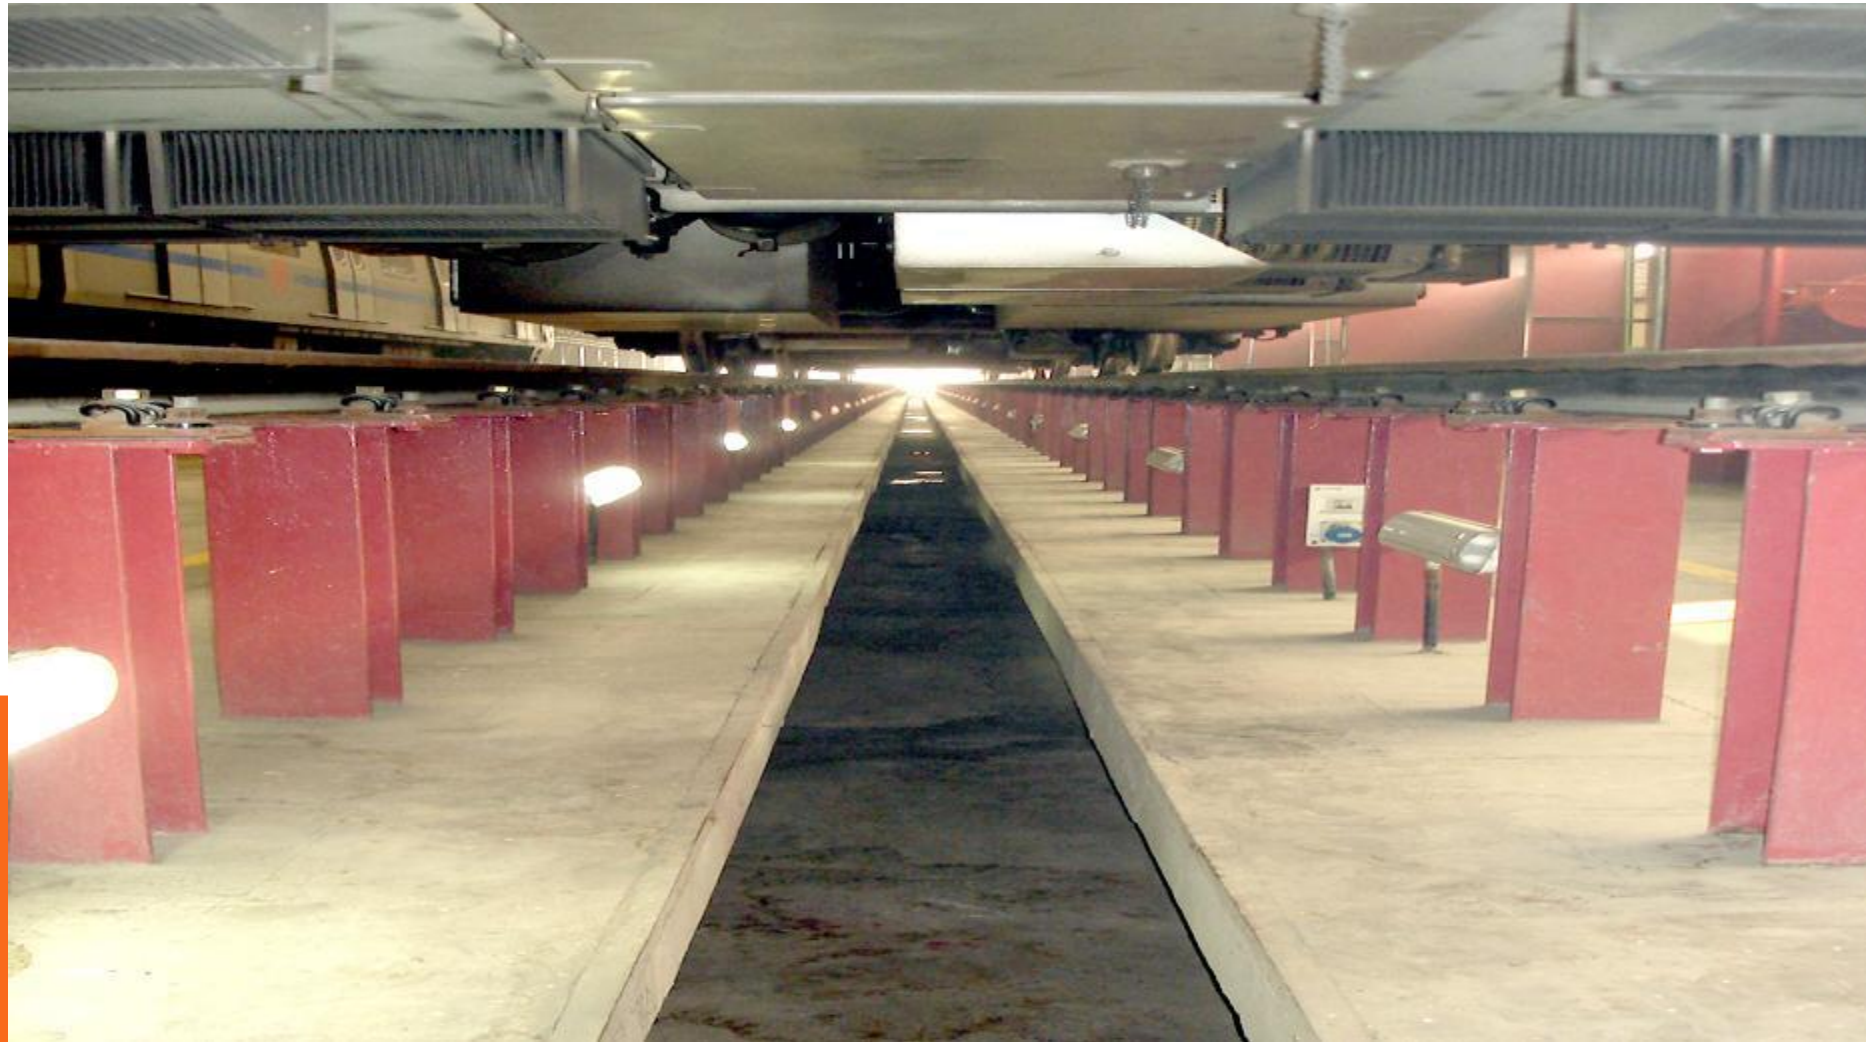
DMRC Coach on Pillar Design Pitline

Proposed System of Coaching Depot

One side or No Catwalk with

Easy to Construct – On Steel Pillar

Economical and Expeditious Completion

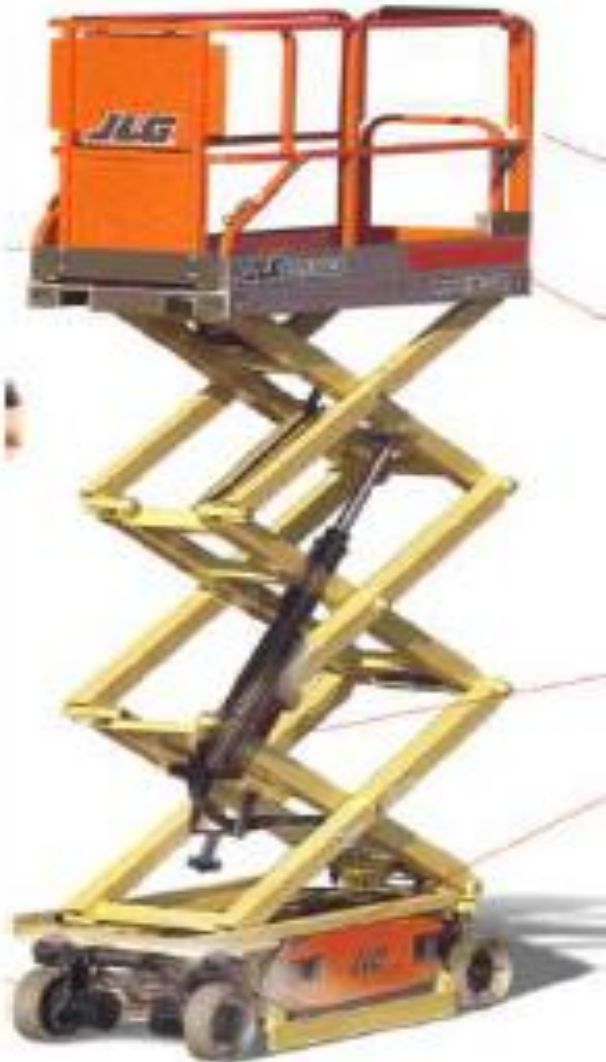
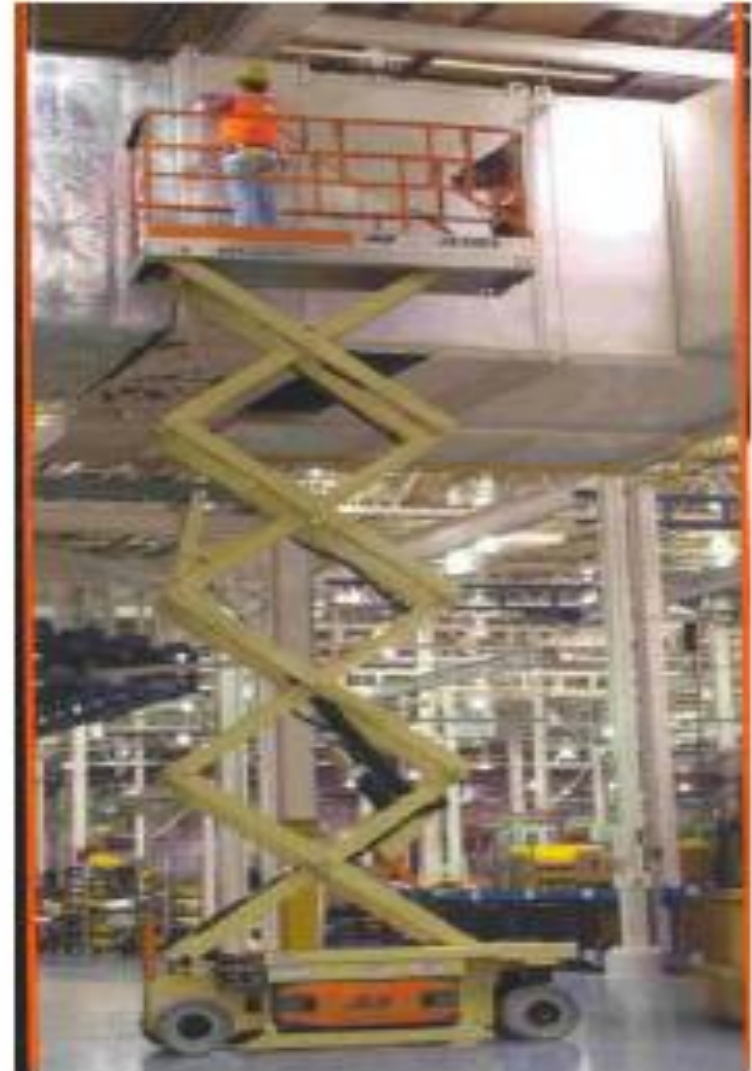
Mobile Lifting Platform

With Help of Mobile Lifting Platform

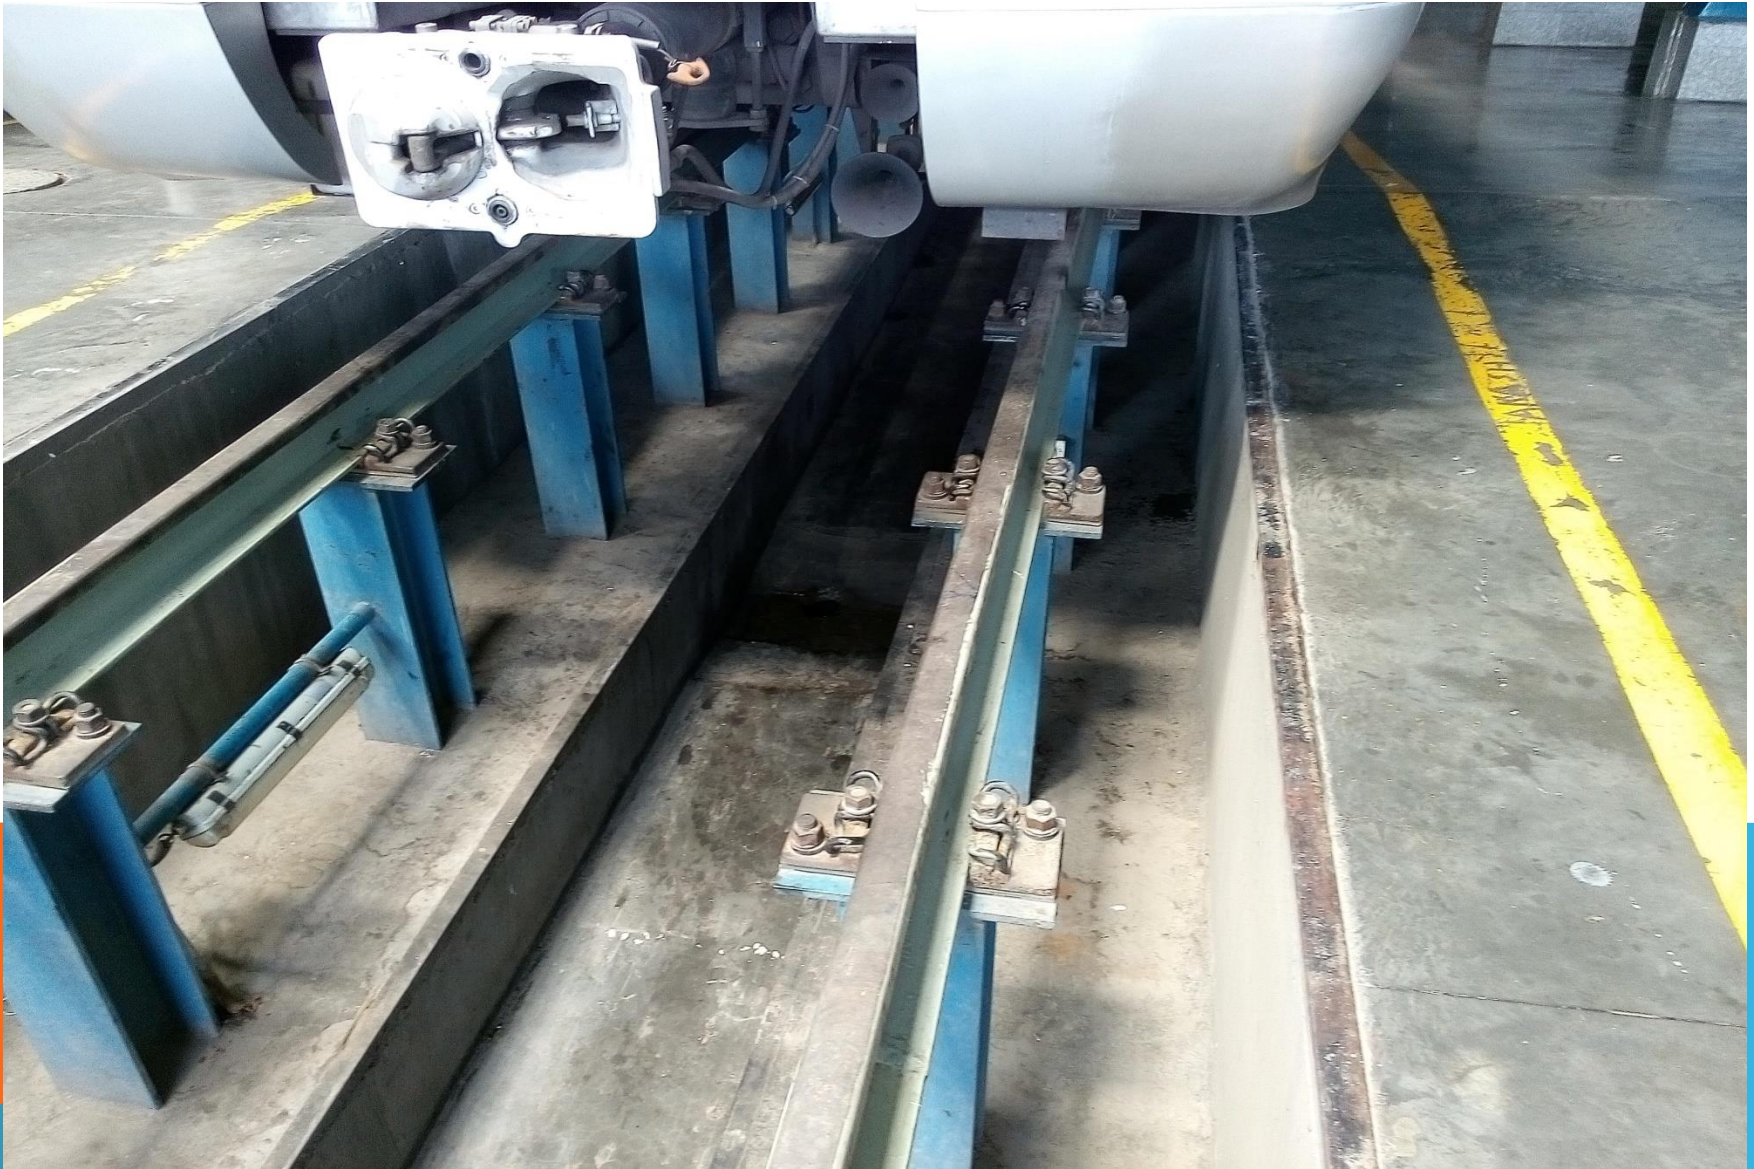
DMRC Coach on Pillar Design Pitline Twin Depth

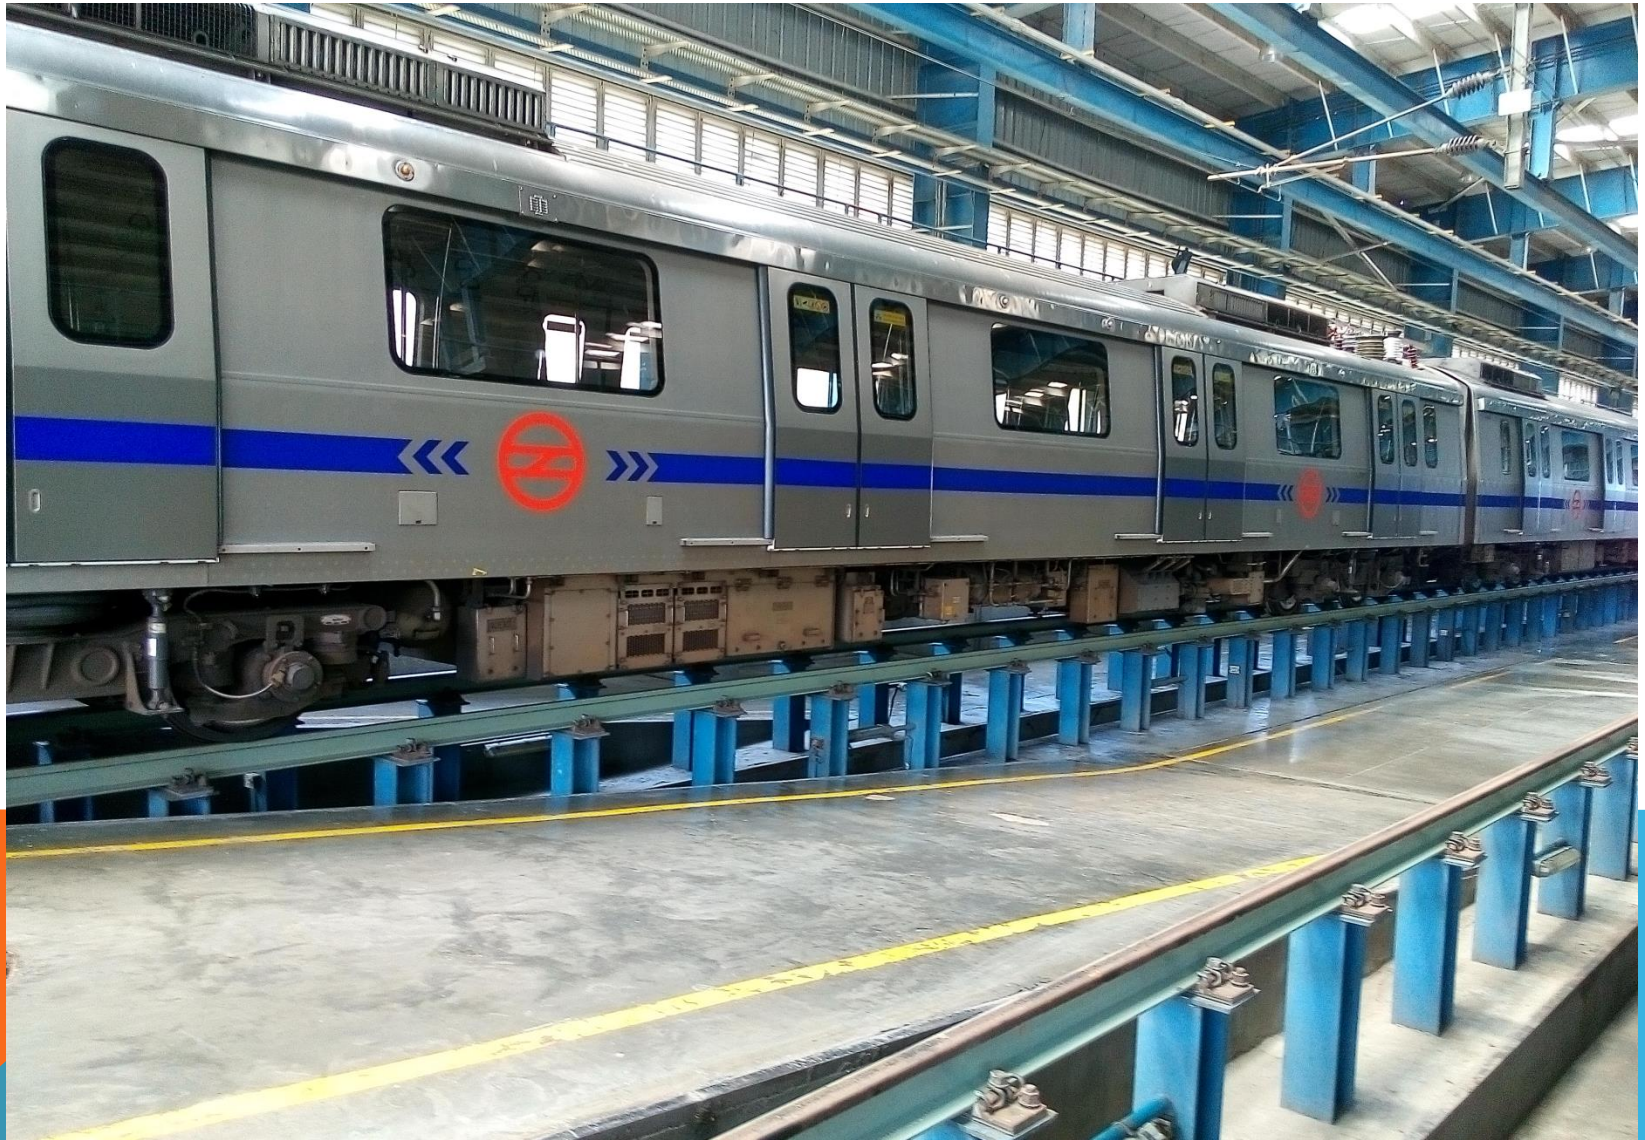
DMRC Coach on Pillar Design Pitline

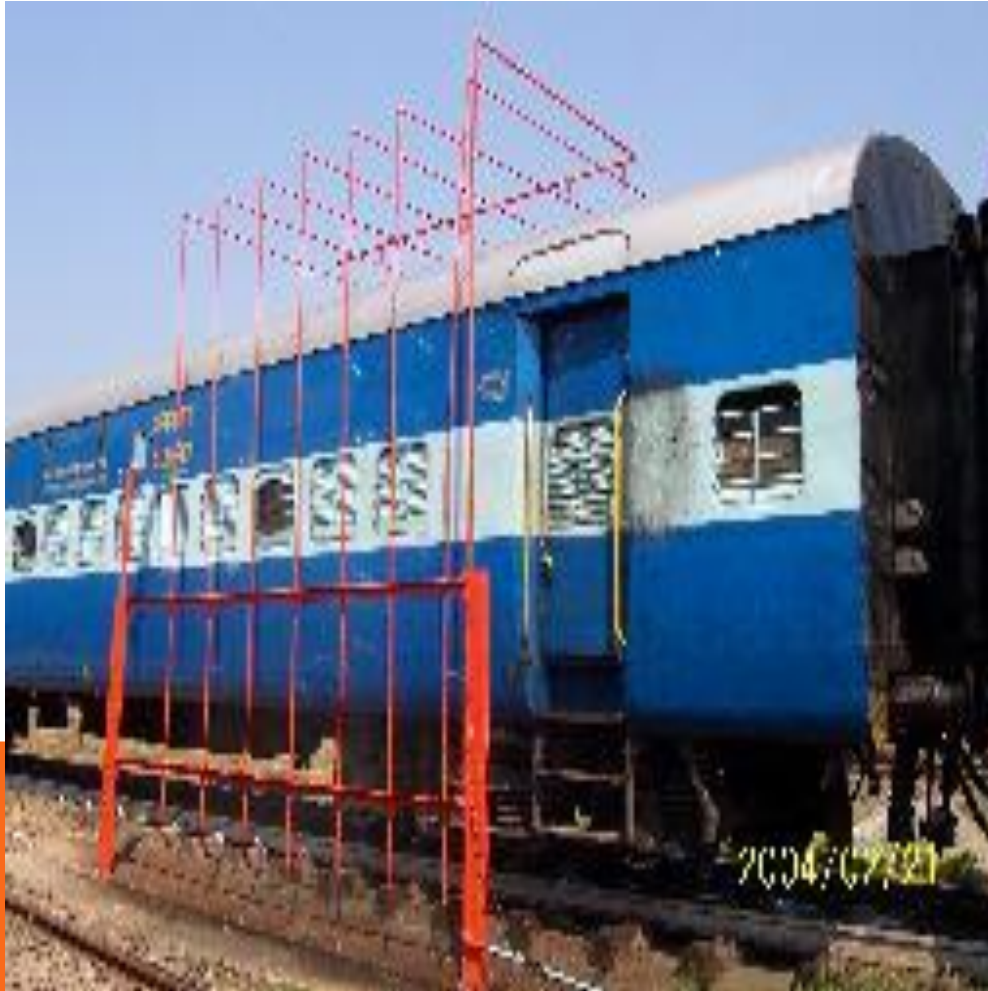
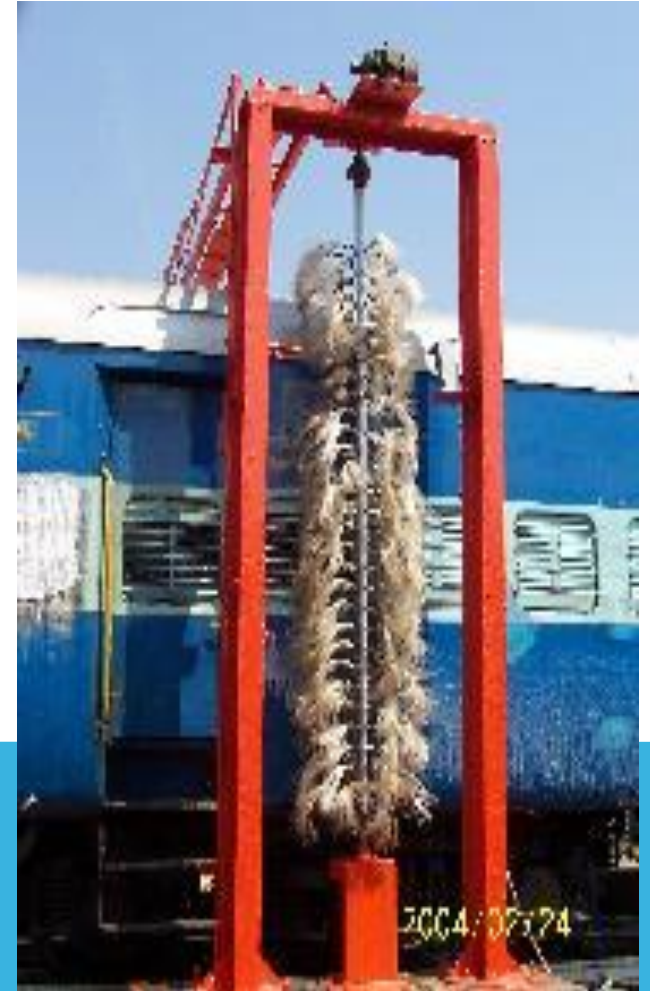
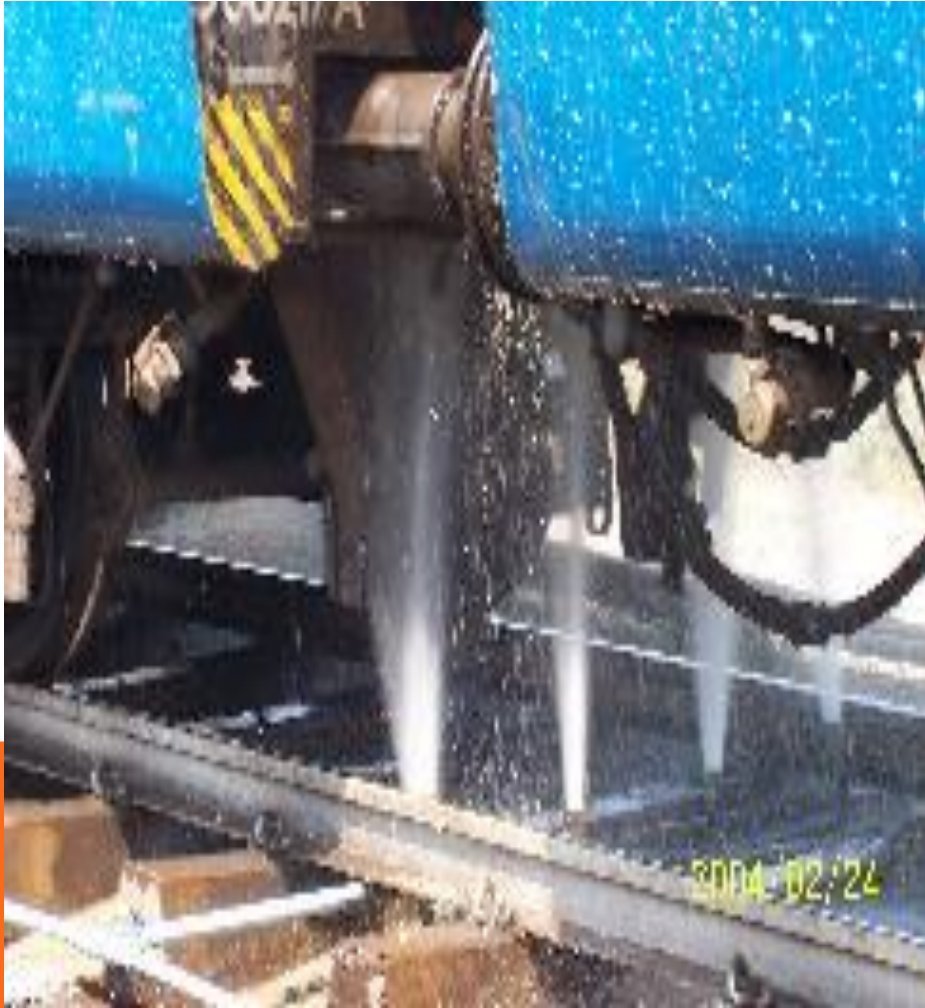
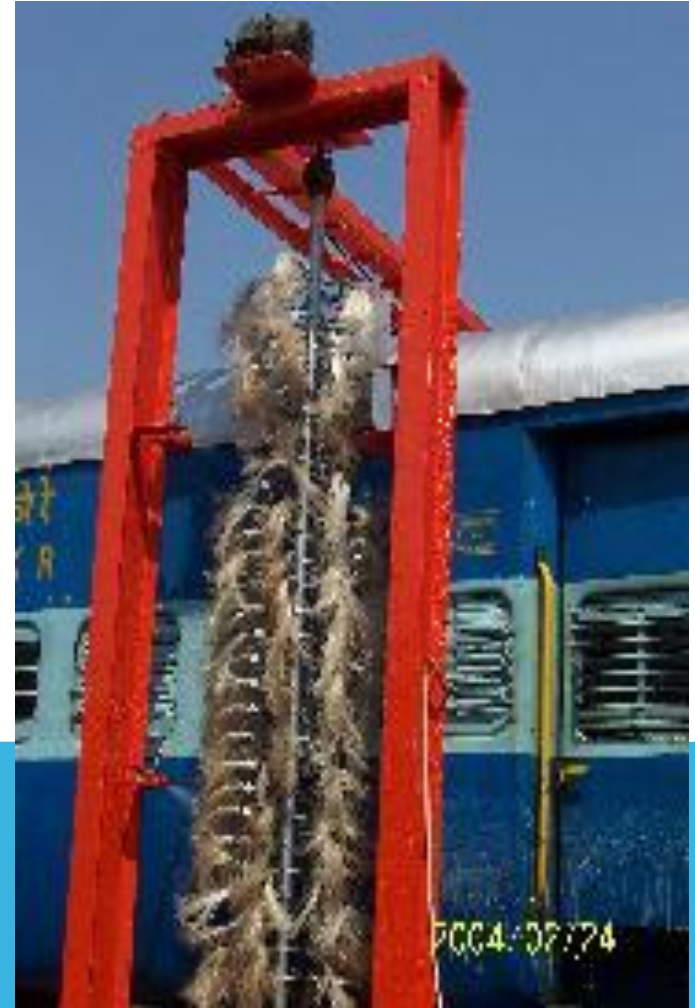
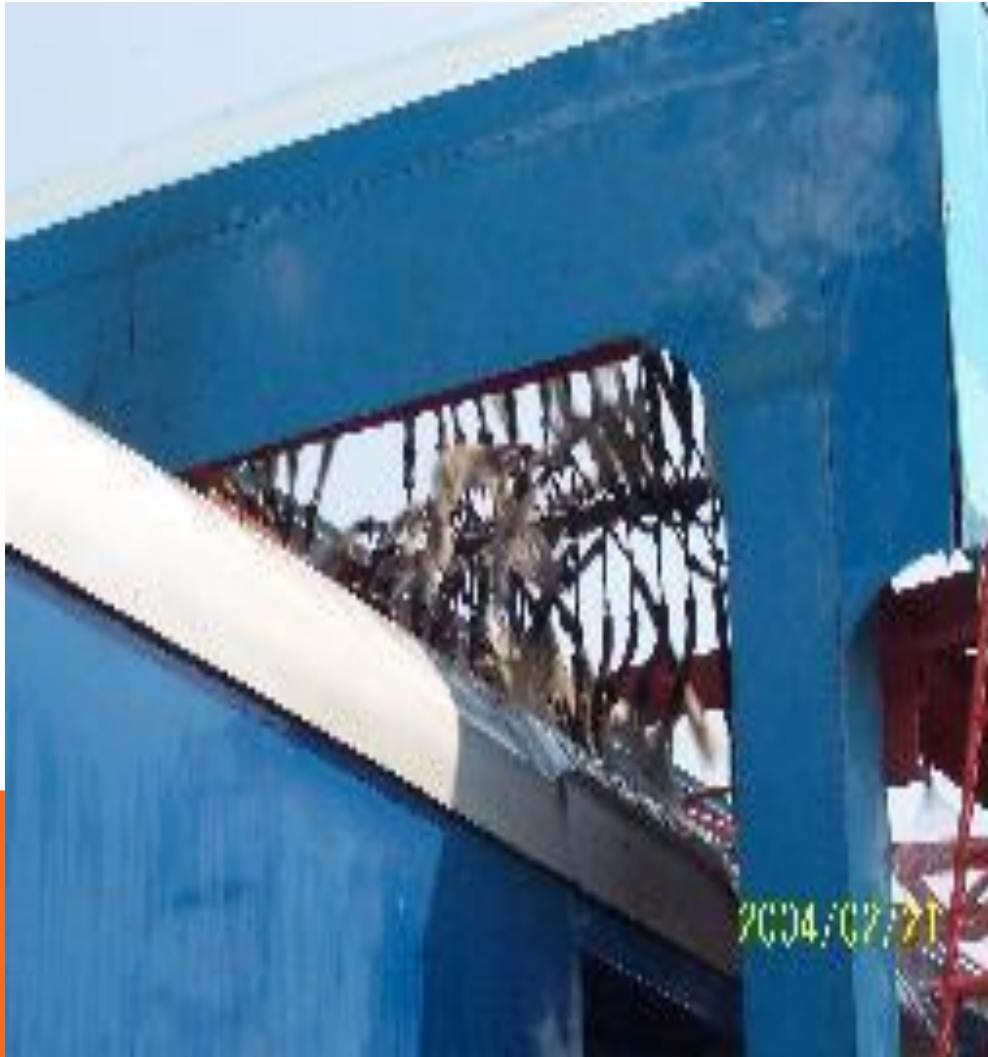
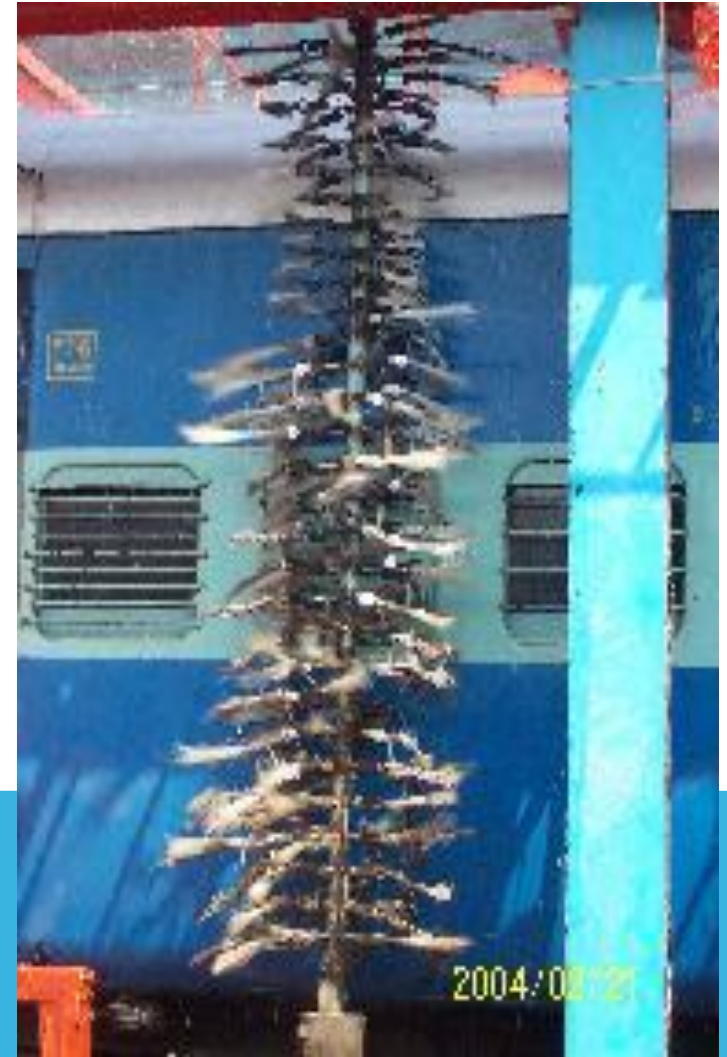
AUTOMATIC COACH WASHING PLANT

Automatic Coach Washing Plant

Automatic Coach Washing Plant

Outside Body Cleaning

In moving condition

Reduce the Coach washing time

Reduction in Water Spillage

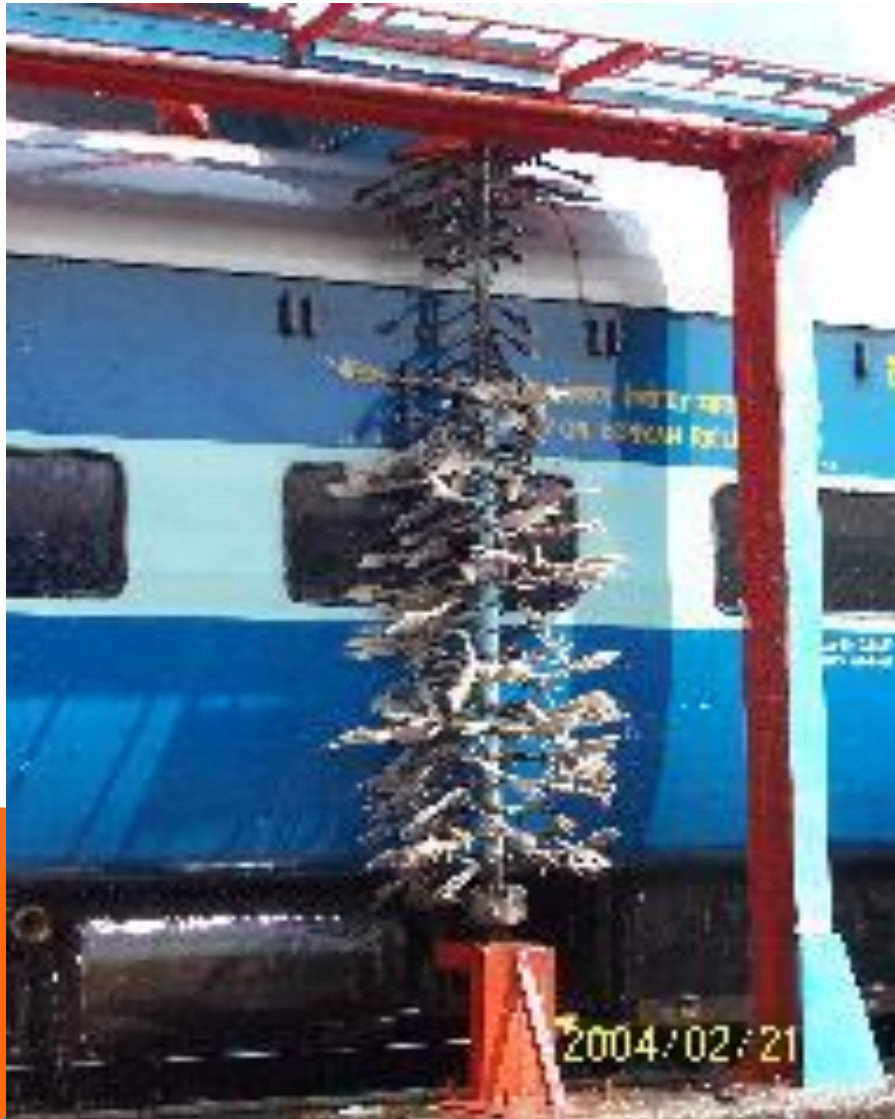
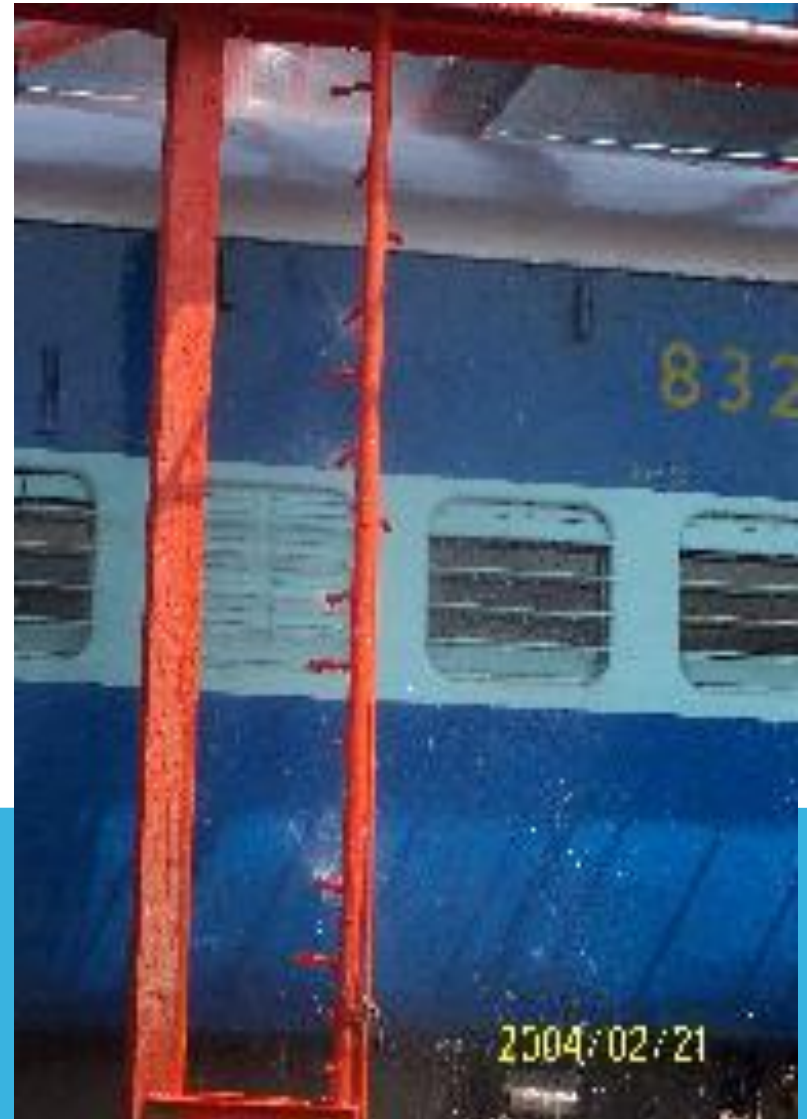
AUTOMATIC COACH WASHING PLANT

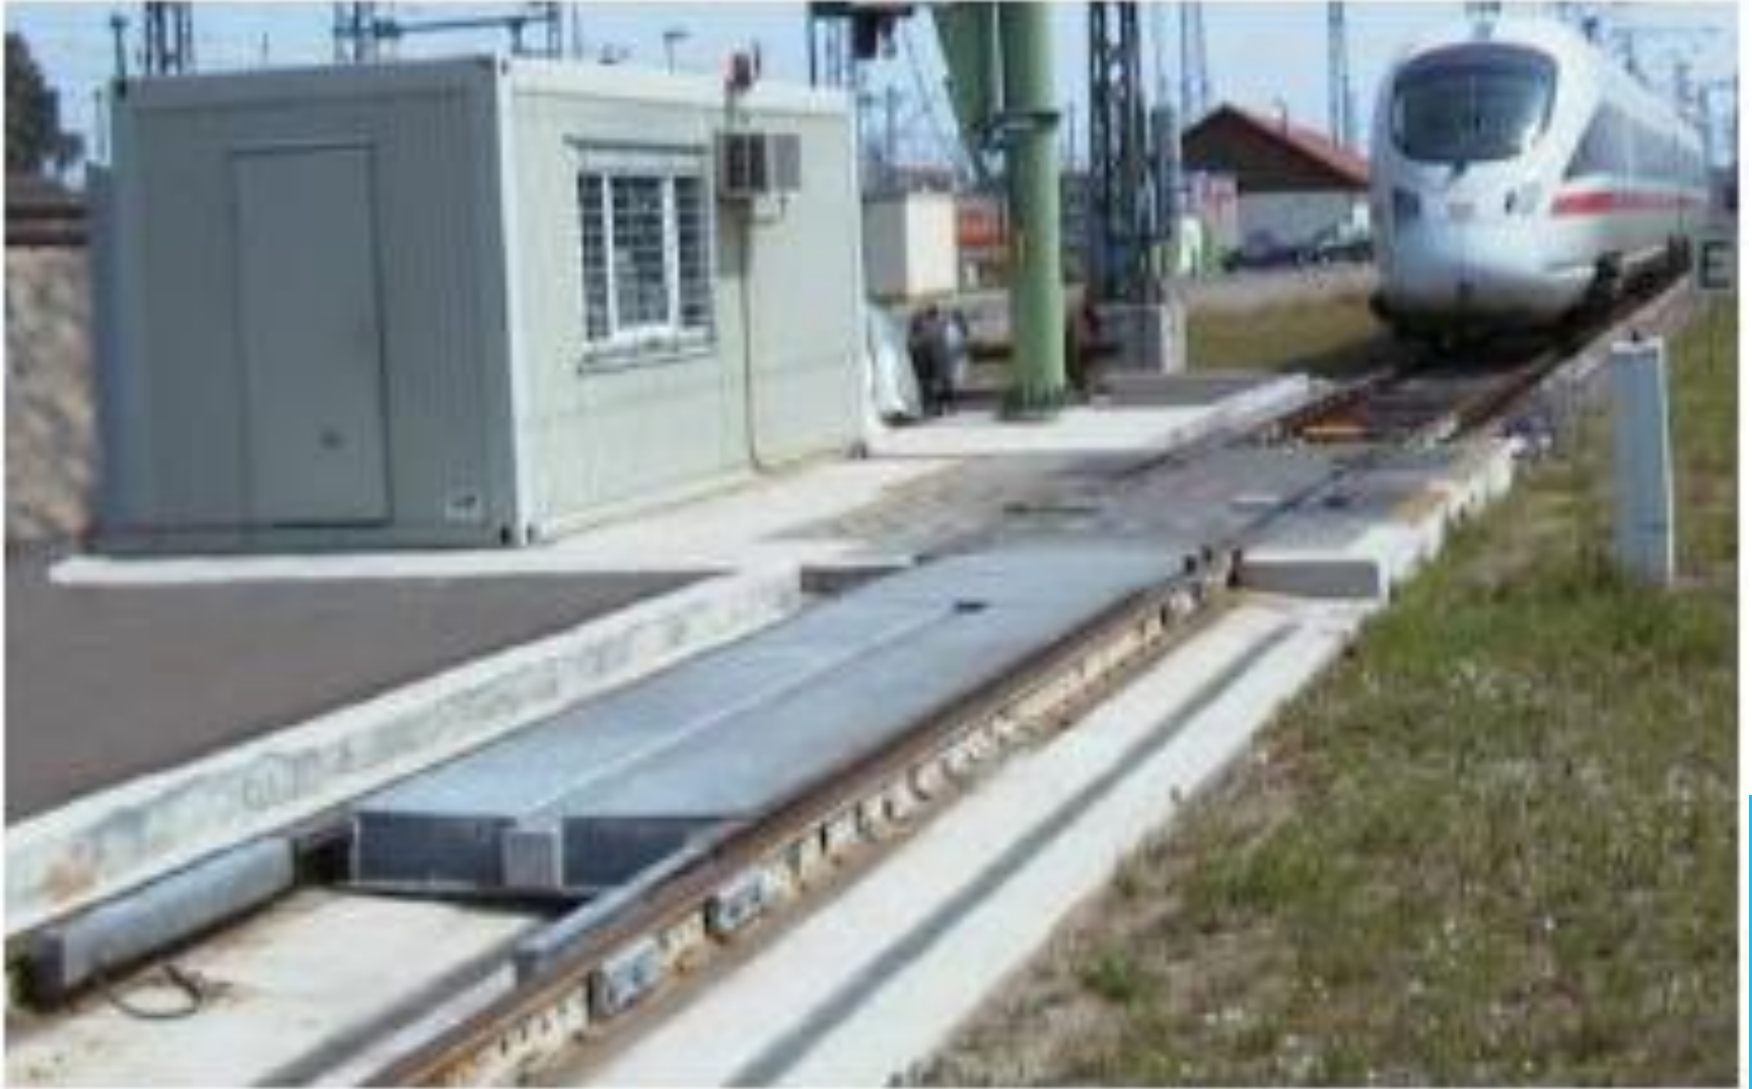
Automatic Wheel Diagnostic System

Automatic Wheel Diagnostic System

On line monitoring of wheel profile

On line Crack detection

On line detection of Flat Place

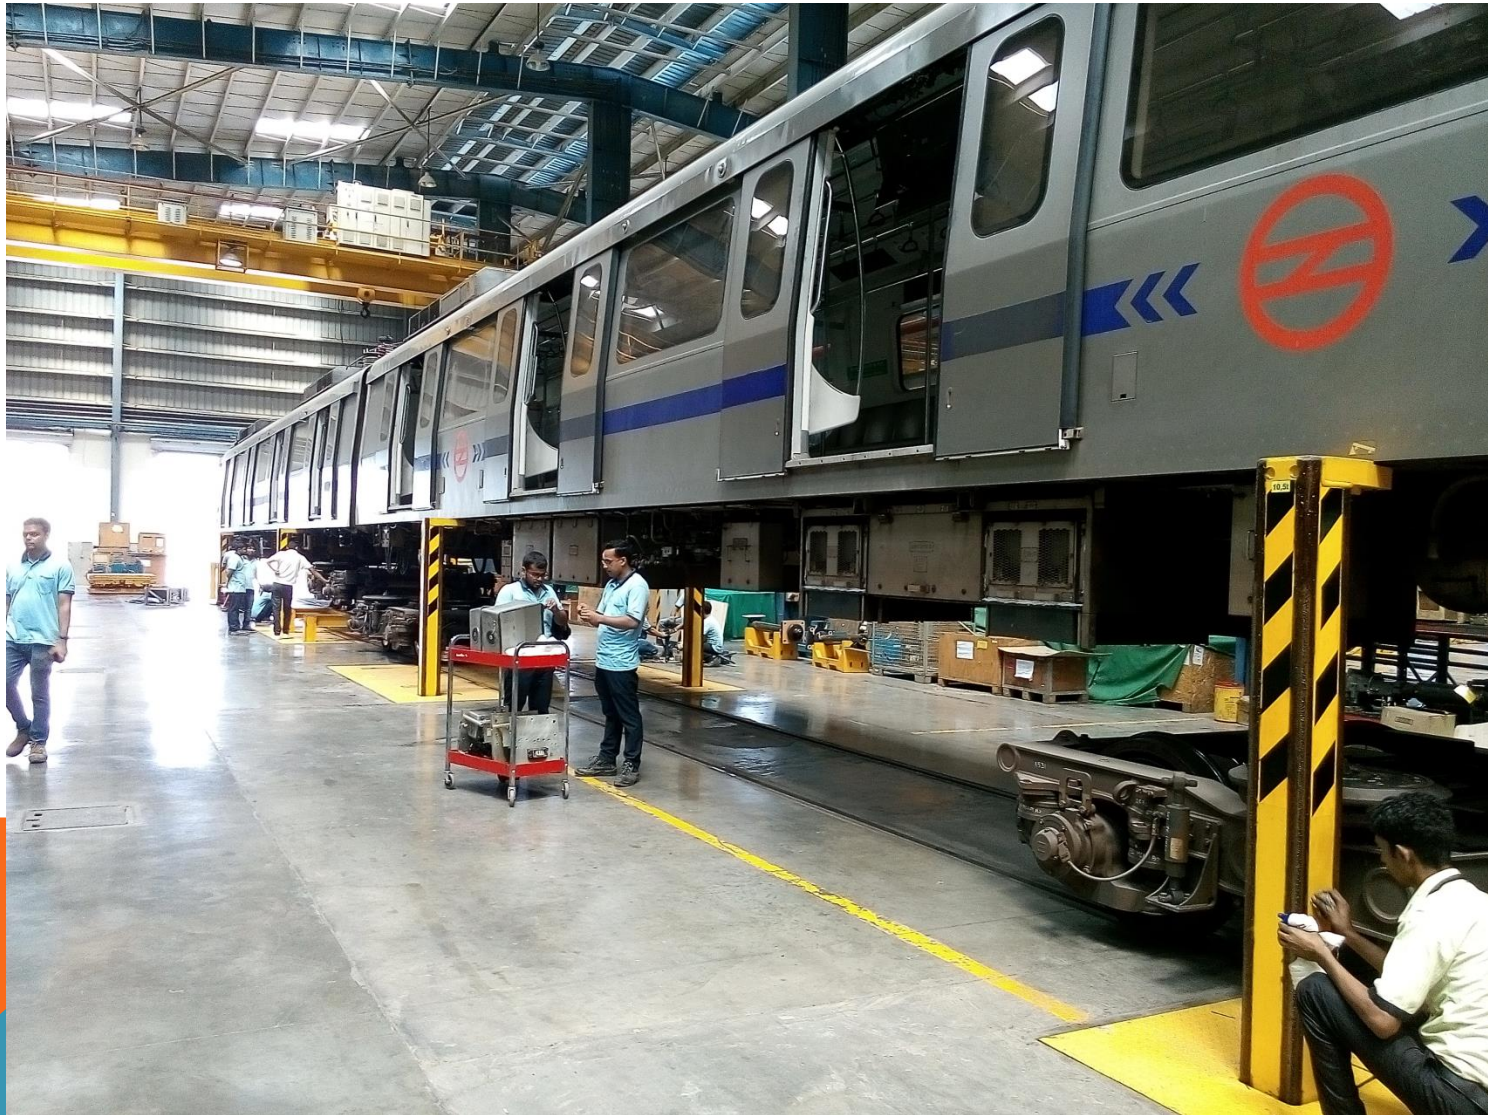
UNDERFLOOR LIFTING PLANT

Underfloor Lifting Plant

In Lieu of Synchronized Lifting Jacks

For Lifting of Whole Train Set
