DEVELOPMENT OF C&W DEPOT INFRASTRUCTURE

DEVELOPMENT IN C&W INFRASTRUCTURE

LESS DETACHMENT SMART YARD

INTEGRATED COACHING MAINTENANCE CONCEPT

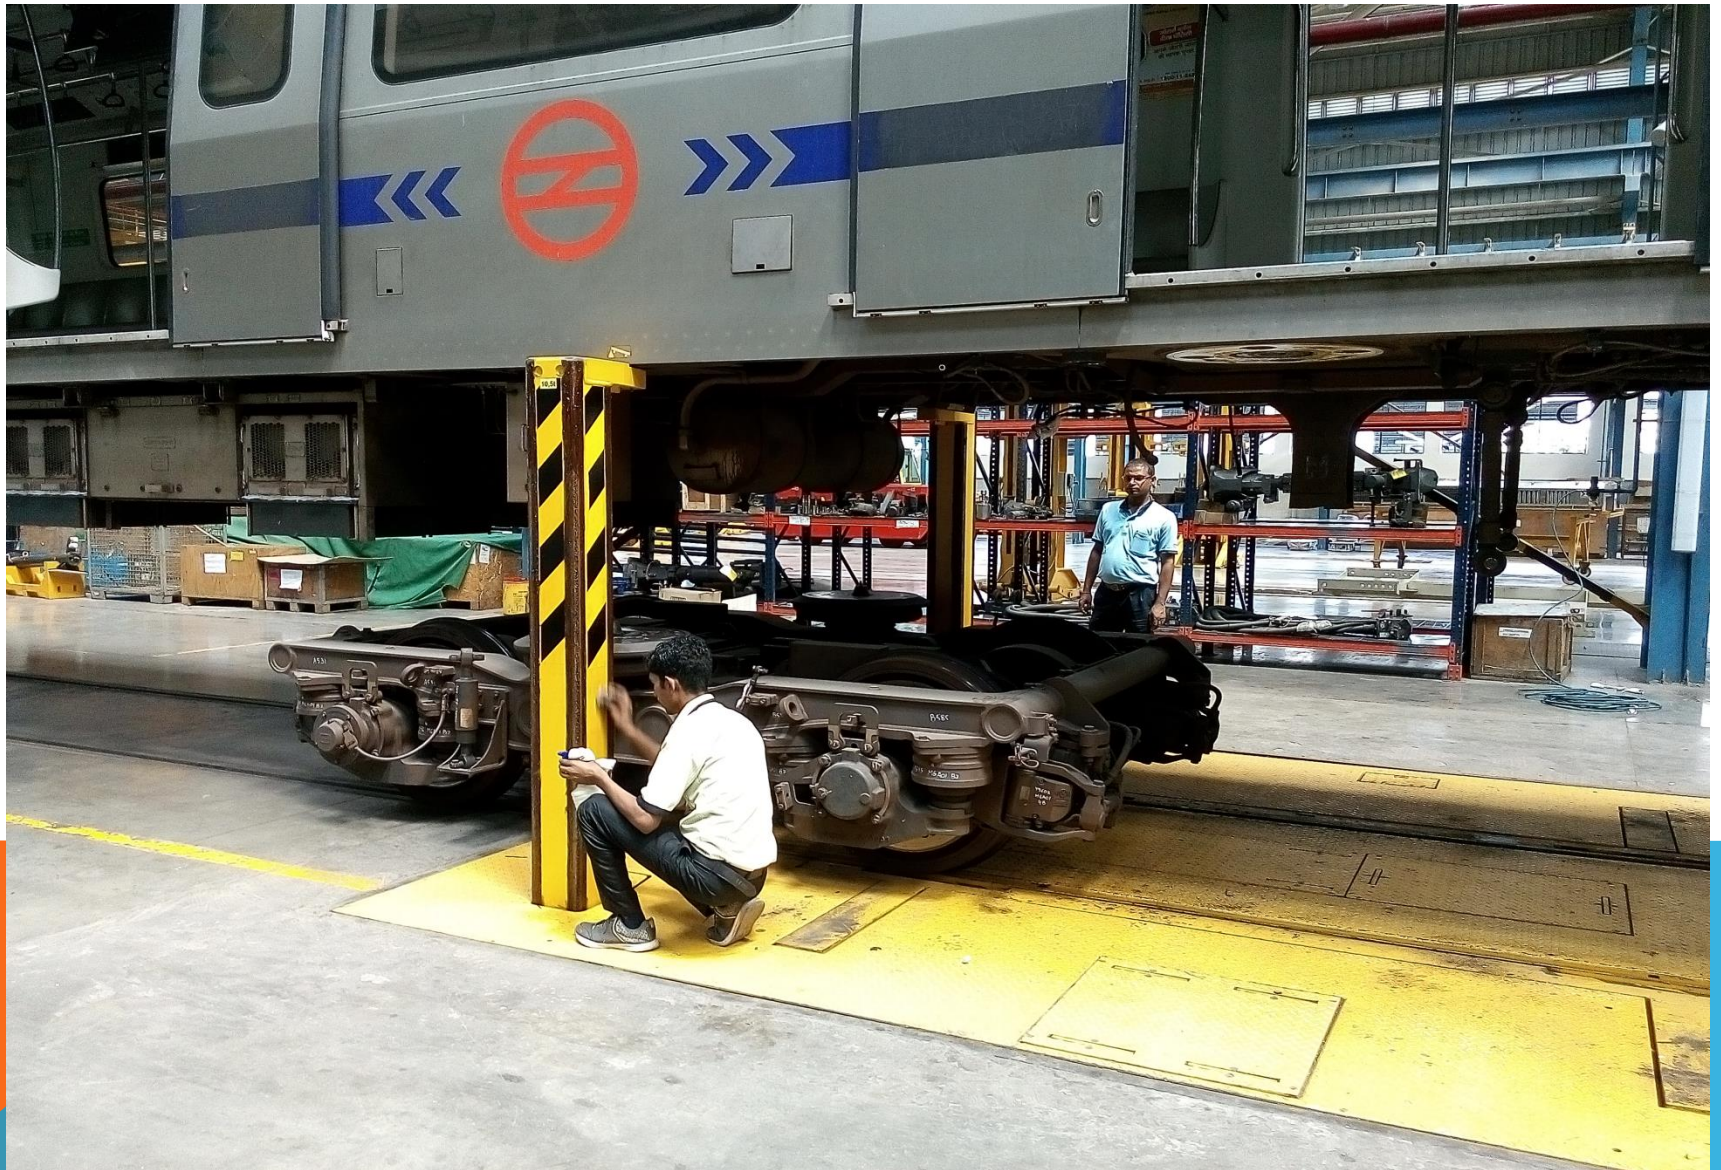
UNDERFLOOR LIFTING PLANT

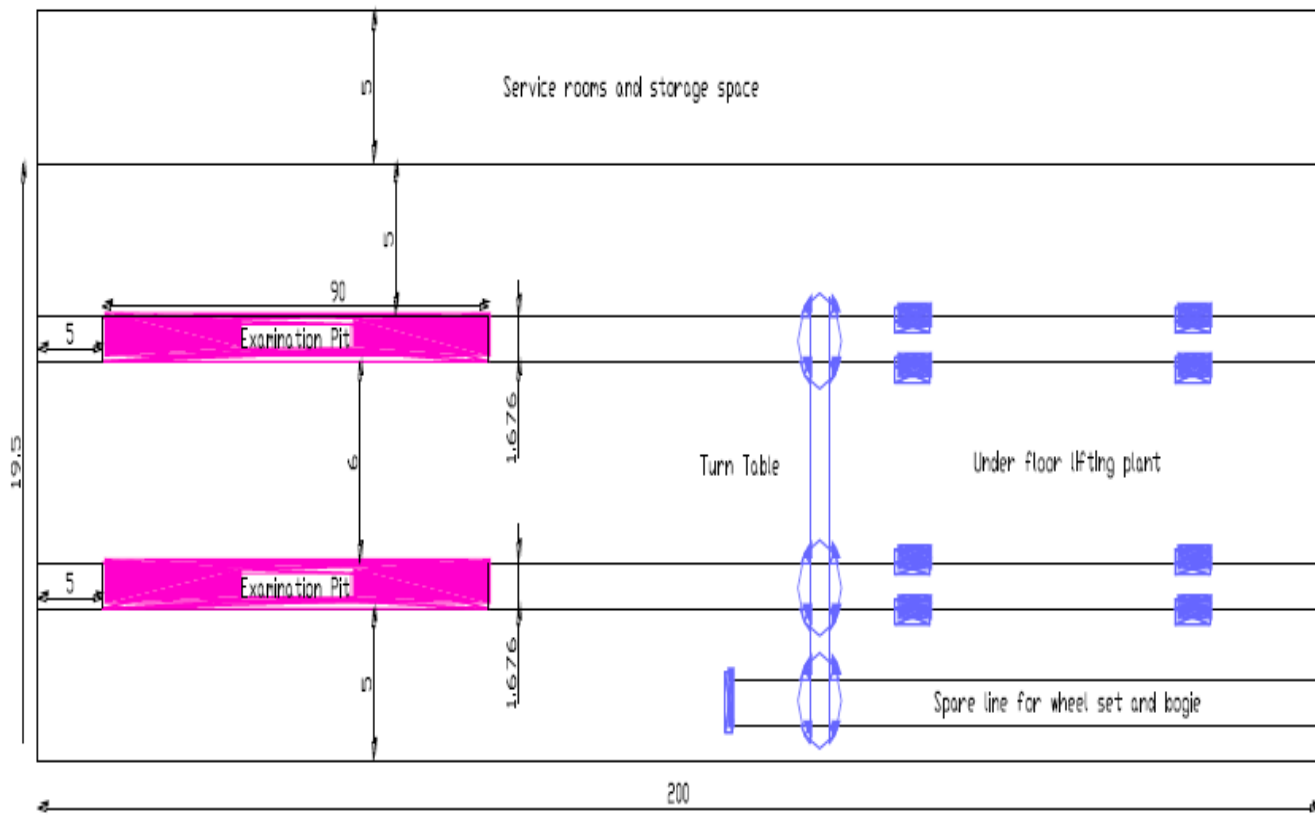
End View

Maintenance Sickline
